Subject: Wake Vortex Effect on Vertical Fin - USAir 737-300 N513AU
Accident Near Pittsburgh - September 8, 1994

Enclosure: Boeing load charts, *Vortex Impingement on 737-300 Vertical Tail*,
July 13, 1995

CALC	NEIL PARKER	13Jul95	REVISED	DATE	VORTEX IMPINGEMENT ON 737-300 VERTICAL TAIL	
CHECK						FIGURE 1.0
APPD.						
APPD.					BOEING	PAGE

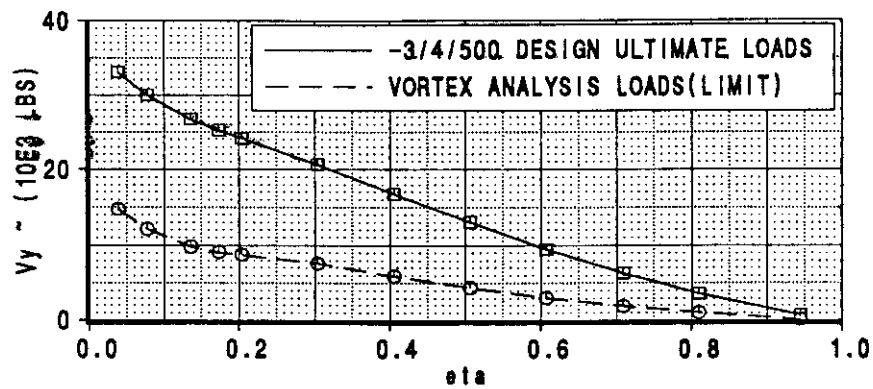
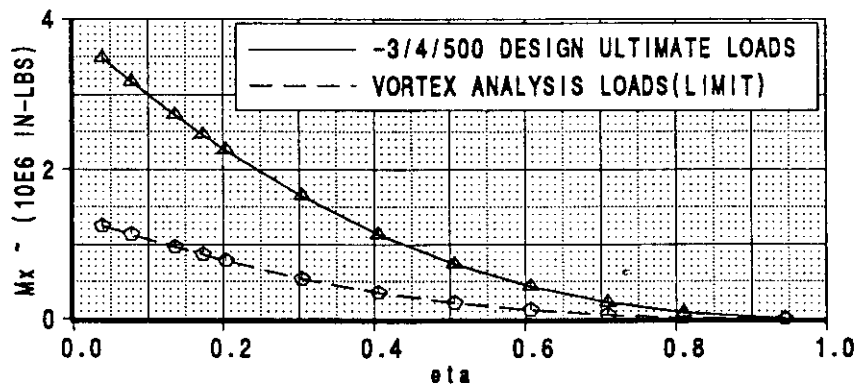
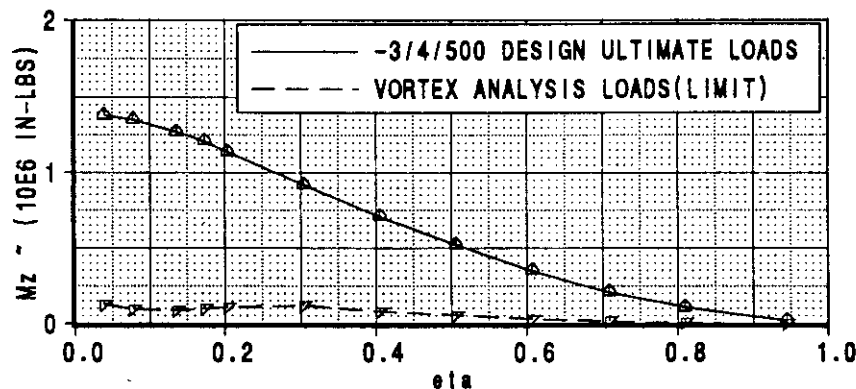
The analysis of an assumed theoretical "worst case" wake vortex impingement from the Delta 727 on a 737-300 vertical tail has been completed by Boeing. In this analysis the assumption is made that the 737 is flying parallel to the centerline of the vortex, at an airplane speed of 190 knots, with the vertical tail projecting through the vortex centerline. The analysis assumes the worst case wake vortex definition, with the centerline of the vortex positioned at the most critical spanwise location on the vertical tail. The results of this analysis in comparison with the ultimate design loads of the 737-300 vertical tail are shown in Figure 1, enclosed. In this figure, V_y is the lateral shear, M_x is the lateral bending moment, and M_z is the torsion about the vertical tail. η is the distance from the base of the vertical tail divided by the height of the vertical tail. The equivalent tangential velocity at the most critical spanwise location is 191 ft/sec, with a vortex circulation of 2400 ft²/sec, and a vortex radius of 2 feet. As a result, the tangential velocity that would be needed to cause damage to the vertical tail would be significantly higher than what the worst case wake vortex could produce.

BASED ON WORST CASE POTENTIAL VORTEX VELOCITY PROFILE AT MOST CRITICAL LOCATION ON THE VERTICAL TAIL.
 WORST CASE: $I = 2400 \text{ FT}^2/\text{SEC}$
 $r_c = 2 \text{ FT.}$
