**FedEx Flight 14
MD-11-F, N611FE
Newark, New Jersey
31 July 1997
DCA97MA055**

**Proposed Findings
Boeing—Long Beach Division**

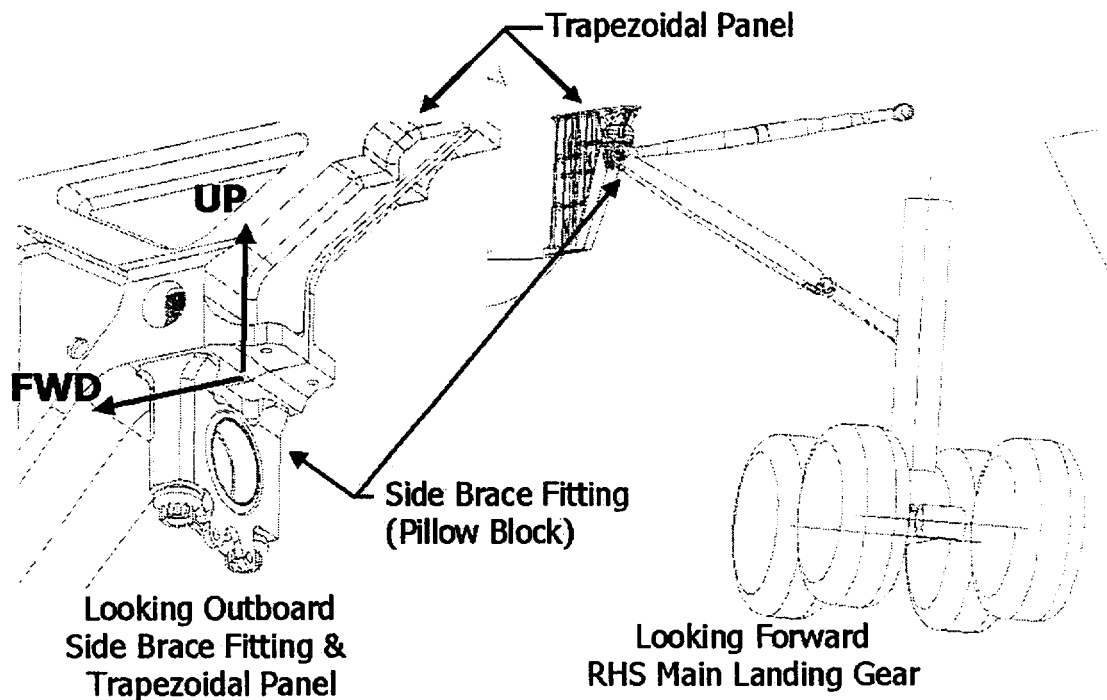
Illustration 2
Side Brace Fitting and Trapezoidal Panel

The RMLG side brace fitting (sometimes called the “pillow block”) was found still connected to the fixed side brace and the upper folding side brace. Also, a portion of the trapezoidal panel was found connected to the side brace fitting by the intact inboard side-brace-fitting-to-trap-panel attach bolt. The trap-panel-piece fracture surfaces were obliterated by abrasion due to runway contact. Examination of the bolt revealed it was bent slightly in the outboard and aft directions (see Figure 45 of MDC 98K1023). The bend in the bolt is consistent with loads having been applied to it by the side brace fitting in two directions, (1) a bending moment about the aircraft (nose down) pitch axis, and (2) a bending moment about the aircraft roll (right wing up) axis (see page 20 of MDC 98K1023).

The outboard side-brace-fitting-to-trap-panel attach bolt was fractured transversely through the shank portion of the bolt at the interface between the side brace fitting and the trap panel. The threaded portion of the bolt was found

in the trap panel; the remainder of the bolt was found on the runway (see Figures 46-48 of MDC 98K1023). Examination showed that the outboard bolt failed primarily due to a shear overload with the origin of the failure on the outboard side of the bolt. The fracture face was smeared indicating that the bolt was subjected to a compression load as it sheared. The fracture face was also dramatically sloped indicating a bending load was present. See Figures 164 and 165 of MDC 98K1023. (The presence of a bending load is also indicated by the bolt showing evidence of being loaded in compression since binding of the bolt inside the side brace fitting is necessary for the side brace fitting to apply such a load). The exposed end of the piece of the bolt still attached to the trap panel was mechanically damaged by contact with the side brace fitting. (The tip of the fracture was broken off as the side brace fitting moved inboard and the tip was "hooked" on the outboard edge of the outboard attachment hole in the side brace fitting). Altogether, this damage is consistent with the side brace fitting having applied to the bolt (1) an inboard-acting shear load, (2) a bending moment about the aircraft (right wing up) roll axis, and (3) an axial compression load.

The side brace fitting exhibited mechanical damage along the lower surface of its two outboard flanges, which coincide with mechanical damage observed along the inner edges of the fixed side brace inboard end clevis lugs (see page 28 and Figures 50, 51, and 84 from MDC 98K1023). This damage is consistent with contact of the fixed side brace clevis against the side brace fitting and its applying to the side brace fitting a moment about the aircraft (right wing up) roll axis via "prying action". The mechanical damage on the aft flange was more pronounced than that on the forward flange. The aft flange was bent up approximately 0.02 inches.

Impressions from the aft flanges of the side brace fitting were left on both the inboard and outboard halves of the trap panel, aft of the side brace fitting attachment holes. This damage is consistent with the side brace fitting "rocking" about the aircraft (nose down) pitch axis. The impression was deepest at the outboard aft corner (see Figure 52 from MDC 98K1023).

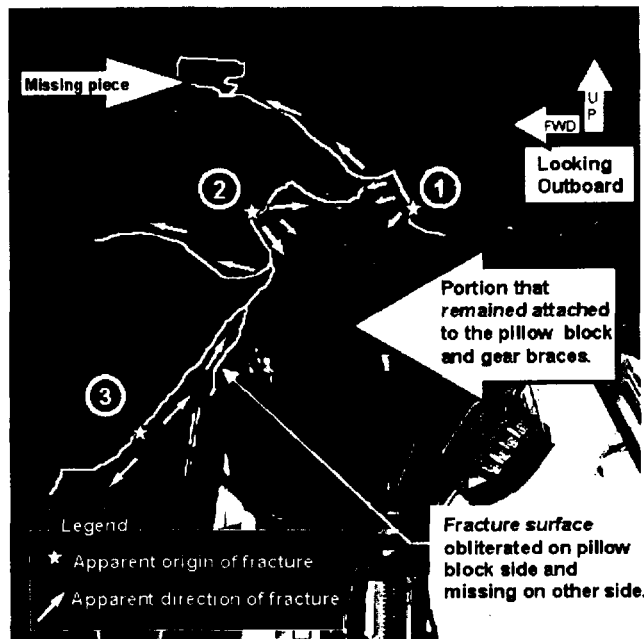
Illustration 3
Inboard Right Trapezoidal Panel

As discussed above, abrasion due to runway contact obliterated the fracture surfaces on the inboard trap-panel-piece found attached to the side brace fitting. However the mating surfaces on the inboard half of the trap panel were intact and were examined. The fracture origins of 3 cracks are shown in Illustration 3 below (the origins are represented as stars, and are numbered such that star 1 corresponds to crack 1, etc.). These fractures are consistent with a failure caused predominantly by a tension load applied by the inboard side-brace-fitting-to-trap-panel attach bolt. Such a tension load is further consistent with the fixed side brace clevis lugs contacting the side brace fitting (as discussed above) and the associated presence of a large "prying" moment about the aircraft (right wing up) roll axis.

To summarize, the evidence from the right-hand trap panel, side brace fitting, and fixed side brace inboard clevis, together, indicate that the overload failures were consistent with application of the following loads:

1. a load pushing the side brace fitting up against the bottom of the trap panel.
2. a load moving the side brace fitting inboard relative to the trap panel.
3. a moment "rocking" the side brace fitting about the aircraft pitch (nose down) axis.
4. a "prying" moment about the aircraft roll (right wing up) axis, applied to the side brace fitting by the fixed side brace.

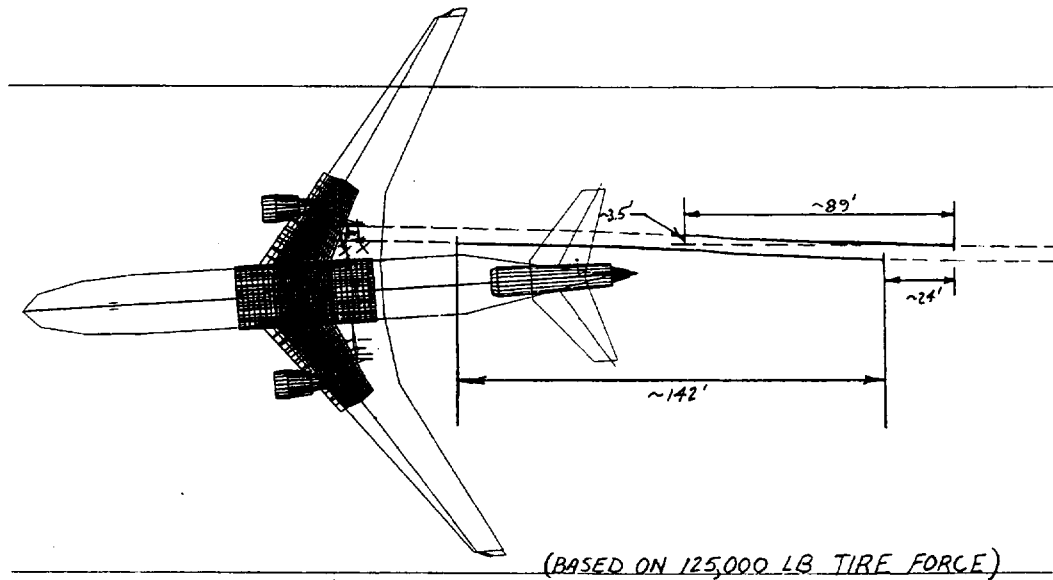
Illustration 7
RMLG Outboard Motion from ADAMS Analysis

The nose-down wing twist noted above also contributes to the right engine nacelle contacting the runway. In the rear-spar-web-failed idealization the nacelle makes contact only momentarily. This conflicts with the documented runway scar data where the nacelle scrape is long and continuous. The explanation for the difference is that in this idealization only the rear spar web is failed. In contrast, the accident airplane undoubtedly saw a rapid progression in the collapse of wing box elements following failure of the rear spar web. This explanation is further supported by the entire-wing-cross-section-failed ADAMS analysis, which shows that the right engine nacelle, once it contacts the runway, stays in contact.
