Our reference no.: CL600-2B16.5194.23-5-12

Subject: Challenger 601-3R N207JB (A/C 5194), In-Flight Main Passenger Door

Separation Accident, 23 May 2012, Hallandale, Florida

Challenger 601-3R N207JB (A/C 5194) In-Flight Main Passenger Door Separation Accident May 23, 2012 Hallandale, Florida

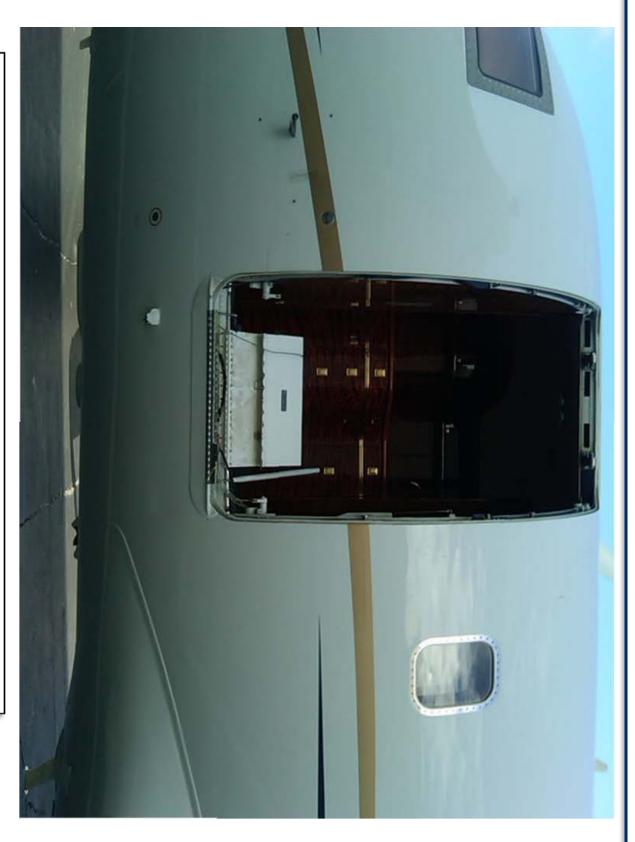
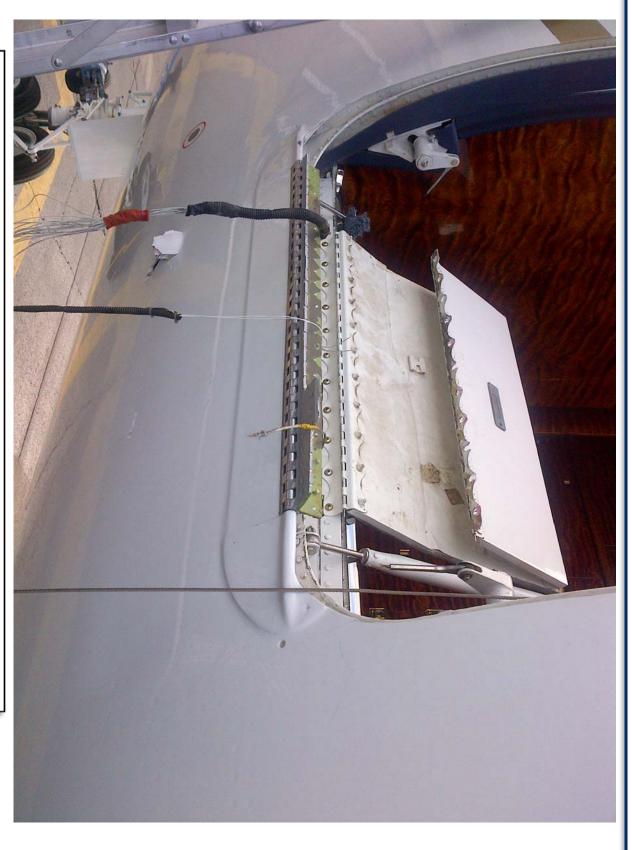
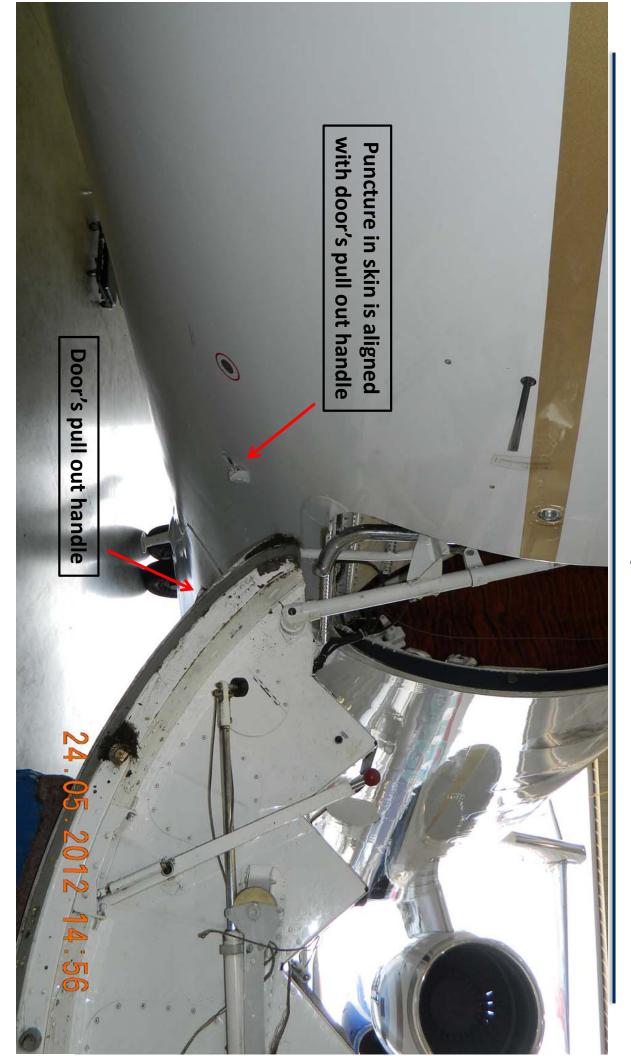
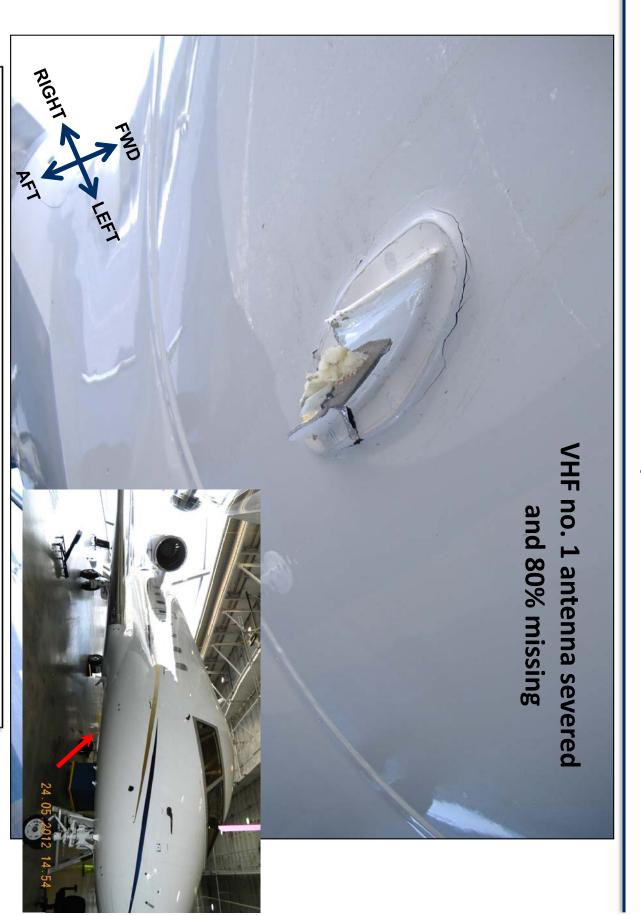
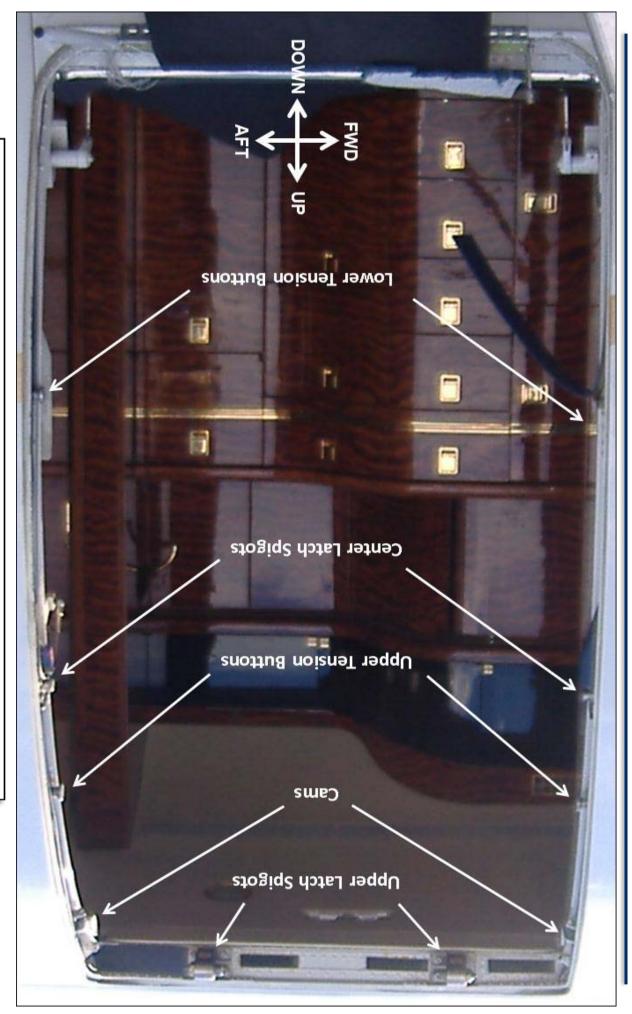
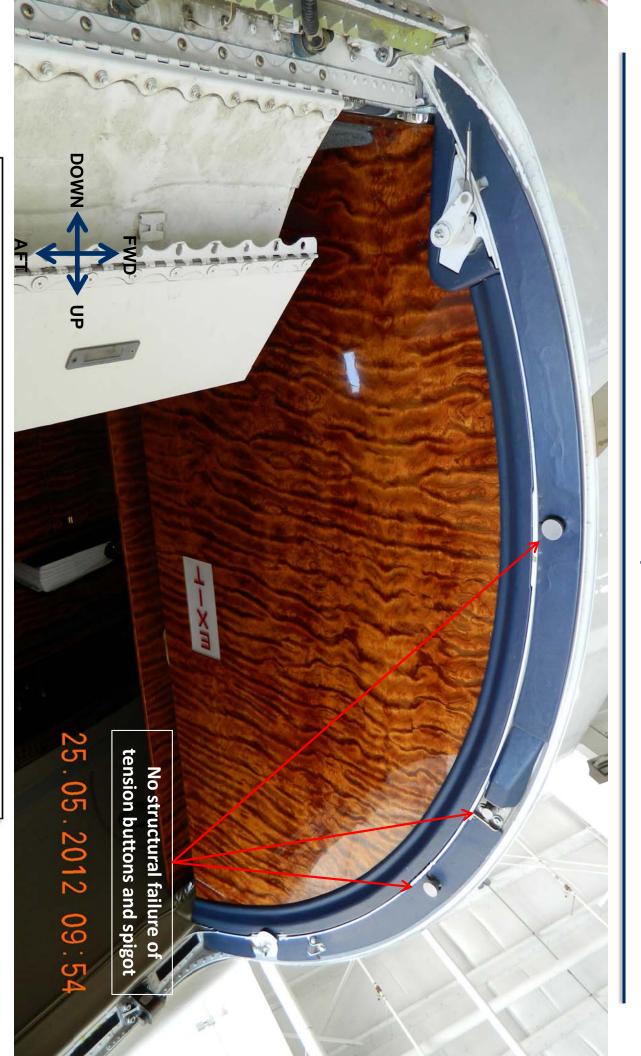
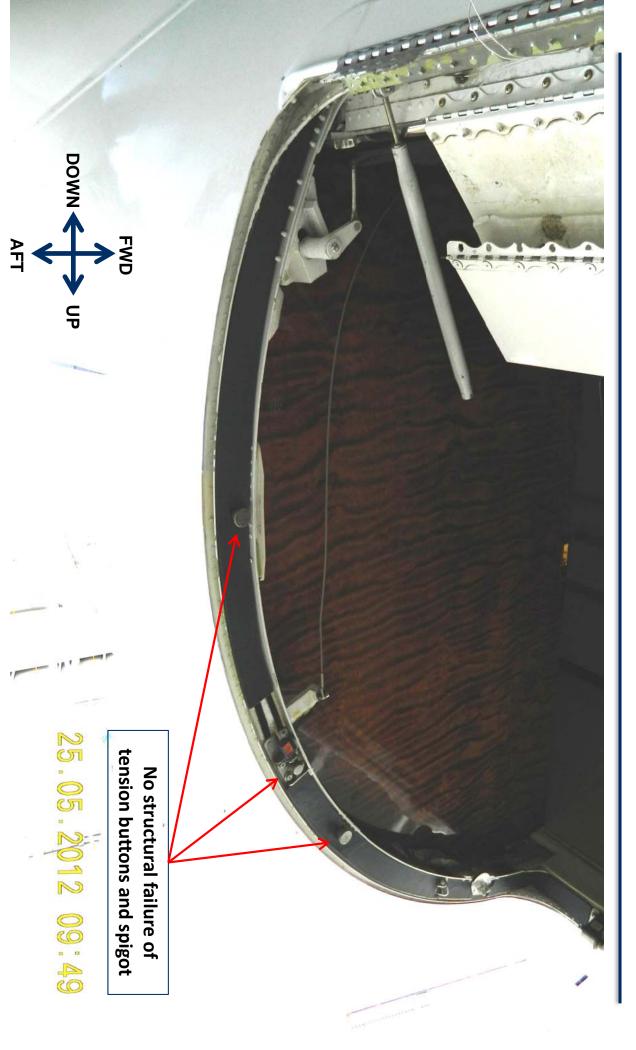
TE Z	4. AIRFRAME (MAIN PASSE	4. AIRFRAME (MAIN PASSENGER DOOR AREA) INFORMATION
	PART / AREA / CHECK	CONDITIO
17	1. Found a pur a) Simil b) Sama 2. Found a hor 2. Found a hor 3 Simil Airframe skin below door area between F/S 310 & F/S 335 and left stringer 19 & 20 deep d) The appr	 Found a puncture on skin: a) Similar in size to the tip of the pull out handle, and b) Same fuselage station as the tip of the pull out handle Found a horizontal impression on skin: a) Similar in size as the external handle, and b) Same fuselage station as the external handle c) The forward end of the impression has a gouge approximately 0.016" deep and is approximately 0.700" high d) The aft end of the impression has a gouge 0.005" deep, 1.950" long and 0.350" high e) There are some other minor gouges in the middle of the impression of approximately 0.003" and 0.004" deep

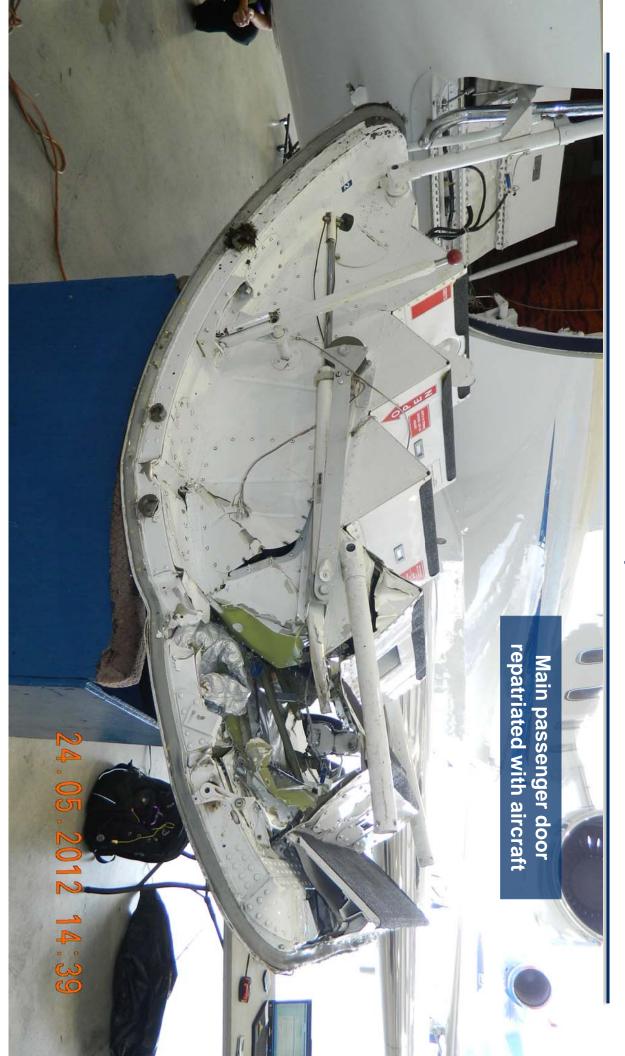
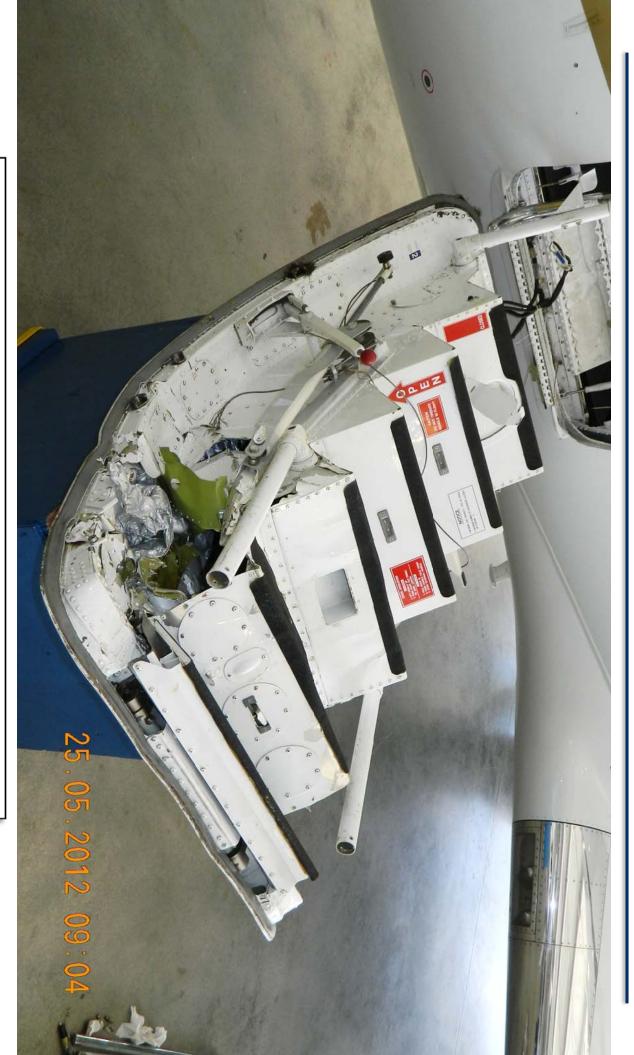
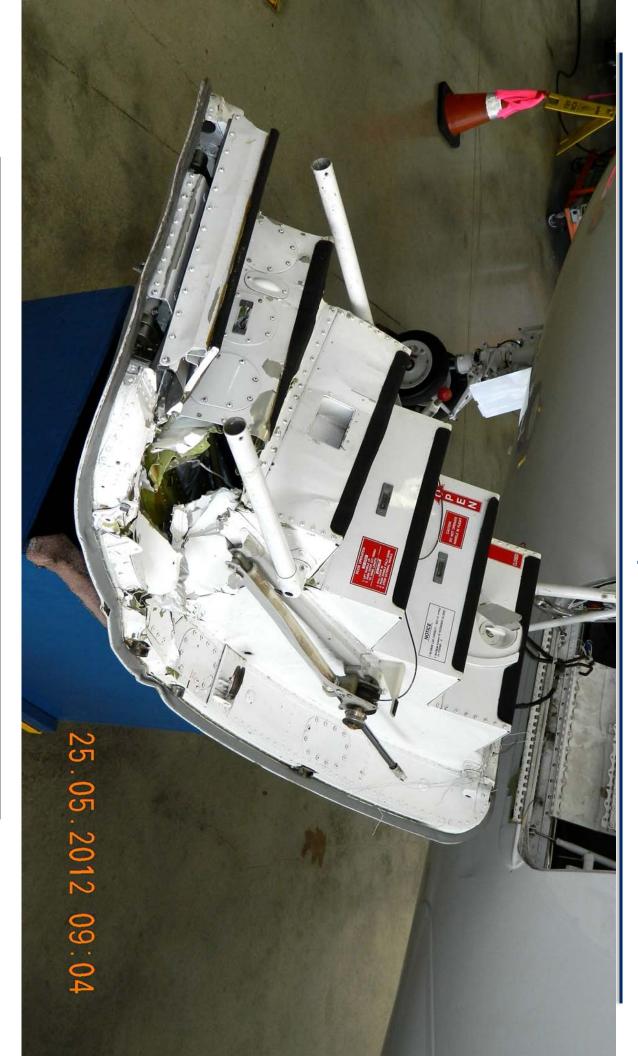
16	15	14	13	12	11	10	ITEM	
Pushrod between upper latch cams and center latch cams	Aft handrail	Forward handrail	Door upper half	External handle	Pull out handle	Internal handle	PART / AREA / CHECK	
Found severed at lower rod end with evidence of compression load failure	Found severed	Found severed	Found crushed with evidence of compression load failure	 Found no evidence of visible anomalies or structural failure When operated by hand, the forward and aft center latch cams, the internal handle and their associated linkages operated normal When centered horizontal, the handle would retract in its stowed position 	 Found handle bend approximately 20 degrees opposite from its contour Found handle in its stowed position with the bend portion standing proud and was difficult to extend Found its linkage to the internal and external handles severed from tension loads 	 Found no evidence of visible anomalies or structural failure When operated by hand, the forward and aft center latch cams, external handle and their associated linkages operated normal 	CONDITION	5. MAIN PASSENGER DOOR INFORMATION

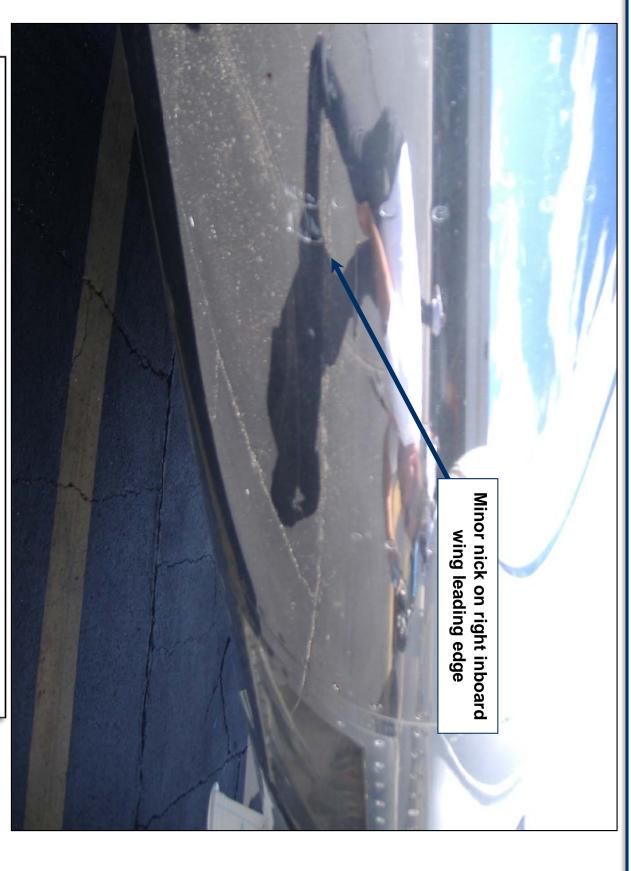
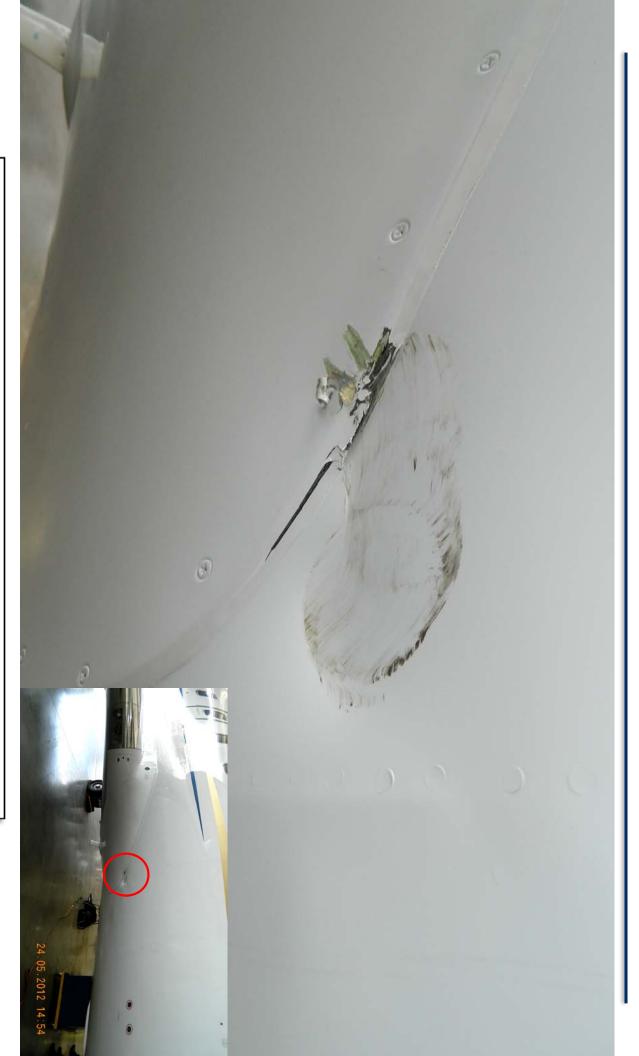
6	И	4	ω	2	Ъ	ITEM	
Upper fuselage	Vertical stabilizer	Left airframe side aft of door area	Belly just aft of door	Right wing	Right airframe F/S 379 to F/S 394 and forward of belly fairing	PART / AREA / CHECK	
Bombardier inspected the upper fuselage and found no evidence of damage	Found several scuff marks on the vertical stabilizer	Found several scuff marks aft and above the door area	Found the no. 1 VHF antenna severed and approximately 80% missing	Found a minor nick on the inboard leading edge	Found a round depression similar in size to the main door support leg	CONDITION	6. AIRFRAME & WING INFORMATION

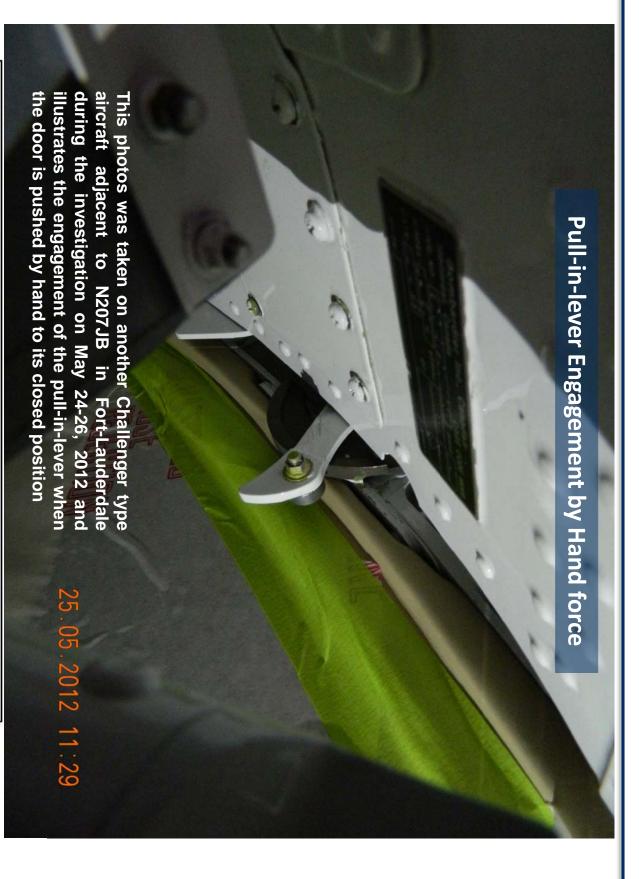
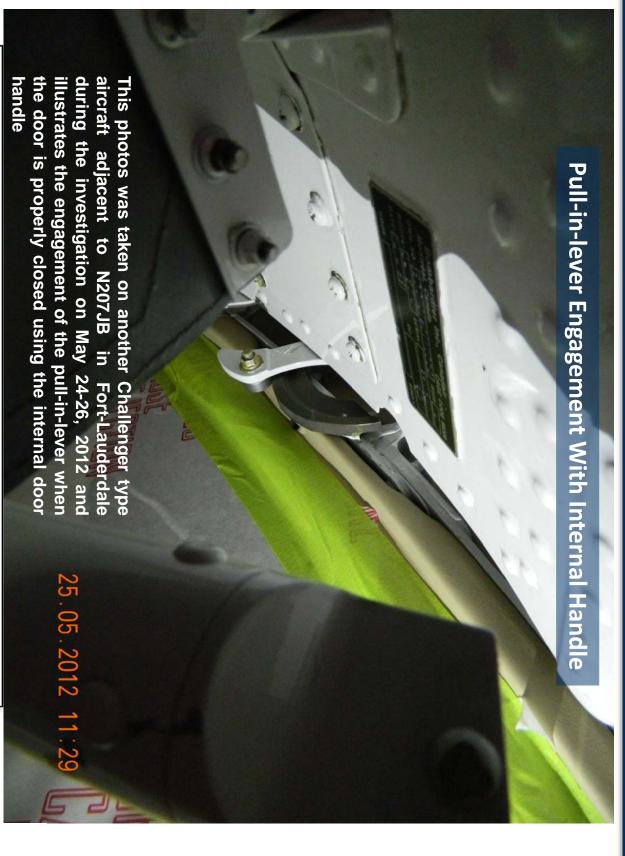
2	Ь	ITEM	
Door closed properly with the use of the internal handle	Door pushed by hand		
When the internal handle was used to properly close the door, the pull-in levers engaged 100%.	The engagement of the pull-in-levers was checked on another Challenger type aircraft by pushing the door to the closed position with a normal hand force. The pull-in-levers engaged approximately 40%.	CONDITION	7. PULL-IN-LEVER CHECK

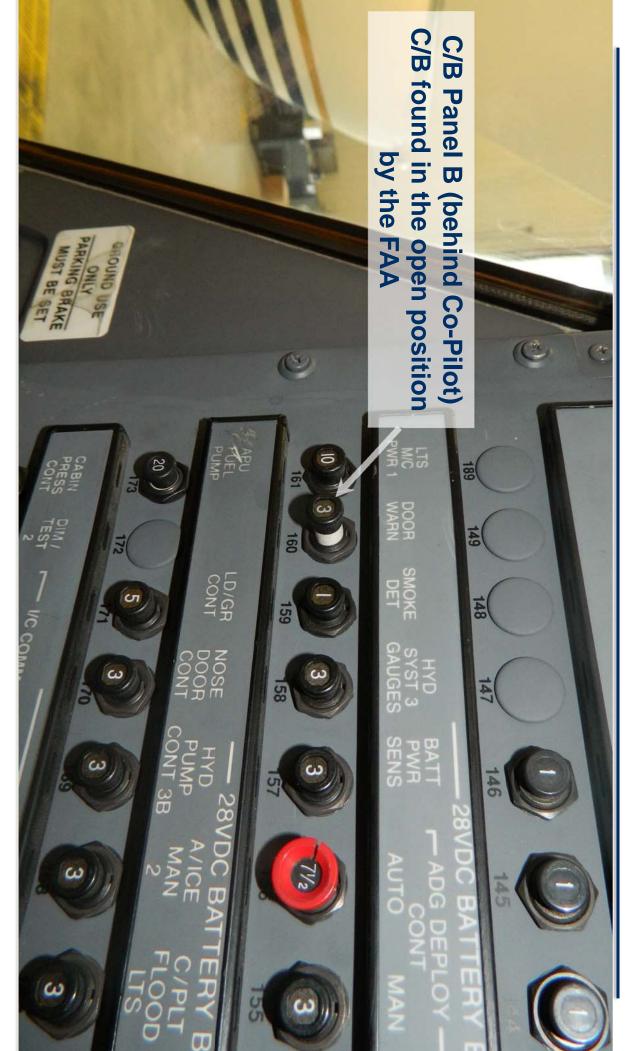
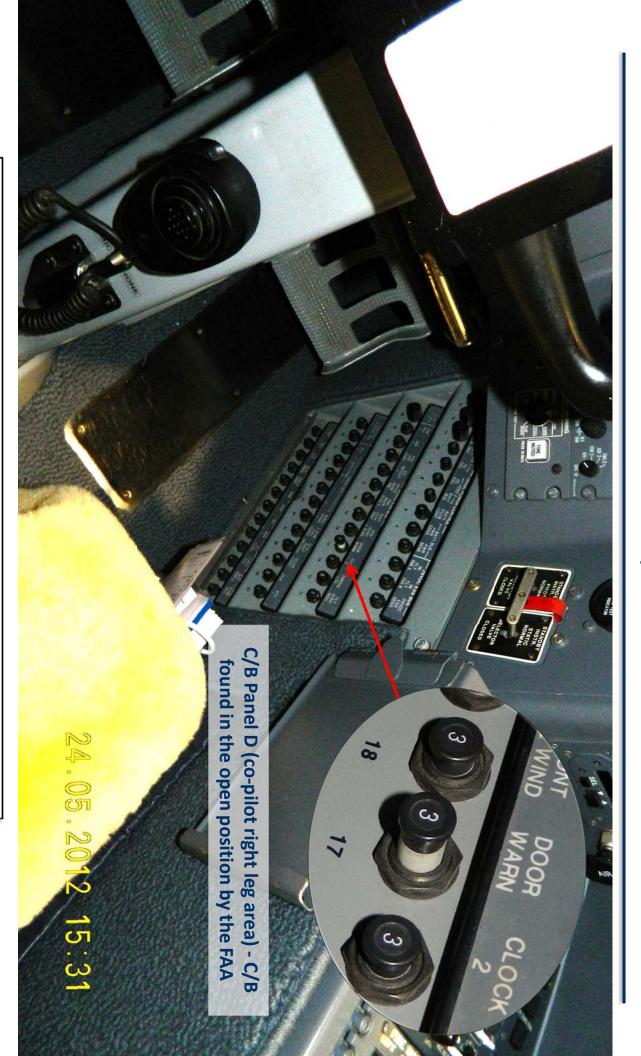
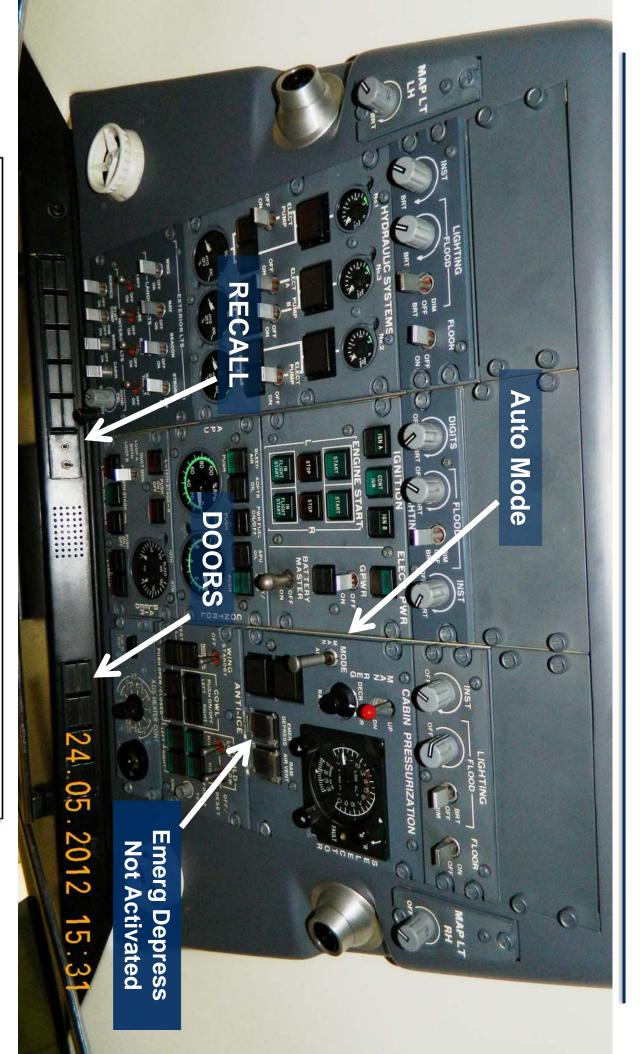
TEM	PART / AREA / CHECK Circuit Breaker B-160 "DOOR	8. COCKPIT INFORMATION
1	Circuit Breaker B-160 "DOOR WARN"	Found in the open position
2	Circuit Breaker D-17 "DOOR WARN"	Found in the open position
ω	Pressurization system	Found selected in the "AUTO" mode and Emergency Depressurization not selected
4	Checklist	Found a Bombardier / SimuFlite Quick Reference Handbook PSP 601A-15 Revision 12 — October 2010, which it includes: • CHALLENGER 601-3A/3R PILOT CHECKLIST, Page N-6, BEFORE TAKEOFF, item 8: Annunciator
И	Checklist	Found a checklist "Benair / Bahrain executive Air Services Co. WLL" Revision 00 23-Jan-07, page 2, TAKE OFF CHECKS does not contain: "Annunciator

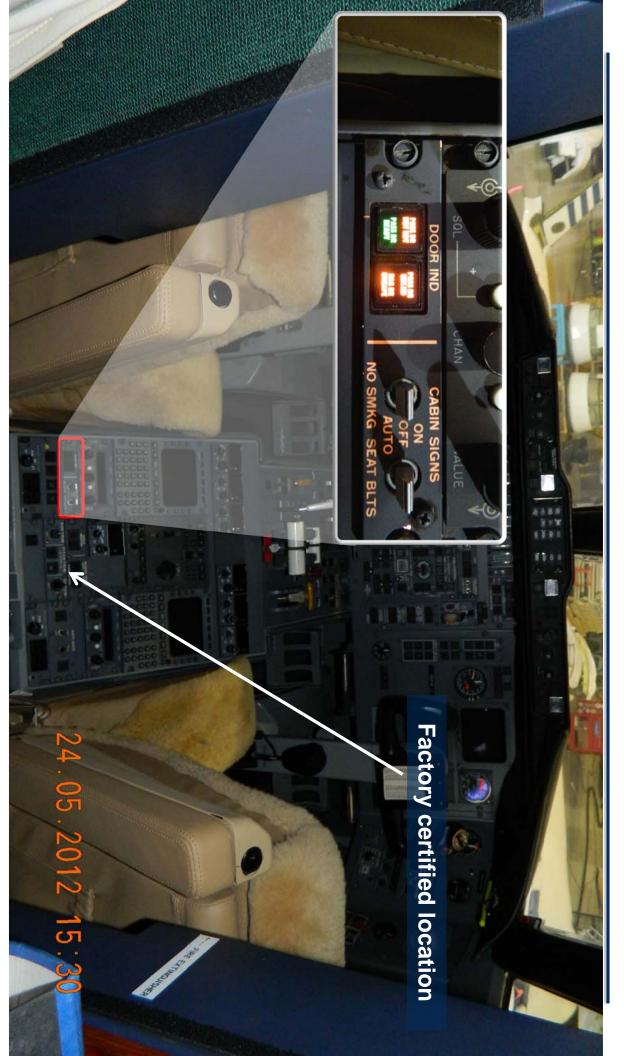
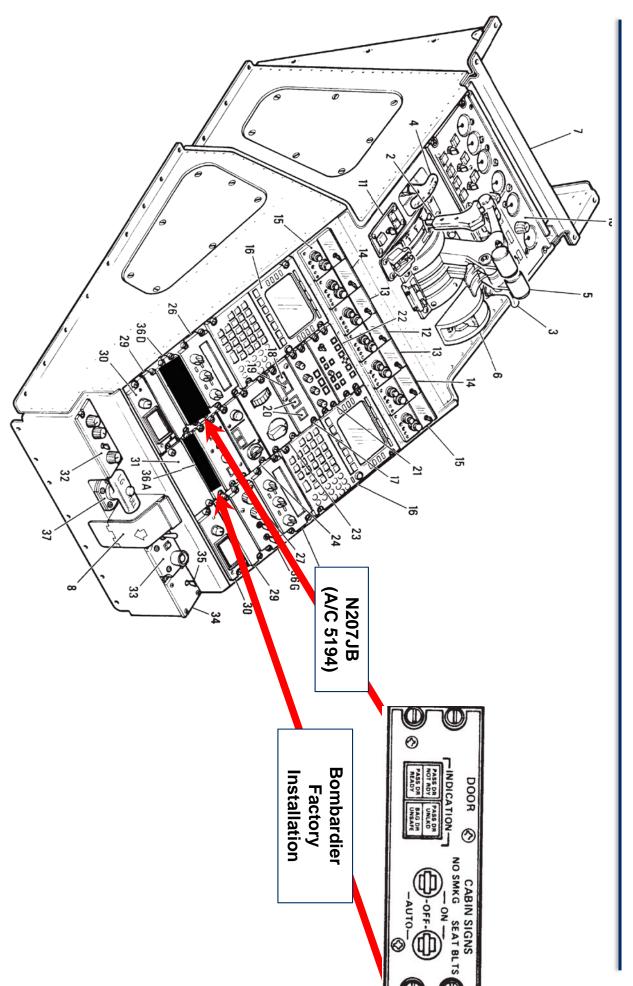
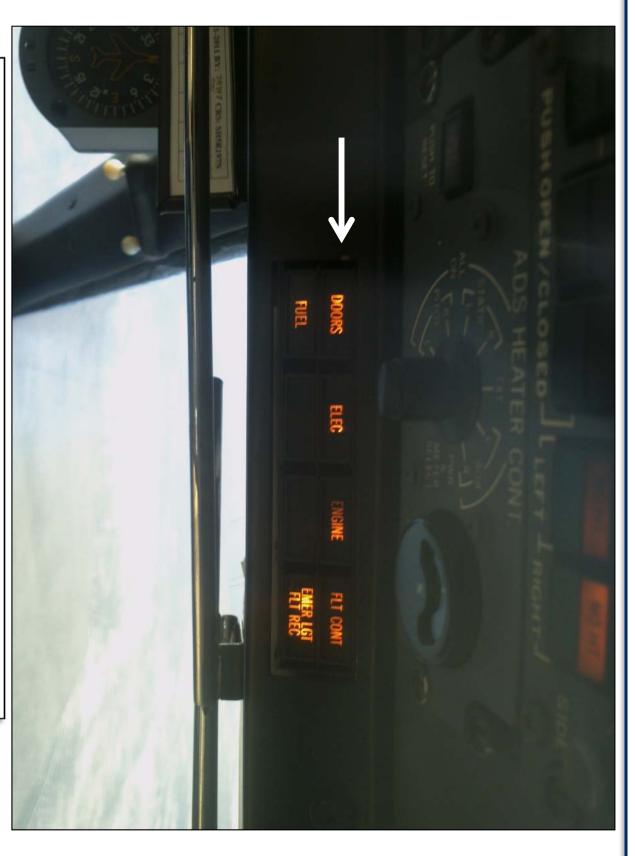
a) The DOORS caution light on the 8-CHANNEL ANNUNCIATOR PANEL illuminated when the cockpit was electrically powered up and extinguished normally when pressing the master caution button b) The DOORS caution light on the 8-CHANNEL ANNUNCIATOR PANEL was successfully recalled when the RECALL switch, located on the 10-CHANNEL ANNUNCIATOR PANEL, was selected 	The following was found during the illumination check of the door warning lights: a) The PASS DR UNLKD light, on the cockpit CABIN & DOOR SIGNS PANEL ASSEMBLY, was not illuminated when the cockpit was electrically powered up due to the severed door interface circuitry Note: The PASS DR NOT RDY, PASS DR READY lights do not illuminate if the door is opened normally on the ground b) The PASS DR NOT RDY, PASS DR UNLKD and PASS DR READY lights on the CABIN & DOOR SIGNS PANEL ASSEMBLY illuminated when tested with the cockpit pushto-test switch located on the pilot's side console	Found the CABIN & DOOR SIGNS PANEL ASSEMBLY, on the cockpit center pedestal , not in the factory certified location Note: The factory certified location is in the center lower portion of the cockpit center pedestal	Found no anomalies with the master caution warning system	CONDITION	9. MAIN PASSENGER DOOR WARNING SYSTEM INFORMATION
