NATIONAL TRANSPORTATION SAFETY BOARD

BRAKE ASSEMBLY EXAMINATION

WPR13FA420

Examination Report - N194SJ Cessna 525A

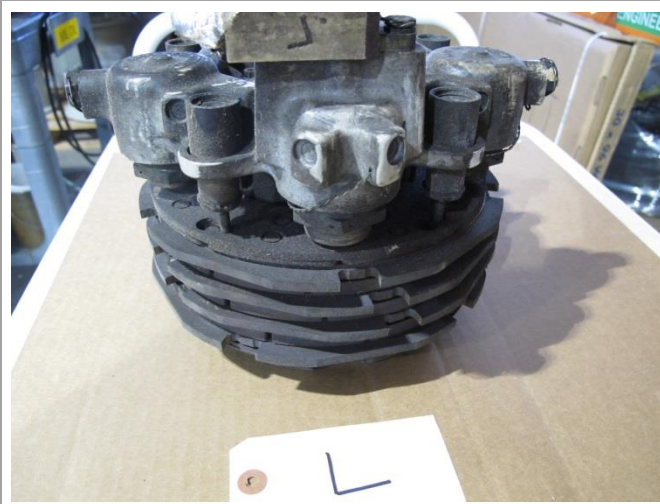
Left brake assembly (side view)

The left brake assembly was visually examined. The piston housing was coated in soot and dirt, the paint had discolored to a light brown tint. The paint discoloration is an indication of exposure to an external heat source. Excessive corrosion was observed on the torque plate and heat sink disk in comparison to brake assemblies that are received for normal overhaul. No hydraulic leaks or fluid staining was observed. The disk rotors were free to rotate by hand.

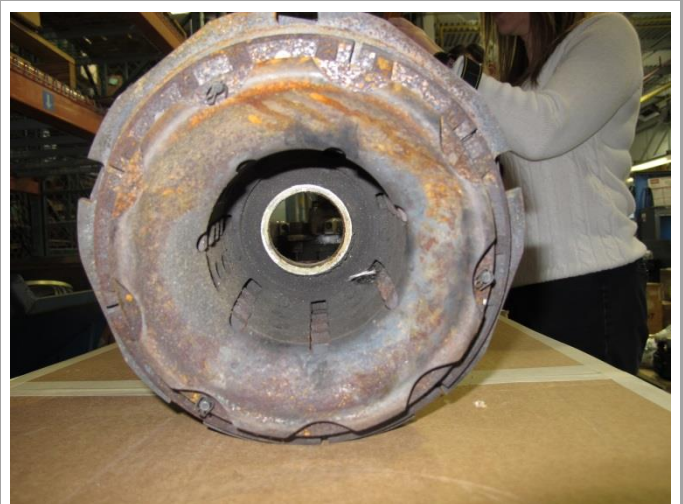
Left brake assembly (hub view)

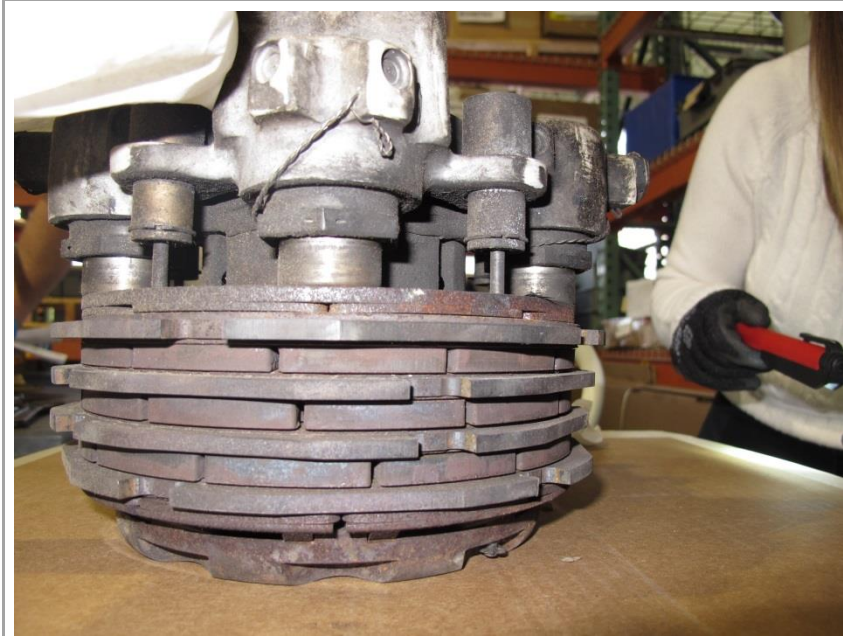
A hydraulic fitting was placed on the primary port of the shuttle valve and pressurized to 100 psi. No leakage was observed, piston movement was observed on all 5 pistons, and the rotors could not be moved by hand. Hydraulic pressure was released and adjuster assemblies were observed to return to their normal position. The system was pressurized to 850 psi, no leaks were observed and the rotors could not be moved by hand. The wear pins extension was measured at 0.262 in and 0.268 in, indicating about 2/3 wear (new pin measures 0.864 in). The system held pressure at 850 psi for 5 minutes. The system was depressurized to 9 psi. The pistons retracted and a feeler gauge measured a gap between rotor and stator disks of 0.020 in.

The hydraulic fitting was removed from the primary port and placed on the pneumatic port (emergency system). When pressurized to 100 psi the shuttle valve could be heard to move from primary to emergency. Indicating the last actuation was via the normal (primary) brake system. The system was pressurized to 850 psi, no leaks were observed, and piston movement evident.

Left brake assembly showing piston extension.

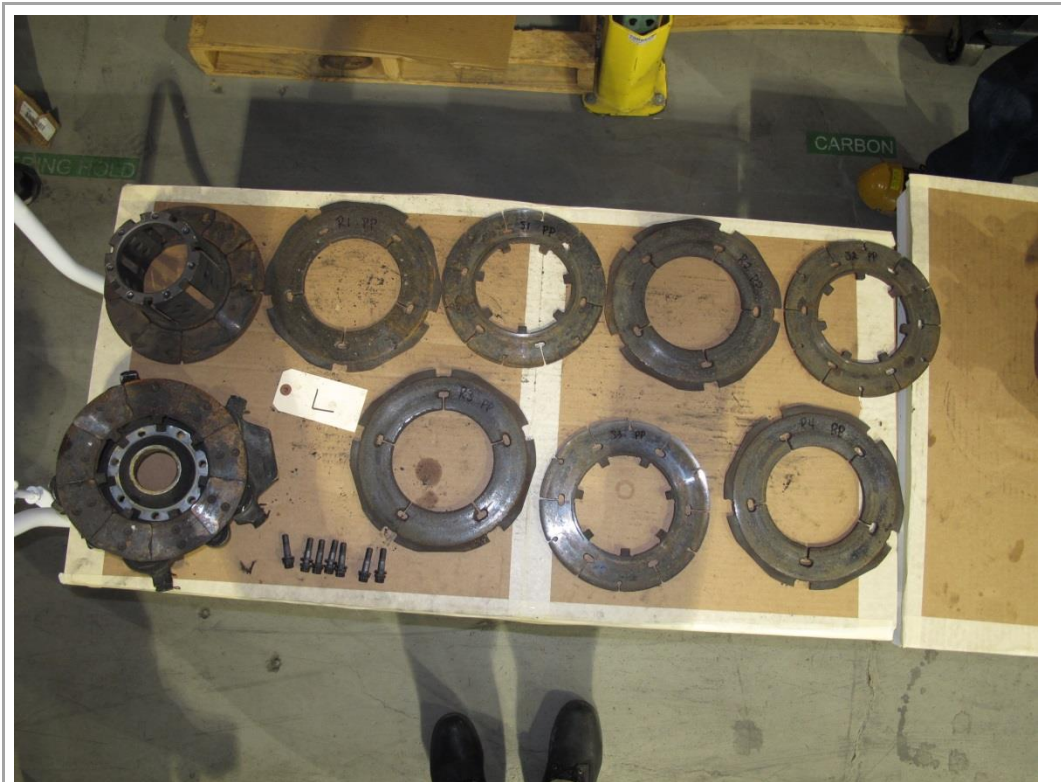
The brake assembly was disassembled. The 7 brake disks (rotors and stators) were removed individually and visually examined. Normal wear signatures were observed, no cracks were evident, and the expansion slots on all disks were all similar in gap size. No evidence of overheating were observed.

Left brake disks

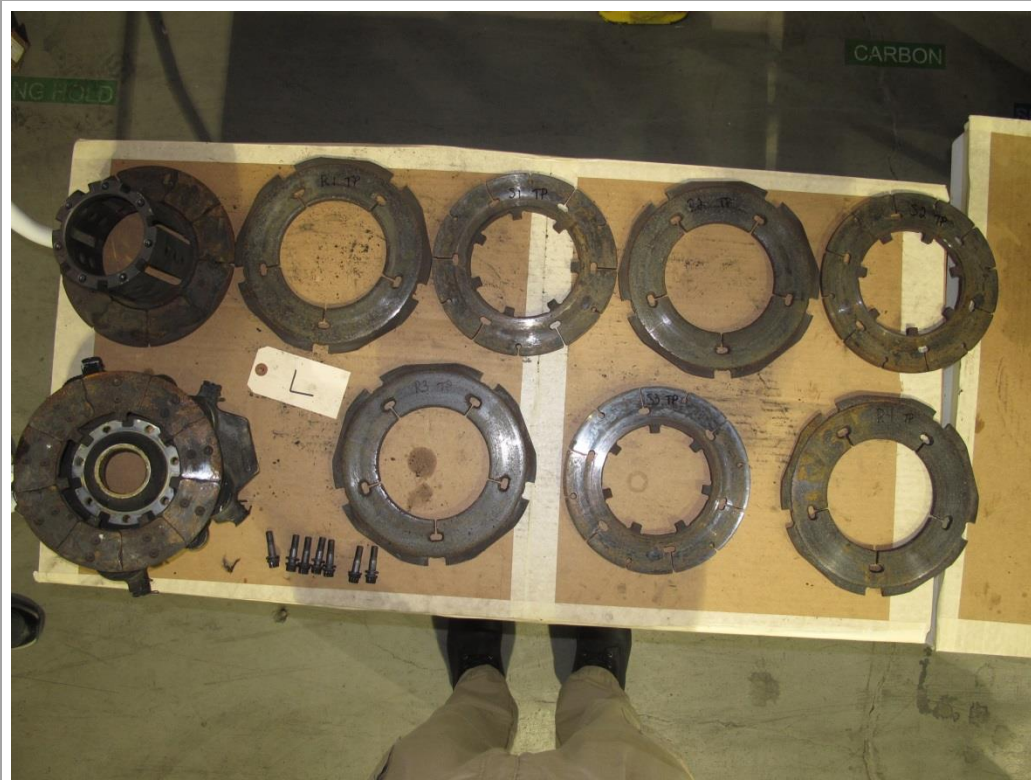
Left brake disks (reverse sides)

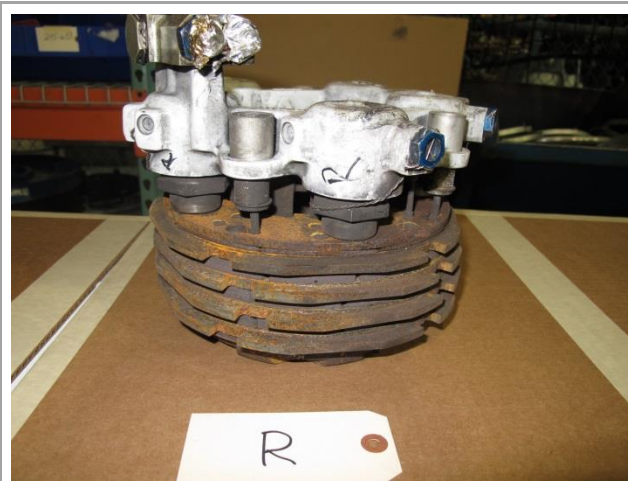
Right brake assembly side view

The right brake assembly was visually examined. The brake piston housing was clean with no discoloration of the medium gray paint. Excessive corrosion was observed on the torque plate and heat sink disk, in comparison to brake assemblies that are received for normal overhaul. No hydraulic leaks or fluid staining was observed. The disk rotors were free to rotate by hand.

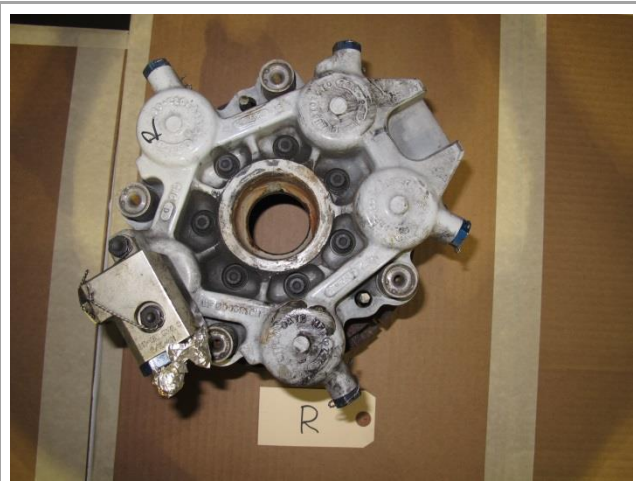
Right brake assembly top view.

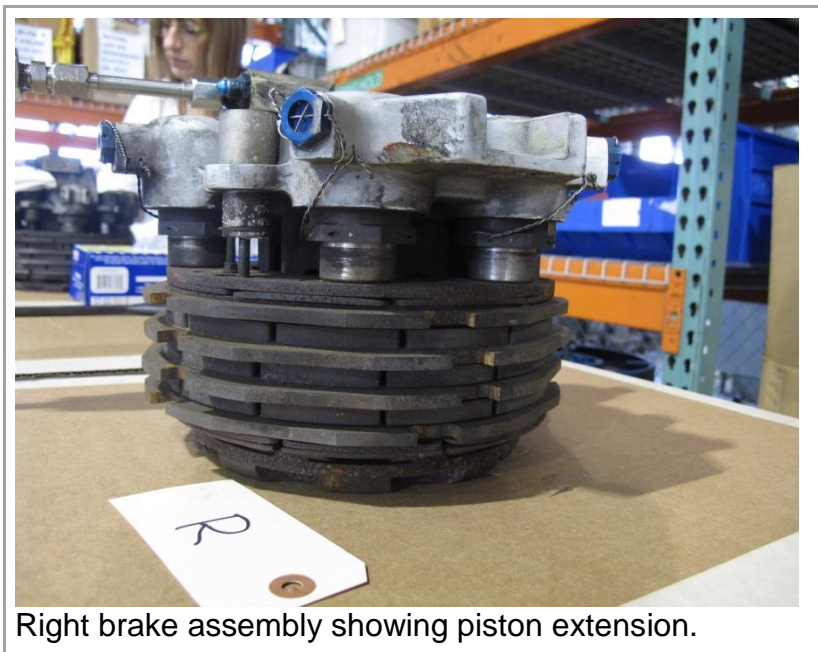
A hydraulic fitting was placed on the primary port of the shuttle valve and pressurized to 100 psi. No leakage was observed, piston movement was observed on all 5 pistons, and the rotors could not be moved by hand. Hydraulic pressure was released and adjuster assemblies were observed to return to their normal position. The system was pressurized to 850 psi, no leaks were observed and the rotors could not be moved by hand. The wear pins extension was measured at 0.300 and 0.294 in, indicating about 2/3 wear (new pin measures 0.864 in). The system held pressure at 850 psi for 5 minutes. The system was depressurized to 9 psi. The pistons retracted and a feeler gauge measured a gap between rotor and stator disks of 0.020 in.

The hydraulic fitting was removed from the primary port and placed on the pneumatic port (emergency system). When pressurized to 100 psi the shuttle valve could be heard to move from primary to emergency. Indicating the last brake actuation was via the normal (primary) brake system. The system was pressurized to 850 psi, no leaks were observed, and piston movement evident.

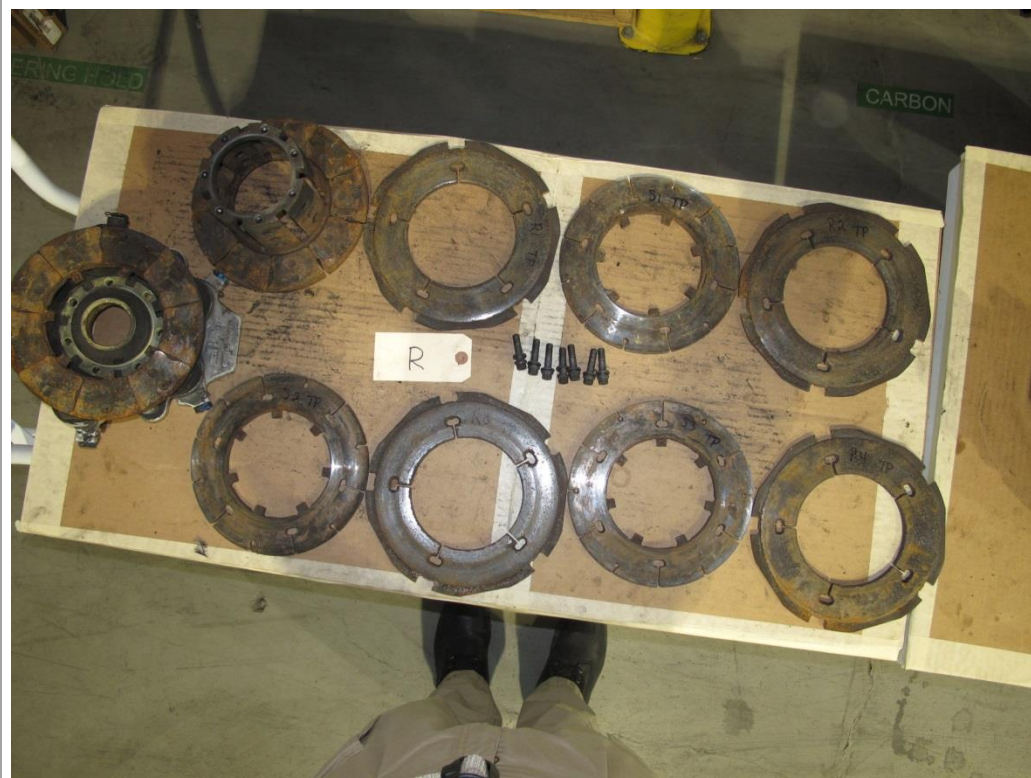
The brake assembly was disassembled. The 7 brake disks (rotors and stators) were removed individually and visually examined. Normal wear signatures were observed, no cracks were evident, and the expansion slots on all disks were all similar in gap size. No evidence of overheating were observed.

Right brake disks

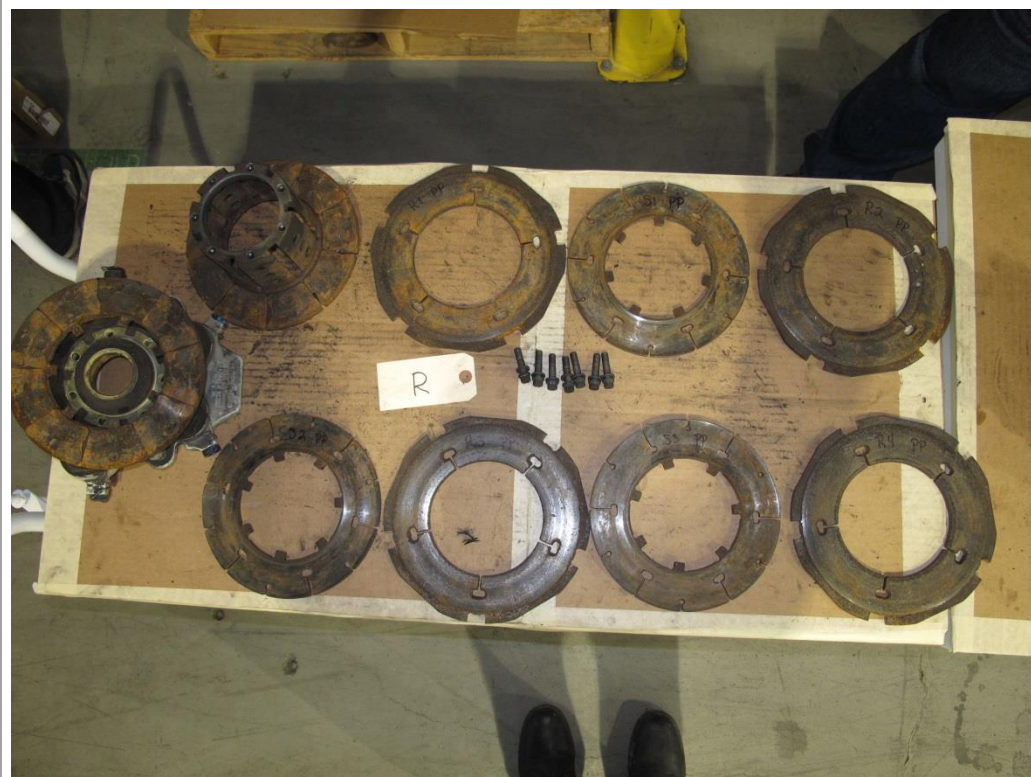
Right brake disks (reverse side)
