NATIONAL TRANSPORTATION SAFETY BOARD

Brake System Component Examination

WPR13FA430

Examination Report - N194SJ Cessna 525A

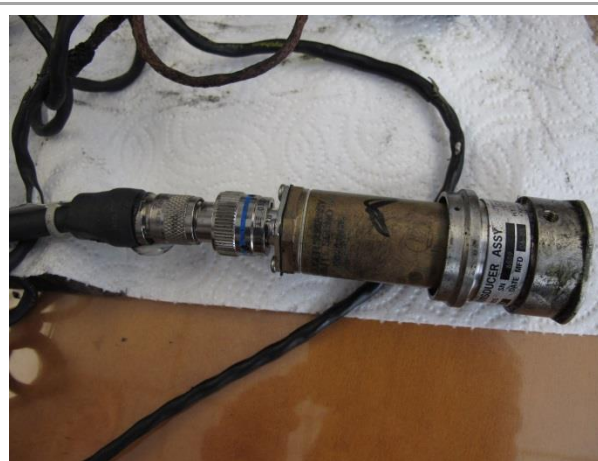
Fig 1 - Left Wheel Transducer

Left Transducer:

The transducer's electrical connector was removed and pins visually examined. The wheel adaptor end was cleaned and placed on the test fixture. A full acceptance test was performed with the results documented on the test data sheet. No anomalies identified.

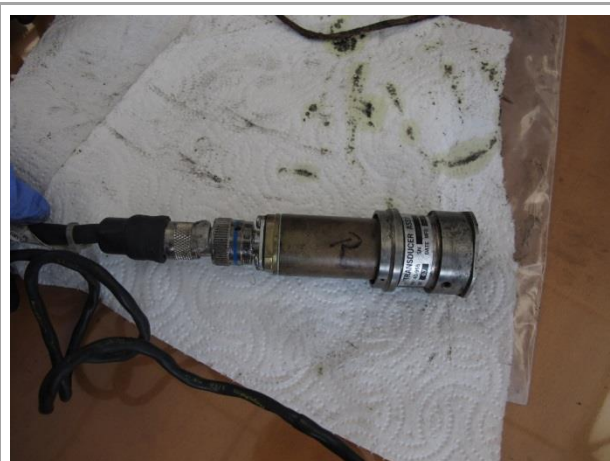
Fig 2 - Right Wheel Transducer

Right Transducer:

The transducer's electrical connector was removed and pins visually examined. The wheel adaptor end was cleaned and placed on the test fixture. A full acceptance test was performed with the results documented on the test data sheet. No anomalies identified.

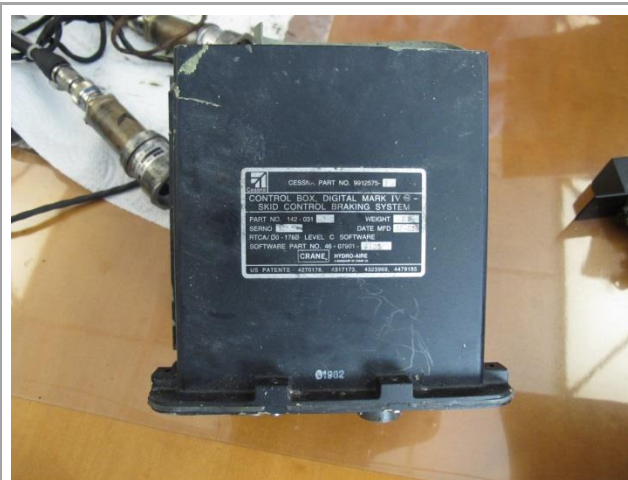
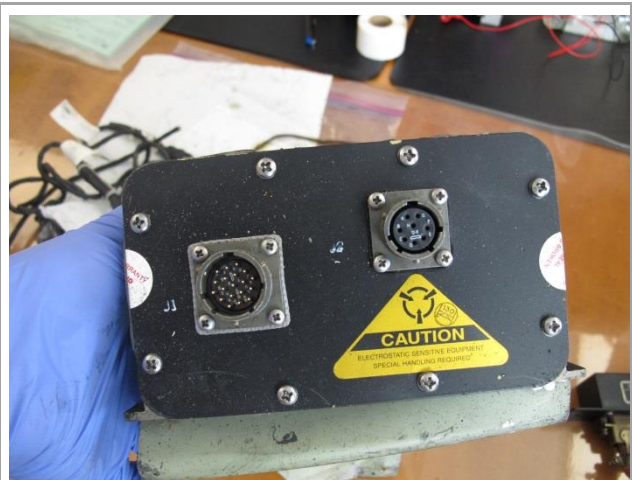
Fig 3 - Control Box (top view)

Fig 4 - Control Box - view of the canon plugs

Control box and canon plug pins were visually inspected. The control box was connected via canon plug terminals to the Antiskid Field Tester (99-791). A full manufacturing acceptance test was performed with the results documented on the test data sheet. No anomalies identified.

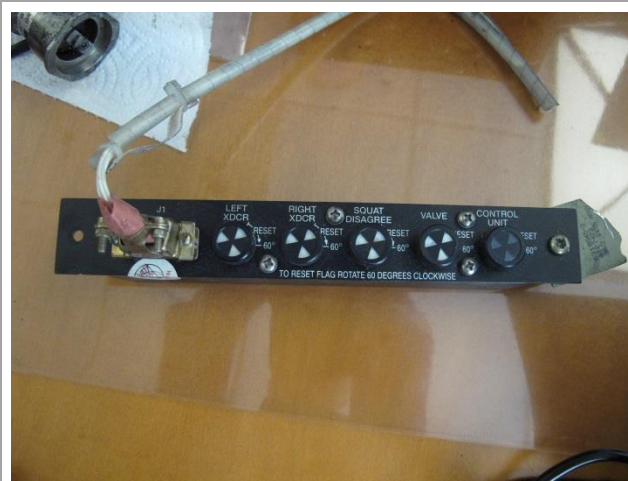
Fig 5 - Skid Control Unit Fault Display - 4/5 flags displayed.

A SK 16641 Test Fixture was attached to the Skid Control Unit Fault Display via the J1 connector. The fault indicators (rotary flag) were manually reset (all black). Individually each fault circuit was grounded resulting in a fault indication to operate by displaying a white & black flag. All rotary flags operated correctly.

Fault indications could be mechanically imparted by a moderate impact load to the fault display unit.

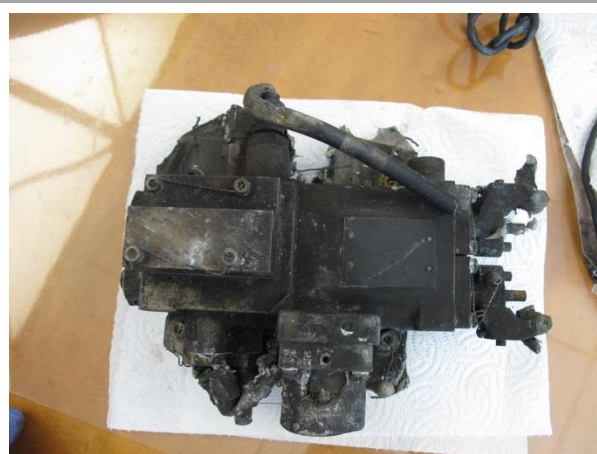
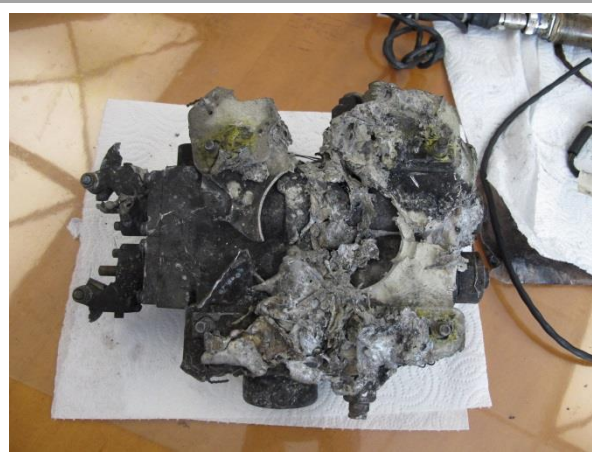
The control valve assembly was discolored black and sooted. Airframe aluminum material had melted onto the back side of the valve body. The melted and deformed aluminum was removed by separating the valve body from the mounting screws. All hydraulic line ports had unions attached. No evidence of hydraulic stains or leaks were evident.

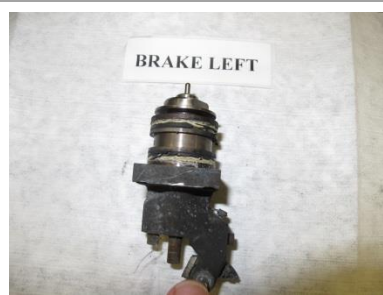
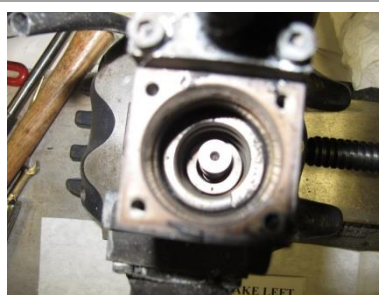
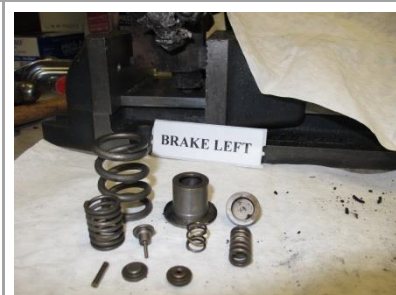
The brake lever assembly was removed from the left brake valve, the main spring, shims, spring keeper, and spring stop were removed. The o-rings that seal the sleeve end assembly were brittle and easily broken. Black flakes were observed inside the valve body.

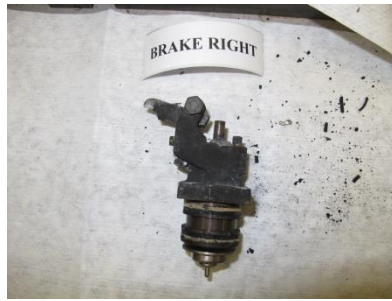
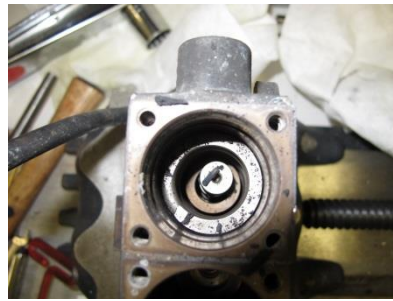
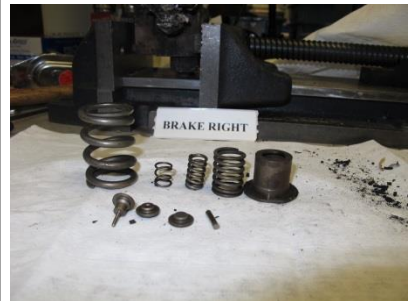
The brake lever assembly was removed from the right brake valve, the main spring, shims, spring keeper, and spring stop were removed. The o-rings that seal the sleeve end assembly were brittle and easily broken. Black flakes were observed inside the valve body.

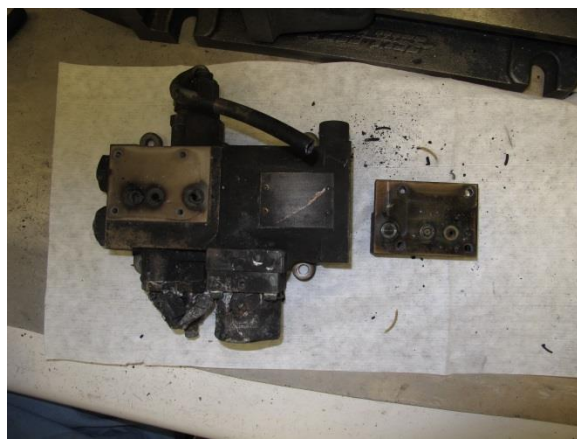
Fig 15 - Damping Chamber Removed

The dampening chamber was removed from the valve body. The chamber ports were clear and o-rings were brittle and cracked. The right return union, the right break pressure union was removed. The left side pressure port union was removed.

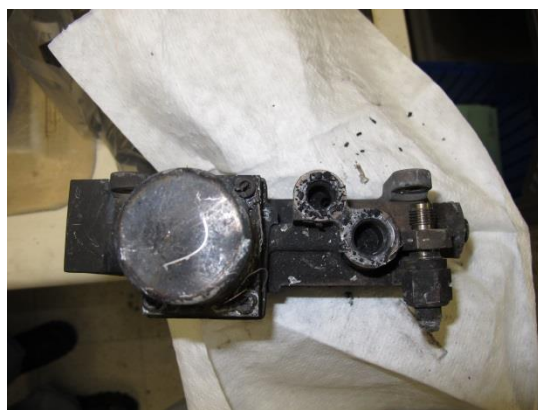
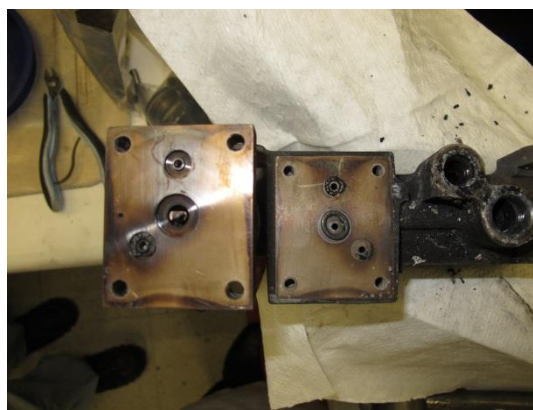
The servo was discolored black and part of the outer case was melted away. The servo assembly was removed and the armature flapper was present.

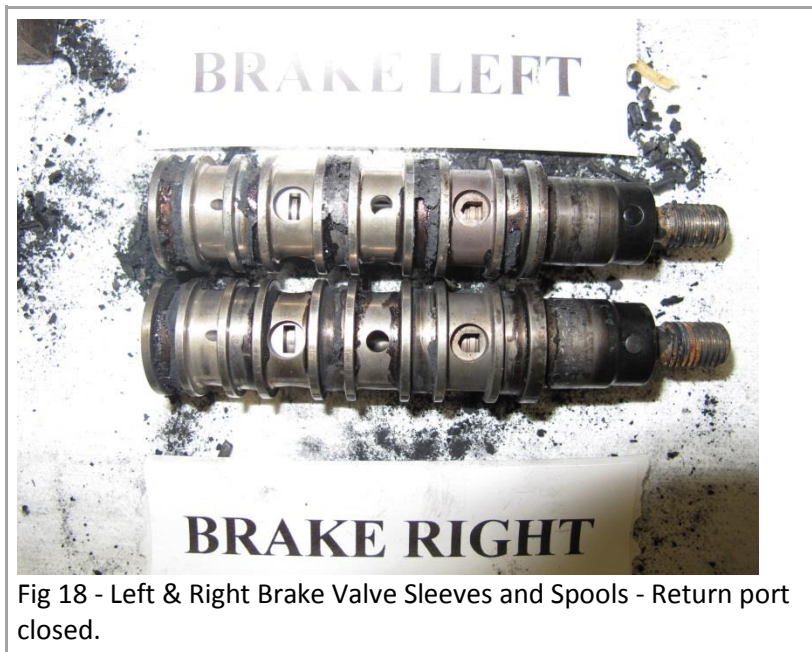
The right valve end cap was removed and the valve sleeve and spool were extracted. All o-ring elements had disintegrated into carbon powder. The valve sleeve and spool were observed to be seized in an OFF position (brake port connected to return port) which corresponds to no brake pressure being delivered to the brakes. As figure 18 shows, the return edge of the spool is within the return slot of the sleeve (brake port connected to return pressure), which is the default position of the spool, without command being applied.

The left valve end cap was removed and the valve sleeve and spool were extracted. All o-ring elements had disintegrated into carbon powder. The valve sleeve and spool were observed to be seized in an OFF position (brake port connected to return port) which corresponds to no brake pressure being delivered to the brakes. As figure 18 shows, the return edge of the spool is within the return slot of the sleeve (brake port connected to return pressure), which is the default position of the spool, without command being applied.

Fig 18 - Left & Right Brake Valve Sleeves and Spools - Return port closed.
