National Transportation Safety Board

Marine Accident Brief

Allision of *Amy Frances* Tow with Natchez–Vidalia Highway 84 Bridge

Accident no.	DCA16FM020
Vessel names	<i>Amy Frances</i> , MM-46
Accident type	Allision
Location	Lower Mississippi River at mile marker 363.3 at Natchez, Mississippi 31°33.6' N, 091°25.2' W
Date	January 21, 2016
Time	1247 central standard time (coordinated universal time – 6 hours)
Injuries	None
Property damage	>\$542,000 est.
Environmental damage	24,654 gallons of catalytic cracked clarified oil
Weather	Visibility 10 miles, winds south at 10 mph, air temperature 71°F
Waterway information	The Lower Mississippi River near mile marker 363.3 was under an extreme high-water safety advisory from the US Coast Guard Captain of the Port due to “hazardous conditions associated with strong currents, severe outdrafts, [and] missing/off-station aids to navigation and diving buoys.”

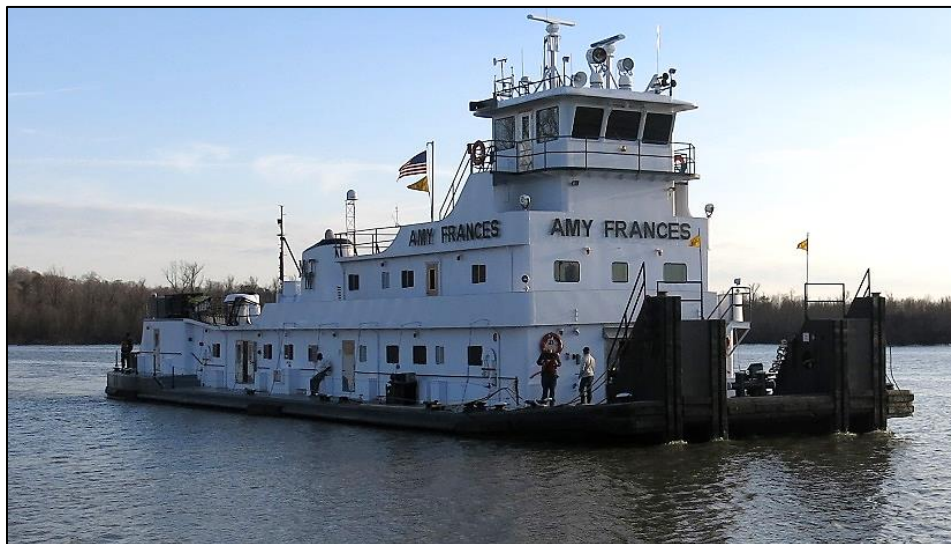
Amy Francis under way after the accident.

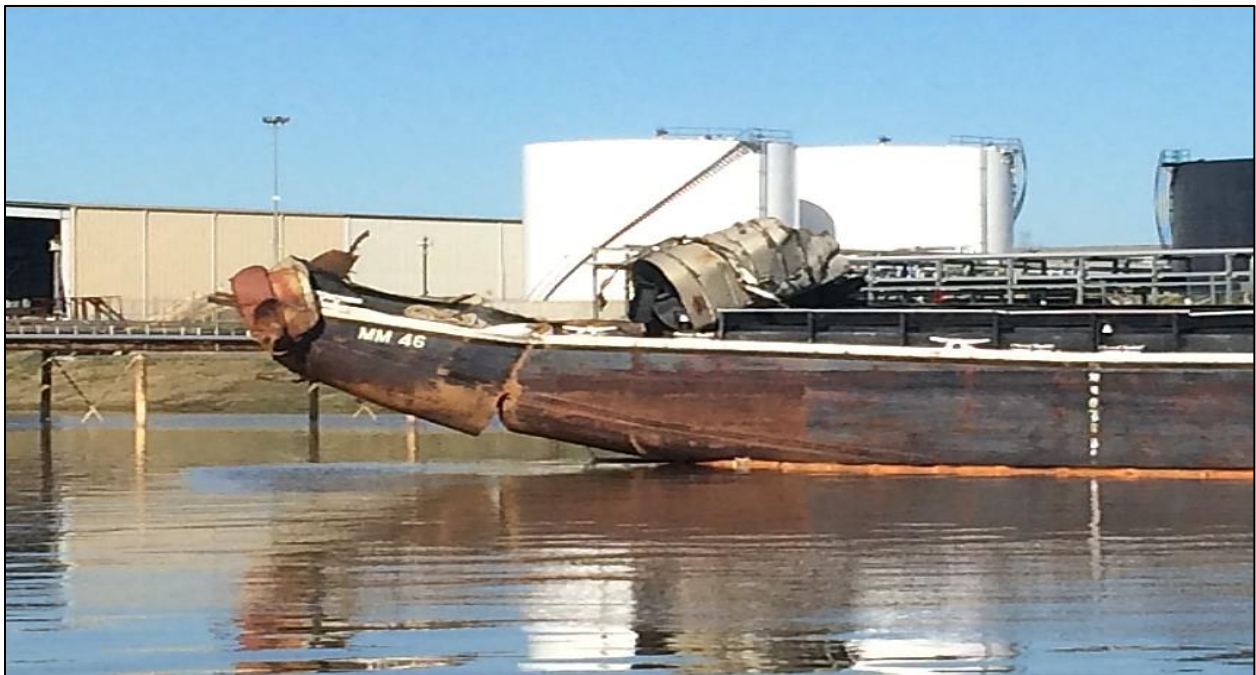
Less than 15 seconds later, at 1244:41, the vessel's heading started changing to the left while the course made good continued to the right. About 0.6 mile from the bridge, the tow was heading for the middle of the center channel pier at a speed of 13.0 mph. At 1245, with the *Amy Frances* about 0.5 mile from the bridge, the vessel was heading 230 degrees and making good a course of about 224 degrees.⁶ The tow was now headed toward the right-hand side of the center pier. About 1247, with the towing vessel backing full astern, the port side of barge *MM-46* struck the right side of the center pier at a speed of about 9.4 mph.⁷

Damaged port bow of barge *MM-46*. (Photo by US Coast Guard)
