BROTHERHOOD OF LOCOMOTIVE ENGINEERS AND TRAINMEN

BEFORE THE NATIONAL TRANSPORTATION SAFETY BOARD

NTSB Accident Number: RRD-18MR003

Proposed findings, probable cause, and safety recommendations, in connection with the head-on collision, derailment and subsequent employee fatalities involving a CSX Transportation (“CSXT”) freight road switcher Train No. F777-03 and a National Railroad Passenger Corporation (“Amtrak”) passenger Train No. P091-03 near Cayce, South Carolina on February 4, 2018

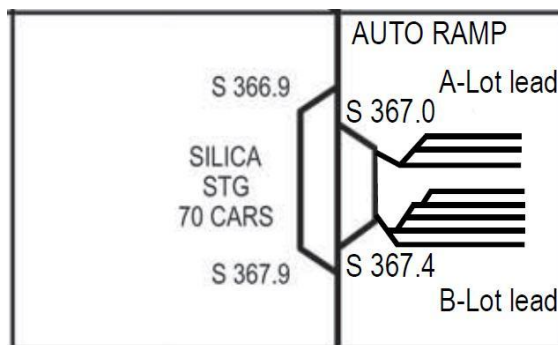
Figure 2. Diagram of the tracks at Silica Storage Track and A and B Lots tracks (graph courtesy of CSXT Timetable)

No. F777, each stated that the Locomotive Engineer questioned the Conductor if he, had returned all switches involved in their switching moves to their normal position for mainline movement. The Conductor suggested turning on the locomotive headlight to bright in order to check the switch alignment for the North End of Silica Storage Track. Although they did this, they could not tell if the switch was properly lined.

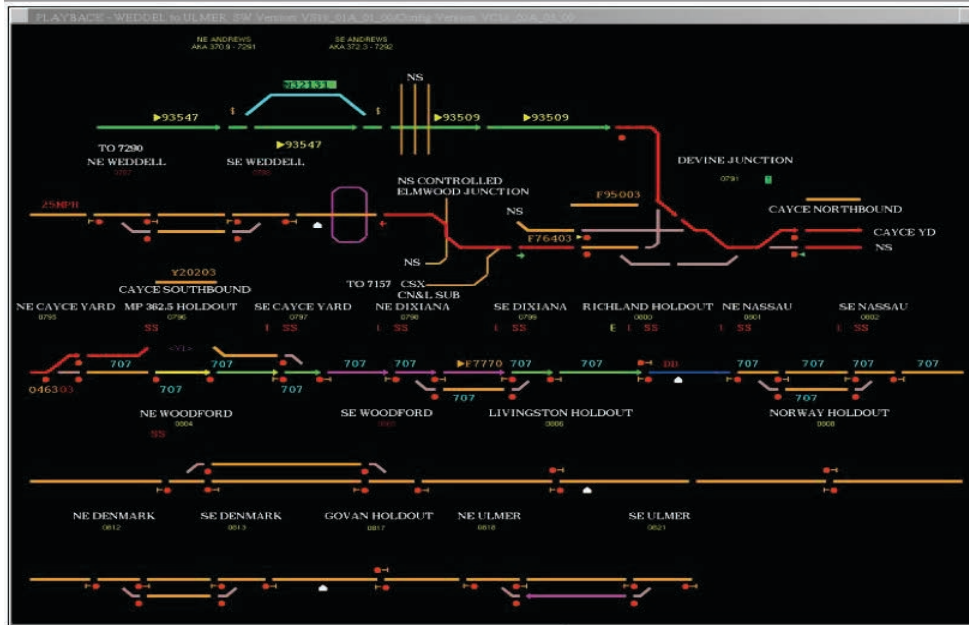
Figure 3 depicts Train F777-03 occupying track segments between S.E. Cayce Yard and S.E. Dixiana. (Courtesy of NTSB)

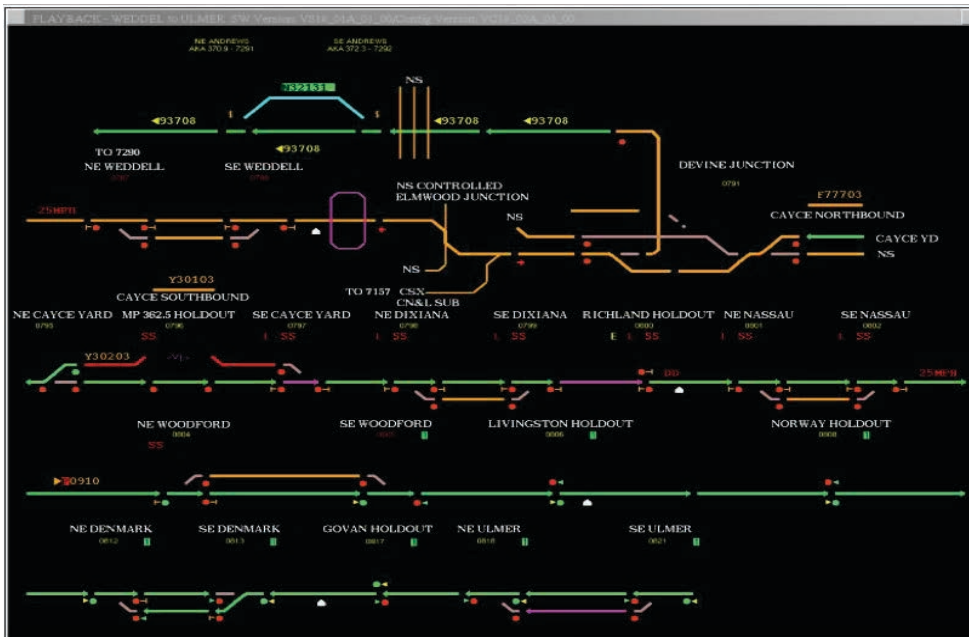
Figure 4 depicts train P091-03 entering the OS track at the S.E. Cayce Yard while the track segment where collision occurred is still reflecting occupied without train designation. (Courtesy of NTSB)

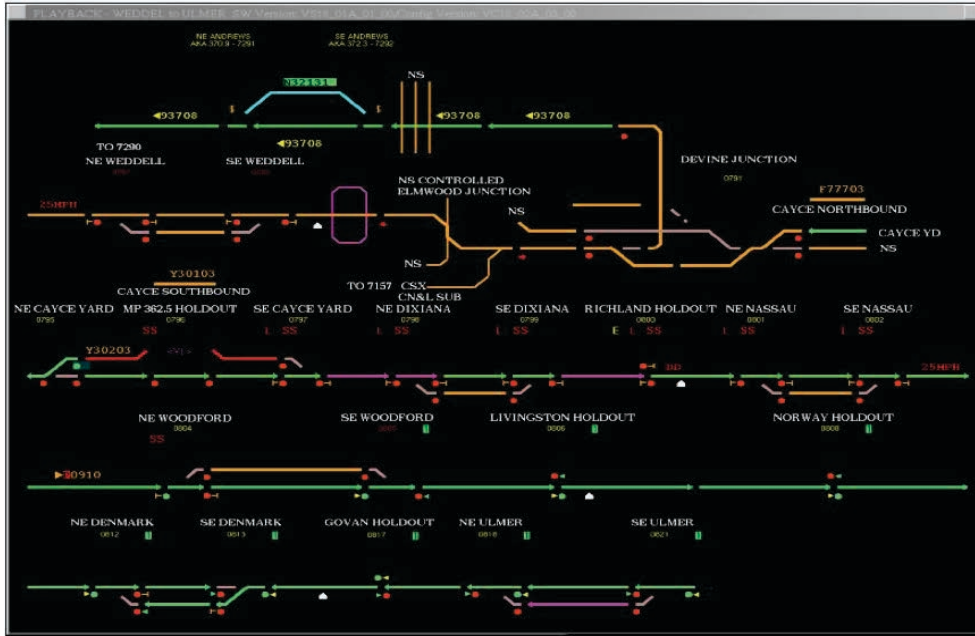
Figure 5 depicts train P091-03 entering the OS at the N.E. Dixiana with the track segment at Silica Storage Track still indicating occupied. (Courtesy of NTSB)

Post-accident interview with the third shift CSXT FF Train Dispatcher established there were visual aids on the dispatcher’s screen for the temporary signal suspension in effect. He stated that there was an “SS” on the screen denoting the territory was under a signal suspension. The Train Dispatcher also stated that a track occupancy light (track light) would not be displayed if a derail or switch were left open in the signal suspension track segment.

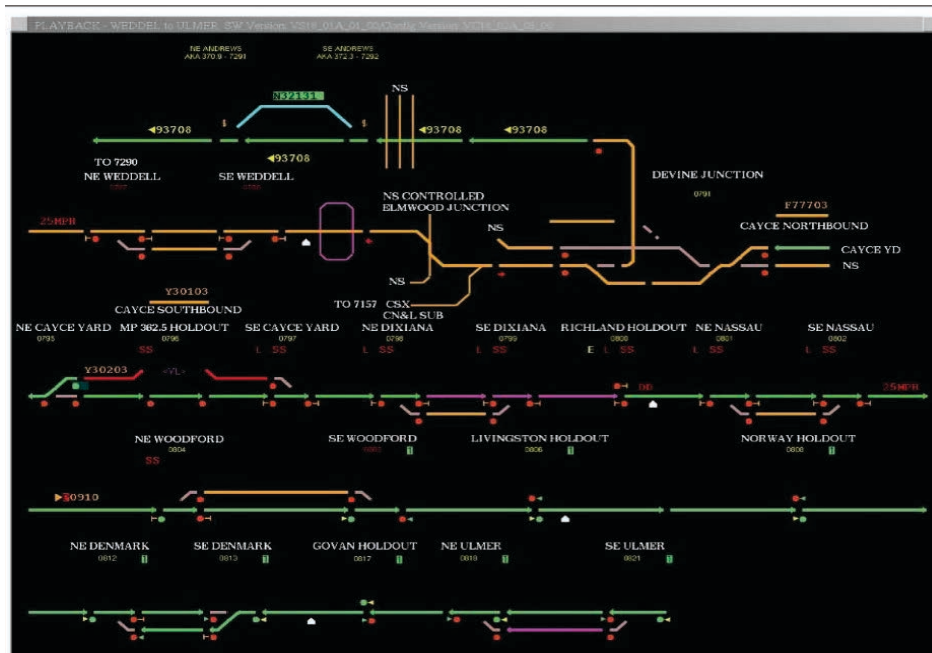
Figure 6 depicts P091-03 entering the already occupied track occupancy circuit at the South End of Dixiana (Courtesy of NTSB).

A field test conducted at CSXT's Dispatcher Center in Jacksonville, Florida by NTSB and the Federal Railroad Administration ("FRA") revealed that a track occupancy circuit is displayed on the Train Dispatcher's Computer Aided Dispatch ("CAD") system screen even during a temporary signal suspension. The third shift Train Dispatcher stated that he did not recall seeing a track light on his CAD screen. He also stated that, during his job briefing concerning the signal suspension, no one mentioned anything about track occupancy circuits being valid or invalid.
