# **BROTHERHOOD OF RAILROAD SIGNALMEN**

## **BEFORE THE NATIONAL TRANSPORTATION SAFETY BOARD**

**NTSB Accident Number: RRD18MR003**

**Proposed findings, probable cause, and safety recommendations, in connection with the February 4, 2018, head-on collision between southbound Amtrak P091-03 and standing CSXT freight F777-03 near Cayce, South Carolina.**

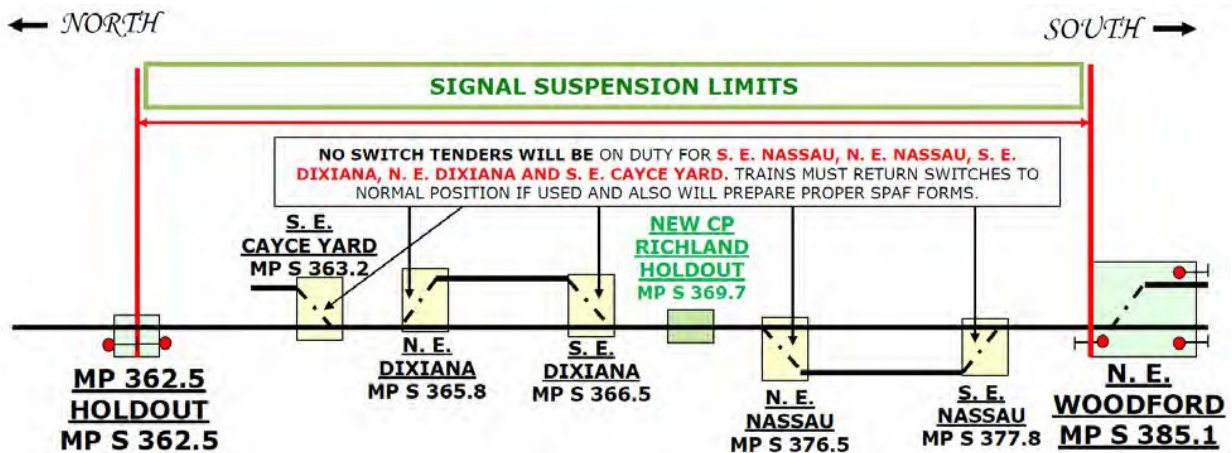
Figure 1. Diagram of the Signal Suspension Limits

Prior to departure, Amtrak P091-03 conducted a job briefing with an Amtrak Road Foreman of Engines, wherein it was discussed that a signal suspension<sup>3</sup> was in effect between Mileposts S362.5 and S385.1 near Cayce, South Carolina.

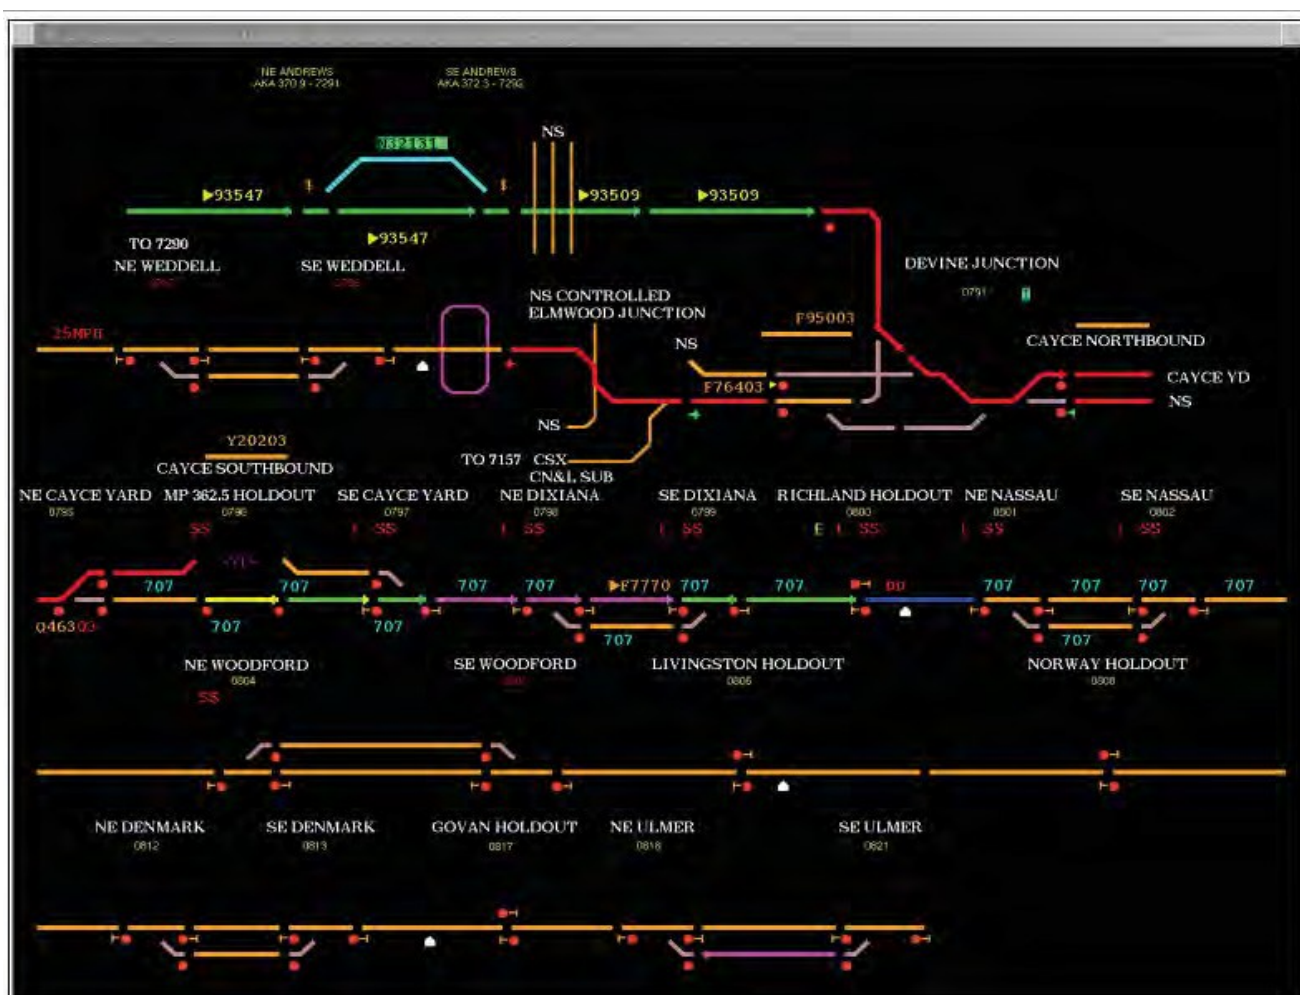
This exhibit reflects CSXT F777-03 occupying the tracks between S.E. Cayce Yard and S.E. Dixiana. Also, depicting the track south of S.E. Dixiana as unoccupied.<sup>11</sup>

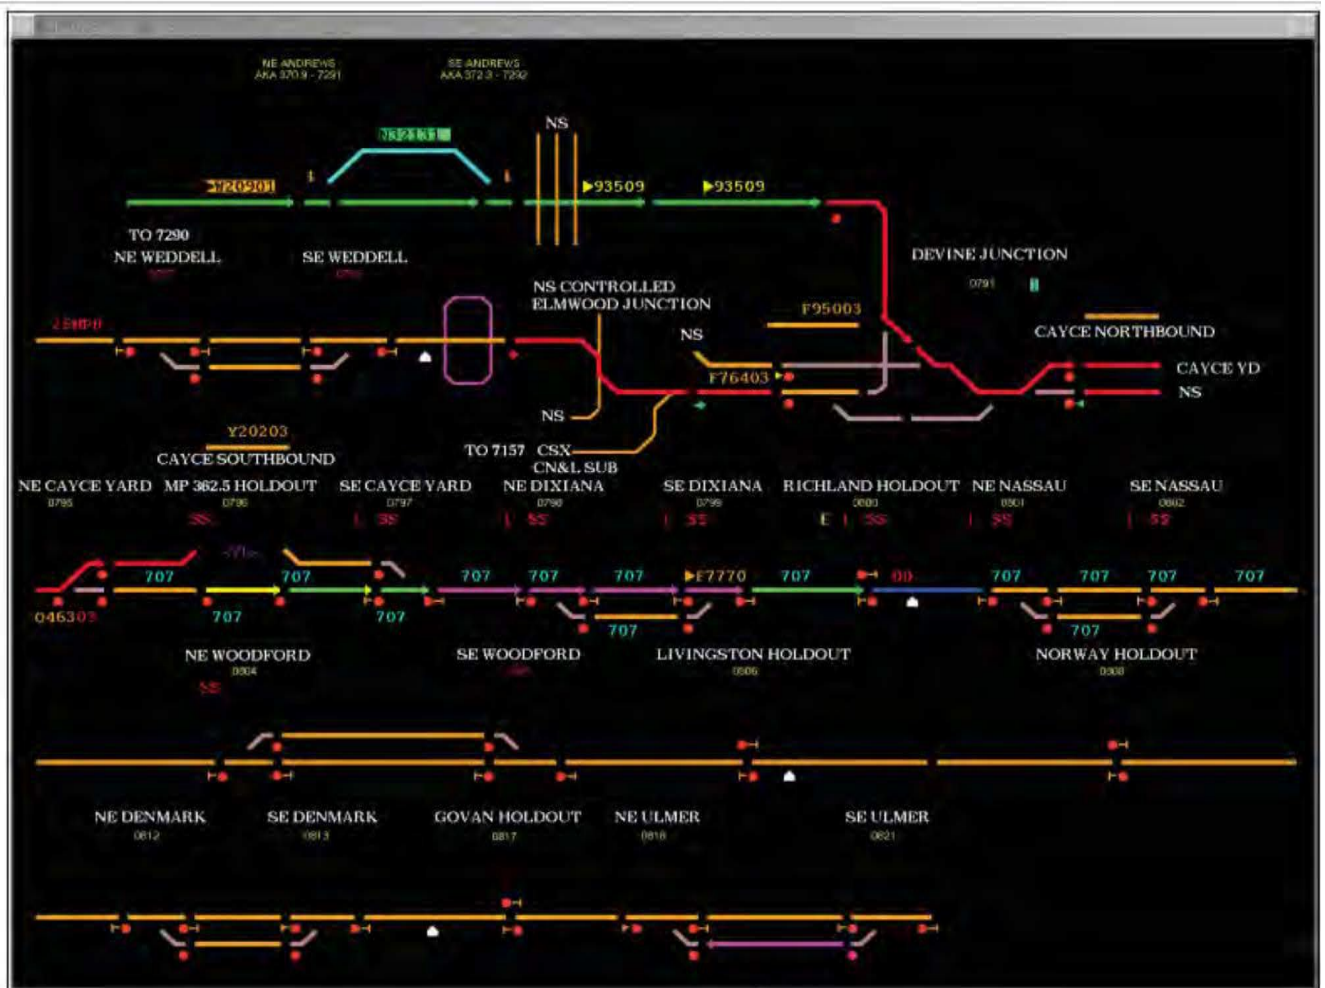
This exhibit depicts CSXT F777-03 in the OS track of S.E. Dixiana with South track still showing unoccupied.<sup>12</sup>

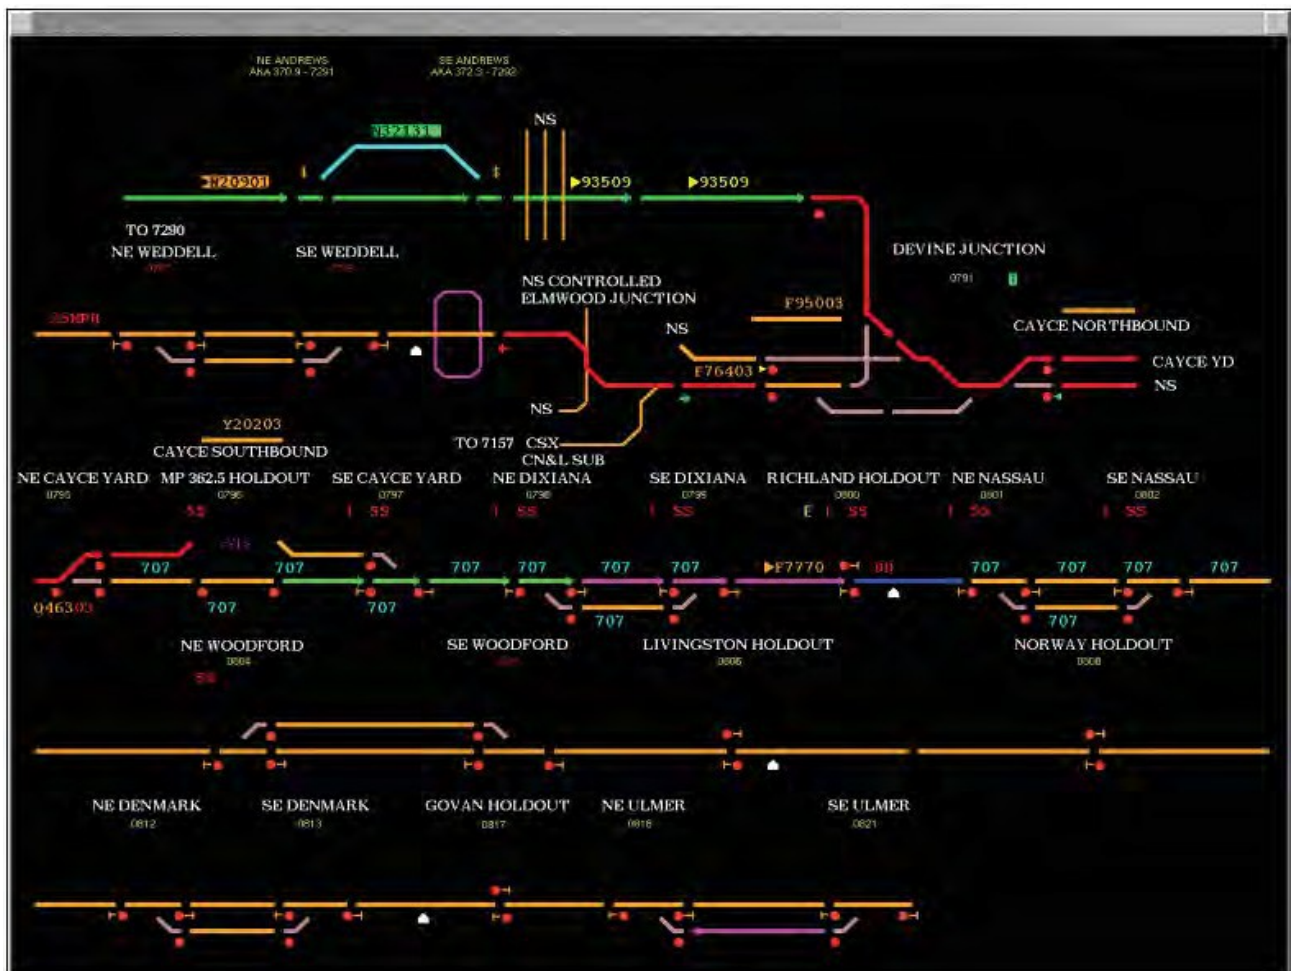
This exhibit shows CSXT F777-03 occupying tracks between N.E. Dixiana and Richland Holdout Signal. The track between Richland Holdout and the S.E. Dixiana does not show unoccupied after this point.<sup>13</sup>

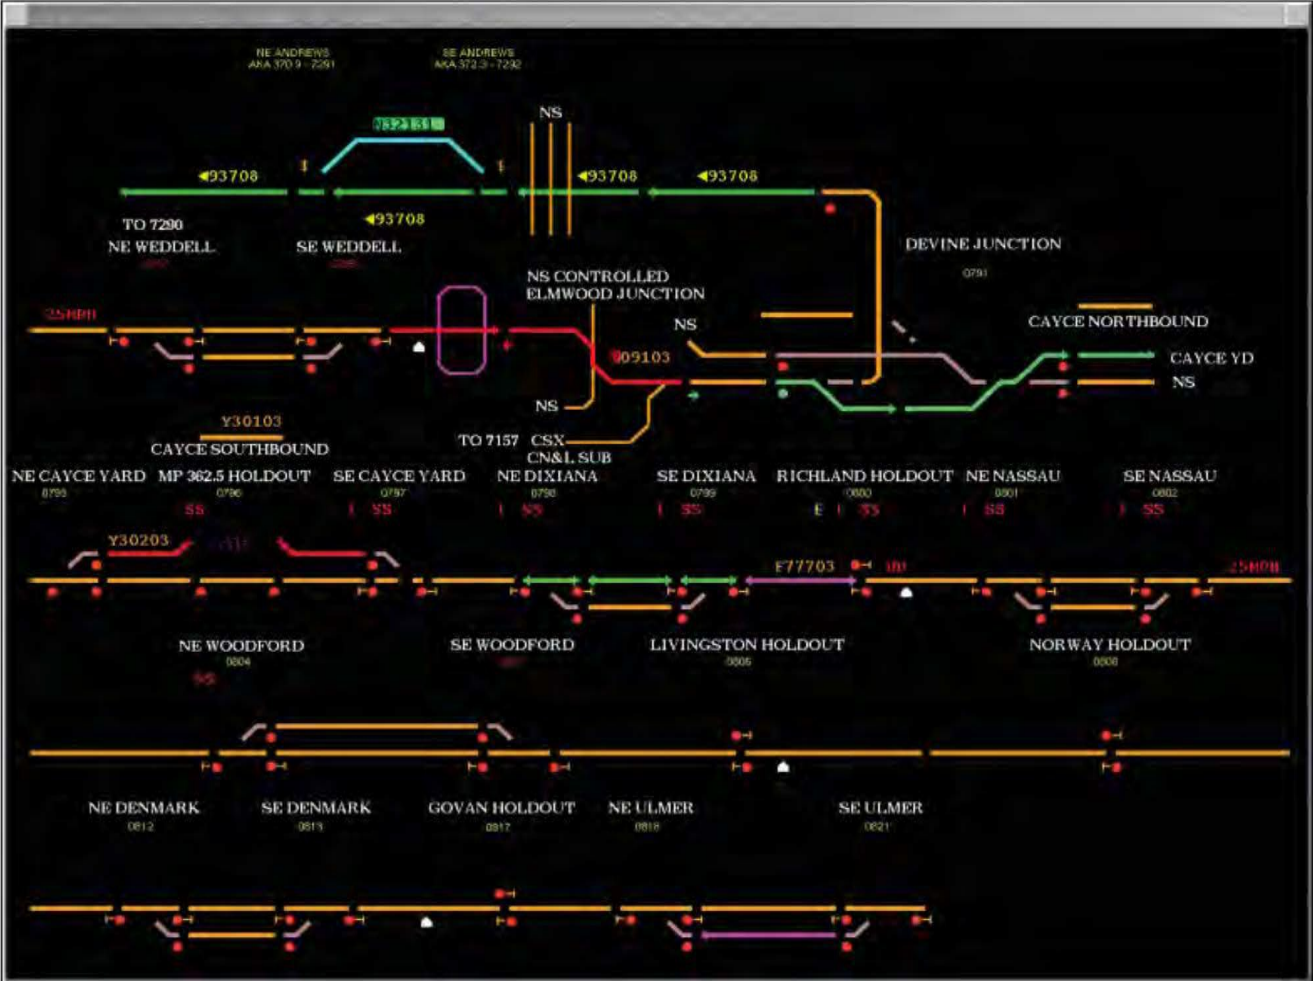
This exhibit shows that CSXT F777-03 only occupying the track between S.E. Dixiana and Richland Holdout.<sup>14</sup>

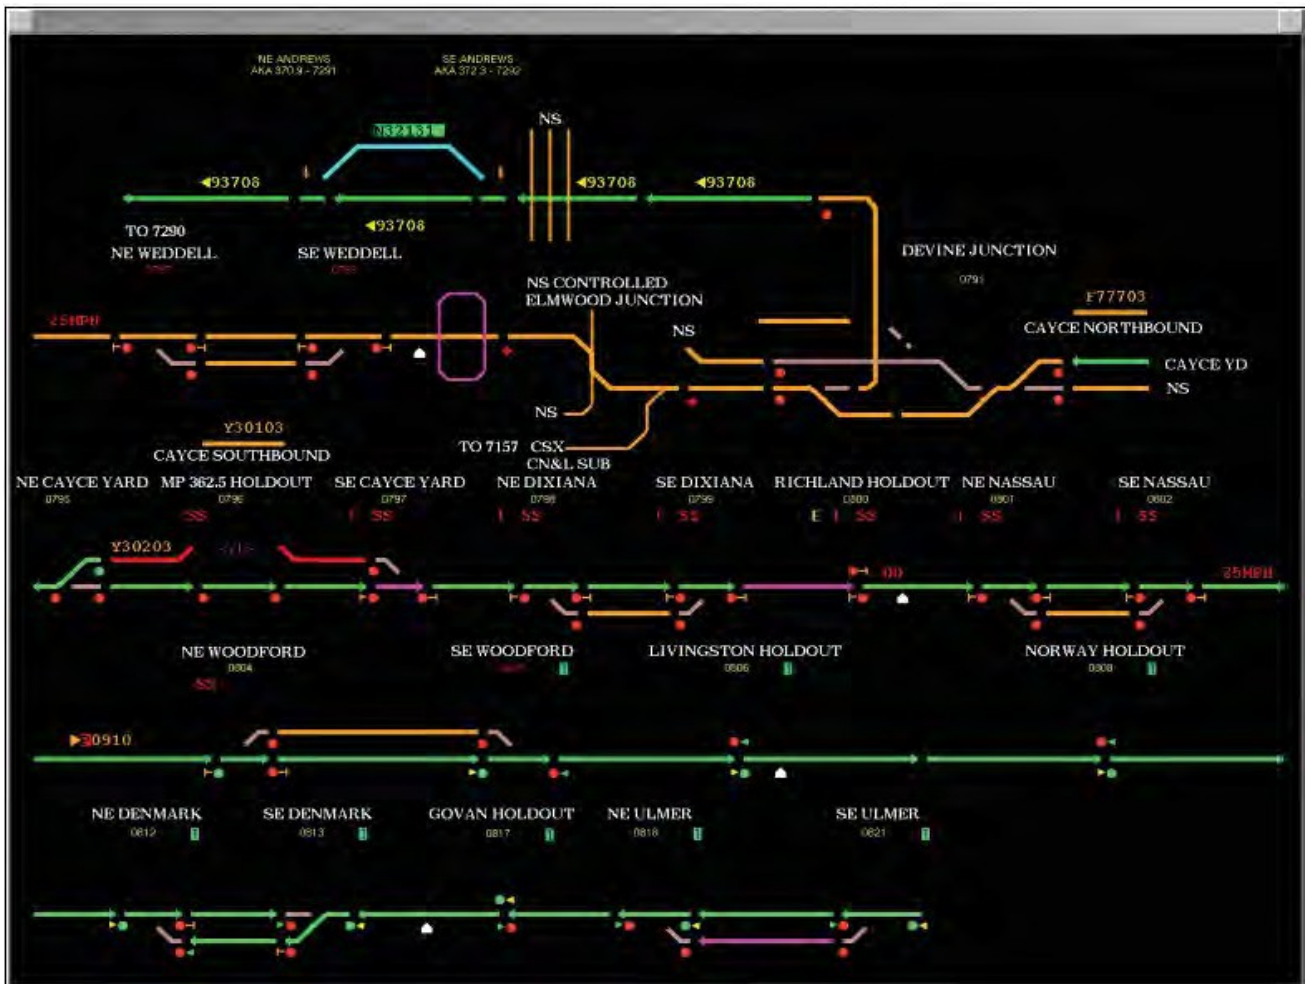
This exhibit shows Amtrak P091-03 occupying the OS an S.E. Cayce Yard and the track between S.E. Dixiana and Richland Holdout is still showing occupied without train designation.<sup>15</sup>

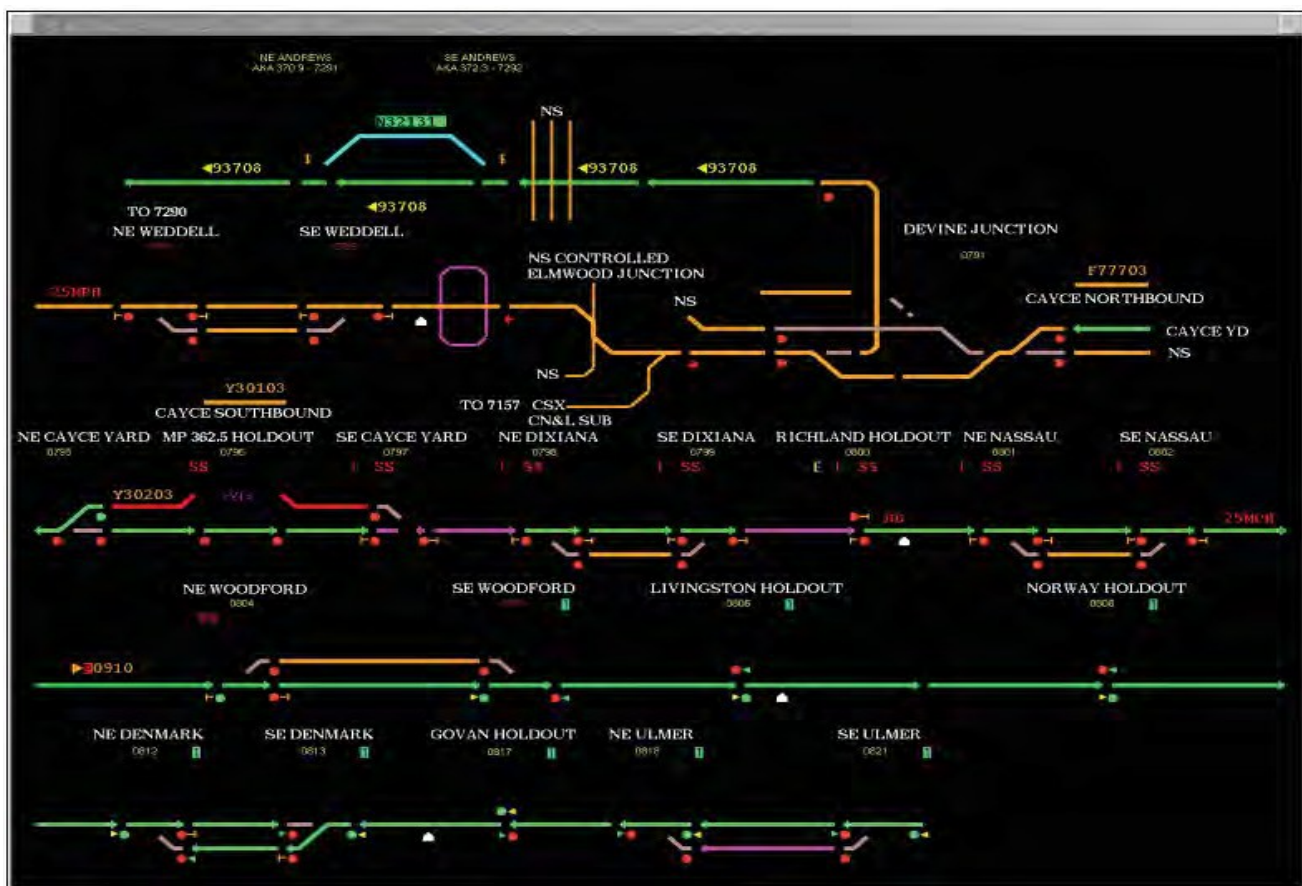
This exhibit shows Amtrak P091-03 occupying S.E. Cayce Yard and N.E. Dixiana.<sup>16</sup>

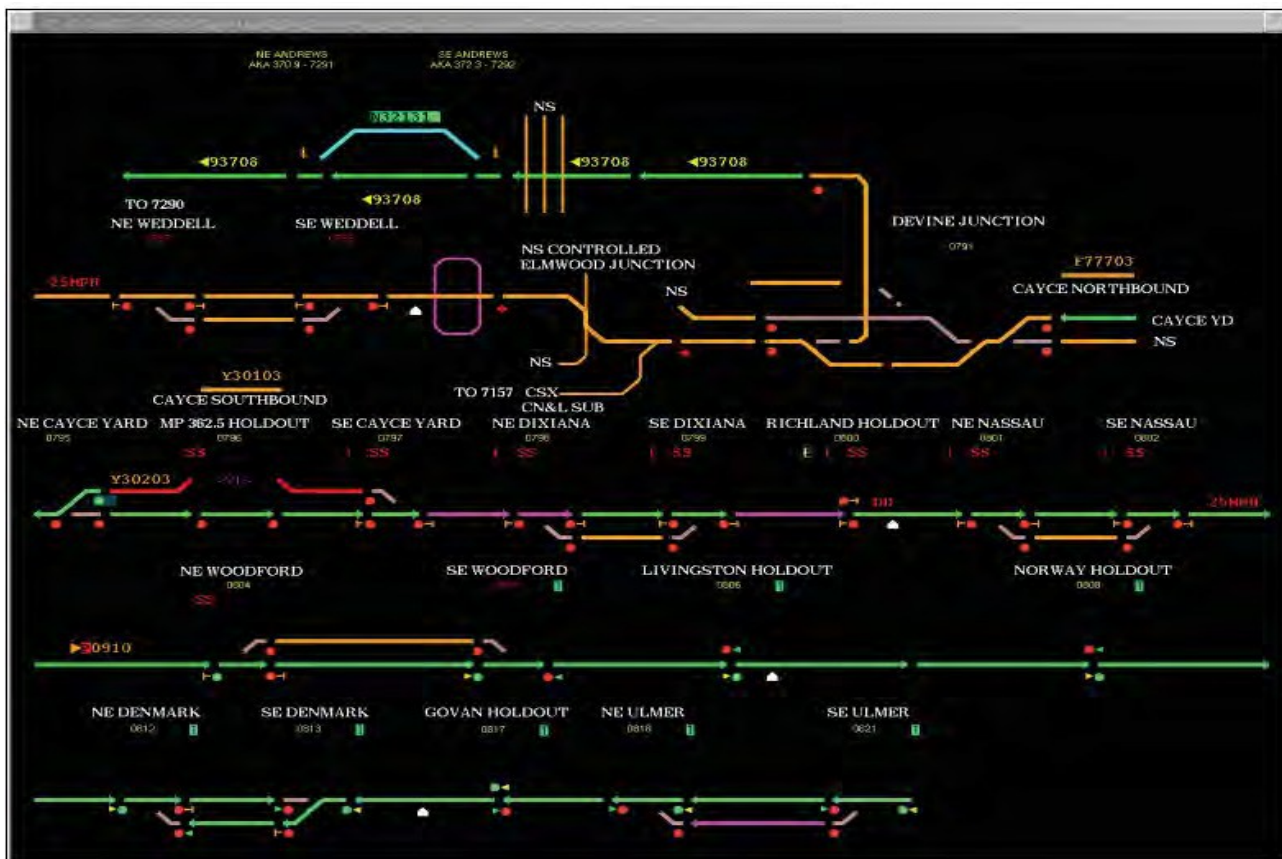
This exhibit shows Amtrak P091-03 entering N.E. Dixiana with the track south of S.E. Dixiana still occupied.<sup>17</sup>

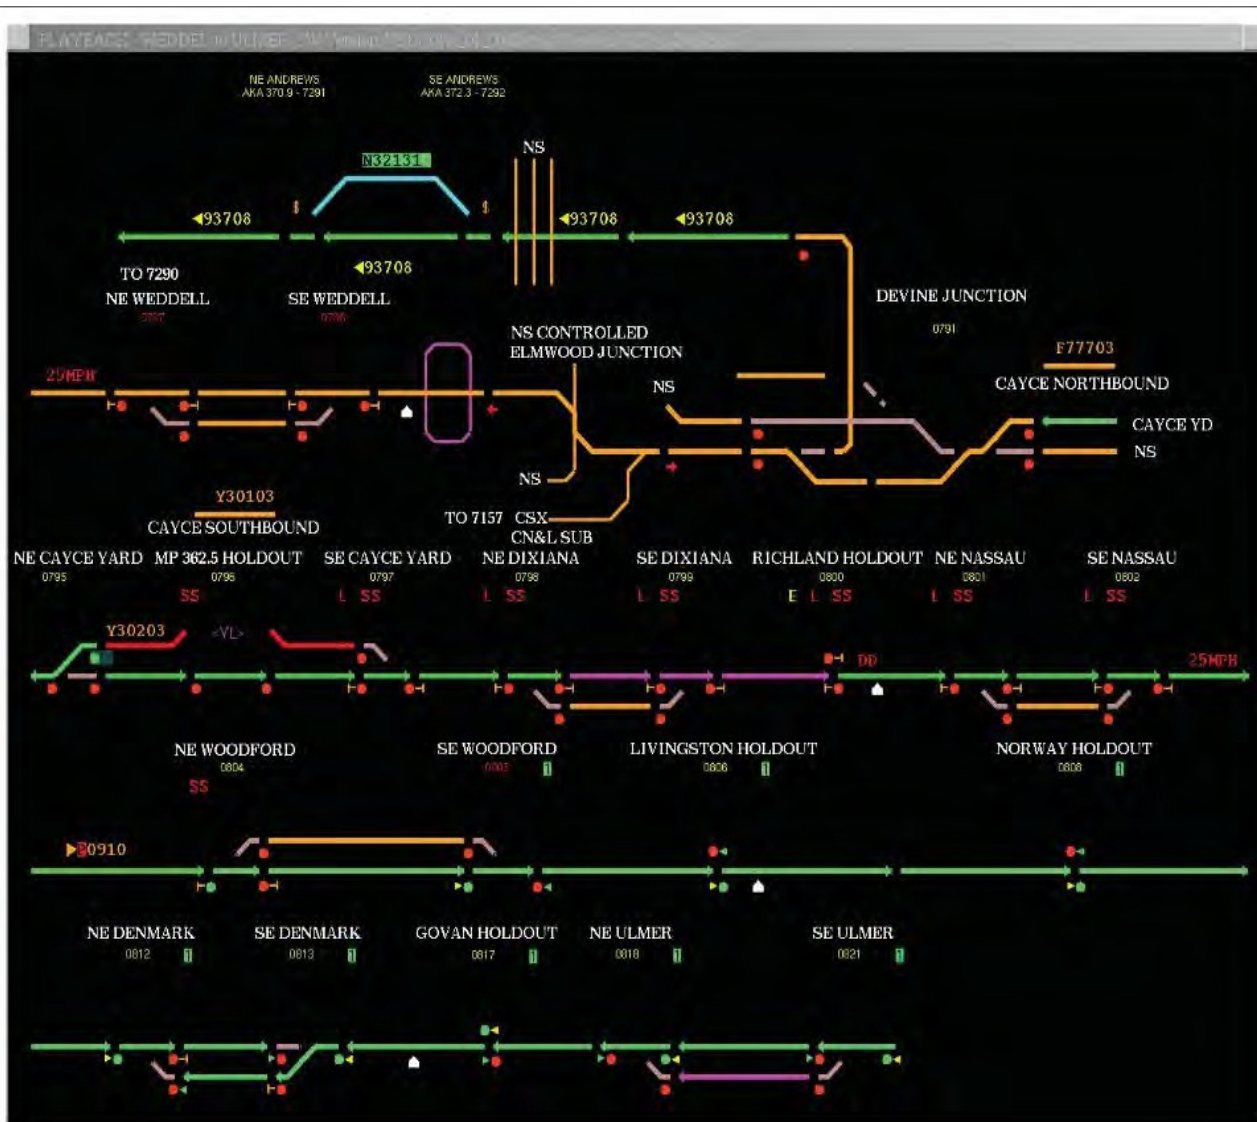
This exhibit shows Amtrak P091-03 entering S.E. Dixiana OS Track with the track south of S.E. Dixiana still occupied.<sup>18</sup>

Additionally, a job briefing between the Dispatcher and the Signal Department employee-in-charge should have been conducted to describe what impact the signal work would have on the signal system. Here we have a situation where the signal system, though suspended, was mostly functional as indicated in the CAD screens shots. Had there been a proper job briefing, the dispatcher would have known that he could depend on the indications on his CAD screen, he would have known that the occupied track indications left by CSXT train F777-03 could have indicated that there was a problem and taken appropriate action.
