**AERONAUTICAL ACCIDENT INVESTIGATION  
AND PREVENTION CENTER**

**FINAL REPORT  
A-022/CENIPA/2008**

**ACFT REGISTRATION: PR-GTD and N600XL**

**MODELS: B-737 8EH and EMB-135 BJ LEGACY**

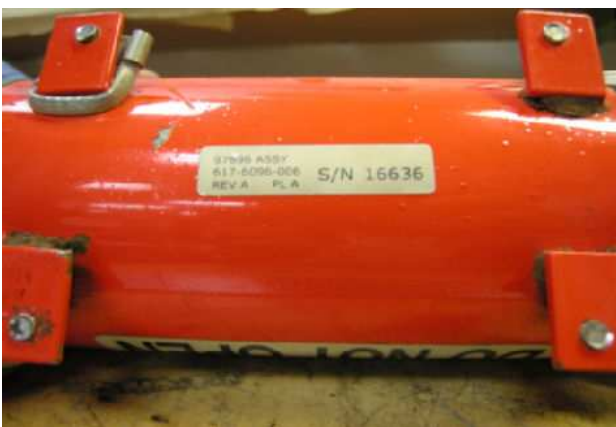
**Figure 19:** SSCVR protected cylinder, PR-GTD

The direct impact of the SSVR unit against a tree trunk or branch was sufficient for the protected cylinder containing the data (Figure 19) to detach from the rest of the set (Figure 20).
