AIR SAFETY INVESTIGATIONS ENGINE FIELD INSPECTION REPORT

ENGINE MODEL: IO-550-N (EXP)

AIRCRAFT MODEL: Lancair Legacy

REGISTRATION: N121J

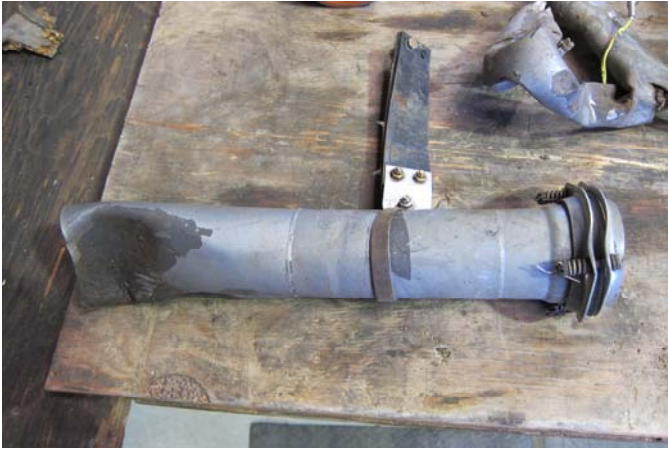
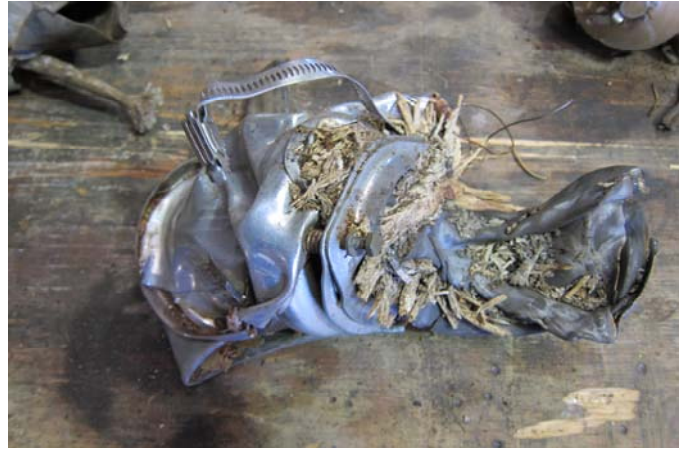
Exhaust assembly

Condition: An impact damaged exhaust pipe and muffler was found in the main wreckage.

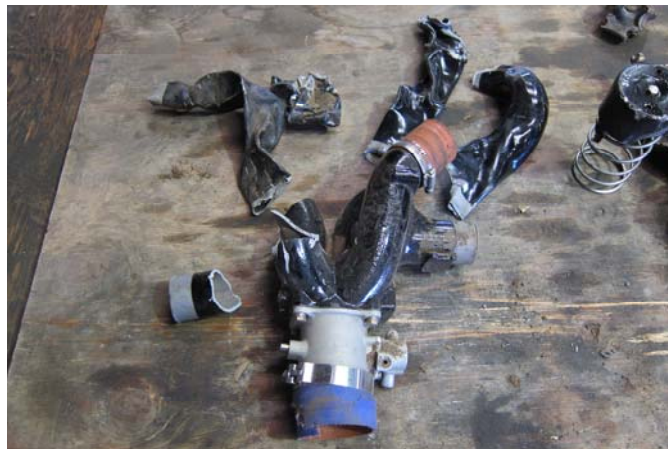
Induction assembly

Condition: The induction assembly separated from the engine and was found in several sections.

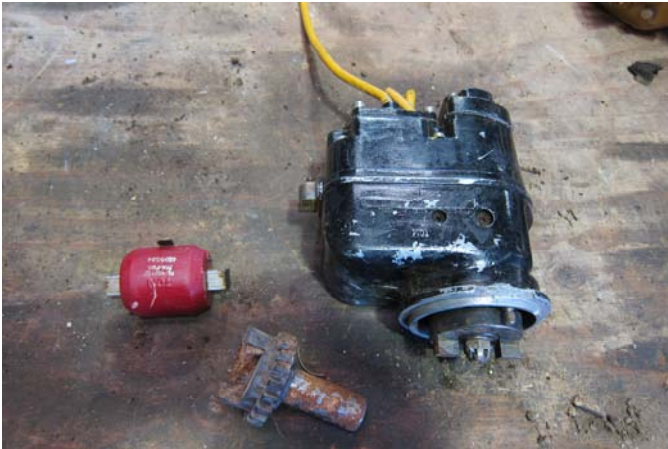
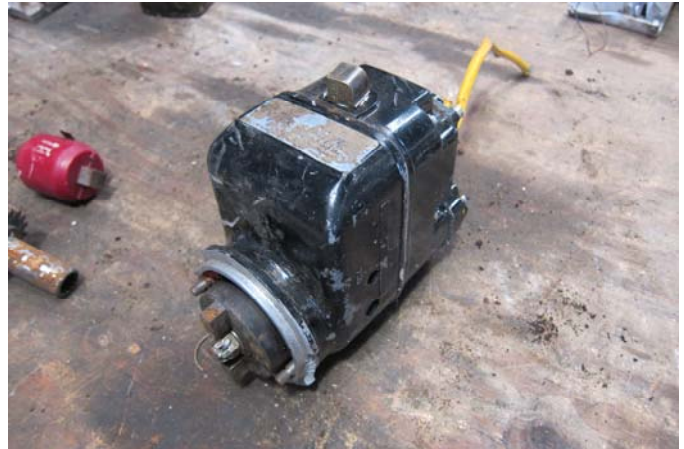
RH Magneto Manufacturer: TCM Type/Part No.: No Data Tag Serial No.: No Data Tag

Condition: The magnetos separated from the engine and only one was found intact. The internal coil of the other magneto was found with the main wreckage. The magneto drive shaft rotated freely with impulse coupling engagement. Spark was visible from the damaged ignition lead ends and at the distributor cover.

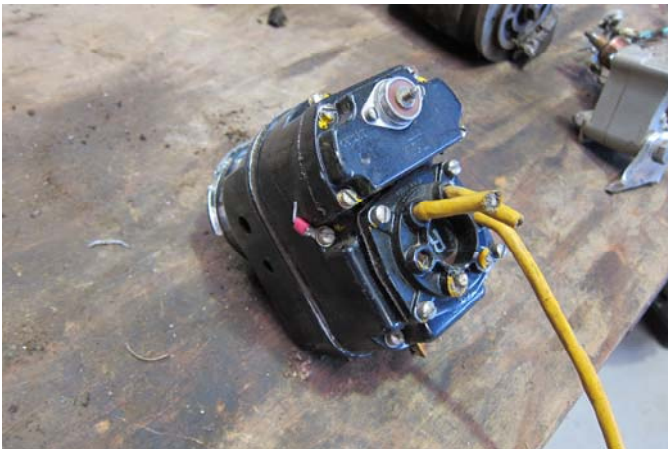
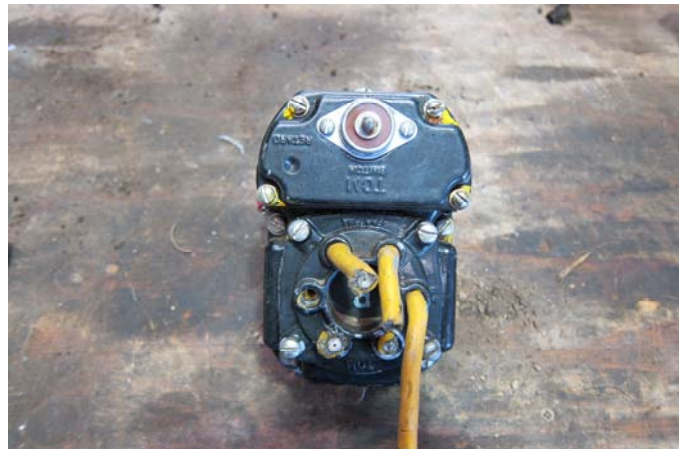
Ignition Harness Manufacturer: TCM

Condition: Small sections of ignition leads remained attached to one magneto. Spark was obtained at the damaged ends.

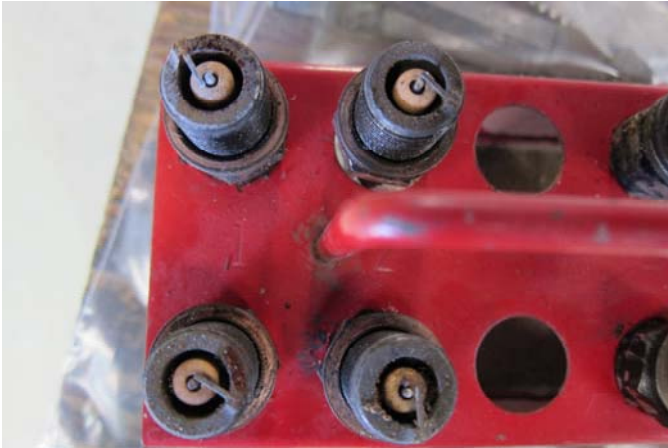
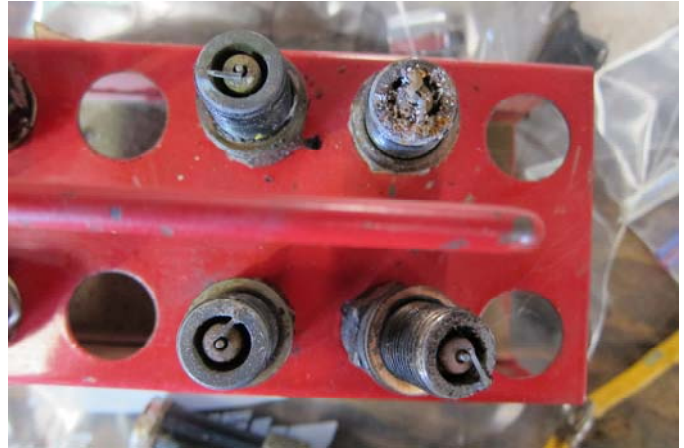
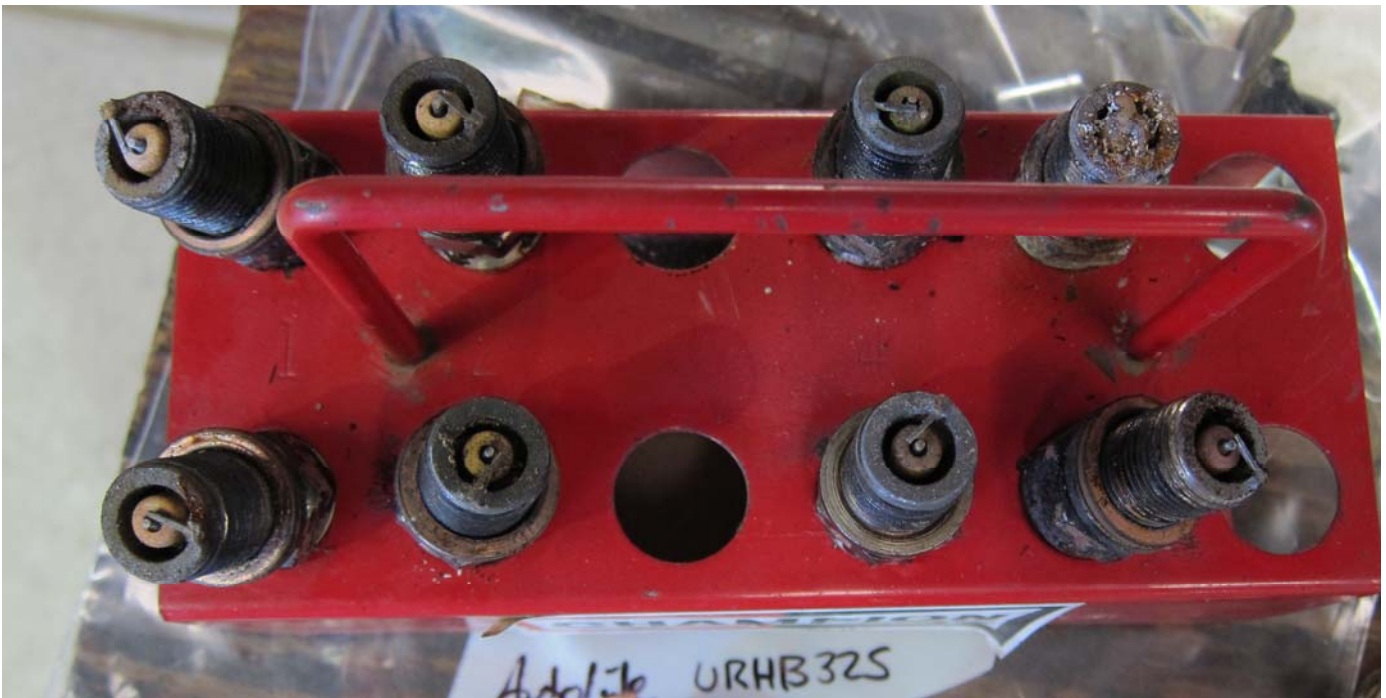
Spark Plugs

Condition: The no. 1, 2, 4 and 5 positioned spark plugs were removed from their cylinders. In accordance with the Champion AV-27 chart, the spark plugs had (Worn Out – Normal) wear signatures indicating a normal service life. The no. 6 cylinder spark plugs remained in the cylinder head and showed (Worn out-Normal) wear conditions. The spark plug electrode areas had gray deposits with the exception of the no. 5 upper spark plug. The no. 5 spark plug electrode area had debris and corrosion deposits.

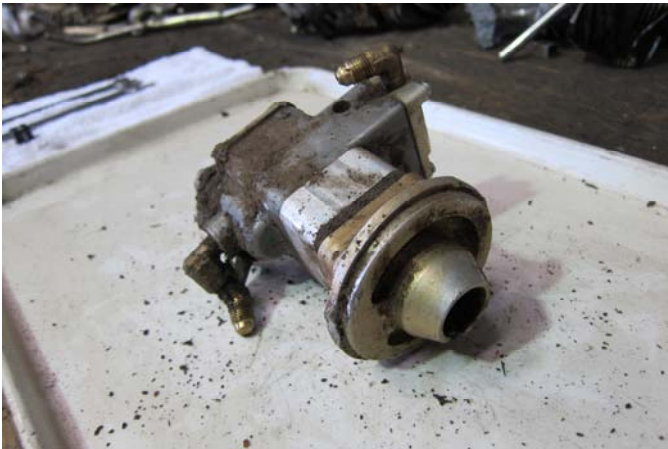
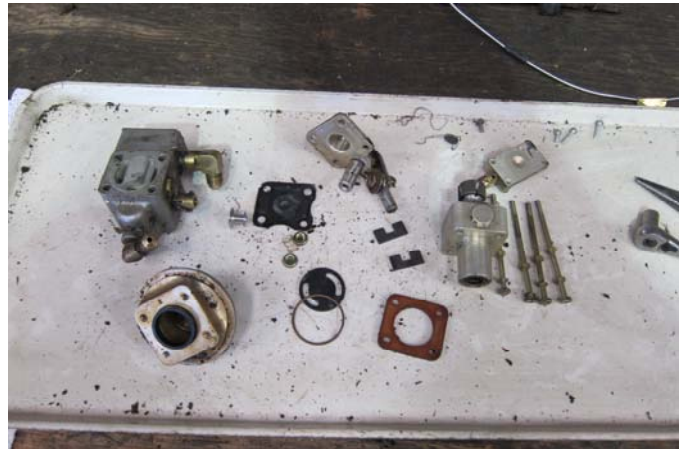
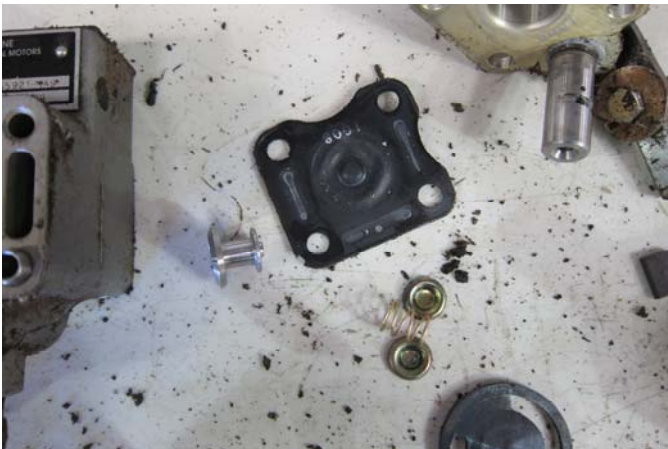
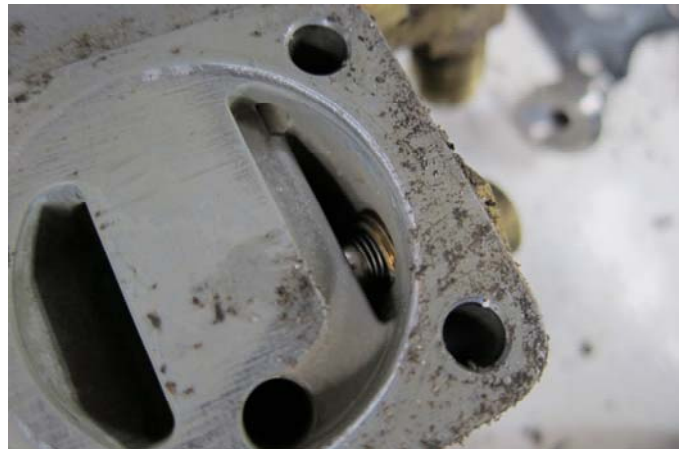
Fuel Pump

Condition: The fuel pump separated from the engine and the drive coupling was not found. The fuel pump was disassembled and no anomalies were noted. Several pressure fittings separated.

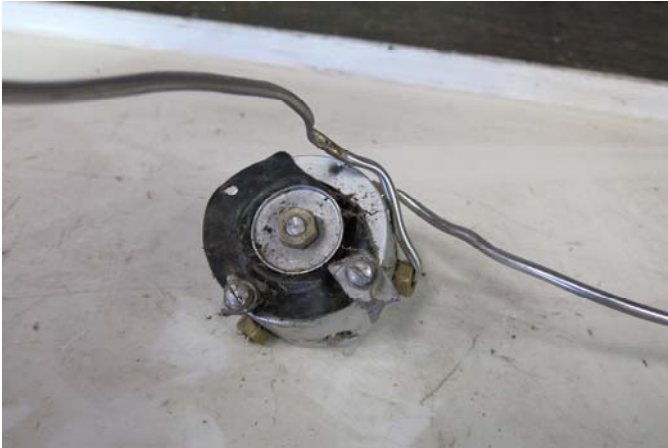
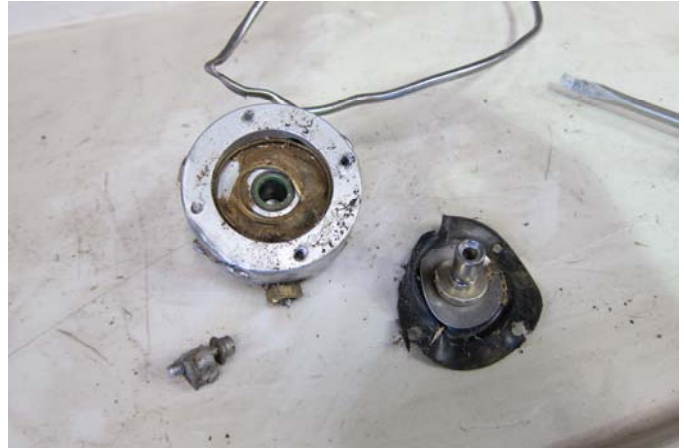
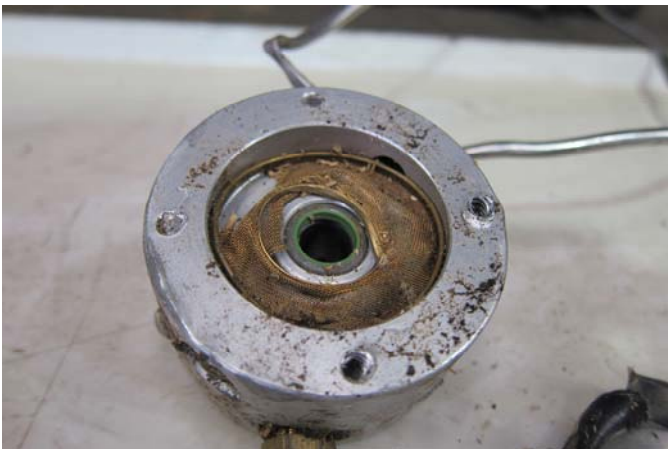
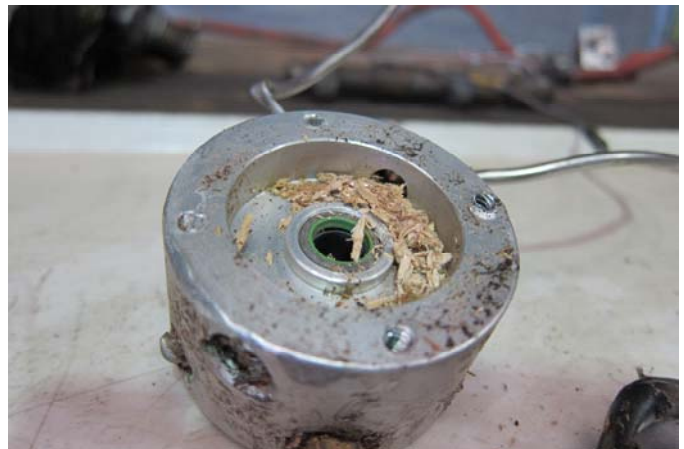
Fuel Manifold Valve Manufacturer: TCM Part No.: 646433-3A1 Serial No.: C03IA027

Condition: The fuel manifold valve separated from the engine and several lines had separated at the fittings. The manifold valve's cover plate had impact damage and the diaphragm was visibly damaged. The valve was disassembled and the inlet screen was crushed. The cavity area had shredded wood debris and the plunger area had a small amount of fuel. The fuel manifold valve plunger and diaphragm retaining nut was tight and secure.

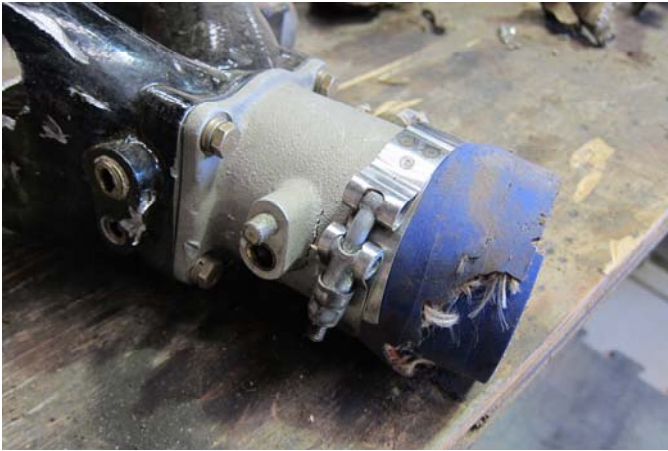
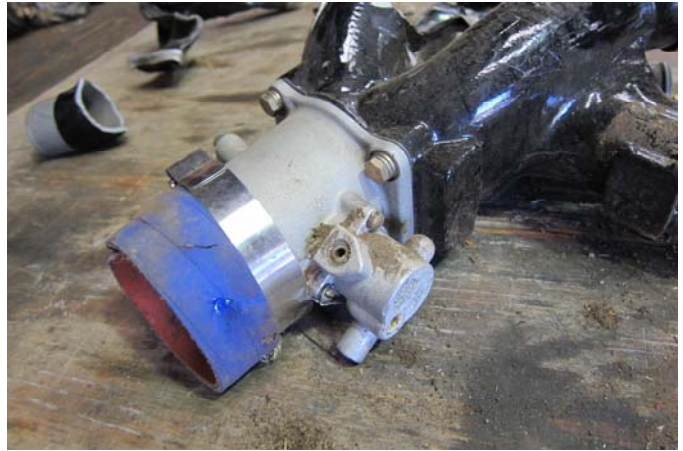
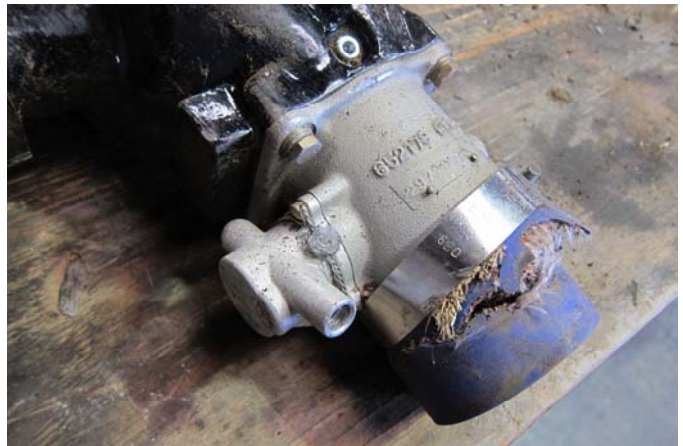
Throttle Body Fuel Control Manufacturer: TCM Part No.: (652179)

Condition: The throttle body fuel control had impact damage and was found with the main wreckage. The throttle linkage separated and the valve was found in the open position.

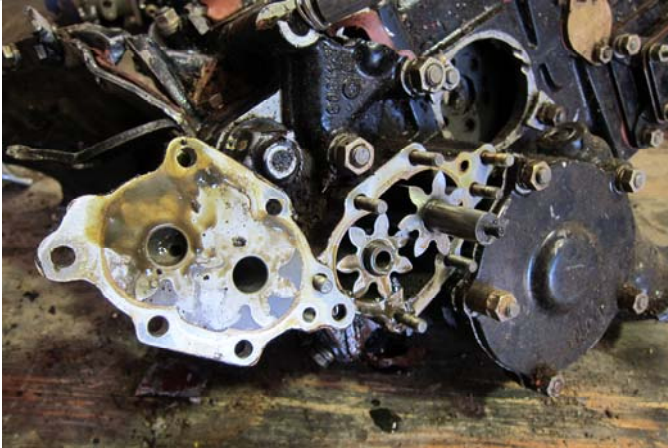
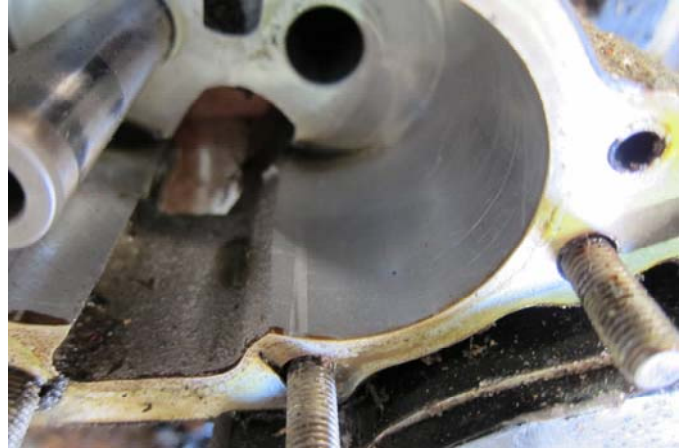
Oil Pump

The oil pump remained attached to the separated accessory section. The cover plate was removed and the gears were undamaged. Both sides of the cavity had impact marks.

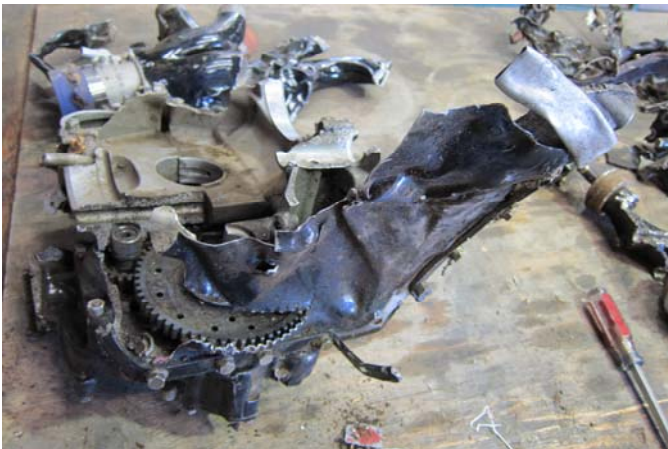
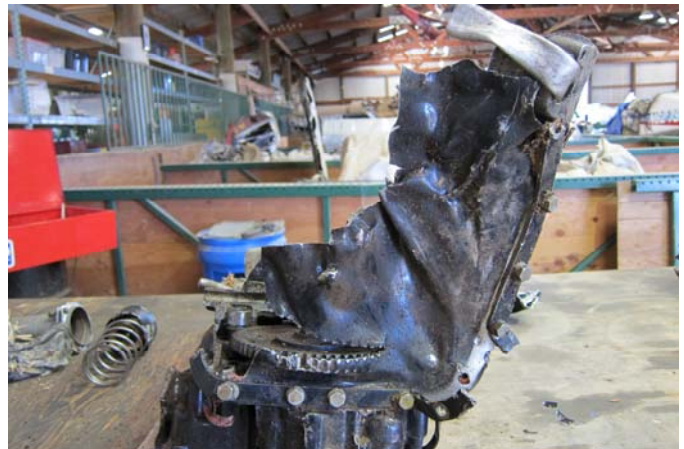
Oil Sump

Condition: The oil sump had impact damage and the largest section remained attached to the separated accessory section.

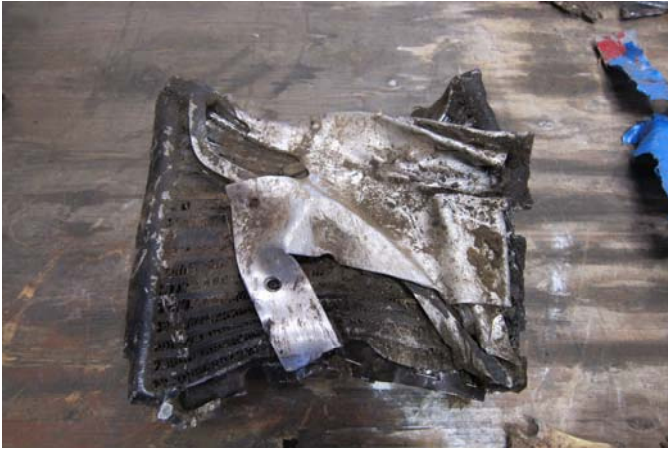
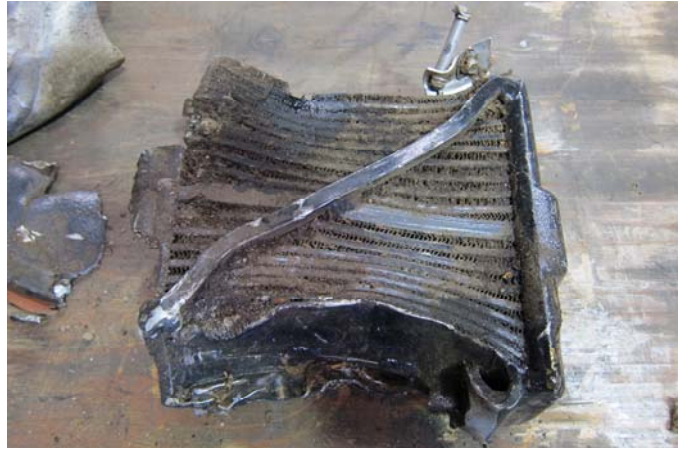
Oil Cooler Condition: The oil cooler separated from the engine and was crushed.

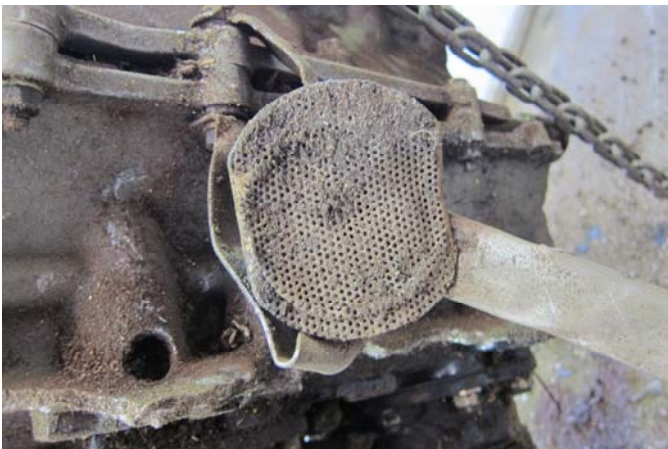
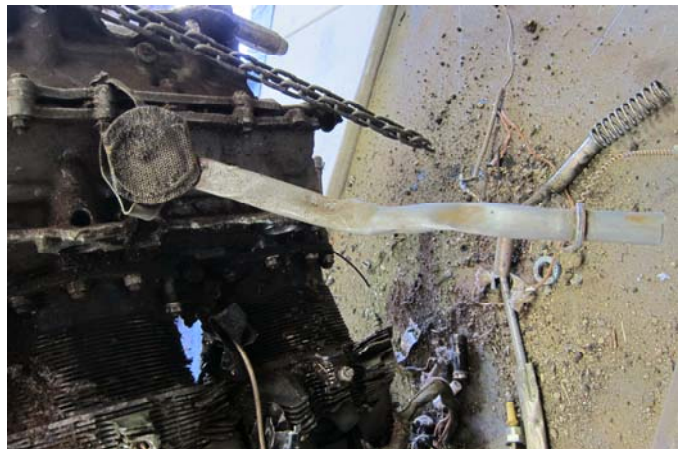
Oil Pick-up Tube & Screen The oil pick-up tube and inlet screen had impact damage. The inlet screen was partially obstructed with dirt.

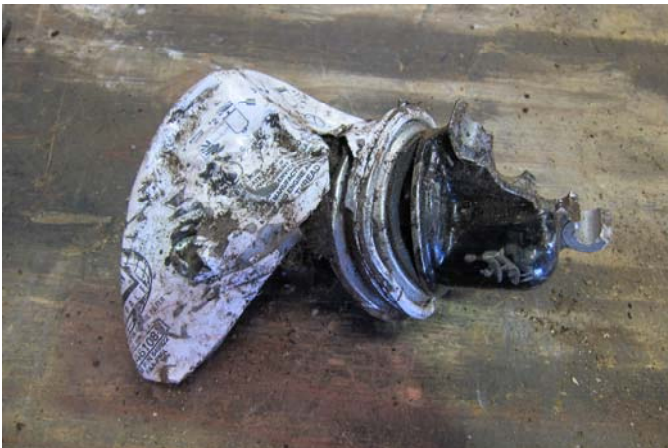
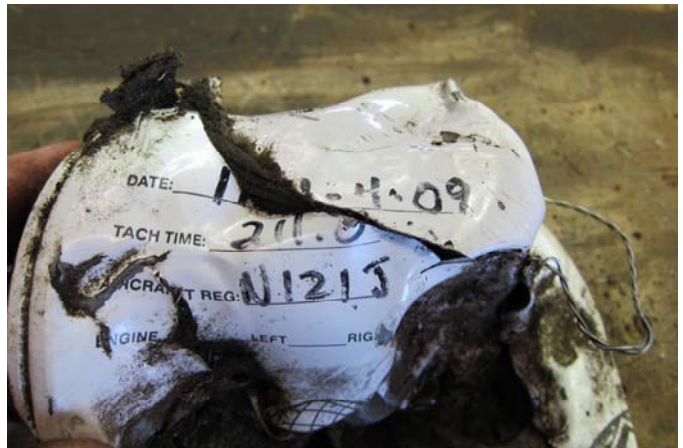
Oil Filter The oil filter and adapter housing had impact damage. The oil filter canister was torn and dirt and debris was on the filter element. The oil canister read "Date: 11-4-09, Tach Time: 211.0..."

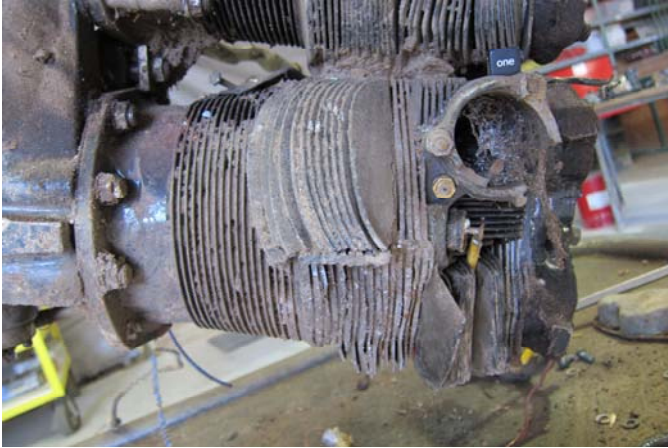
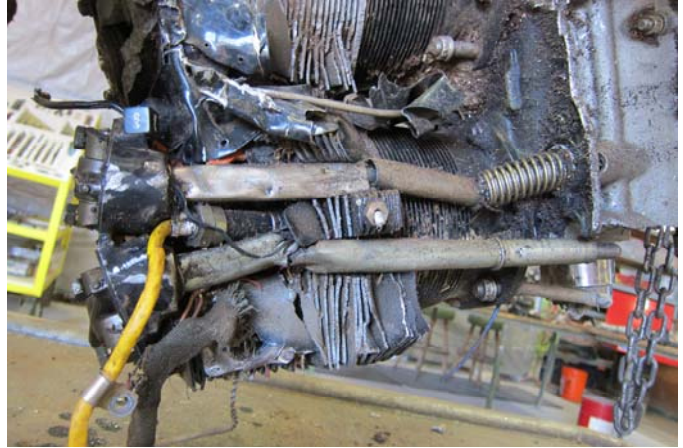
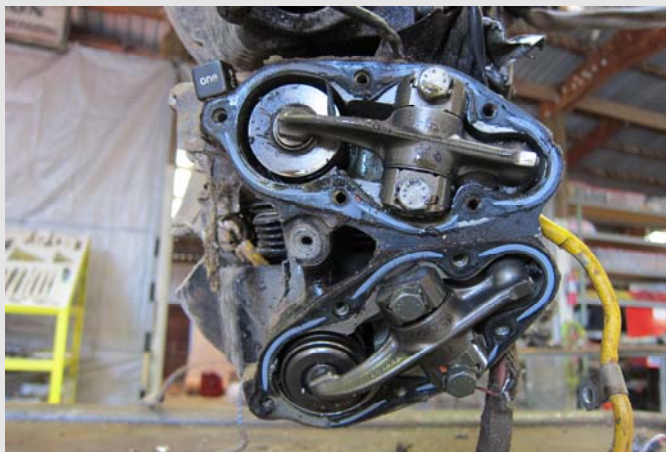
Cylinder #1 Part No.: Unknown Head Date: Unknown Barrel Surface: Steel

Condition: The cylinder remained attached to the crankcase and had impact damage to the rocker covers, induction and exhaust flanges, cooling fins and pushrod assemblies. The cylinder overhead components were lubricated and undamaged. The cylinder was boroscoped and the combustion chamber had a layer of light grey deposits and the cylinder barrel was undamaged. The valve heads were undamaged and had no signs of abnormal thermal discoloration.

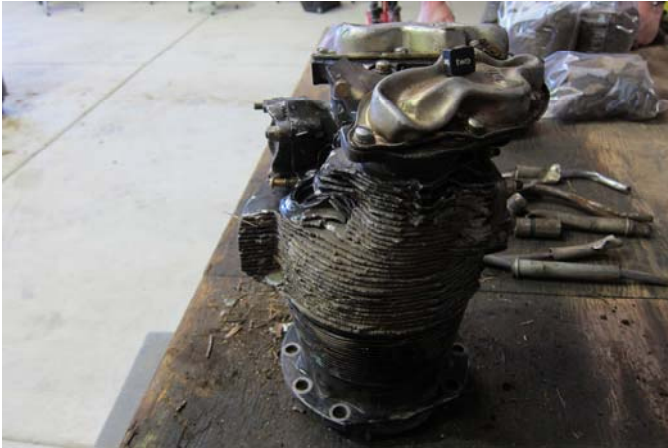
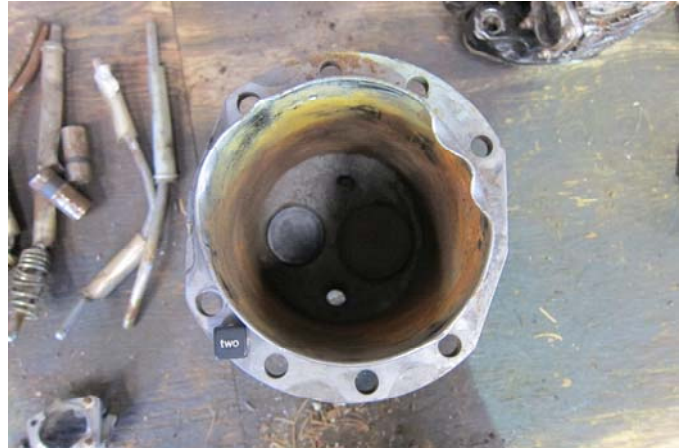
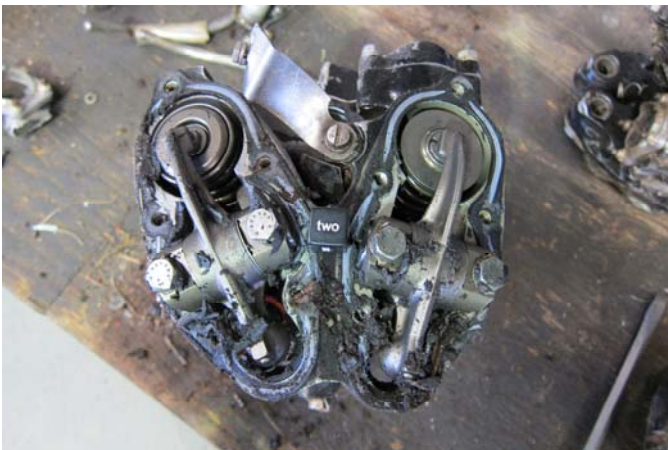
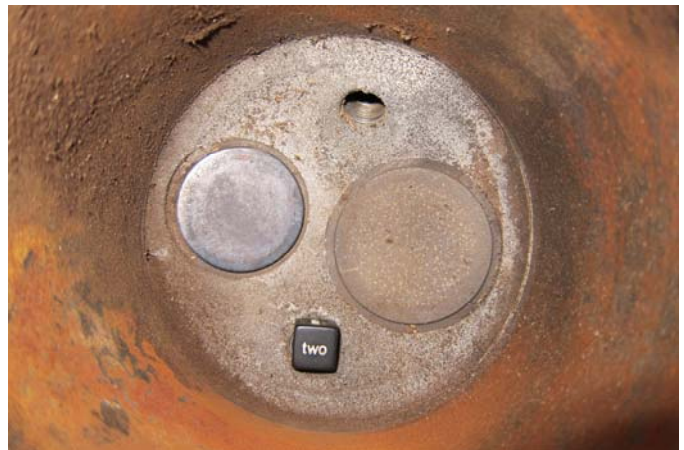
Cylinder #2

Condition: The cylinder separated from the engine and was found with the main wreckage. The cylinder rocker covers, induction and exhaust flanges, cooling fins and pushrod assemblies had impact damage. The cylinder overhead components were lubricated. The combustion chamber had a layer of light grey deposits and the cylinder barrel had corrosion deposits. The valve heads were undamaged and had no signs of abnormal thermal discoloration.

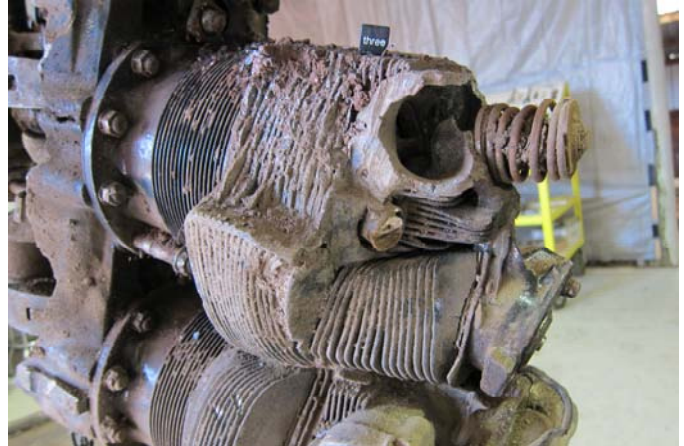
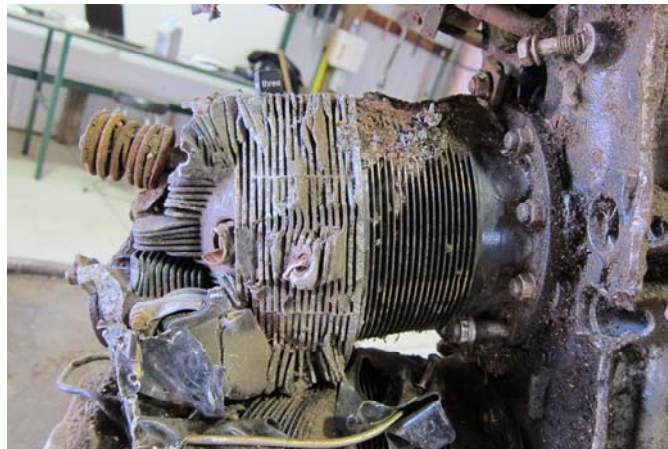
Cylinder #3

Condition: The cylinder remained attached to the crankcase and had impact damage to the overhead, induction and exhaust flanges, cooling fins and pushrod assemblies. The rockers and rocker bore material separated from the cylinder head. The damaged spark plugs could not be removed from the cylinder.

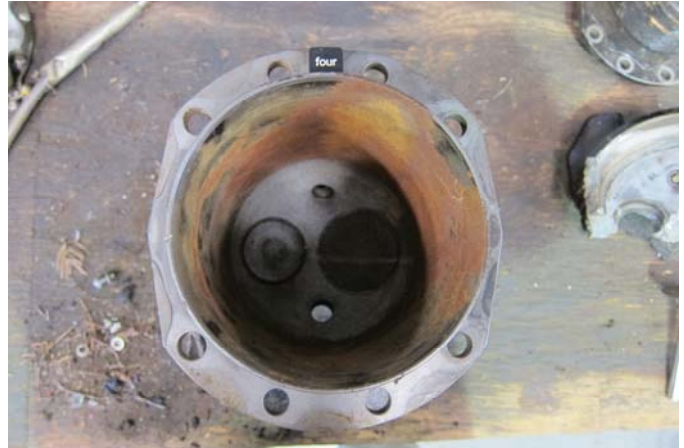
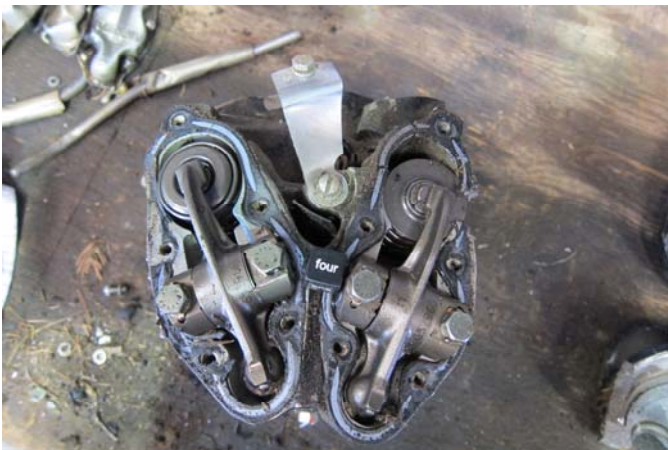
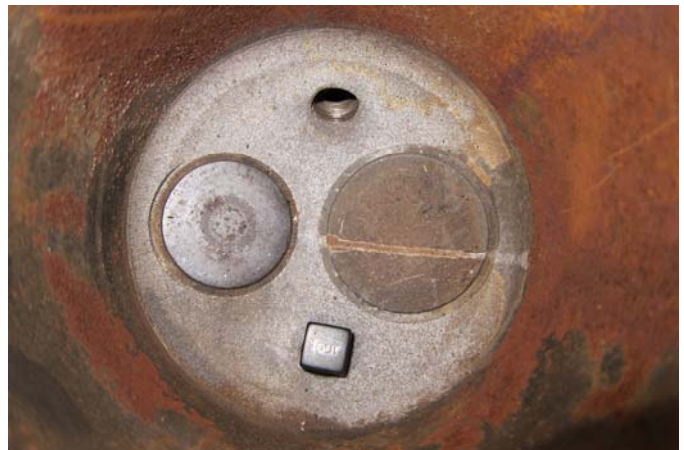
Cylinder #4

Condition: The cylinder separated from the engine and was found with the main wreckage. The cylinder rocker covers, cooling fins and pushrod assemblies had impact damage. The cylinder overhead components were lubricated and undamaged. The combustion chamber had a layer of light grey deposits and the cylinder barrel had corrosion deposits. The valve heads were undamaged and had no signs of abnormal thermal discoloration.

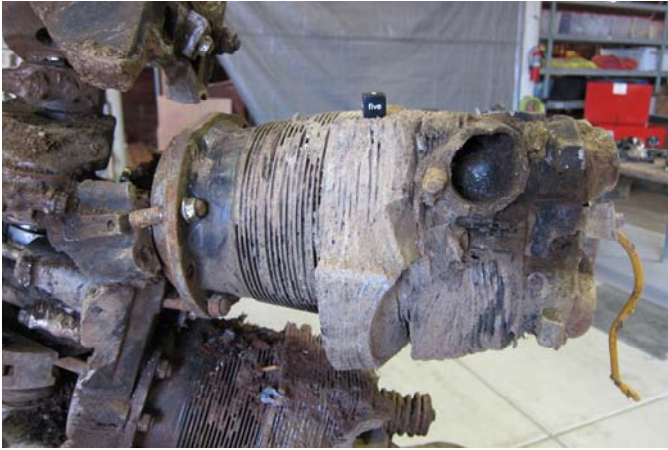
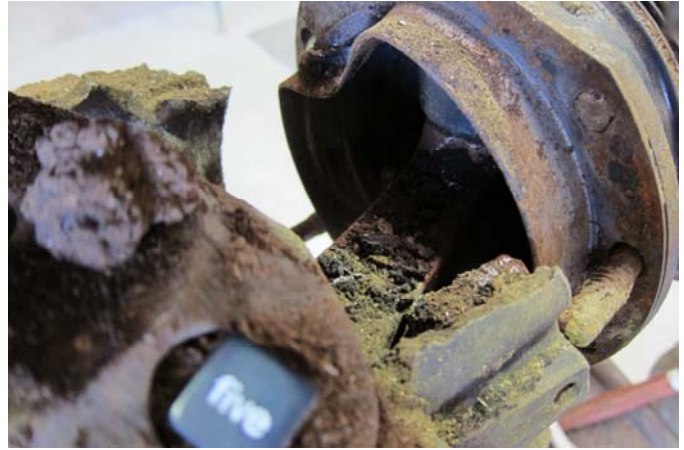
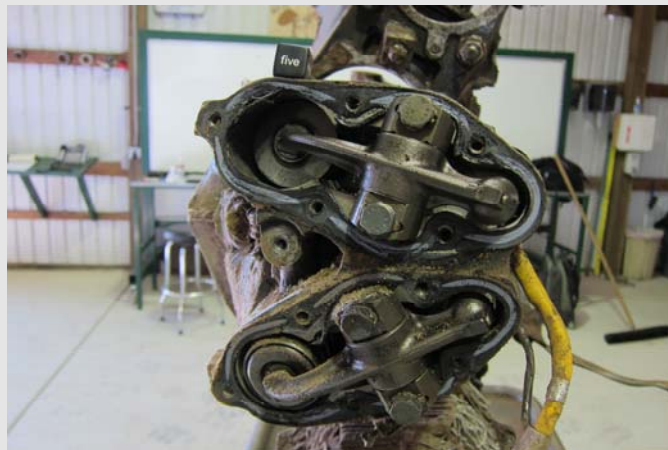
Cylinder #5

Condition: The cylinder separated from the crankcase and remained attached to its connecting rod. The cylinder had impact damage to the rocker covers, induction and exhaust flanges, cooling fins and pushrod assemblies. The cylinder overhead components were lubricated. The cylinder was boroscoped and the combustion chamber had a layer of light grey deposits and the cylinder barrel was undamaged. The valve heads were undamaged and had no signs of abnormal thermal discoloration.

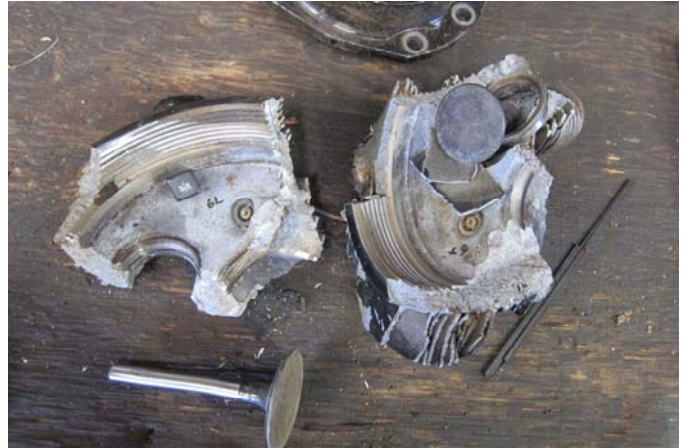
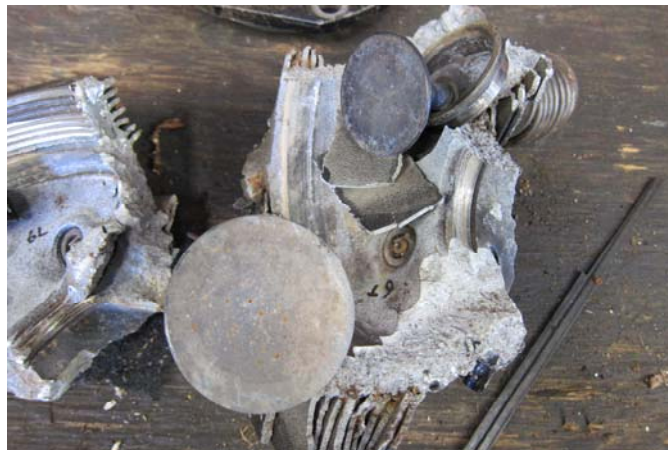
Cylinder #6

Condition: The cylinder separated from the engine and was found in several sections with the main wreckage. The cylinder overhead components were not found during the inspection. The cylinder head separated from the barrel and was found in two large sections. The combustion chamber had a layer of light grey deposits and the valve heads showed no signs of abnormal thermal discoloration. The spark plugs remained in the cylinder head and showed (Worn out-Normal) wear conditions when compared to a Champion AV-27 chart.

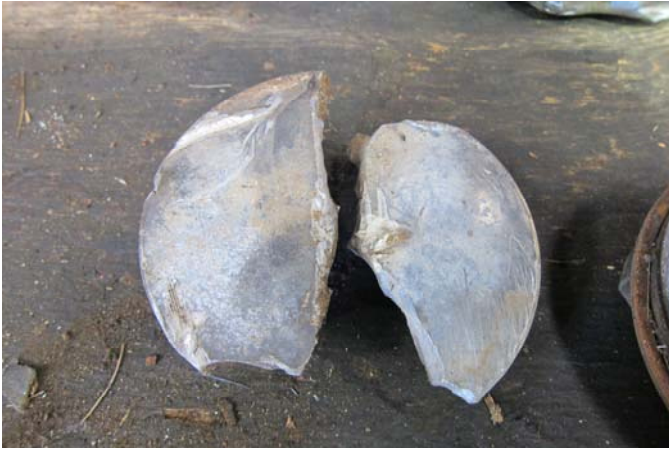
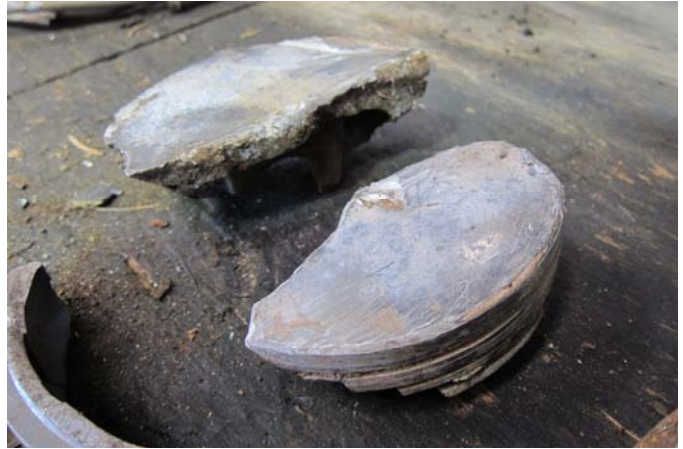
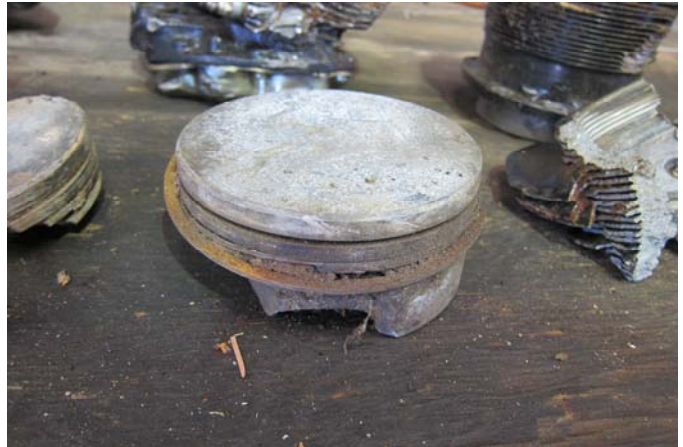
Pistons, Rings and Pins Piston Part No.: Not checked.

Condition: Two piston heads were found with the main wreckage and had impact damage. Both had missing rings and separated skirts.

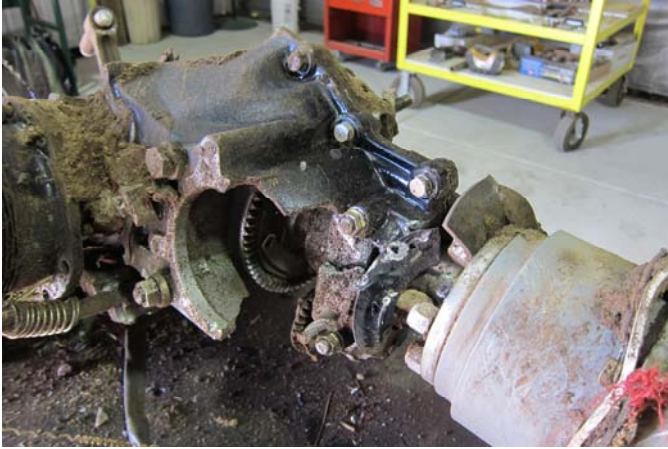
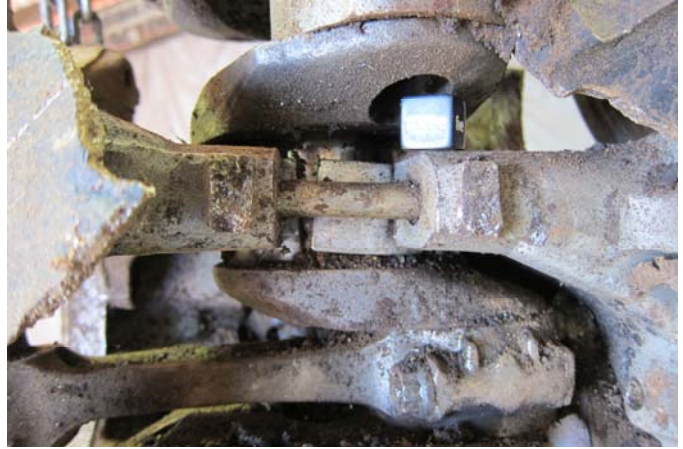
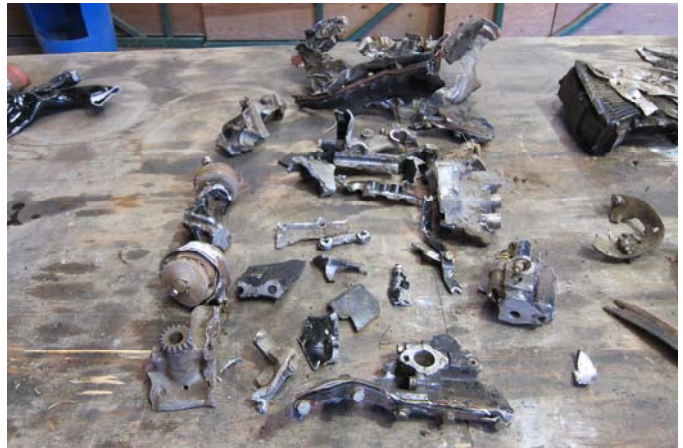
CRANKCASE ASSEMBLY:

Condition: The crankcase had impact damage and the majority of the material was found with the main wreckage. The crankshaft had impact damage and remained in the damaged crankcase. Several crankcase mating surfaces were visible and no fretting was noted.

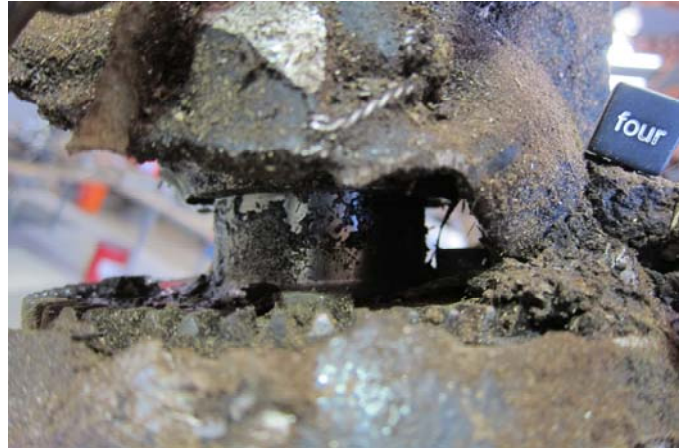
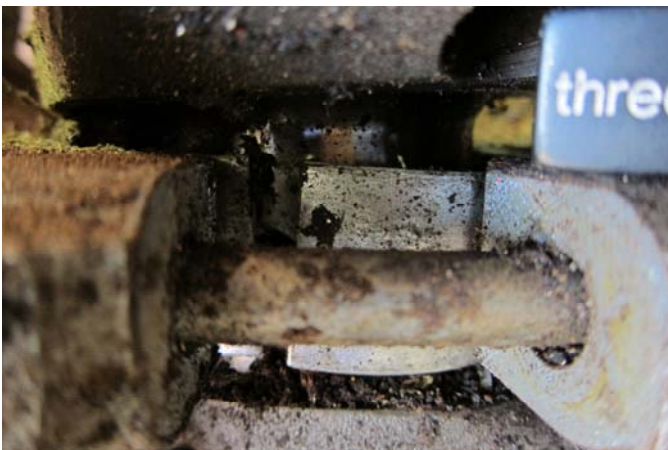
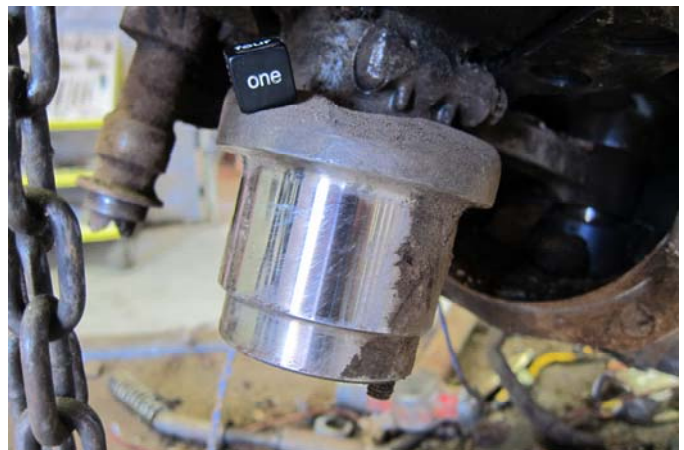
CRANKSHAFT ASSEMBLY:

Condition: The crankshaft and counterweight assemblies had impact damage and showed no signs of thermal damage or lubrication distress. The crankshaft remained intact from the propeller flange to the aft gear attachment. Multiple bending and cracking was noted near several of the crankshaft cheeks. The connecting rod journals, main journals and thrust surfaces had impact damage. The crankshaft counterweight pins, plates and snap-rings were intact. The counterweights had movement on the hanger blades.

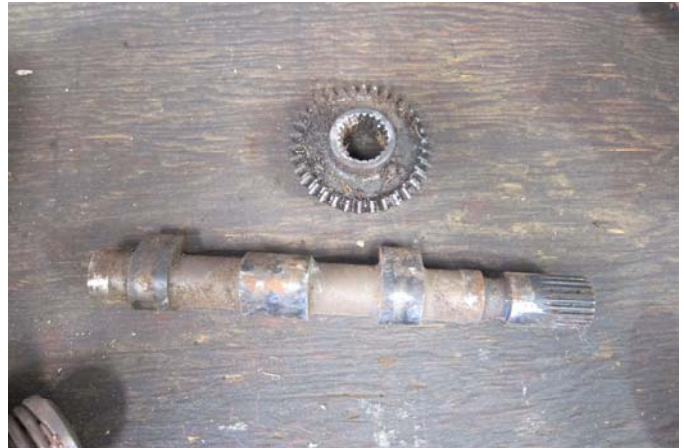
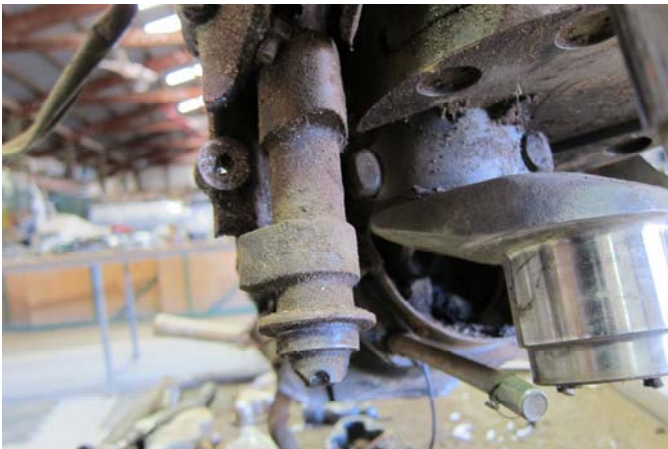
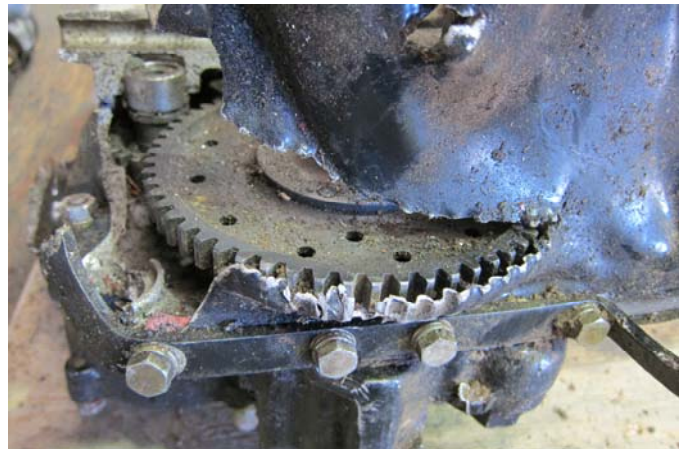
Camshaft

Condition: The camshaft had impact damage and was found in three sections. The aft camshaft gear and camshaft gear flange remained attached to the separated crankcase accessory section. A section of the camshaft from the no. 1 to the no. 3 main journal remained in the crankcase. The forward section of the camshaft and the forward drive gear was found in the main wreckage. The camshaft lobes showed normal operational signatures and the forward and aft gears showed normal operation.

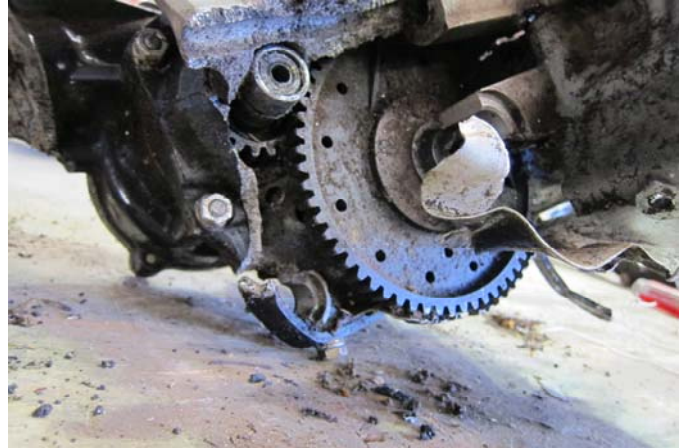
Accessory Gears

Condition: The accessory gears had impact damage. The gear teeth were intact and there were no anomalies noted.

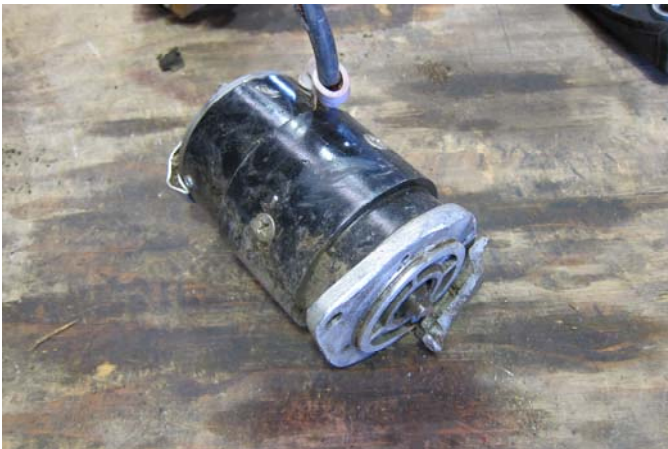
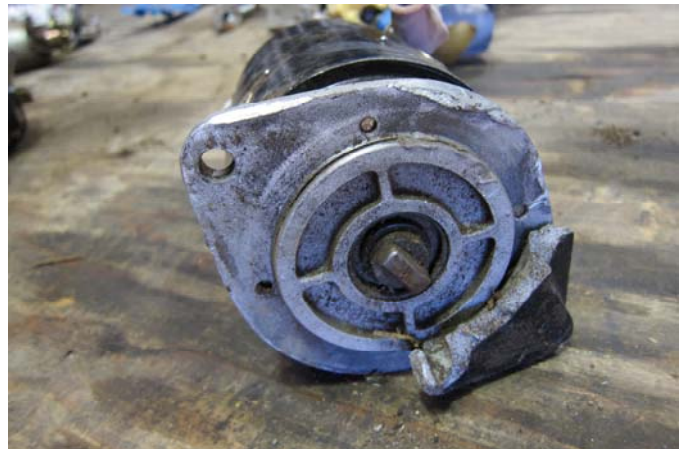
Starter Manufacturer: No Data Tag

Condition: The starter separated from the engine and a section of the starter adapter remained attached to the starter mounting flange. The starter drive shaft rotated with some resistance.

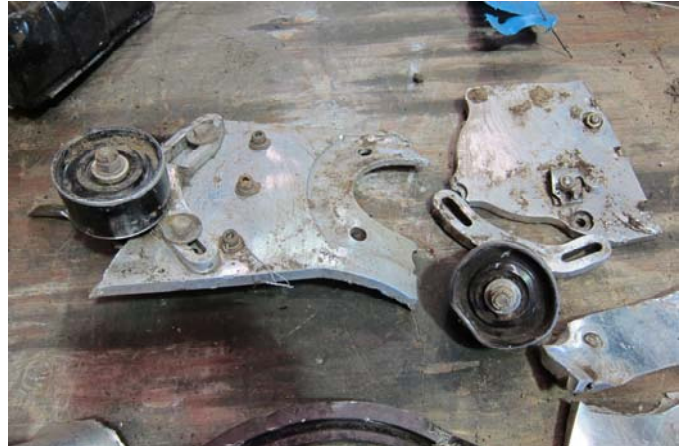
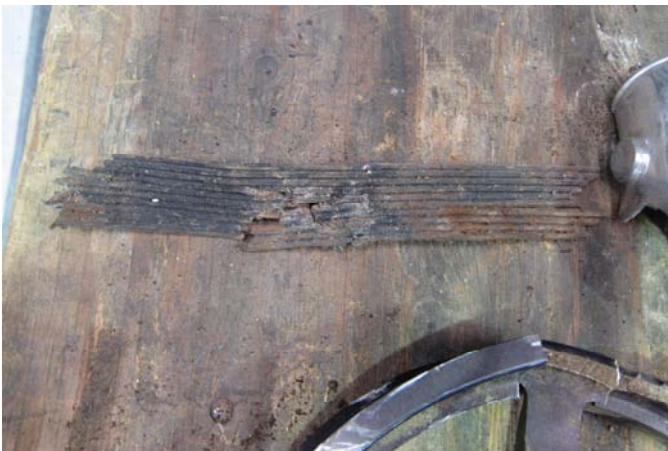
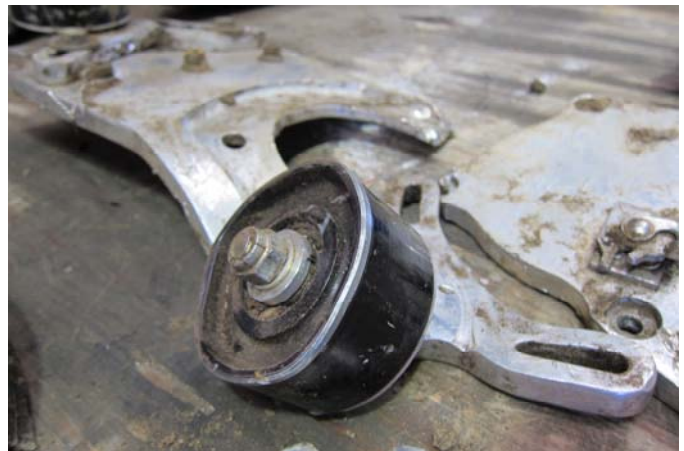
Supercharger

Condition: The supercharger assembly separated from the engine. The bracket assembly, main drive pulley, belt tensioners and a small section of the drive belt was found in the main wreckage. The compressor and compressor housing were not found during the inspection.
