AIR SAFETY INVESTIGATIONS ENGINE FIELD INSPECTION REPORT

ENGINE MODEL: IO-550-N (EXP)

AIRCRAFT MODEL: Lancair Legacy

REGISTRATION: N121J

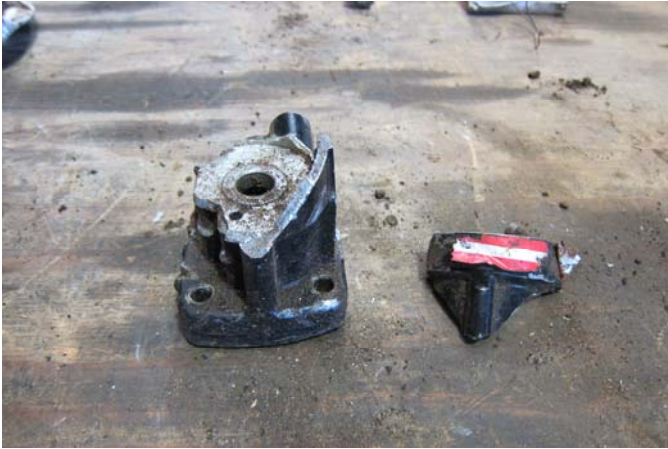
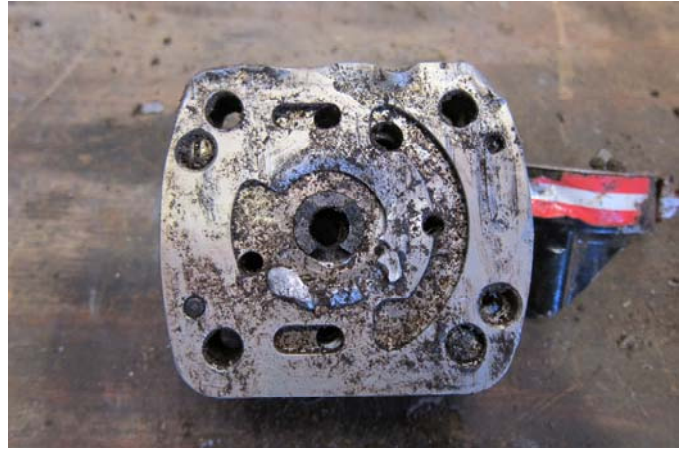
Propeller Governor Model No.: No data tag

Condition: The propeller governor separated from the engine and two sections were found in the main wreckage.

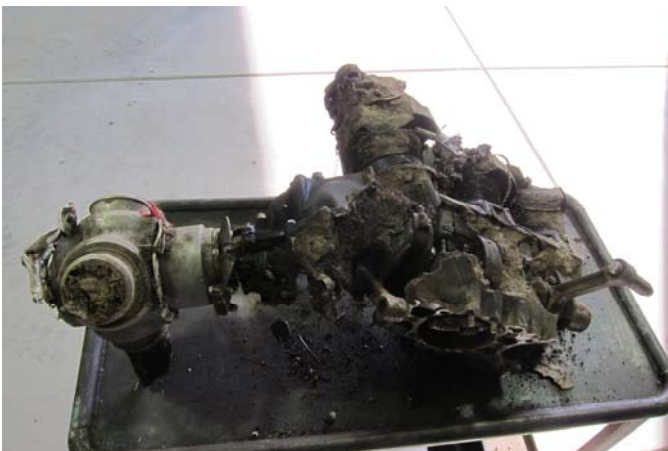
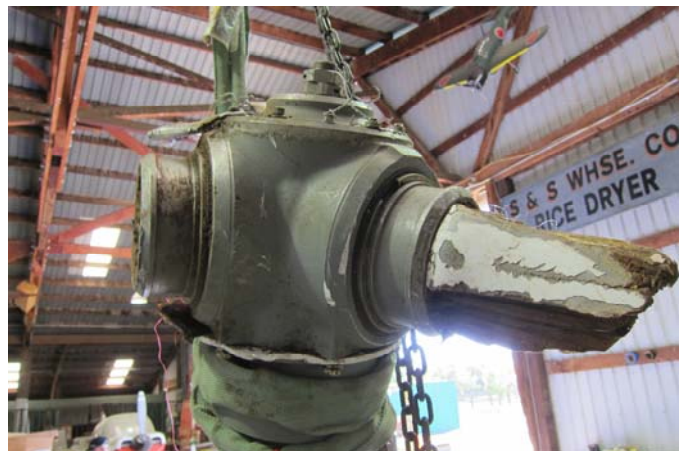
Propeller: Manufacturer: MT Propeller Model/Blade No.: MTV-9-D/183-50-A HUB S/N: 05203

Condition: The propeller assembly had impact damage and remained attached to the crankshaft during the inspection. The blades separated and only sections of the shanks remained attached to the hub. The hub remained intact.
