**Continental Motors, Inc.**

## **ENGINE OPERATIONAL TEST REPORT**

<b>DATE</b>	December 6, 2011
<b>REGISTRATION #</b>	N227TX
<b>ENGINE MODEL</b>	TSIO550K
<b>ENGINE SERIAL</b>	1002510
<b>INSPECTOR</b>	Phillip Grice
<b>SEARCH CODE</b>	15-12-68

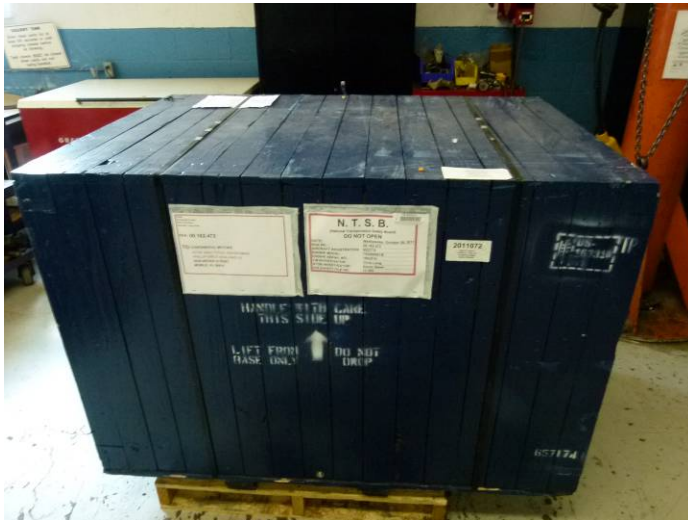
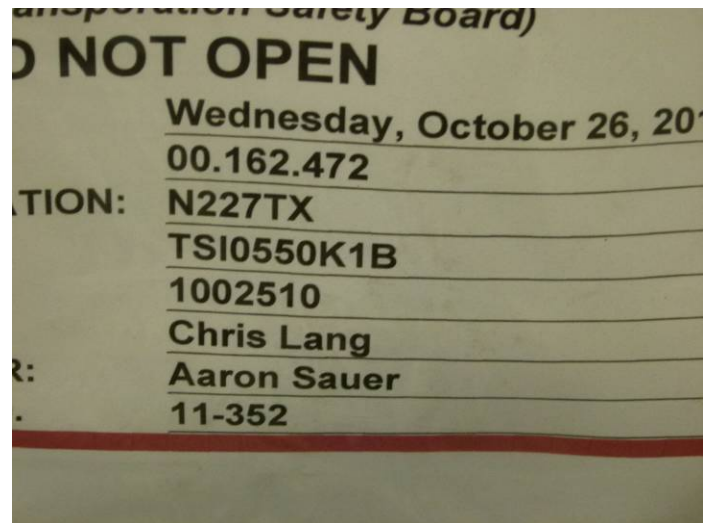
The engine exhibited impact damage concentrated at the Lower part of the engine. The external surfaces of the engine were undamaged. Both engine mount legs were replaced on the right side of the engine before the test run. The exhaust system was crushed and replaced for the engine run. The original turbo chargers were cleaned and reattached to the replacement exhaust system. The fuel Pump Inlet fitting was broken from the pump during the accident. The remainder of the fitting was removed and replaced and the fuel pump reinstalled. The starter and starter adapter were impact damaged and replace before the engine test.

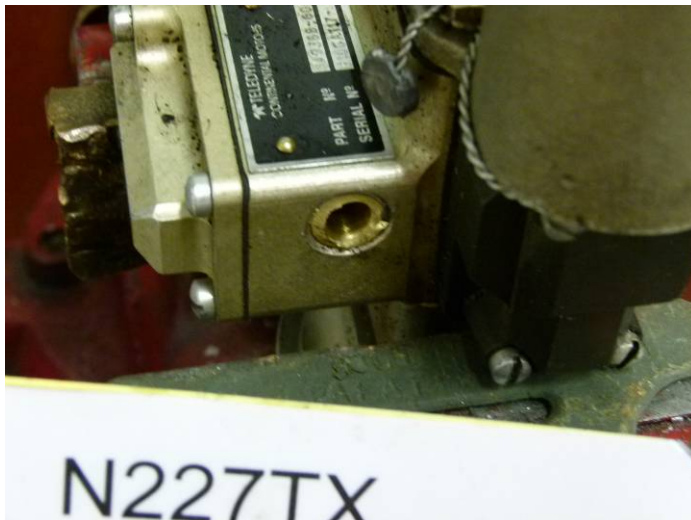
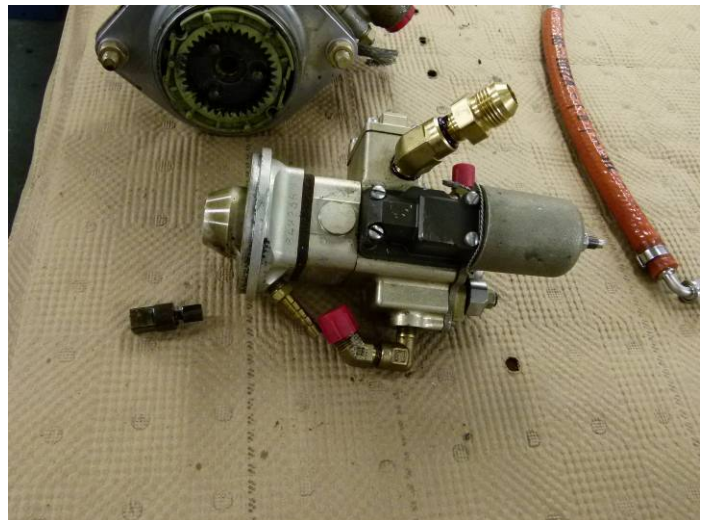
Note: During full power run fuel pressure was noted to decline below min. pressure after approximately 30 seconds of operation. During accident the main fuel pump fitting was broken off of fuel pump. The remainder of the fitting had to be removed from the pump body.

A replacement fitting was installed. Debris from both of these operations was introduced in the inlet of the pump. The vapor ejector port was back flushed in reverse flow from the return fitting through the inlet of the fuel pump. Pump pressure was normal after the back flush operation.
