# Continental Motors

## ENGINE FIELD INSPECTION REPORT

<b>ENGINE MODEL</b>	E225-8
<b>ENGINE SERIAL NUMBER</b>	35818-D-0-8-R
<b>AIRCRAFT MAKE &amp; MODEL</b>	Beechcraft 35G Bonanza
<b>AIRCRAFT SERIAL NUMBER</b>	D-4863
<b>AIRCRAFT REGISTRATION</b>	N394CW
<b>CMI FILE NUMBER</b>	15-238

<b>EXAMINATION</b>		<b>ACCIDENT DATA</b>	
<b>DATE</b>	10-13-2015	<b>NTSB ACCIDENT #</b>	CEN16FA011
<b>FACILITY</b>	Beegles Aircraft Services	<b>NTSB INVESTIGATOR</b>	Josh Lindberg
<b>ADDRESS</b>	[REDACTED]	<b>FAA INVESTIGATOR</b>	Wesley R. Dollahite
		<b>ACCIDENT DATE</b>	10-13-2015
		<b>ACCIDENT LOCATION</b>	Eaton, Colorado

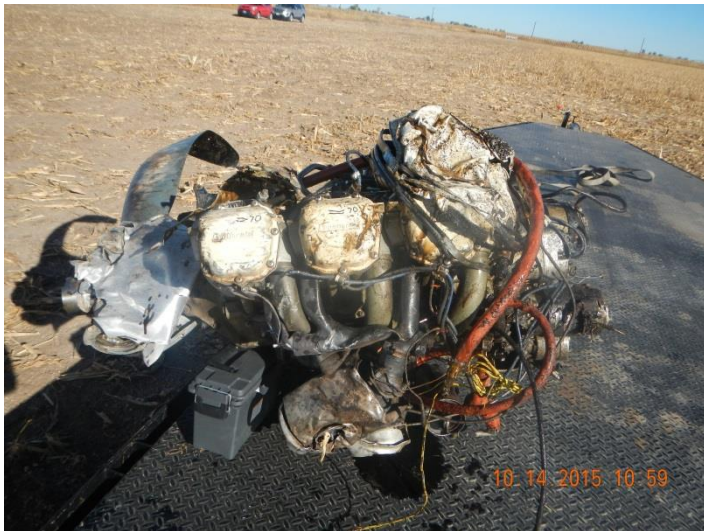
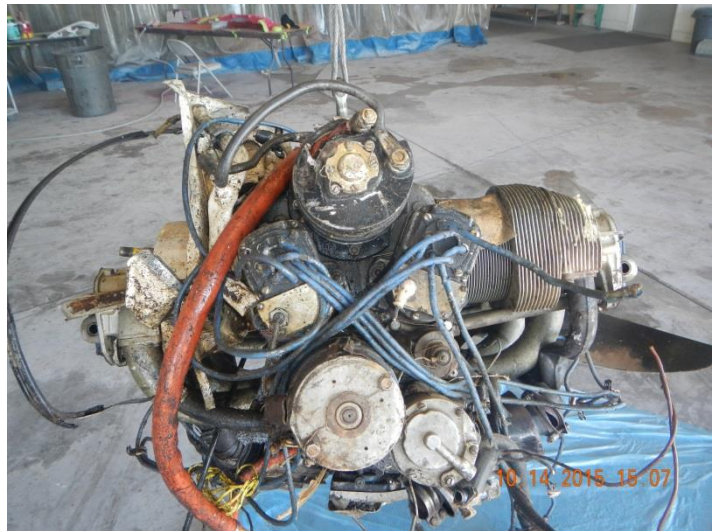
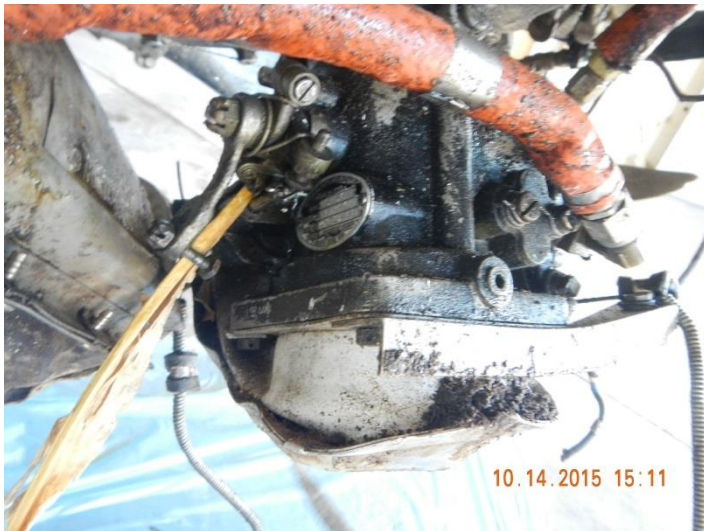
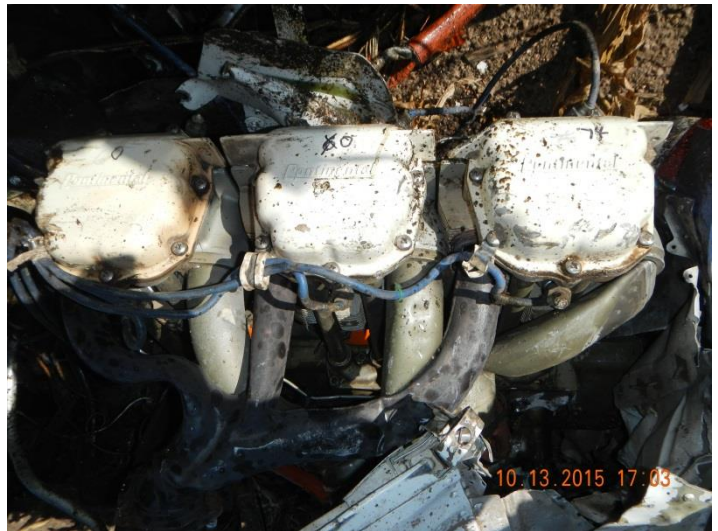
The aftermarket propeller governor and "T" pad adapter separated from the accessory case due to impact forces. The accessory case housing exhibited impact damage.

The electric starting motor remained attached with a slight amount of impact damage to the rear casing. The engine driven generator remained attached and intact. The engine driven "wet" type vacuum pump remained attached and intact. The air/oil separator was impact damaged. Right and left magnetos remained intact and mounted to the accessory case.

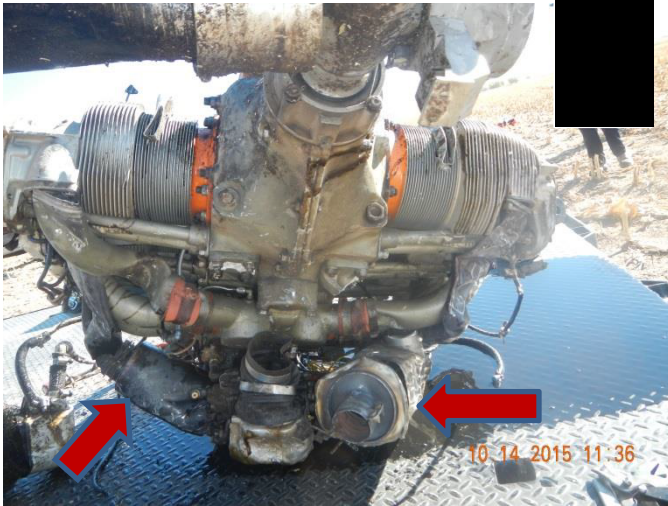
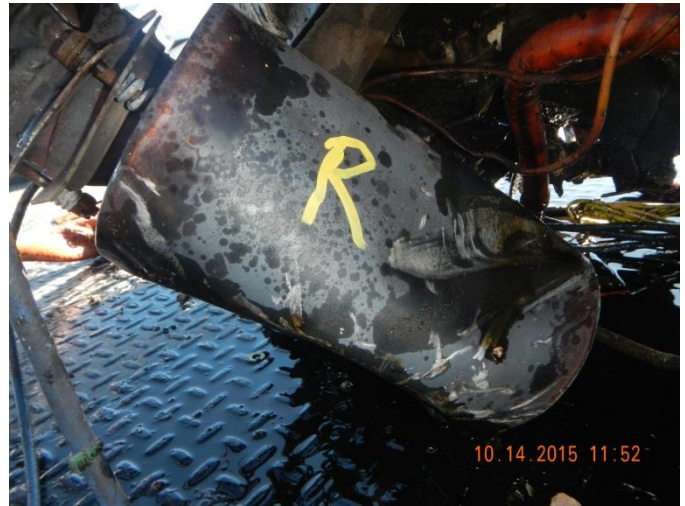
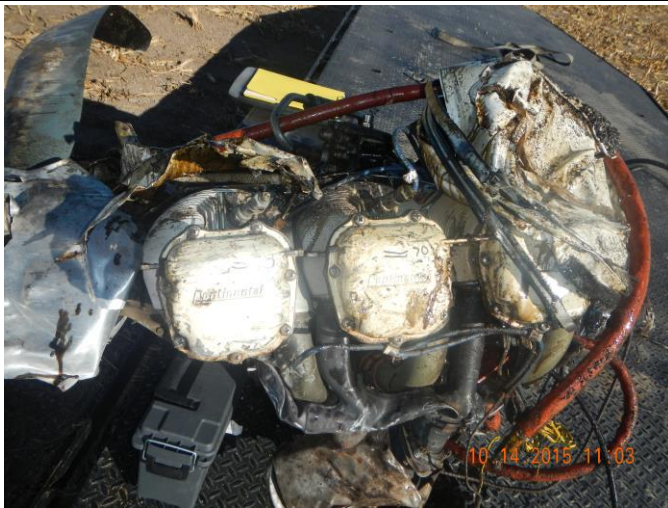
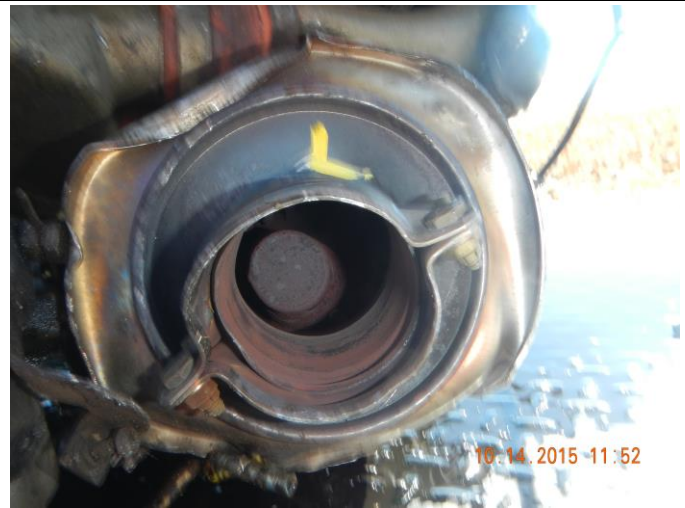
EXHAUST SYSTEM

Right and left mufflers and right tailpipe were crushed by impact forces but remained attached. The left tailpipe separated. Muffler flame cones were intact.

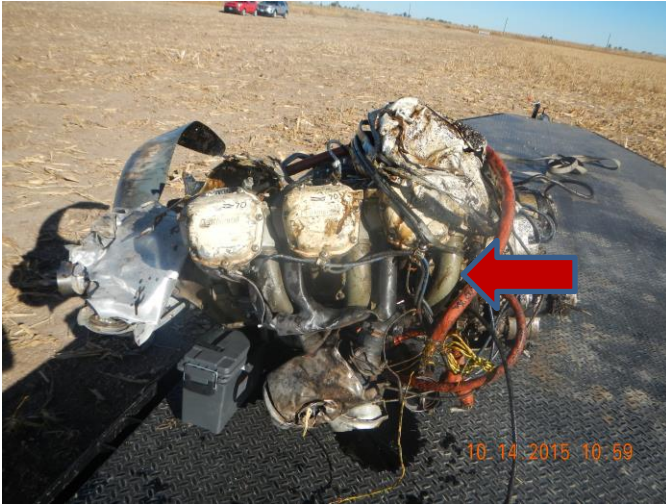
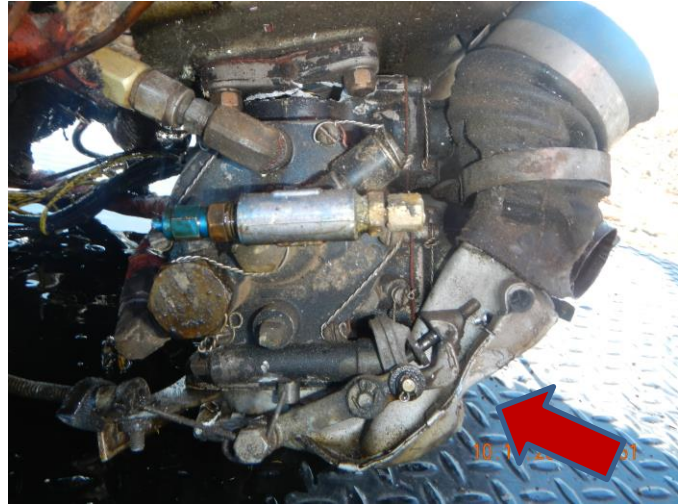
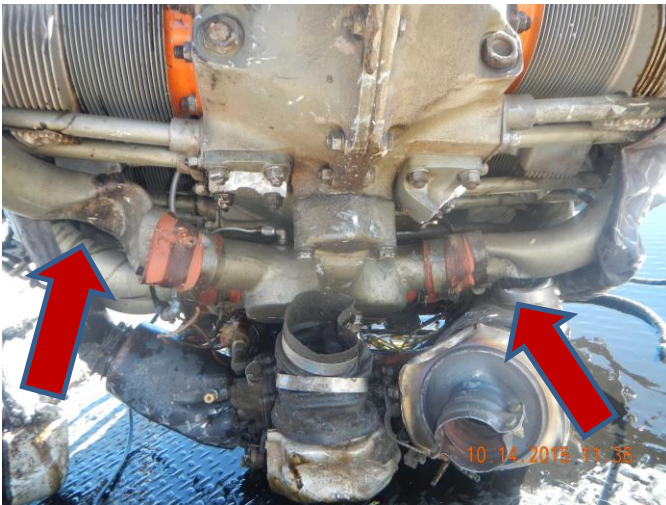
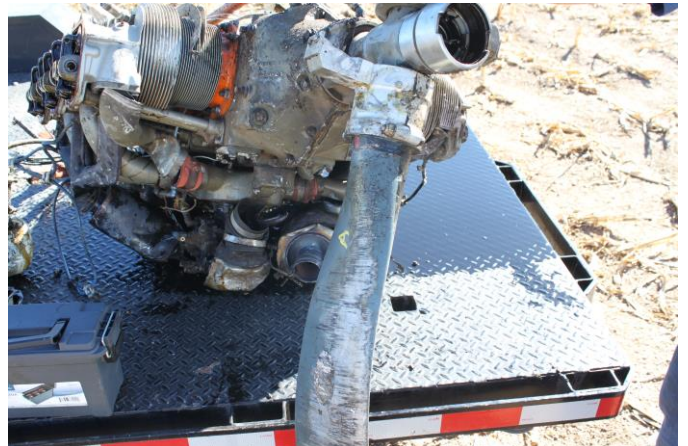
## INDUCTION SYSTEM

The induction system was impact damaged but remained attached. The front mounted air box and induction filter was impact damaged

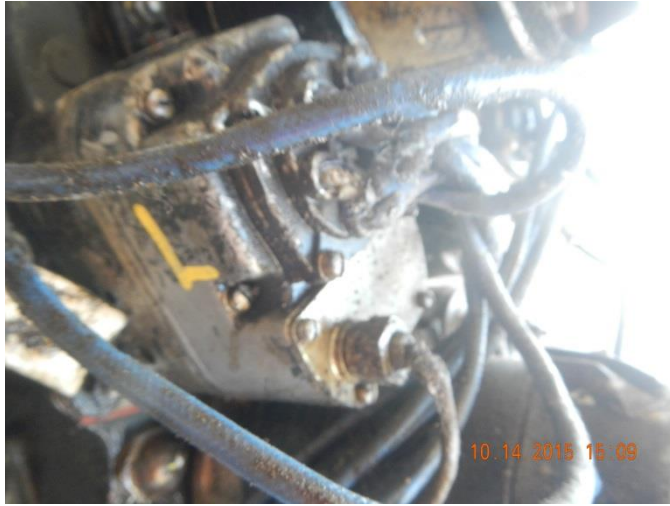
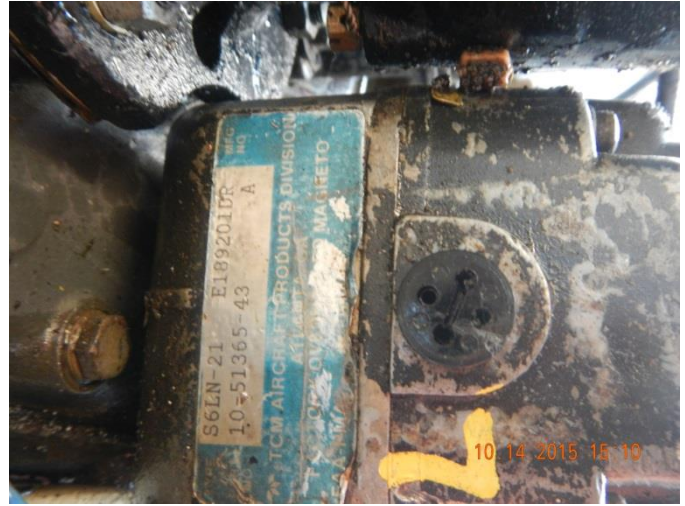
<b>LEFT MAGNETO</b>	Manufacturer: TCM	P/N: S6LN-21	S/N: E189201DR
Condition:	The magneto received impact damage. The bushing cup was cracked. The magneto was removed and manually rotated using a drill motor. Spark was produced to each ignition lead.

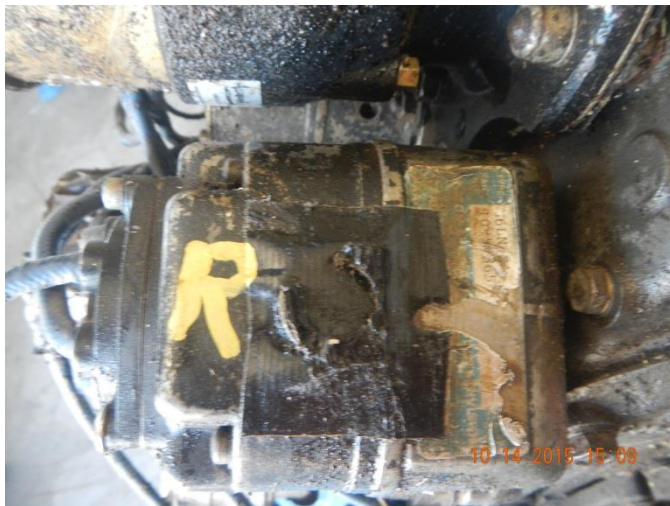
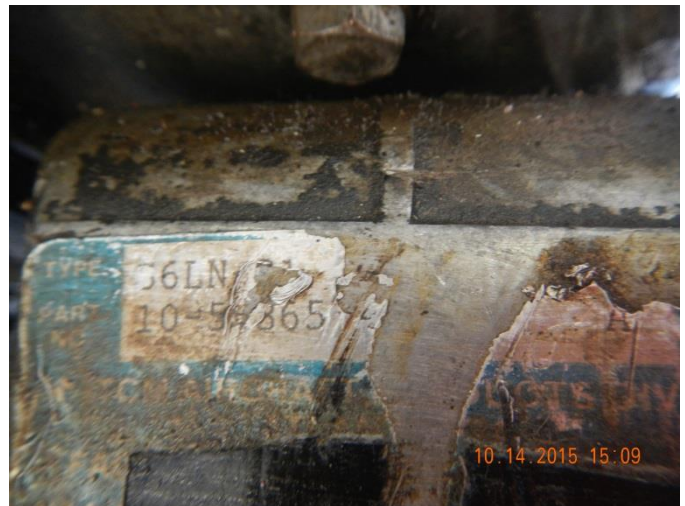
<b>RIGHT MAGNETO</b>	Manufacturer: TCM	P/N: S6LN-???	S/N: Undetermined
Condition:	The magneto did not display damage. The magneto was removed and manually rotated using a drill motor. Spark was produced to each ignition lead. The data decal was damaged and the serial number was not legible.

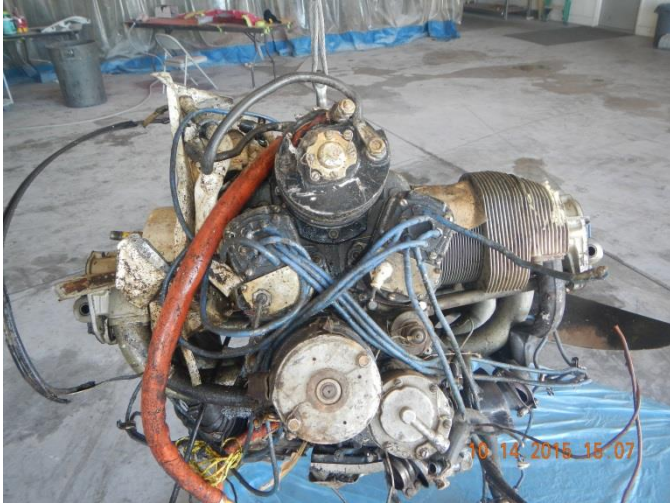
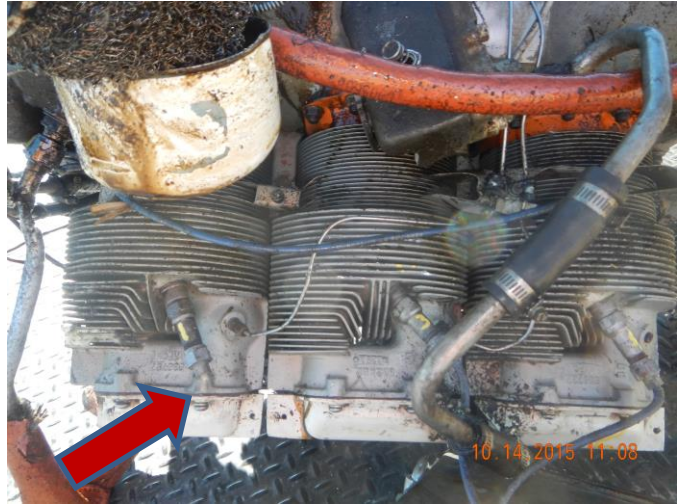
<b>IGNITION HARNESS</b>	Manufacturer: Undetermined	P/N: Undetermined	S/N: Undetermined
-------------------------	----------------------------	-------------------	-------------------

**Condition:** The ignition harness remained intact with the exception of leads to cylinders one and six which were separated. (top sparkplugs)

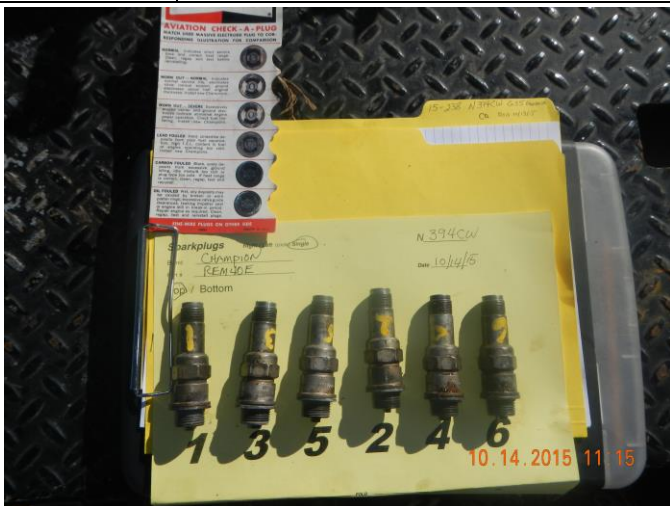
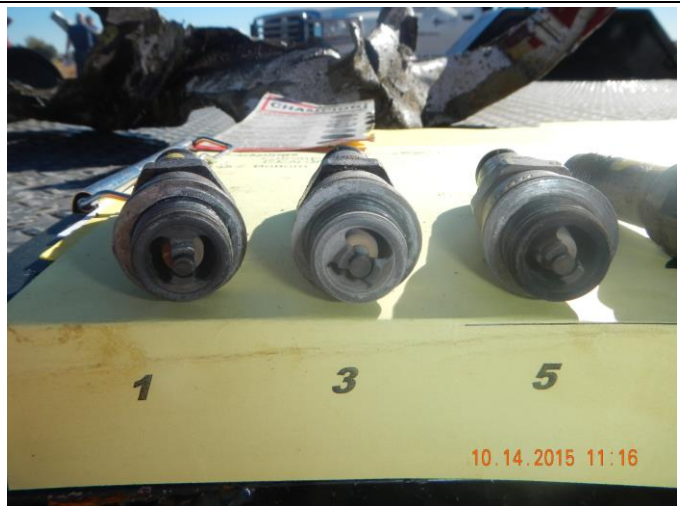
<b>SPARK PLUGS</b>	Manufacturer: Champion	P/N: REM40E
--------------------	------------------------	-------------

**Condition:** When compared to a Champion "Check A Plug" chart, sparkplugs from cylinder one was "worn out severe", while sparkplugs from cylinders 2, 3, 4, 5 and 6 exhibited "normal" wear signatures. Sparkplugs from cylinders 2, 4, and 6 were wet with oil. Note: the engine was positioned with cylinders 2, 4, and 6 positioned downward for nearly 24 hours.

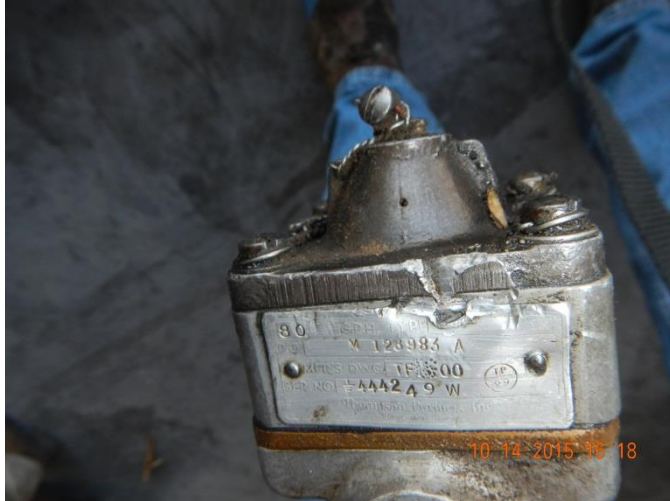
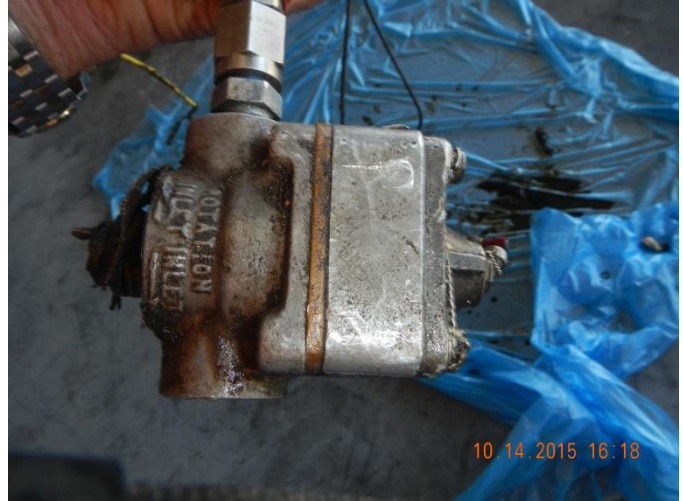
<b>FUEL PUMP</b>	Manufacturer: Thompson Products, Inc.	P/N: M128983A	S/N: 444249W
Condition:	The engine driven fuel pump separated from the accessory case but remained attached by a fuel hose. The fuel pump housing was impact damaged and could not be rotated manually. The drive coupling and gear were separated and not recovered.

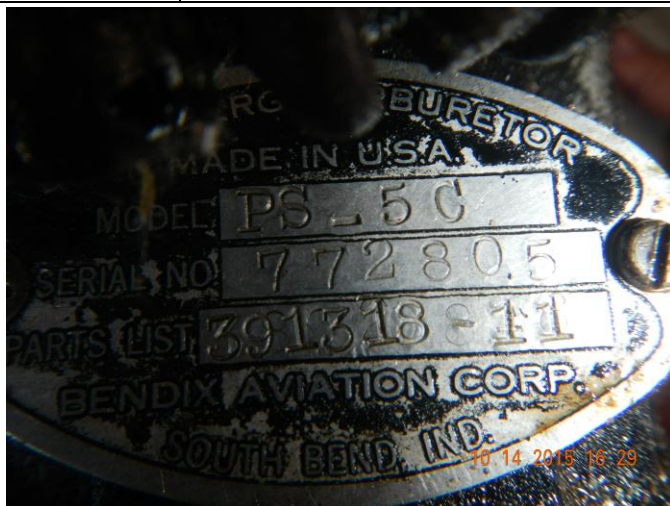
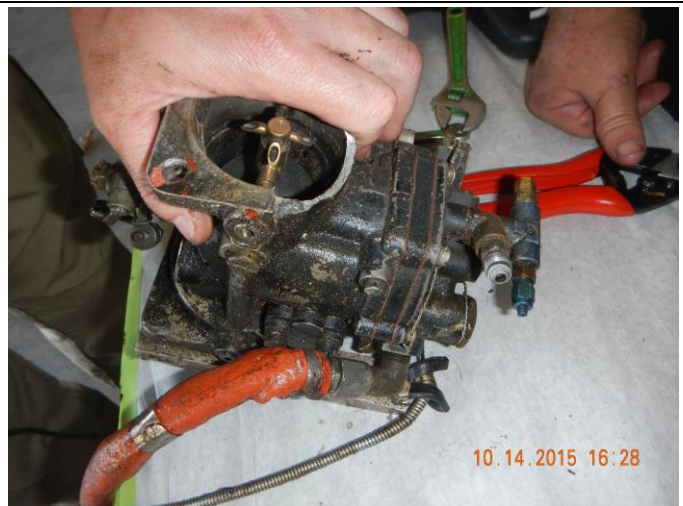
<b>CARBURATOR</b>	Manufacturer: Bendix	P/N: PS-5C	S/N: 772805
Condition:	The pressure carburetor was intact and in place with damage noted to the mounting flange. The fuel screen was removed and a small quantity of contamination was noted. No fuel was released from the carburetor during the bench inspection. The carburetor throttle control and mixture arms remained attached and secured.

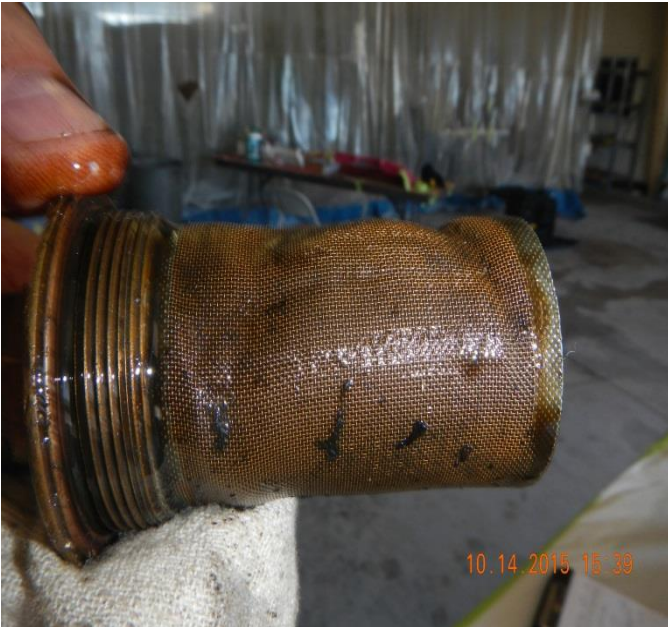
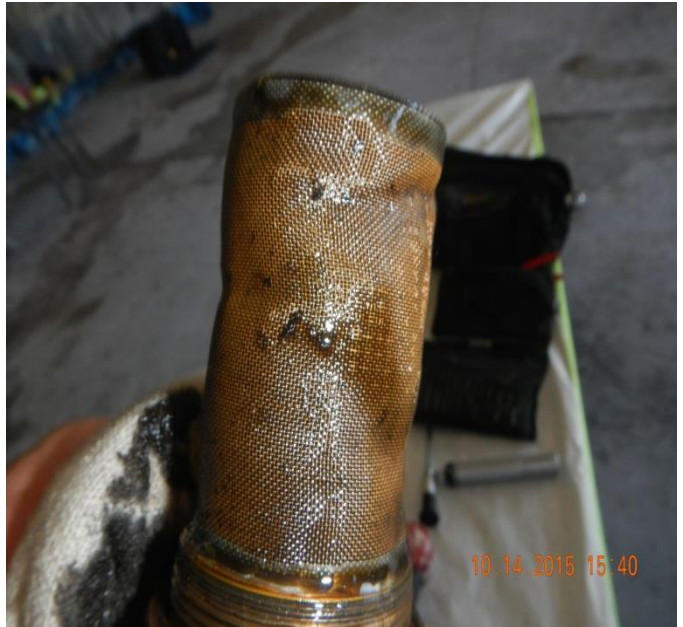
<b>OIL SCREEN</b>	Manufacturer: TCM	P/N:A25131
Condition:	A small amount of carbon was found on the screen surface.

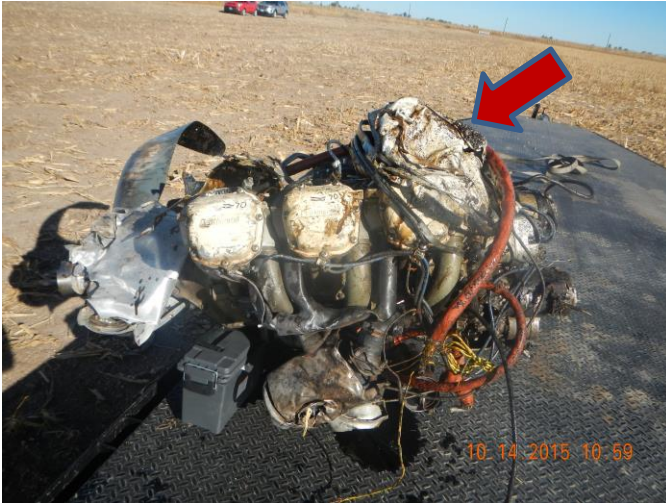
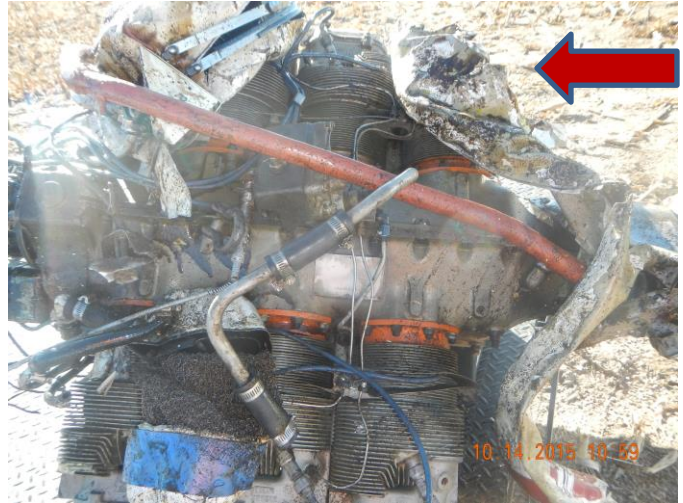
### OIL TANK/ COOLER

The combination oil tank and cooler was impact damaged

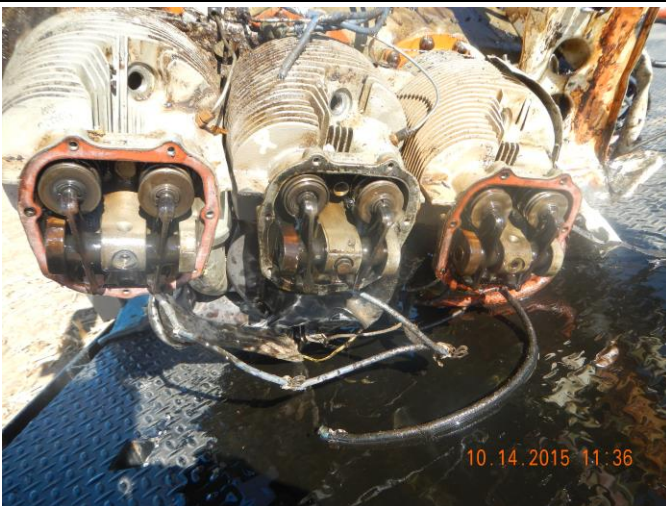
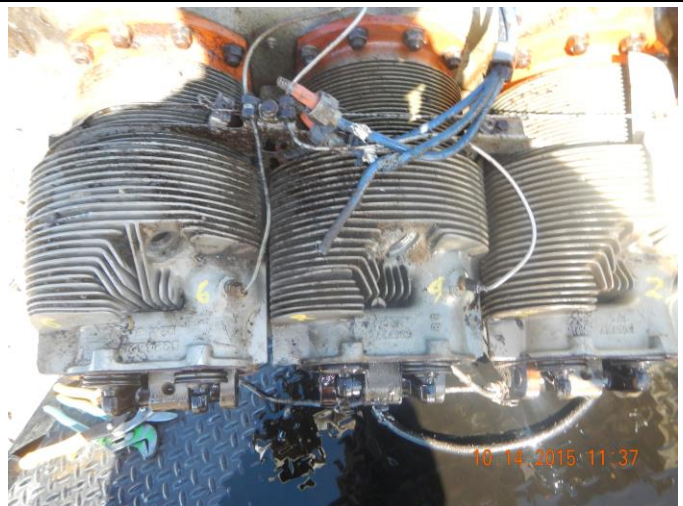
## CYLINDERS

All six cylinders remained intact and in place with little or no impact damage. All six cylinders displayed orange paint on each mounting pad indicating that the internal cylinder barrels were "channel chrome" plated. All six cylinders achieved thumb compression when the engine was manually rotated. . A lighted borescope inspection was performed and all exhaust and intake valves were noted to be intact. Cylinder rocker covers were removed and rocker arm movement was noted when the crankshaft was manually rotated.

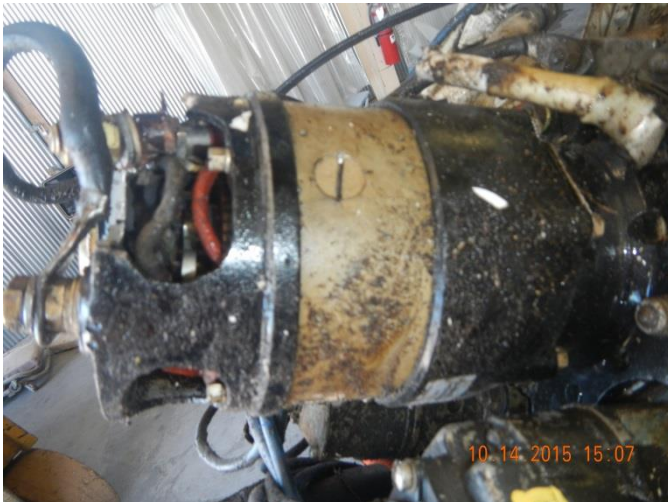
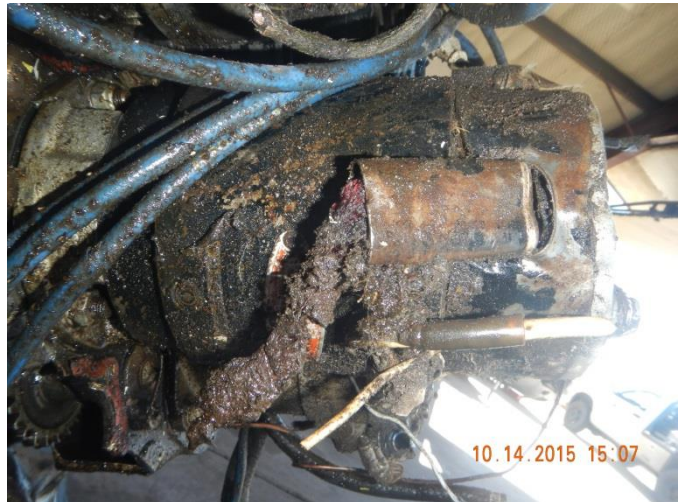
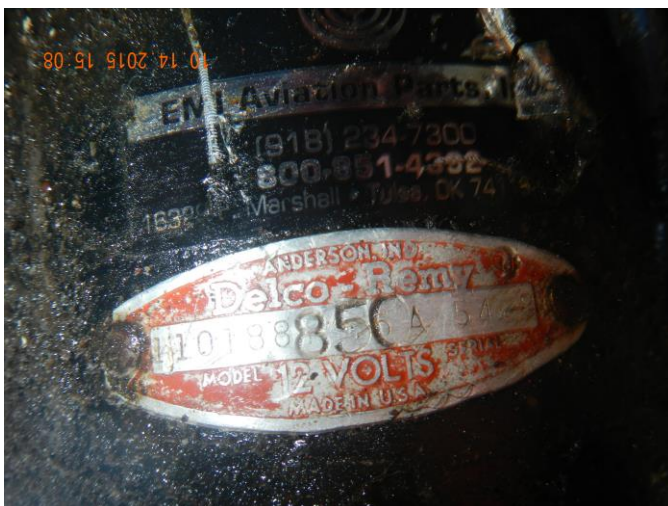
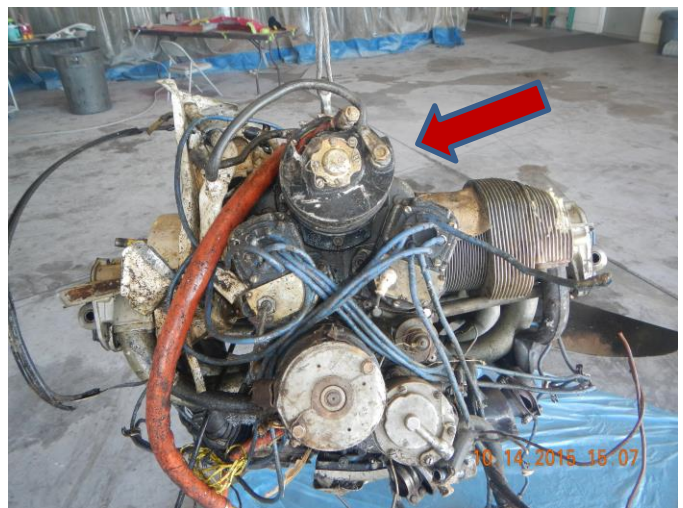
<b>STARTER</b>	Manufacturer: Delco Remy- Serviced by EMI Aviation Parts	P/N: Undetermined	S/N: Undetermined
Condition:	The starter motor was impact damaged.

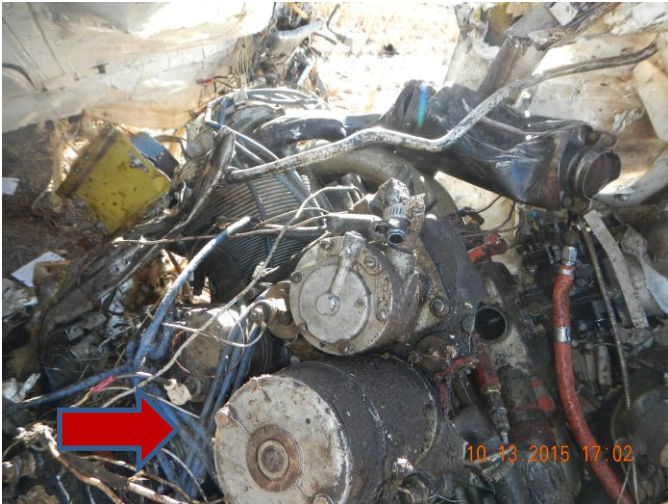
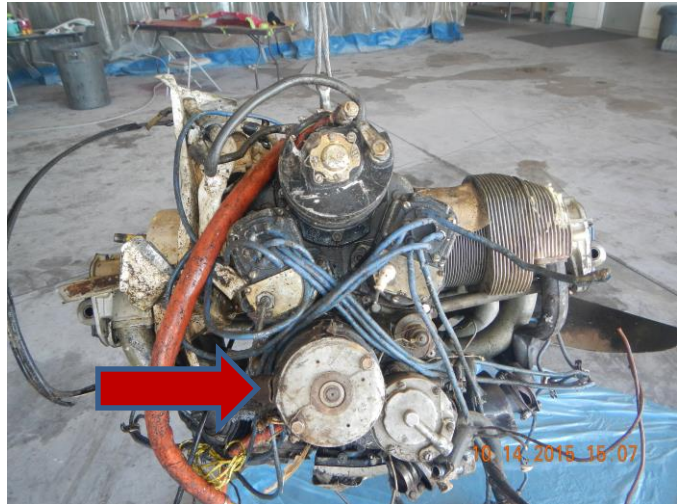
<b>ALT/GEN #1</b>	Manufacturer: Delco Remy	P/N: 11018885	S/N: 5428
<b>Condition:</b>	The engine driven generator remained attached and intact

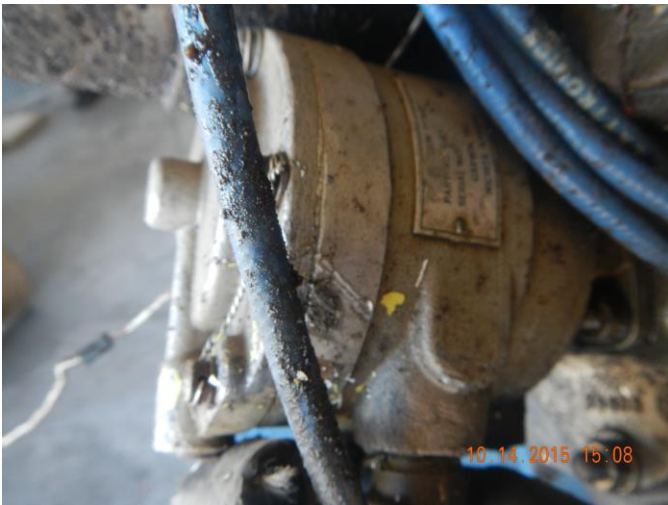
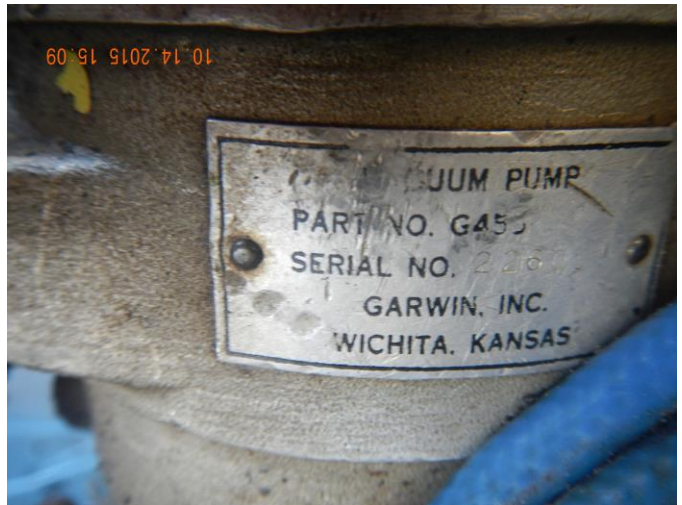
<b>VACUUM PUMP</b>	Manufacturer: Garwin	P/N: G45?	S/N:2260
<b>Condition:</b>	The engine driven "wet" type vacuum pump remained attached and intact. The air/oil separator was impact damaged.

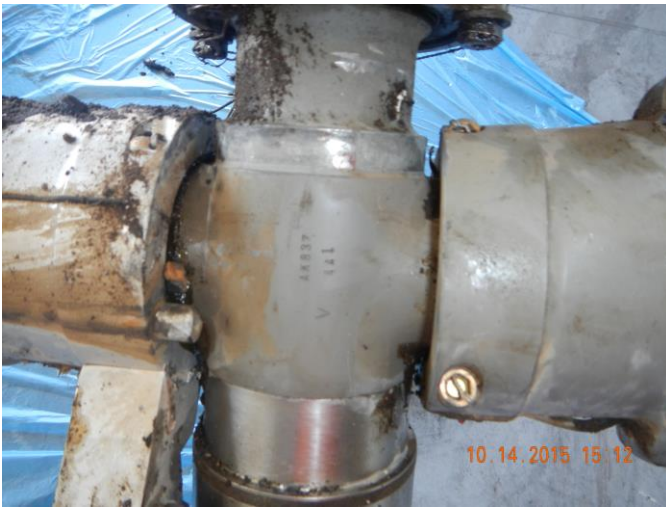
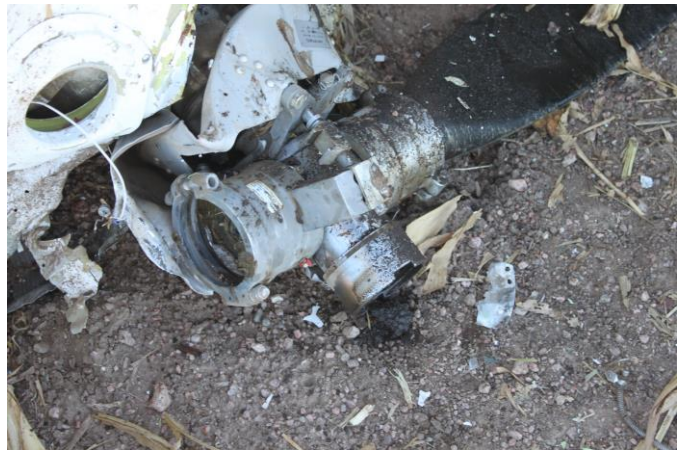
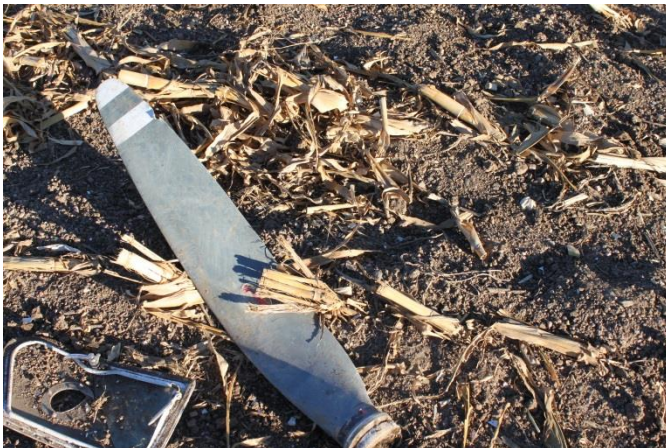
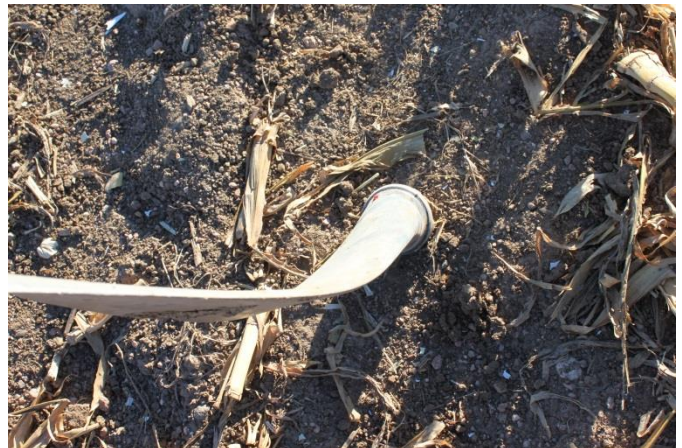
**PROPELLER**

<b>PROPELLER GOVERNOR</b>	Manufacturer: Undetermined	P/N: Undetermined	S/N: Undetermined
Condition:	The aftermarket propeller governor and "T" pad adapter separated from the accessory case due to impact forces.		
<b>PROPELLER</b>	Manufacturer: Hartzell	M/N: HC-A2V20-4A1/V8433	S/N:AK847
Blade 1 S/N:	87993		
Blade 2 S/N:	85703		
Condition:	<p>Blade A remained attached to the propeller hub but was loose in the hub assembly. Blade A displayed heavy scratching and scoring on the cambered face and the blade displayed a smooth rearward bending signature beginning approximately 16 inches from the blade root.</p> <p>Blade B separated from the hub and exhibited a smooth forward bending signature beginning approximately eight inches from the blade hub. There was a deep gouge on the trailing edge approximately five inches from the blade tip.</p>
