Continental Motors

ENGINE EXAMINATION REPORT

ENGINE MODEL	O-470-R
ENGINE SERIAL NUMBER	84391-3-R-4
AIRCRAFT MAKE & MODEL	Cessna 182F
AIRCRAFT SERIAL NUMBER	18254796
AIRCRAFT REGISTRATION	N5738F
FILE NUMBER	15-098

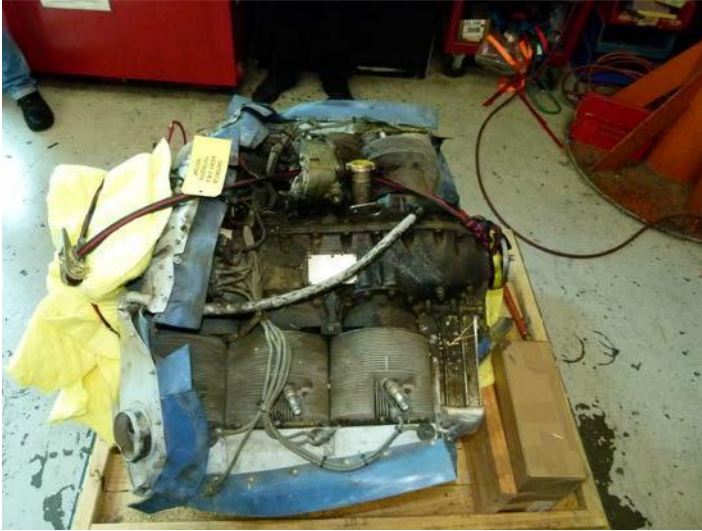
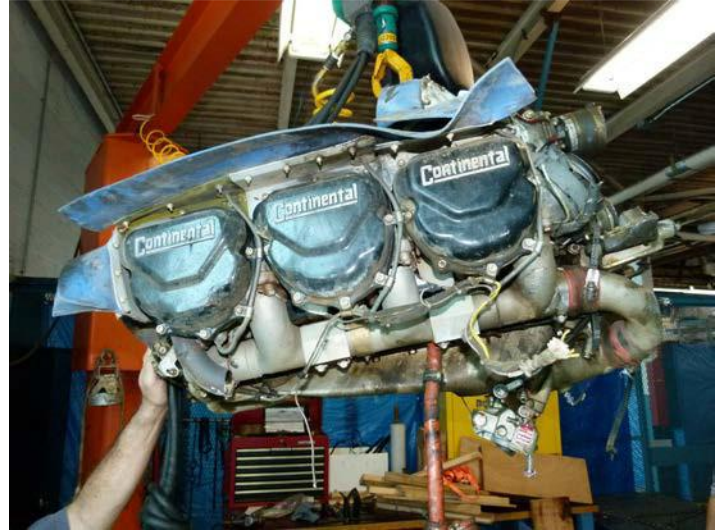
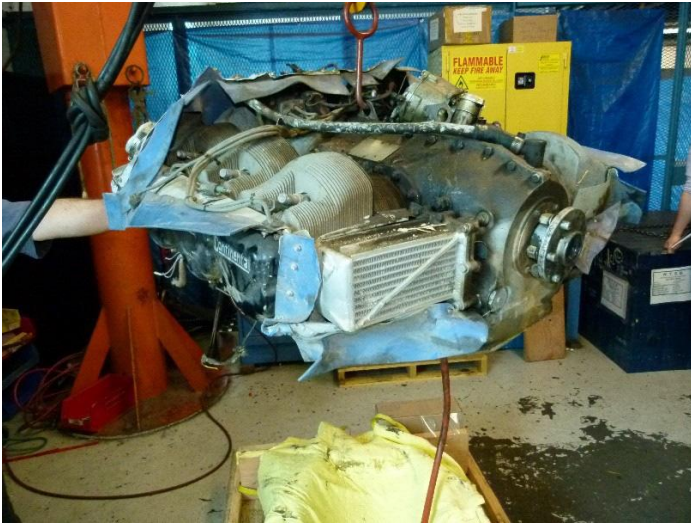
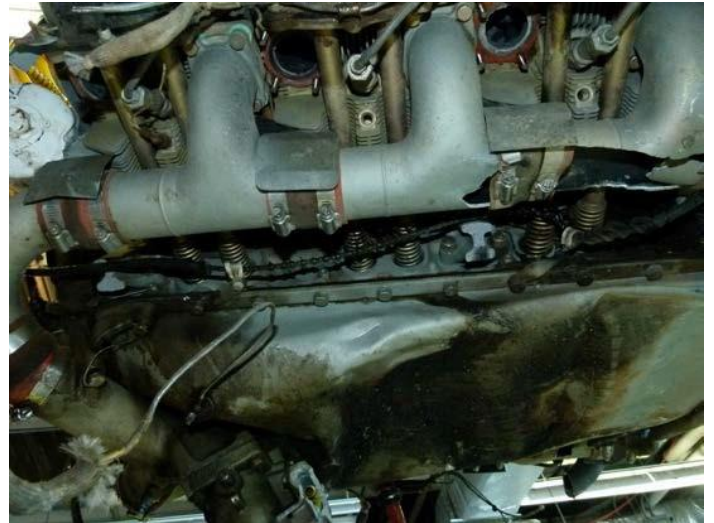
The engine exhibited impact damage to the induction system and oil sump. The carburetor and all four engine mount legs were broken. A hole in the engine crankcase above the number six connecting rod was observed. A residue of oil was observed on the top and front of the engine crankcase.

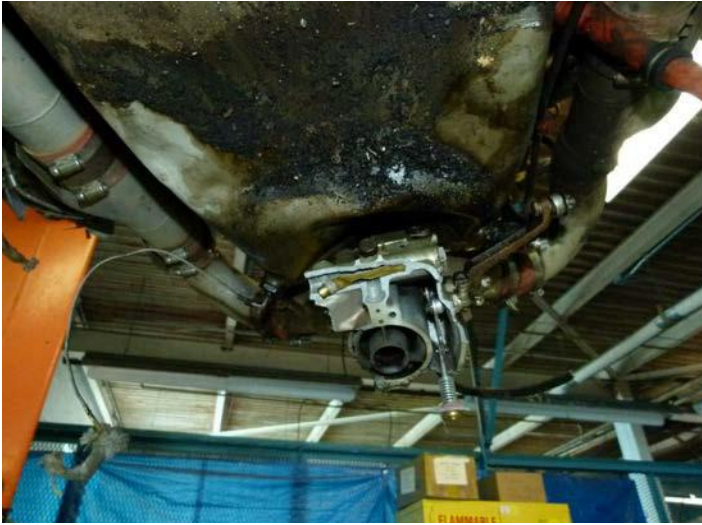
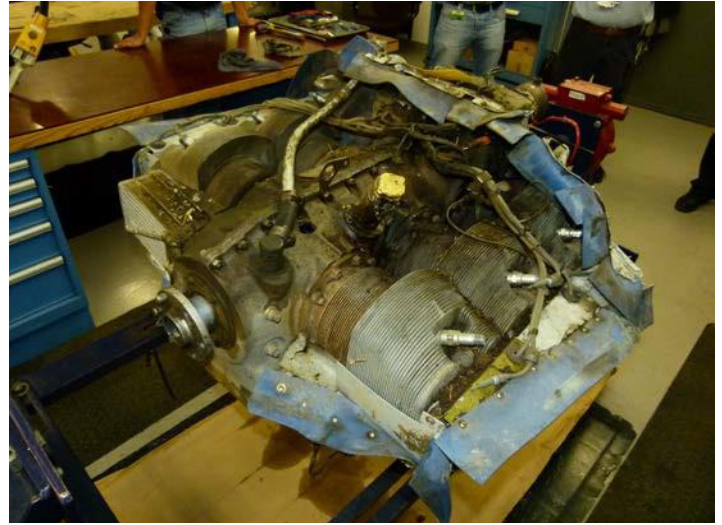
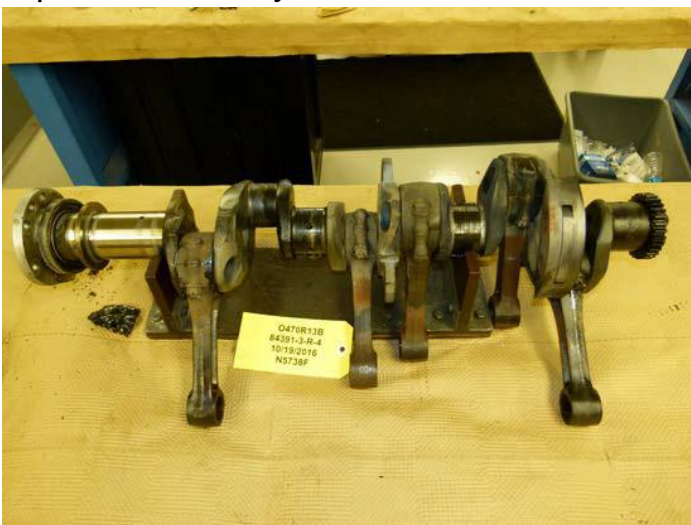
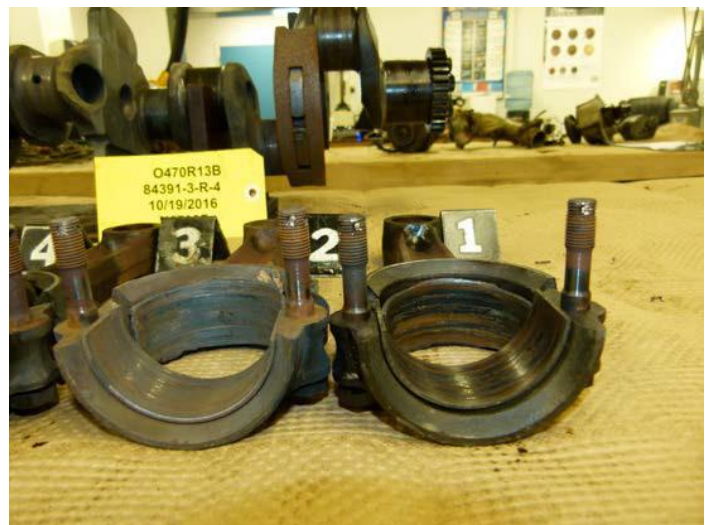
The internal components of the engine exhibited signs of oil starvation resulting in the failure of the number 5 connecting rod. The cause of the oil starvation could not be determined.

The engine was mount on a stand and disassembled. The number five connecting rod had fractured and separated from the crankshaft causing internal damage. Metal was located in the oil sump. The camshaft, connecting rods, crankshaft journals and bearings exhibited signs of oil starvation. The cause of this oil starvation could not be determined during the engine teardown examination. The Textron Aviation investigator reported the belly of the aircraft was coated with fresh oil at the scene of the accident.
