## TANK CAR DAMAGE ASSESSMENT RECORD

| Car Initials and Number | XCRX 210220 | | | |
| Location of Incident | YAZOO SUB MP 113.20 - GREENWOOD, MS. | | | |

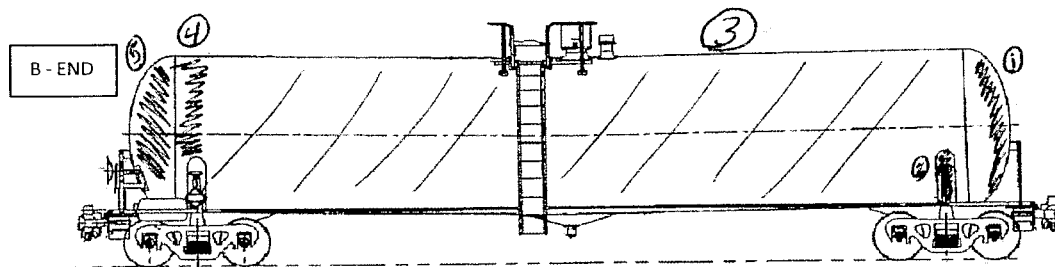
Notes: ① Extensive HEAD DAMAGE with HOLE. SEE A-END DETAILS

② BOILER BENT TOWARD B-END APPROX 7" ③ THERMAL DAMAGE TO JACKET

④ MECH/THERM DAMAGE 2" INSET ⑤ SEE B-END DETAILS

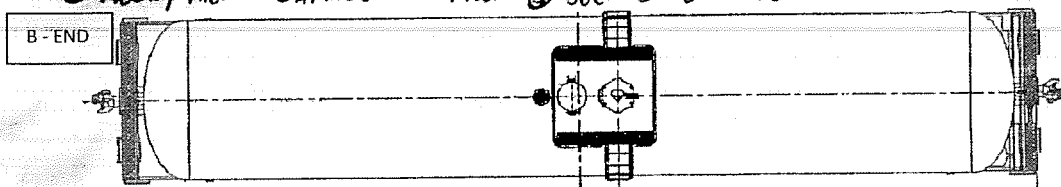
Notes: ALL SEALS IN TACT, NUMBERS UNREADABLE

THERMAL DAMAGE TO TOP

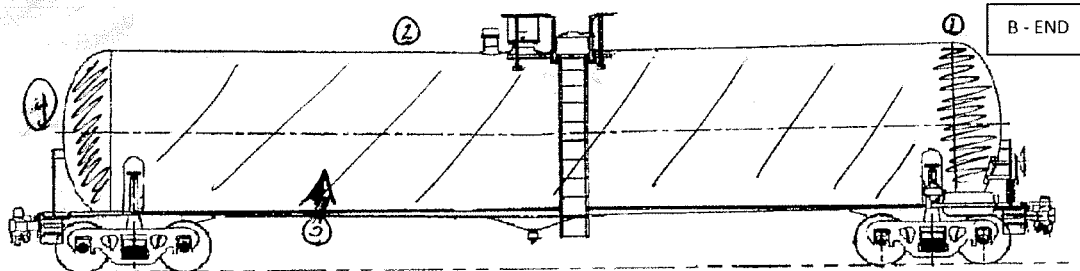
Notes: ① TANK/JACKET COMPRESSION 2" ② THERMAL/MECH DAMAGE TO JACKET  
ON LENGTH OF BL SIDE ③ PRESSURE/DENT ④ SEE B-END DETAILS

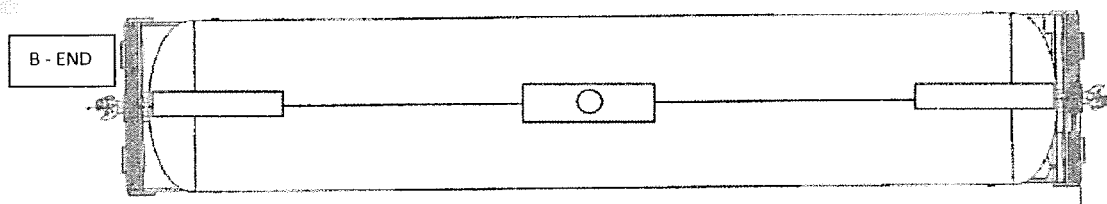
Notes: BOTTOM OF CAR ON GROUND

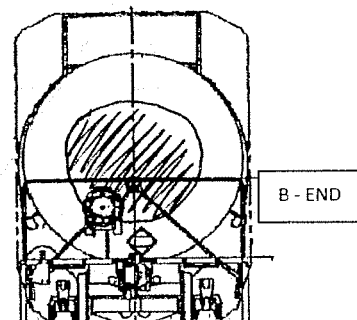
① 7' H 7' 6" W  
2' DEEP

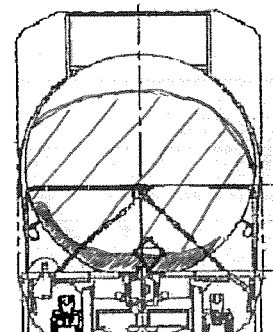
HEAD DENT: 9' W 8' H  
4' DEEP  
HAZ FAILURE 8-5  
O'CLOCK
