Evidence to support Flowline from Coors 6-14Ji was not excavated from the wellhead to the cut end at the house. I would hope this photo log is evidence enough.

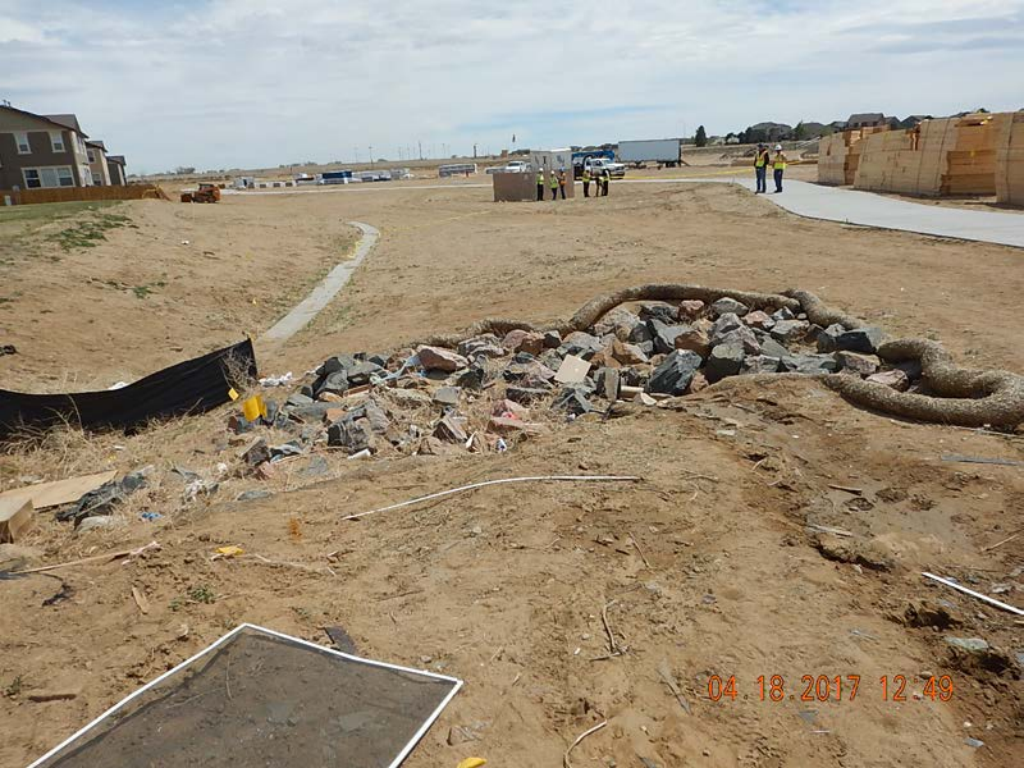
04.18.2017 12:49

- 1) Photo 013(2) is looking from south of the home to the well. Notice the building trusses on the right side of photo and time stamp of 04.18.2017
- 2) Photo 019 shows Abandoned flowline and 1" PE return line on 04.18.2017

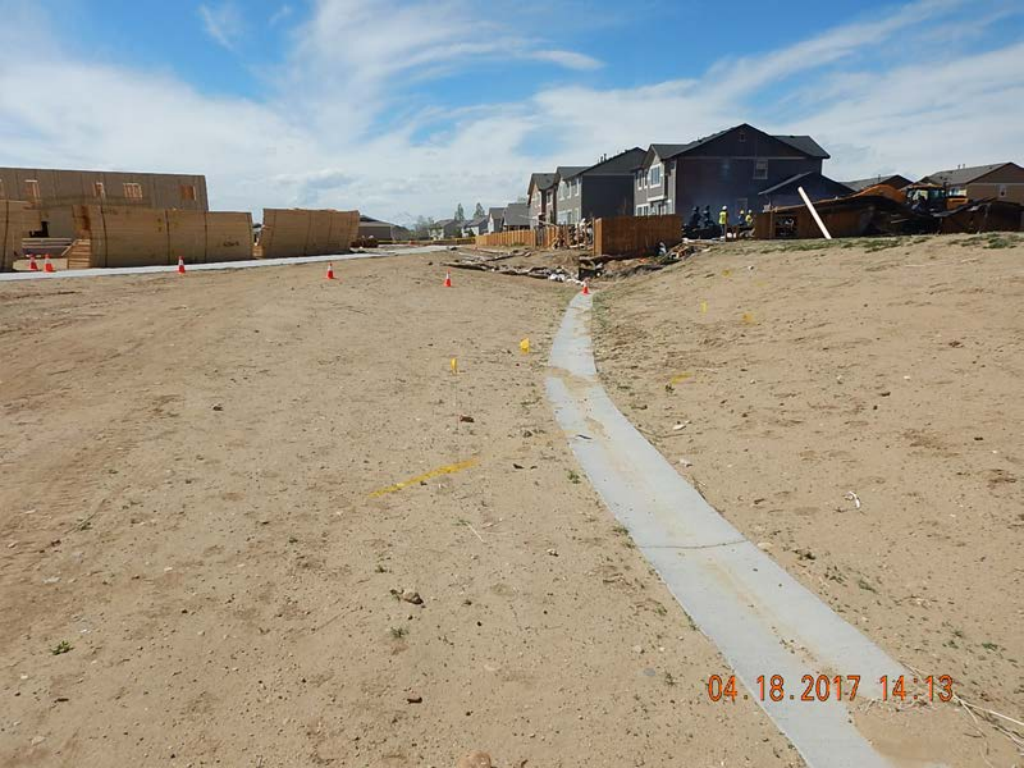
04.18.2017 14:13

- 3) Photo 039 is looking from well to home. Notice line marked on right. This was the active flowline from the wellhead. Again notice trusses to the left and date of 04.18

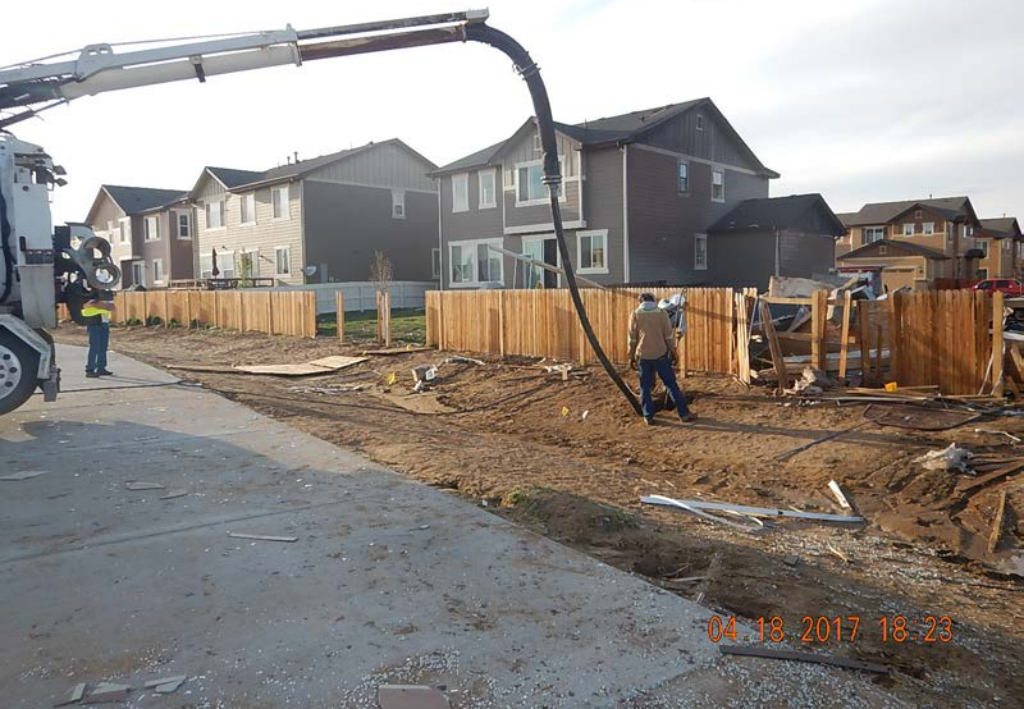
04.18.2017 18:23

- 4) Photo 103 shows the initial excavation just south of the house on 4.18. Notice no open excavation leading to it.
- 5) Photo DSCN1521 shows excavation that exposed lines south of house. Notice date stamp 04.19.

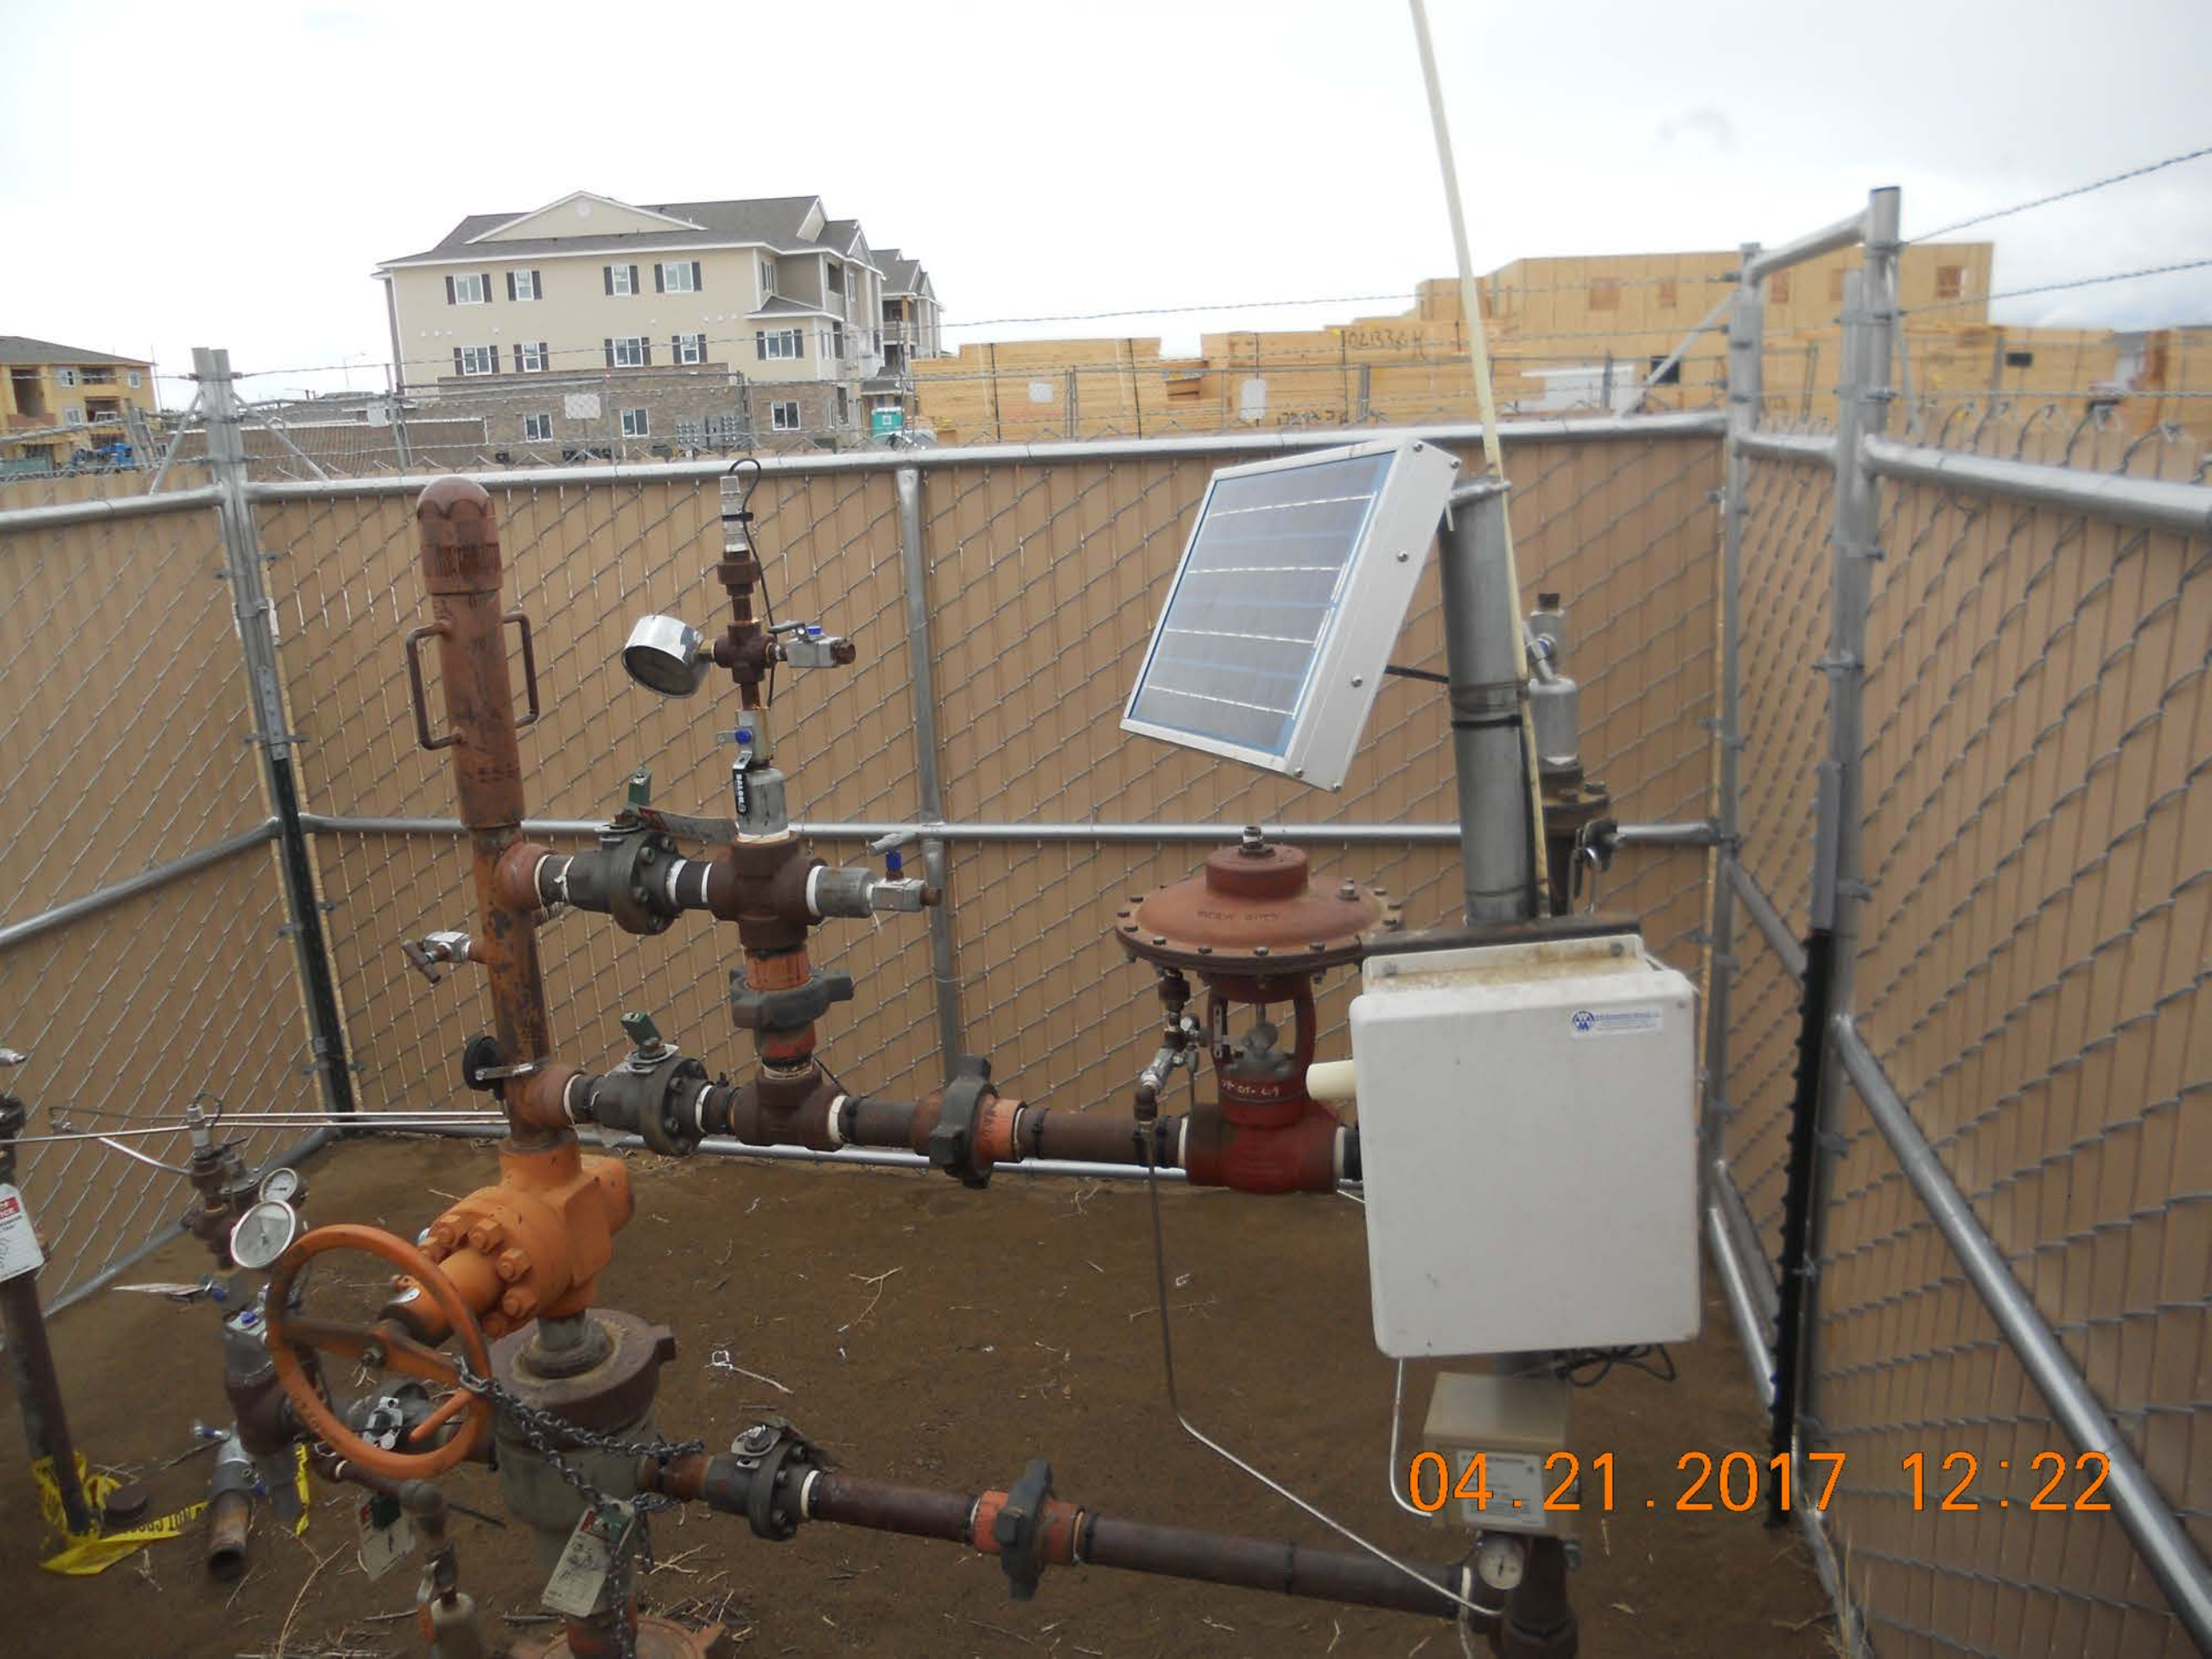
04.21.2017 12:22

- 6) Photo DSCN1541 show wellhead of Coors 6-14 Ji on 04.21.2017. Abandoned flowline and return 1" in bottom left of photo. No evidence of excavation. Notice trusses beyond for reference.

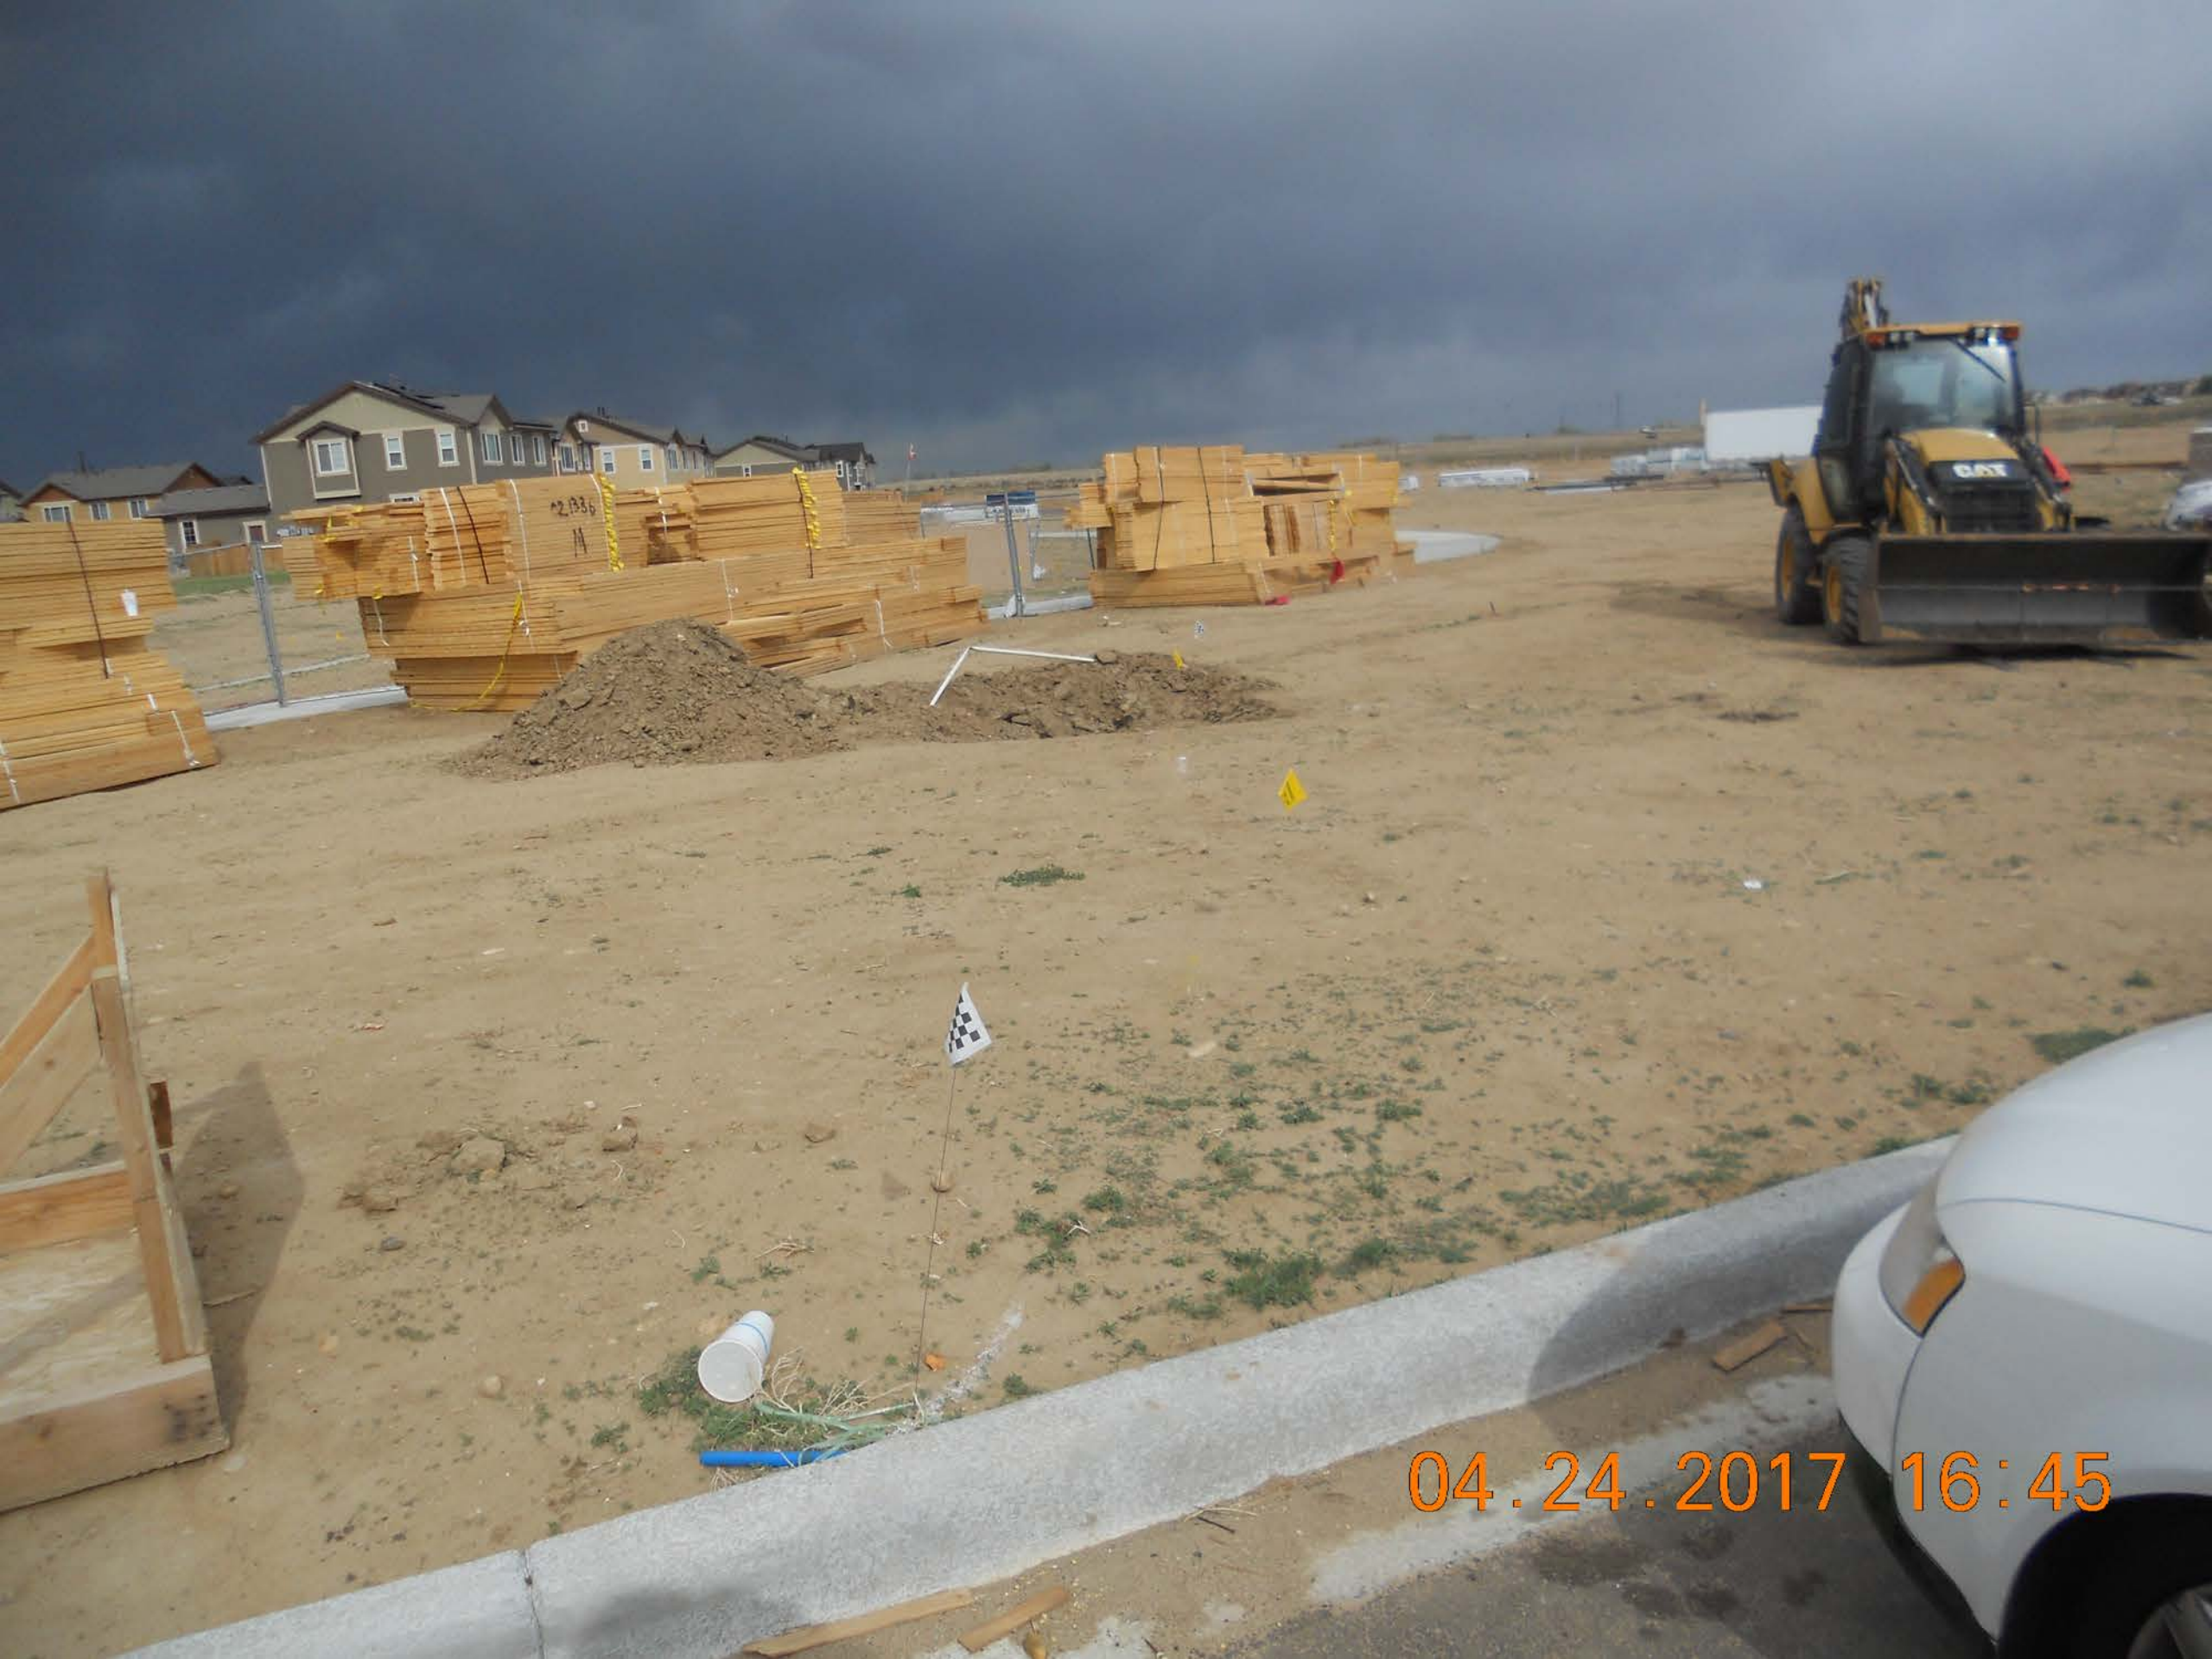
04.24.2017 16:45

- 7) Photo DSCN1567 is looking towards well from parking lot south of house. Notice line markers, these relate to marking of abandoned line from wellhead to house. Notice trusses for reference. No indication of excavation on 04.24.2017.

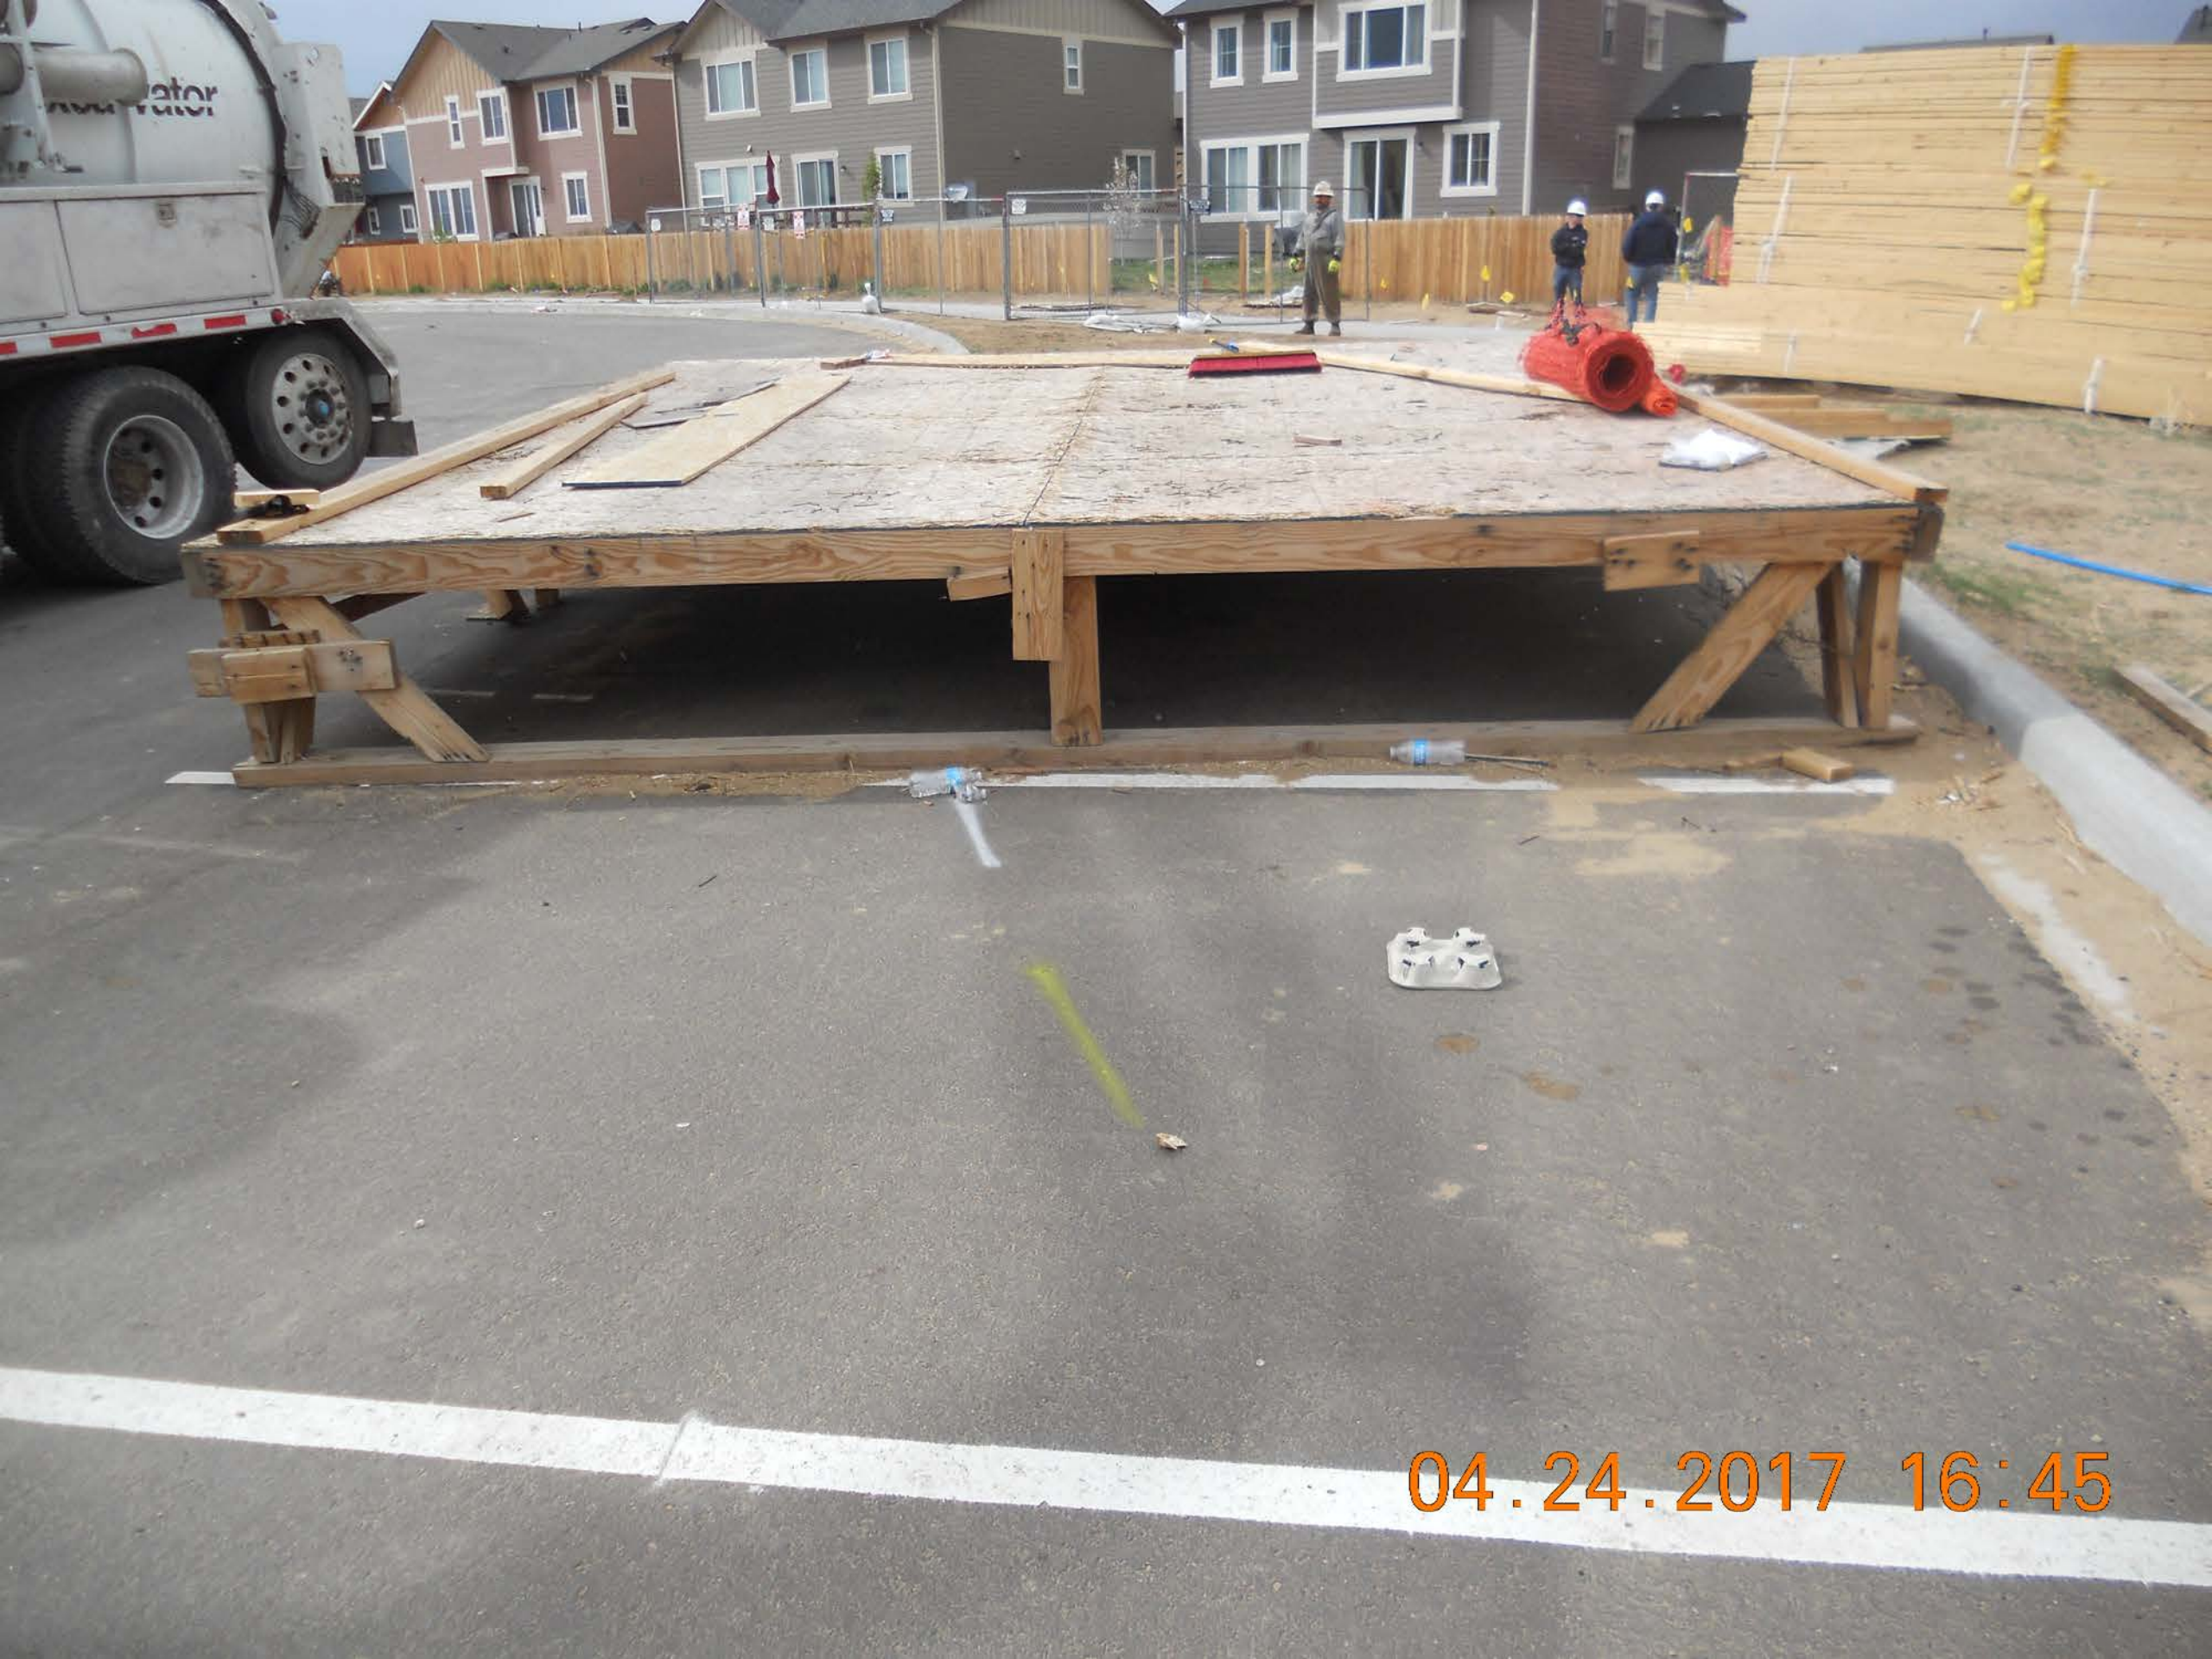
04.24.2017 16:45

- 8) Photo DSCN1568 is taken from same point as DSCN1567 described above. This is looking towards house. Initial excavation as soon in #4 above is near the two men in white hard hats on the right. Notice line marked under parking lot, not excavated.

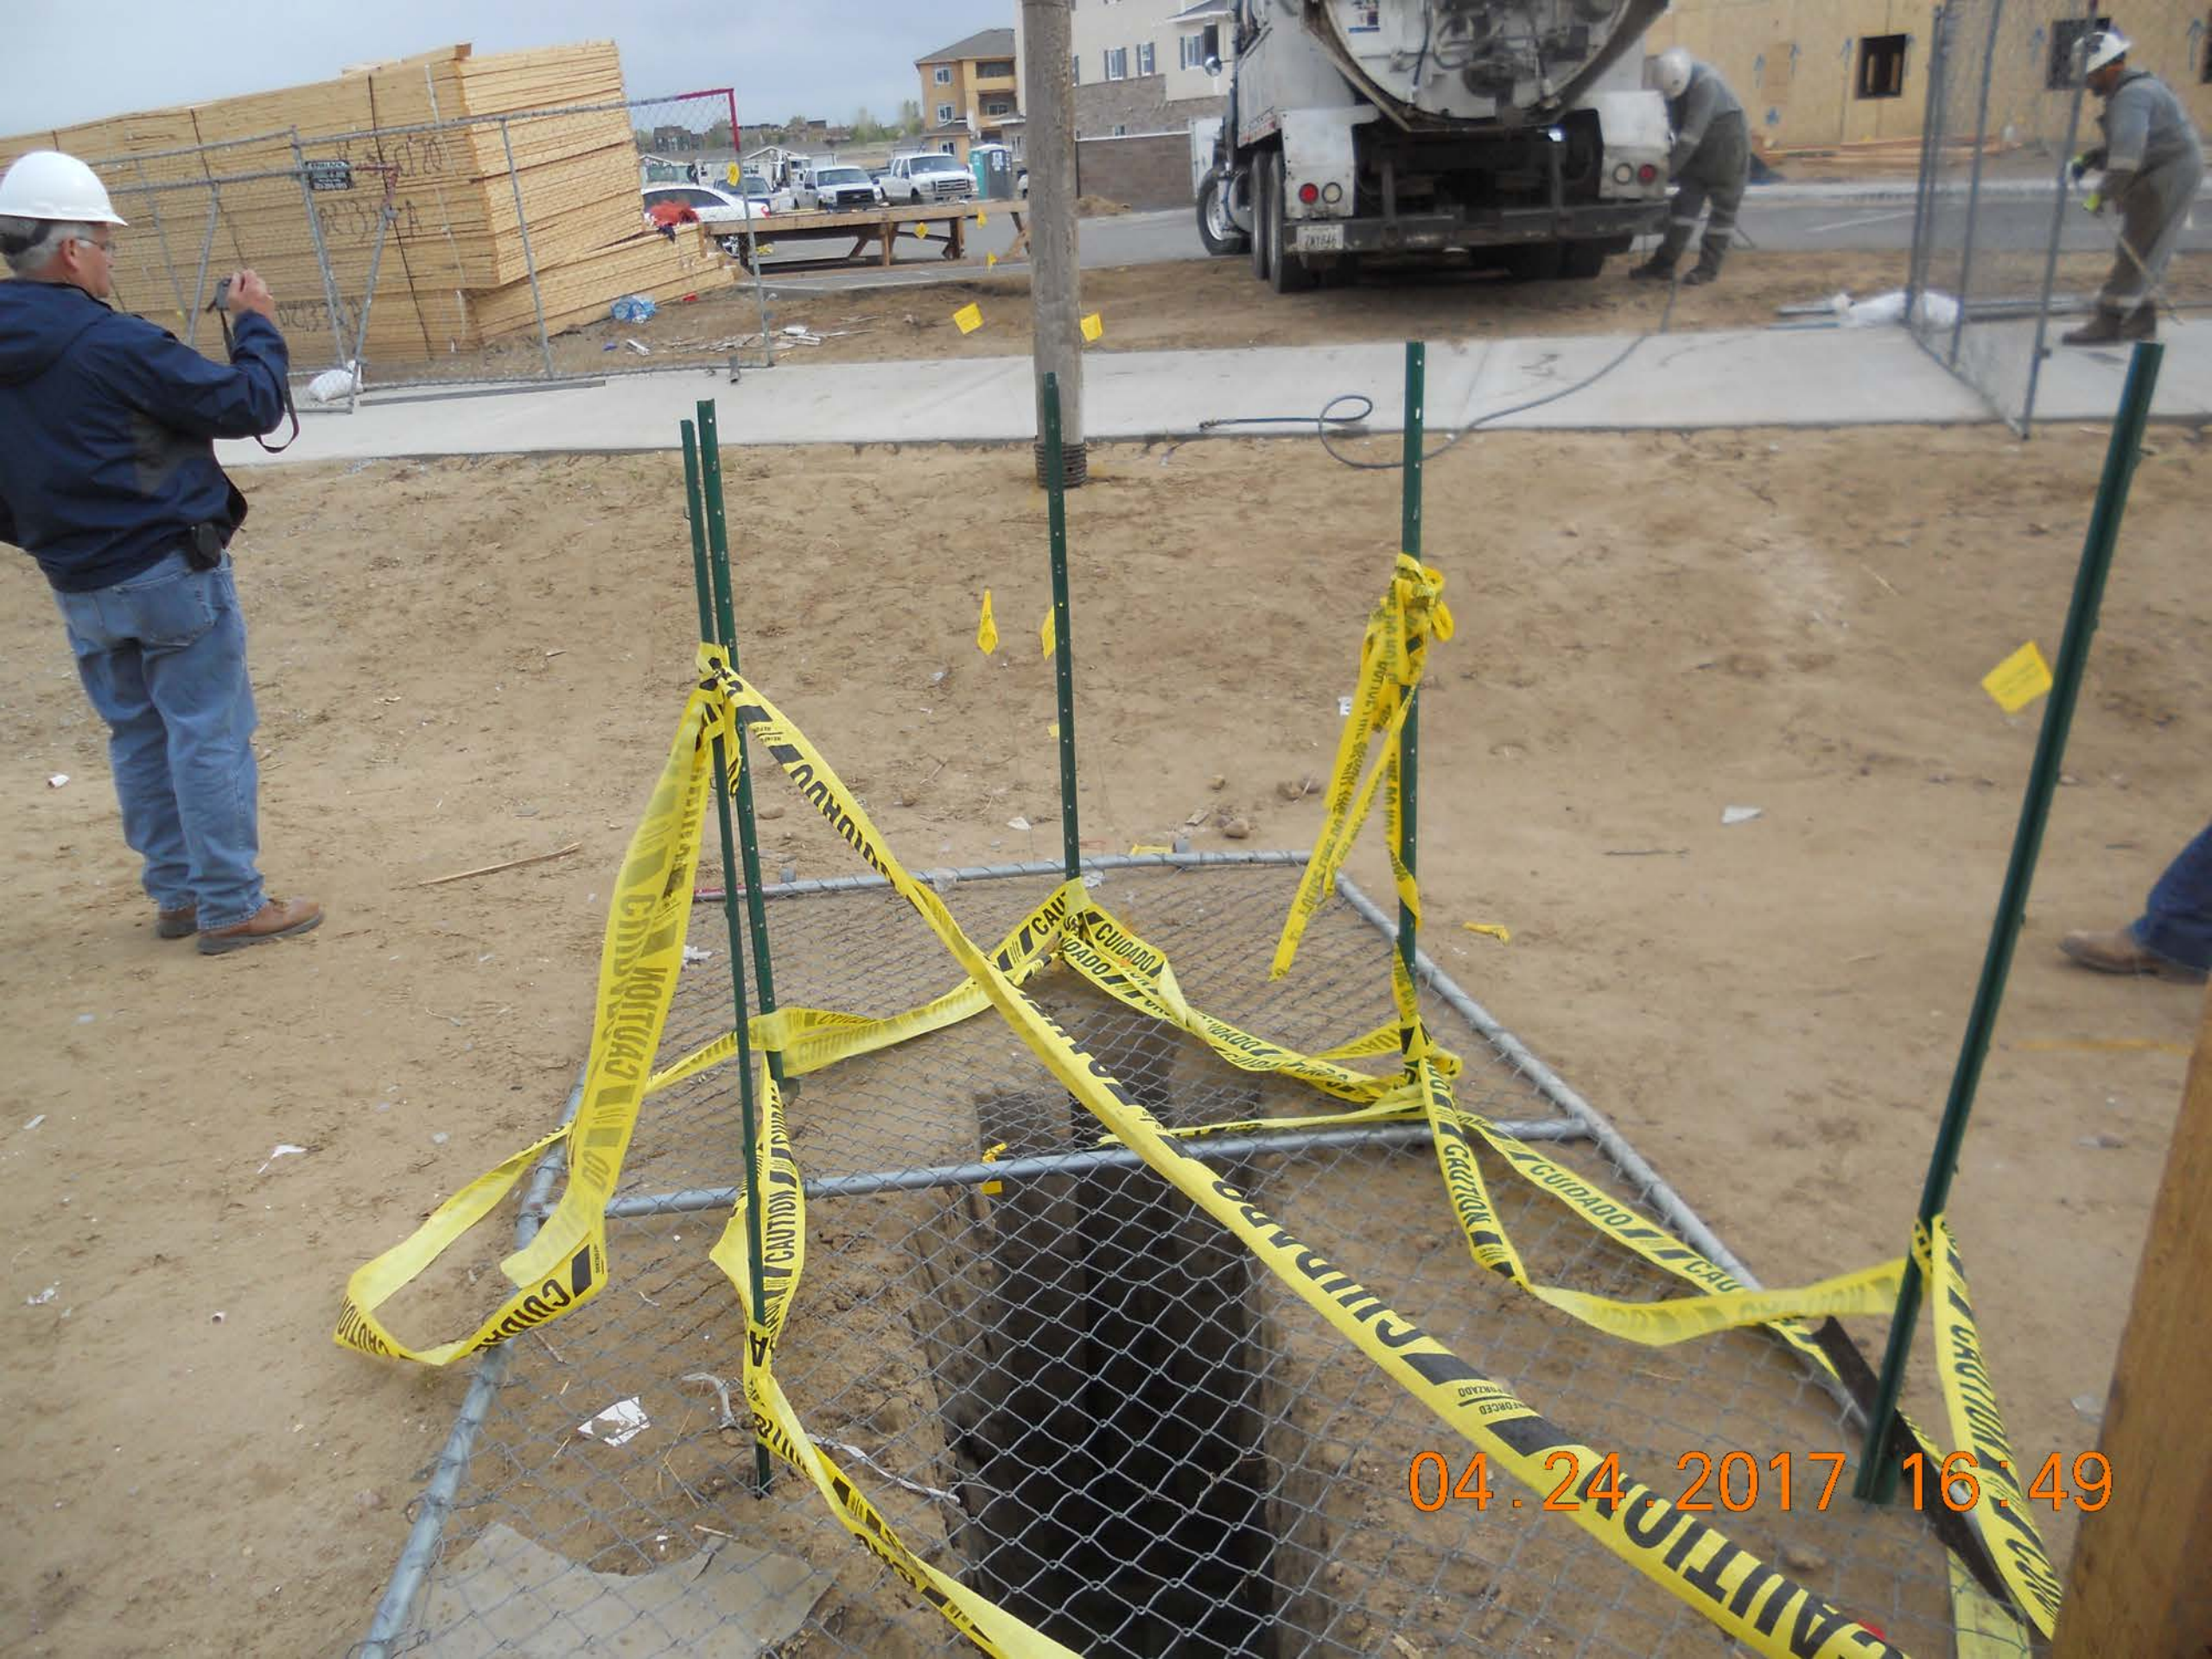
04.24.2017 16:49

- 9) Photo DSCN1572 looking from original excavation south of house to parking lot. Notice elevated work structure in parking lot. Same structure as seen in #8 above

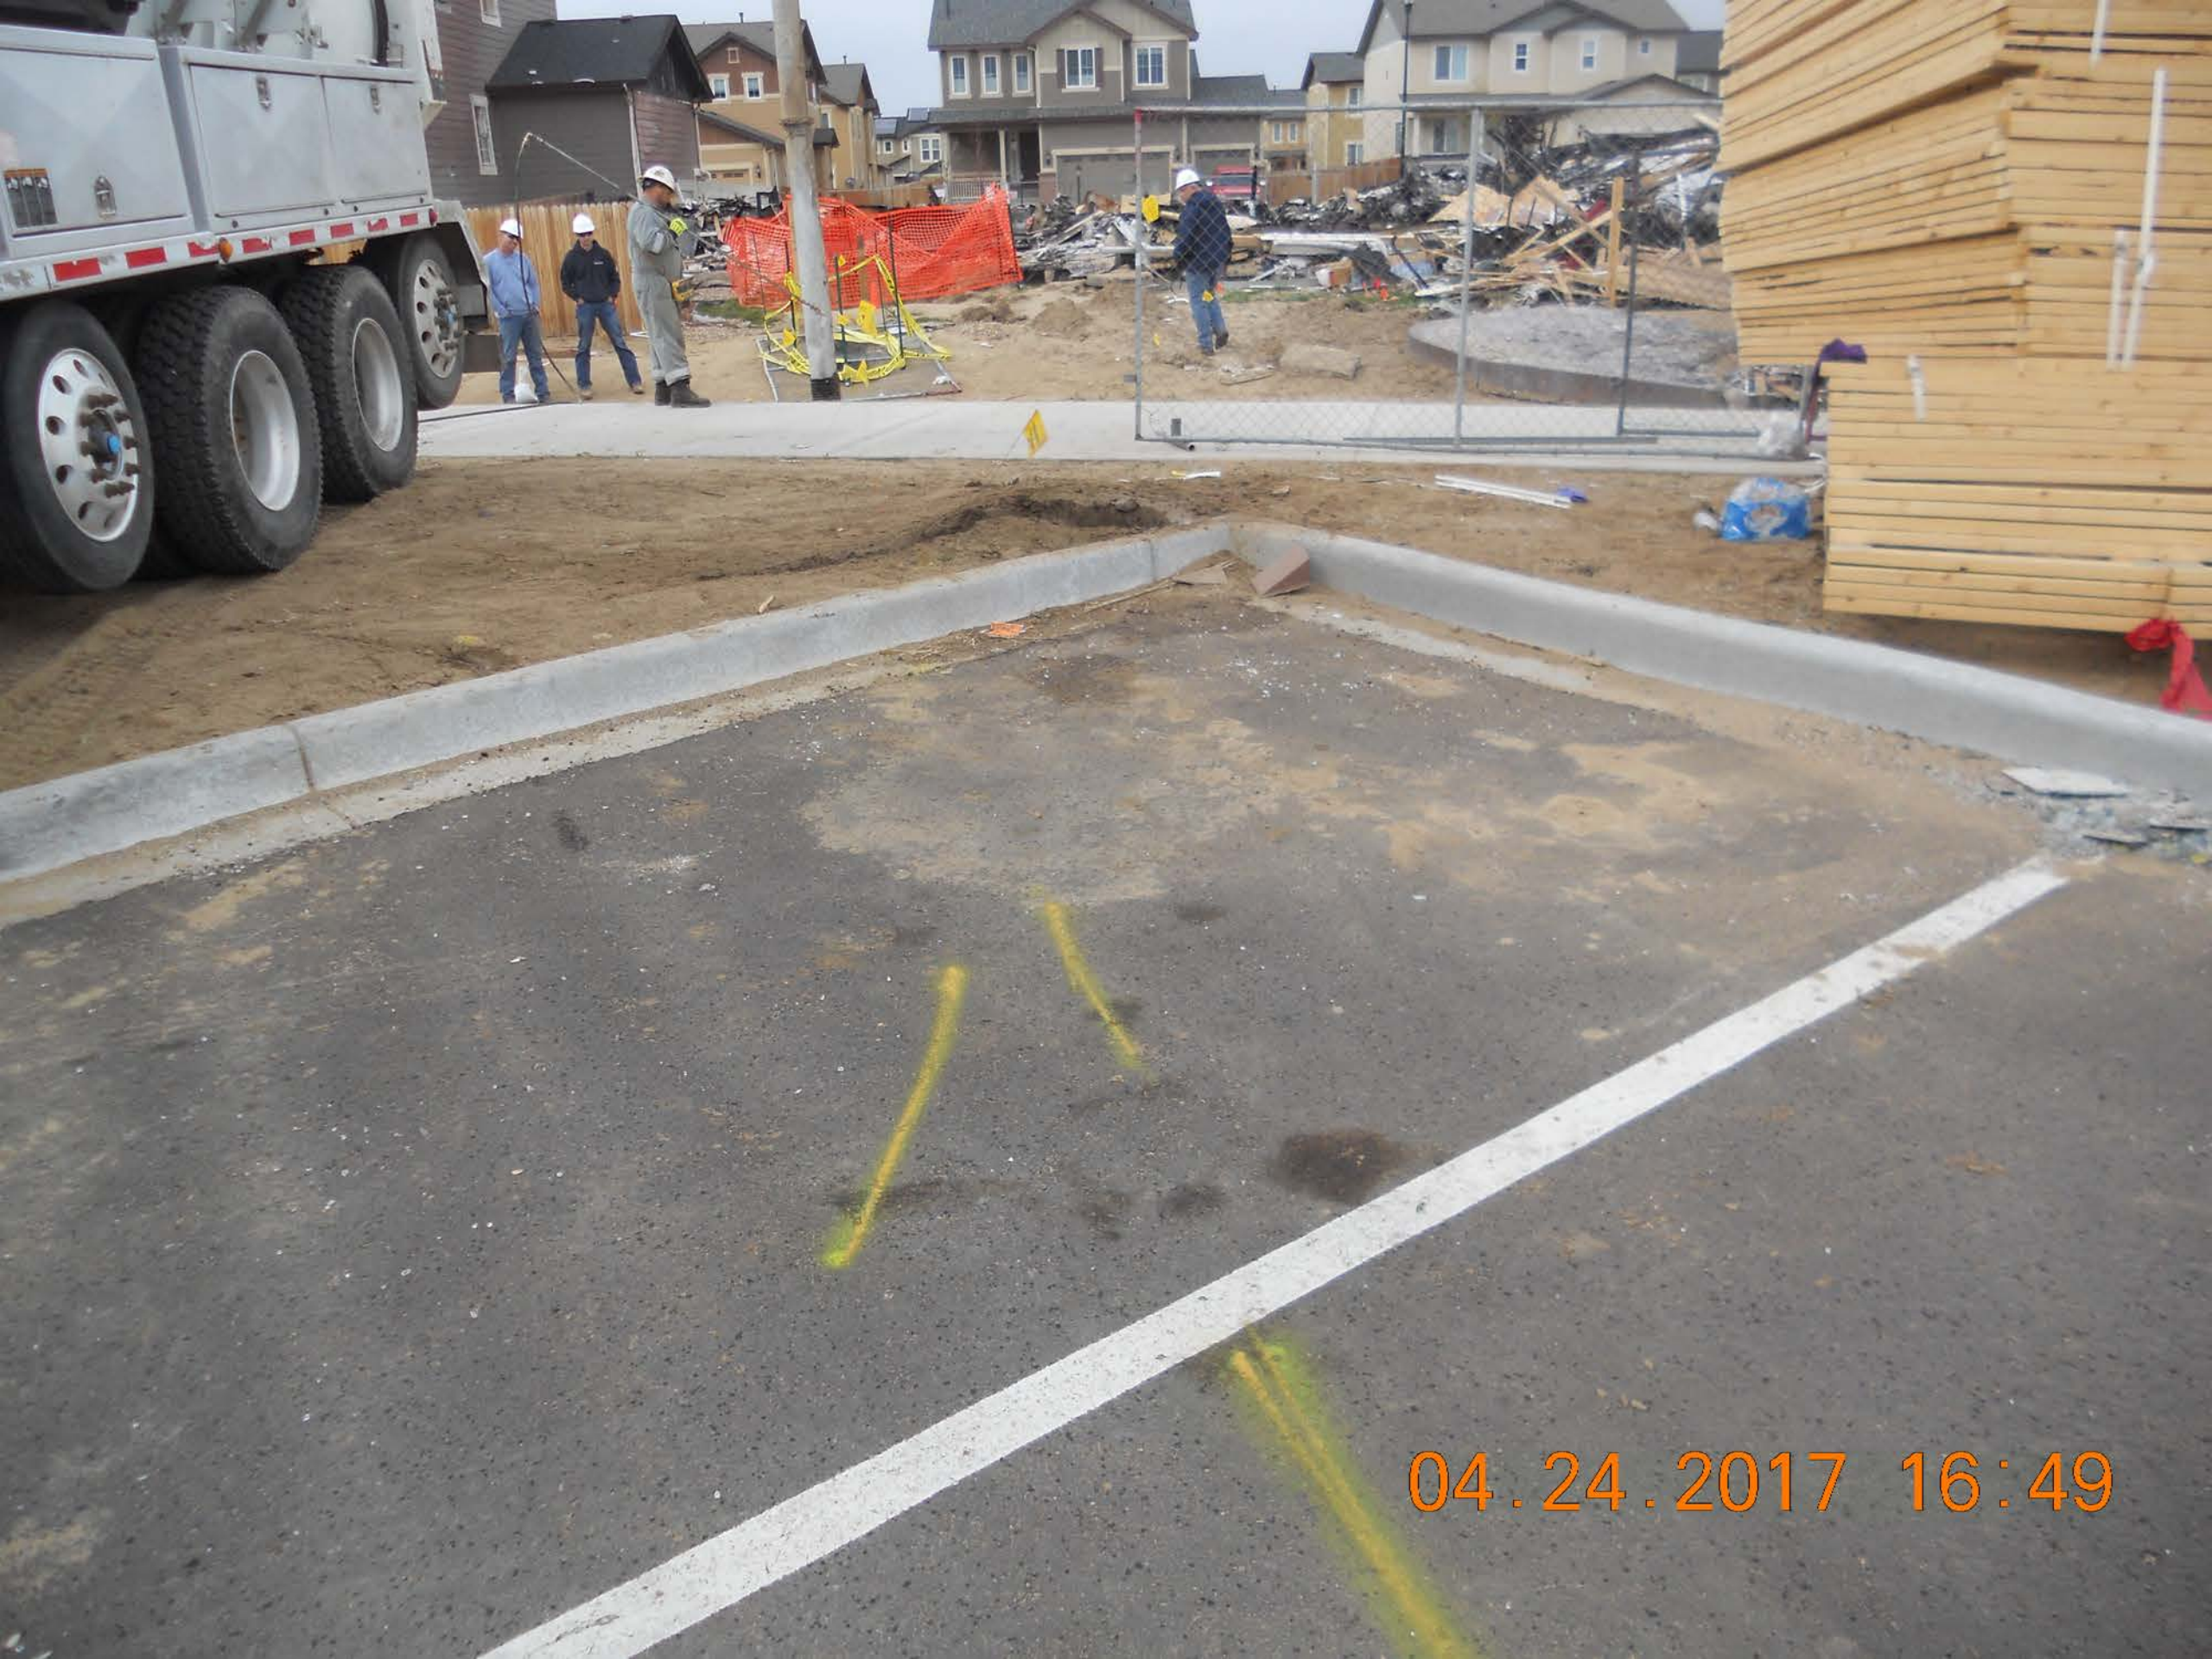
04.24.2017 16:49

- 10) Photo DSCN1573 taken from north end of elevated structure towards house. Yellow lines indicate abandoned lines from 6-14 Ji (right) and 6-14 (left).
