**FORM
INSP**

**State of Colorado
Oil and Gas Conservation Commission**

FIELD INSPECTION FORM

Facility ID	Type	Status	Status Date	Well Class	API Num	Facility Name	Insp Status
249521	WELL	SI	05/01/2017	GW	123-17324	COORS V 6-14Ji	EG

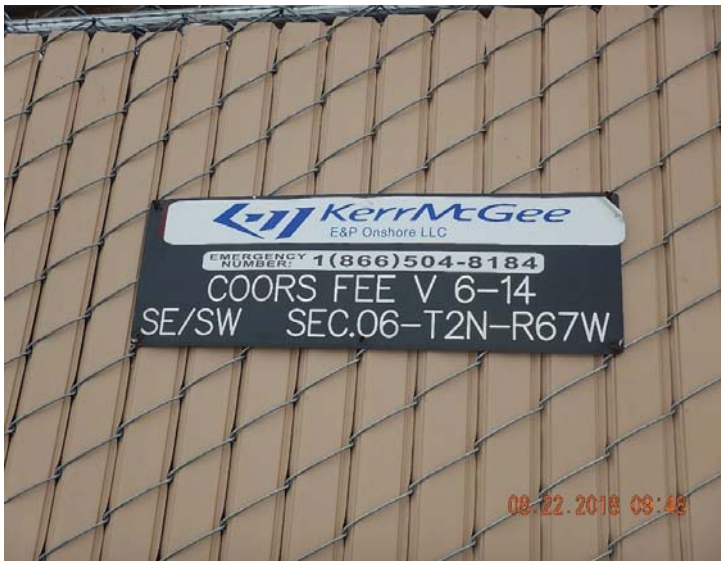
Signage and wellhead fencing

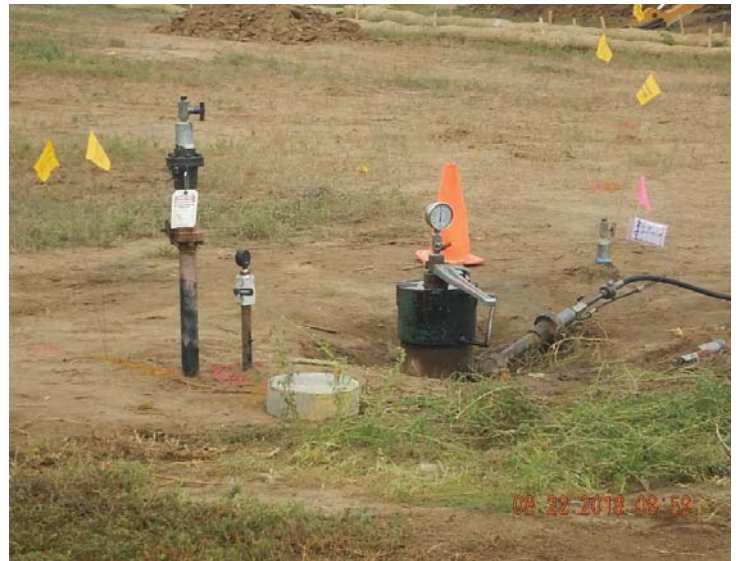
View of Coors V 6-14 JI well casing being pressure tested

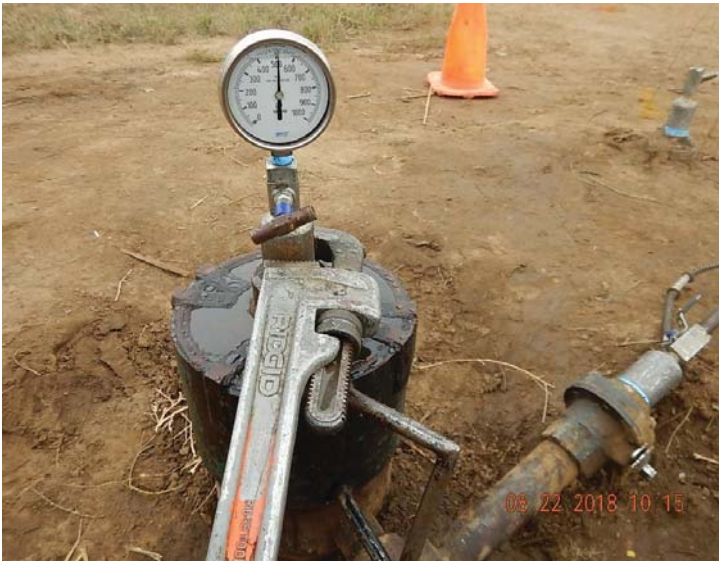
Coors V 6-14Jl pressure test gauge – test Satisfactory

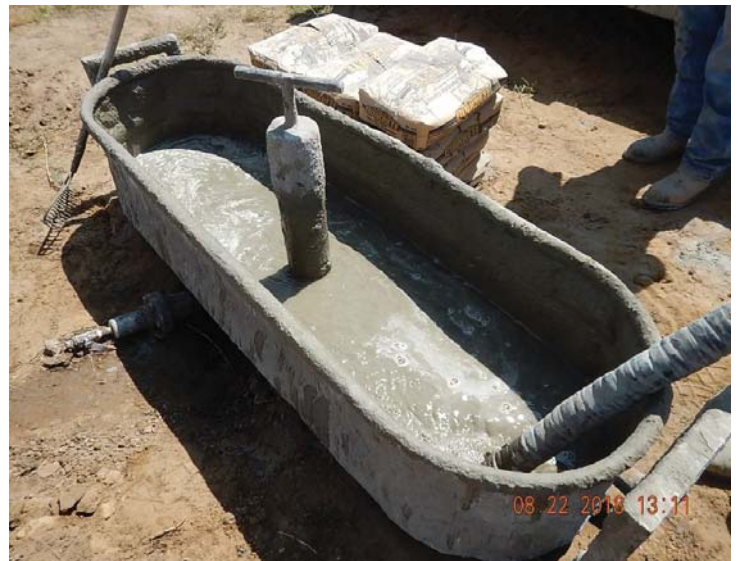
Well casing being cemented from approximately 79' in depth to 6' below grade

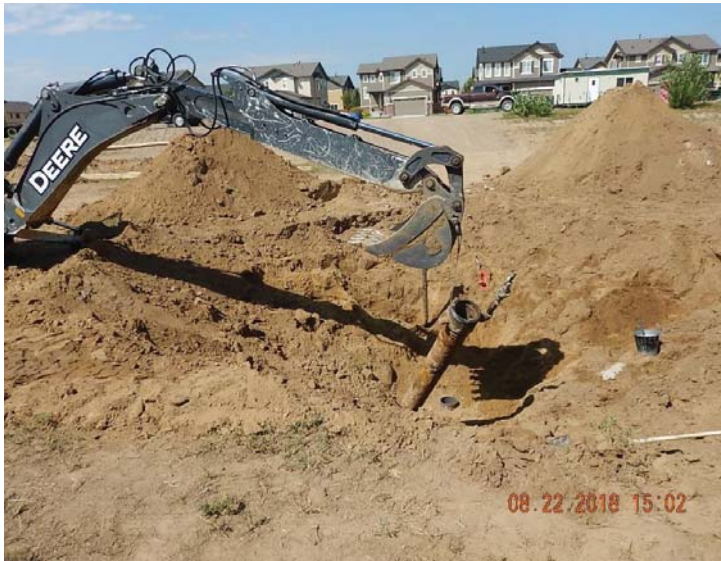
Final stage in plugging and abandonment of the Coors V 6-14JI well – cut and cap of casing after being cemented

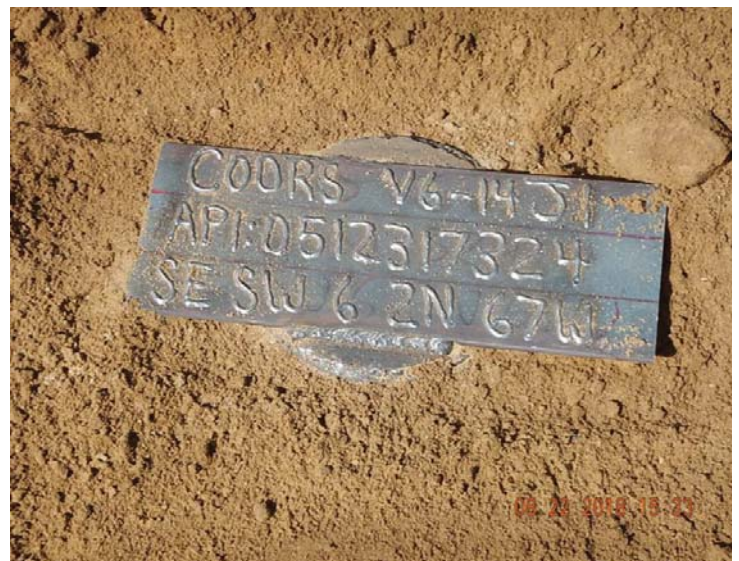
Welded cap on Coors V 6-14JI well casing (PA) to be backfilled and buried 6' below grade

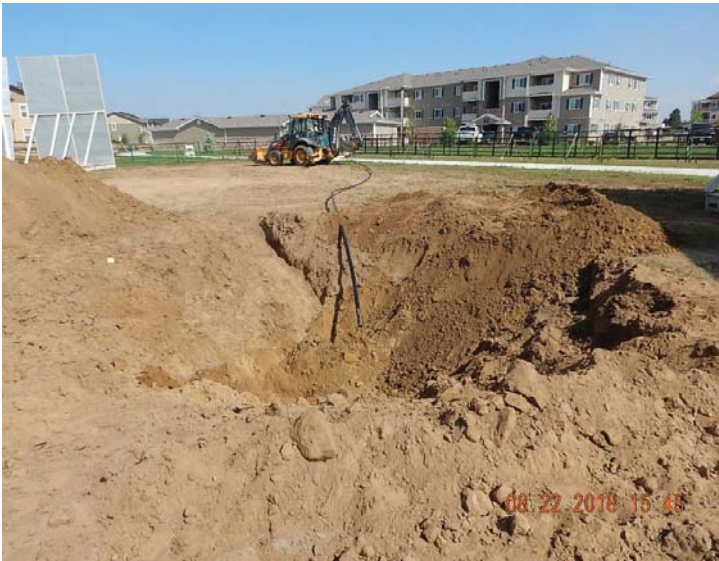
Flowline being removed at Coors V 6-14JI (PA) wellhead

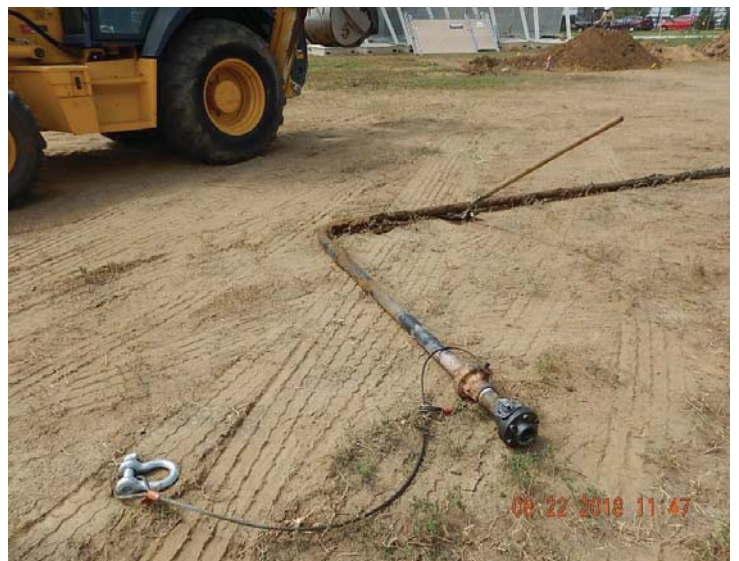
Flowline risers excavated and removed at Coors V 6-14JI wellhead/ location

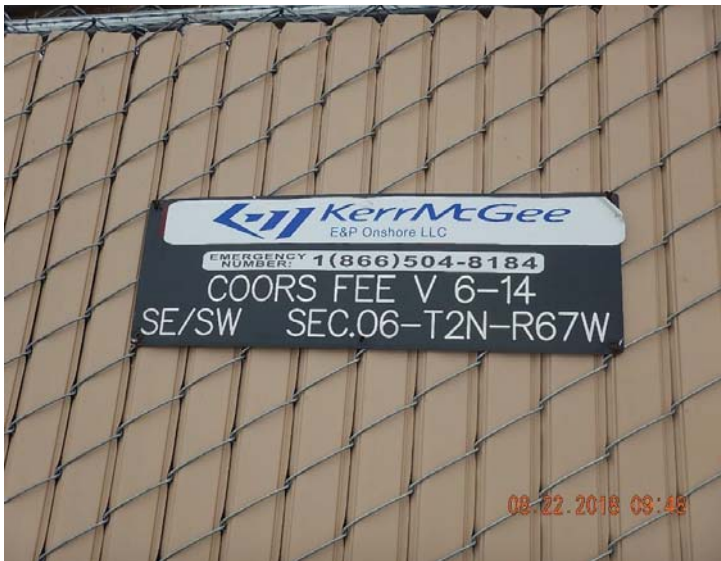
Signage and well fencing (removed).

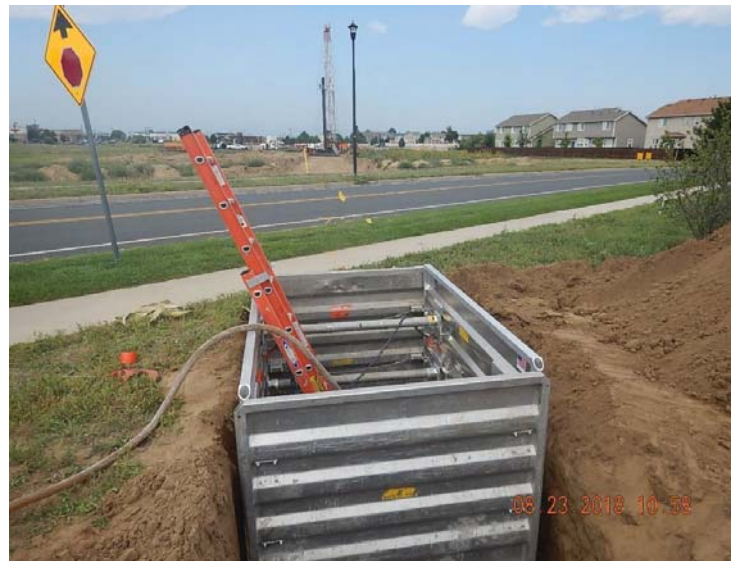
View of excavation/ trench box; Previously abandoned flowline 2" from Coors V 6-13 being cemented (full) at Oak Meadows Blvd; 1: poly line segment abandoned with ends sealed. View to west

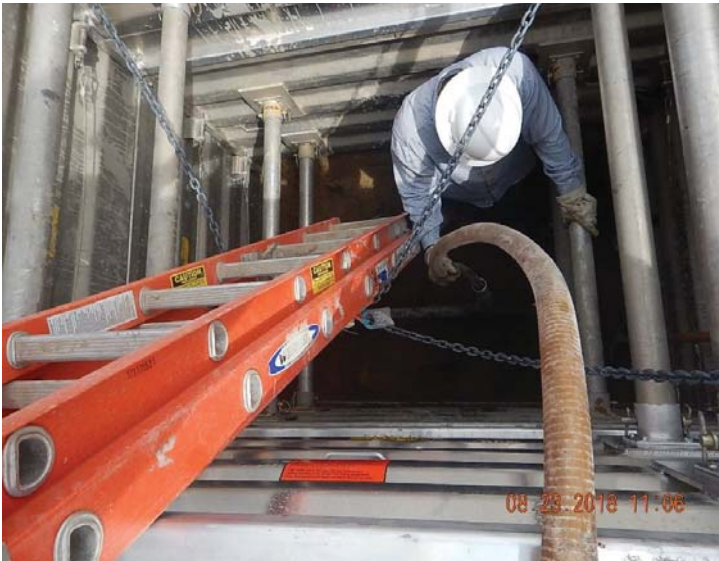
Coors V 6-13 flowline segment (18' long) being cemented, plugged and abandoned in place at Oak Meadows Blvd

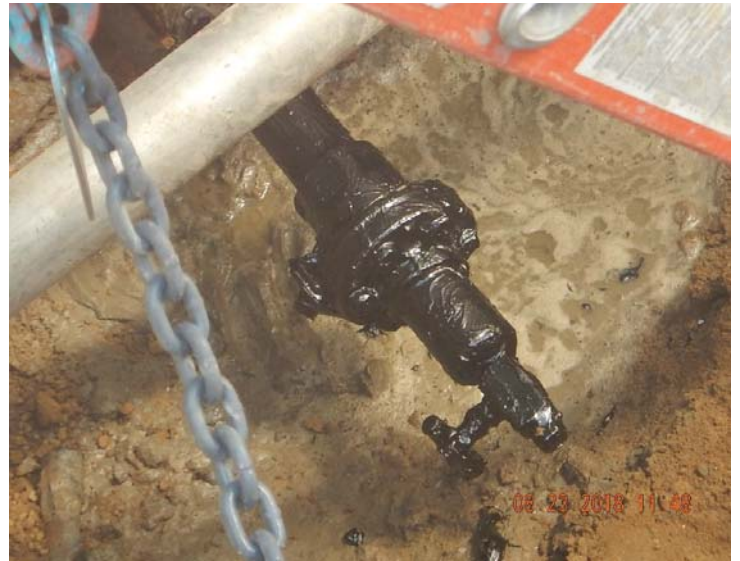
Abandoned flowline segment; ends plugged & sealed. Valves and fittings tar coated.

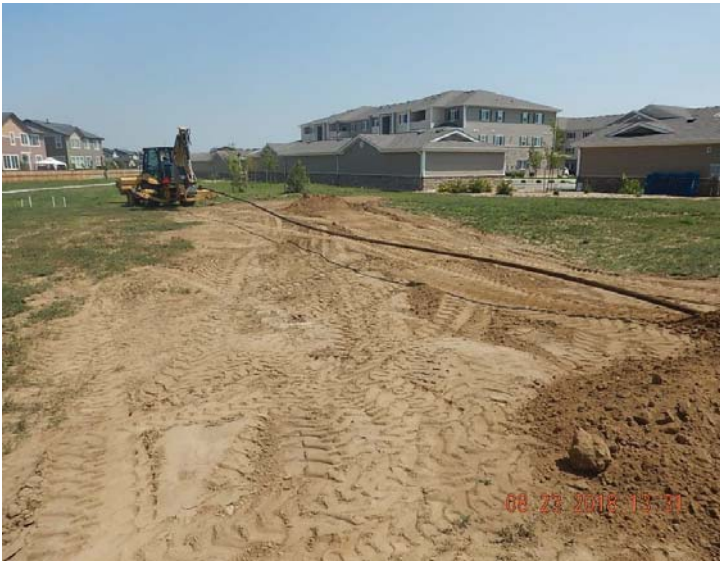
Flowline removal in progress (Coors V 6-13) east of Oak Meadows Blvd.

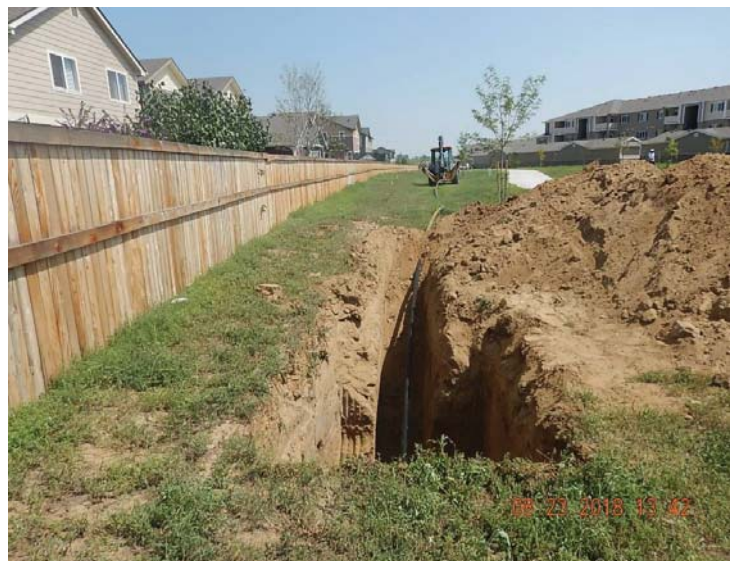
Flowline removal in progress (Previously Active Coors V 6-14JI line) east of Oak Meadows Blvd in ROW south of subdivision.

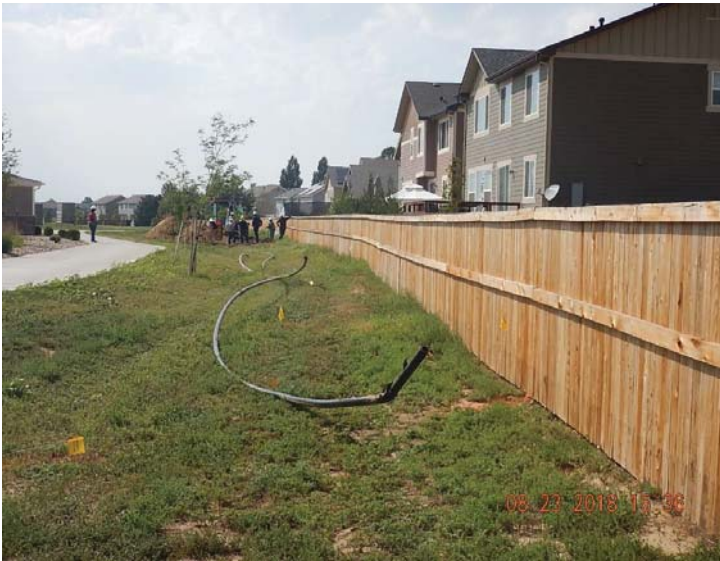
Flowline removed from ROW south of Oak Meadows Subdivision from Coors V 6-14JI (PA) well

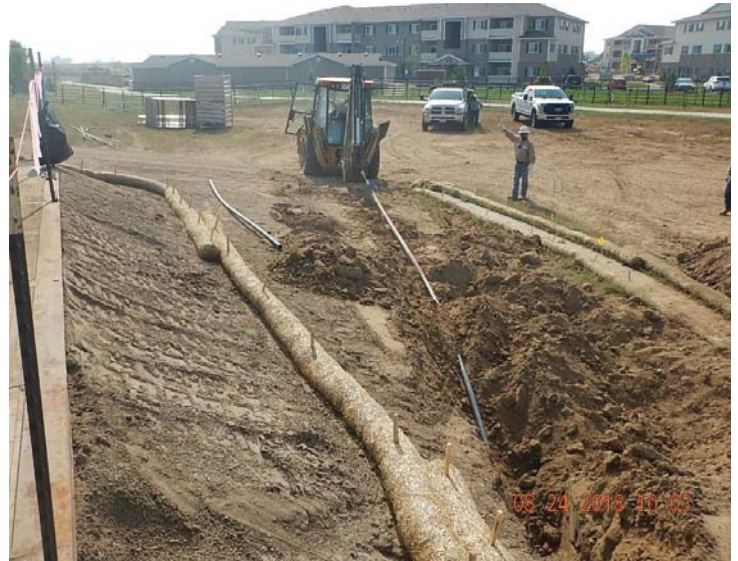
Final segment of flowline from Coors V 6-14 removed near well (now PA).
