**CRANE CO.
Hydro-Aire Inc.
& Lear Romec
Submission to the
National Transport Safety Board
TWA Flight 800 Investigation
DCA96MA070**

I Lear Romec Scavenge Pump

II Hydro-Aire Jettison/Override Pumps

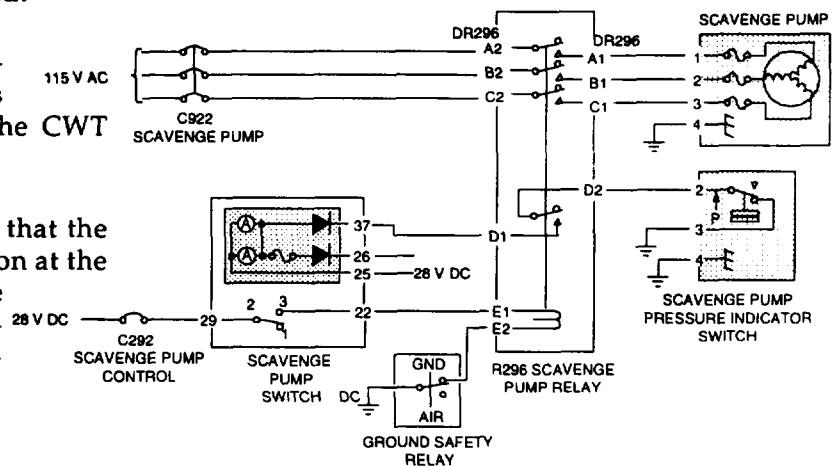
Figure 1 CWT Scavenge Pump Electrical Schematic

The scavenge pump is used to pump any remaining fuel out of the Center Wing Tank (CWT) once the level of fuel is below the pick ups of the other CWT pumps. Figure 1 illustrates the electrical schematic diagram for the scavenge pump system.

Operating power is supplied to the pump motor windings via the Scavenge Pump Relay (R296) which receives power from the 115 volt ac Scavenge Pump Circuit Breaker (C922).

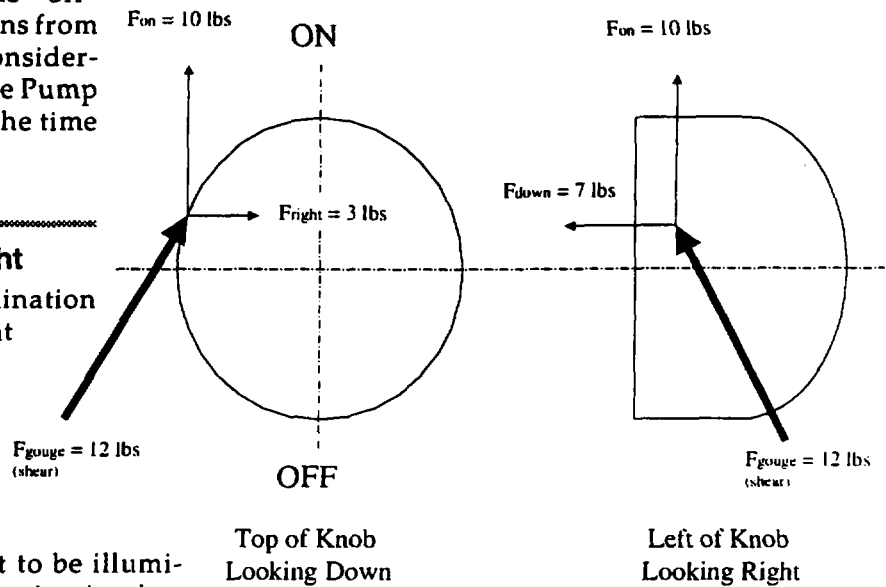
Figure 2 Gouge Force Diagram

Report WL/MLS 97-074 addresses the question of whether an impact to the scavenge pump switch knob, as evidenced by a gouge, resulted in a force toward the "OFF" direction.⁴ The conclusion drawn and evaluation presented in the factual report vector force diagram⁵ is based on the assumption that the impact between the knob and the striking object is a glancing collision, such as two pool balls striking each other. The gouge in the knob and associated displacement of metal is evidence that the switch was not forced toward the "OFF" direction. Consideration must be given to the direction and magnitude of the force to cause the gouge and the resultant reaction forces in the knob. **Figure 2** represents the force of the impact causing the gouge and shows the components of that force as related to switch operation. An estimated force of twelve pounds was required to cause the gouge. This results in approximately ten pounds of force in the "ON" direction and seven pounds of force along the toggle shaft preventing movement over the cam locking ring. Movement of the knob in the "ON" direction is blocked by the detent mechanism. Such an interaction also produces approximately a three pound force on the knob to the right while in the "OFF" position, consistent with the damage noted on the locking cam.⁶

support any forced movement to the "off" position by impact or some other means from the mishap breakup", there is also considerable evidence to indicate the Scavenge Pump Switch was in the "OFF" position at the time of the accident.

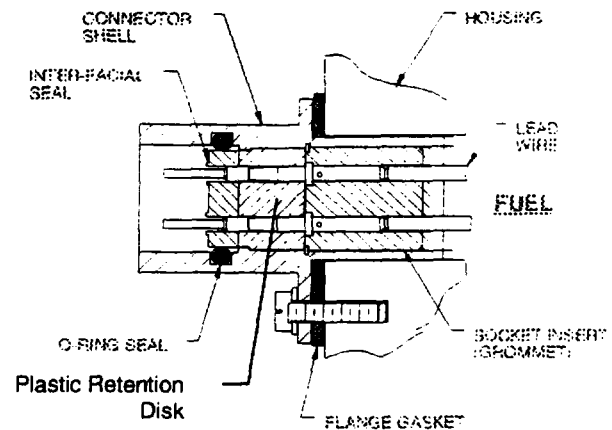
Figure 3 Electrical Connector Cross Section

During the investigation it was found that some scavenge pumps had electrical connectors installed during non-factory overhauls, that were made with an unqualified socket insert (grommet) material which can degrade with long-term fuel exposure. These findings gave rise to the desire to further evaluate the continued explosion proof capability of the scavenge pump and its leak tightness with the incorrect grommet material installed.

In addition to the testing, "The [Group] design review found that the scavenge pump connector pins were held apart by a plastic contact retention disk and that if a fire were ignited by a short circuit at the connector, it would have to pass through the flame arrestor tubes and the check valve to reach the fuel tank. The wheel well also had been equipped with heat detectors. Soot and fire patterns were not found to emanate from the rear wing spar at the fuel pump mounting hole."²⁴

Crane Co. concurs with the evaluation. The connector grommet material issue was not a factor in the accident.
