Re: NTSB/HAR-18/01, Safety Recommendations R-18-14 and R-18-15  
and Petition for Reconsideration Pursuant to 49 C.F.R. § 845.32. – NTSB  
Accident ID: HWY17MH010

**CSXT'S NOVEMBER 21, 2018 LETTER RE NTSB/HAR-18/01,  
SAFETY RECOMMENDATIONS R-18-14 AND R-18-15 AND  
PETITION FOR RECONSIDERATION PURSUANT TO 49 CFR § 845.32**

### **2015 MDOT Inspection Report**

**April 2013 Google Maps  
Street View of Crossing**

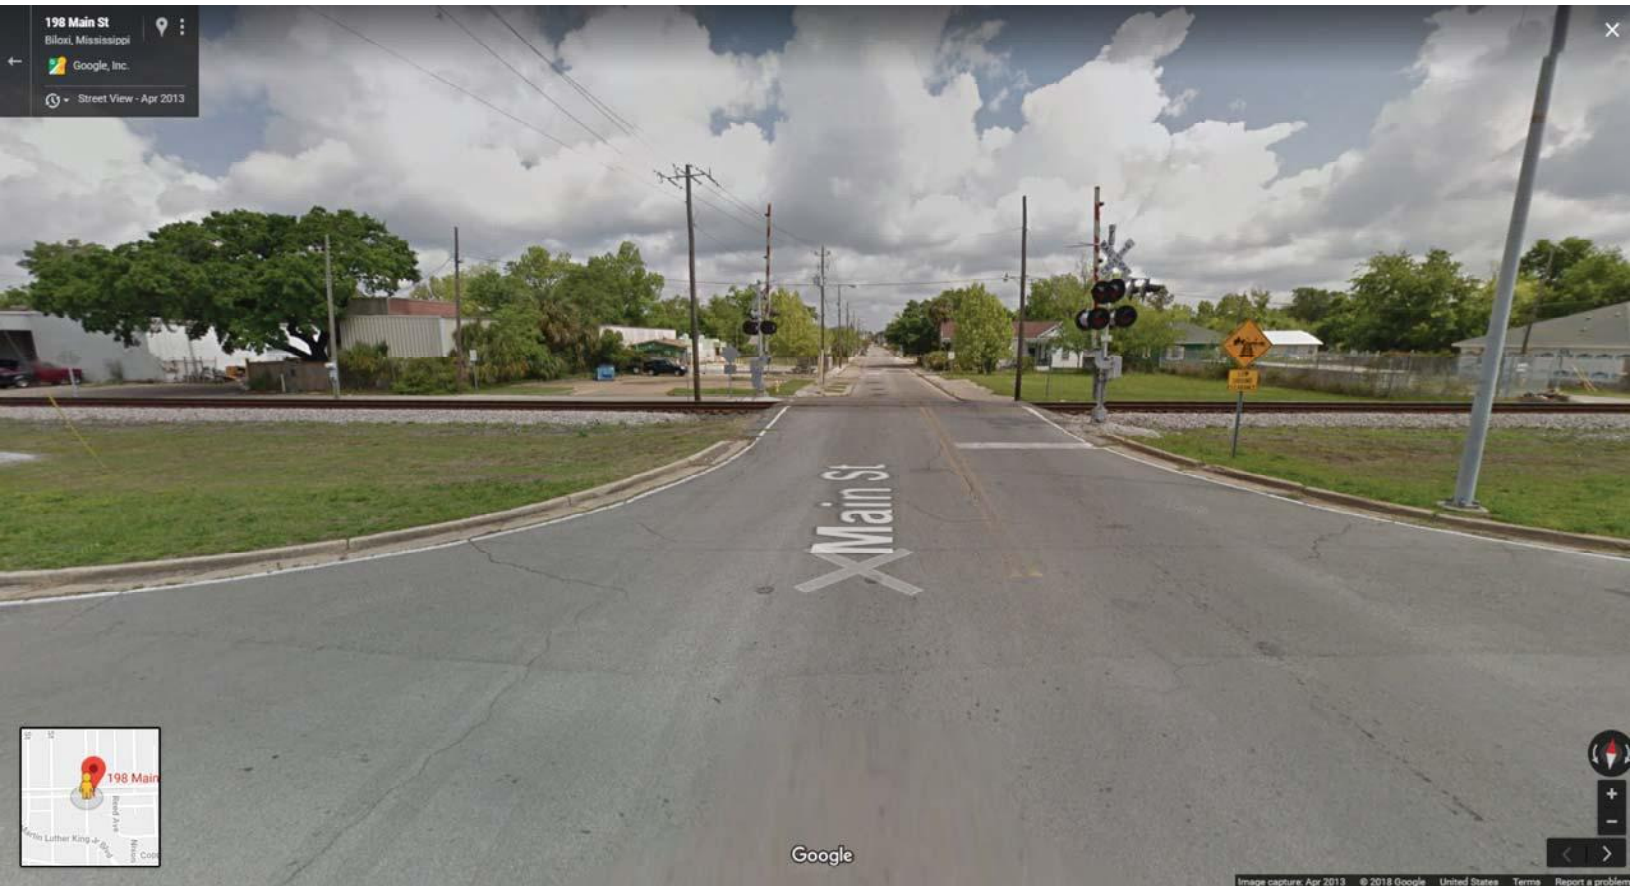
<sup>11</sup> Specifically, the docket contains a Google Maps Street View image dated April 2013. Highway Factors Group, Photographs, Photograph No. 15. The image in the docket is closely cropped and therefore does not show the sign and plaque. The identical, albeit zoomed out, version of the April 2013 Street View image available on Google Maps shows the sign and plaque in its current location. A copy of that image is attached hereto as **Exhibit B**.
