NATIONAL TRANSPORTATION SAFETY BOARD

CARBURETOR EXAMINATION FIELD NOTES

Aircraft: N22721, Cessna 150H

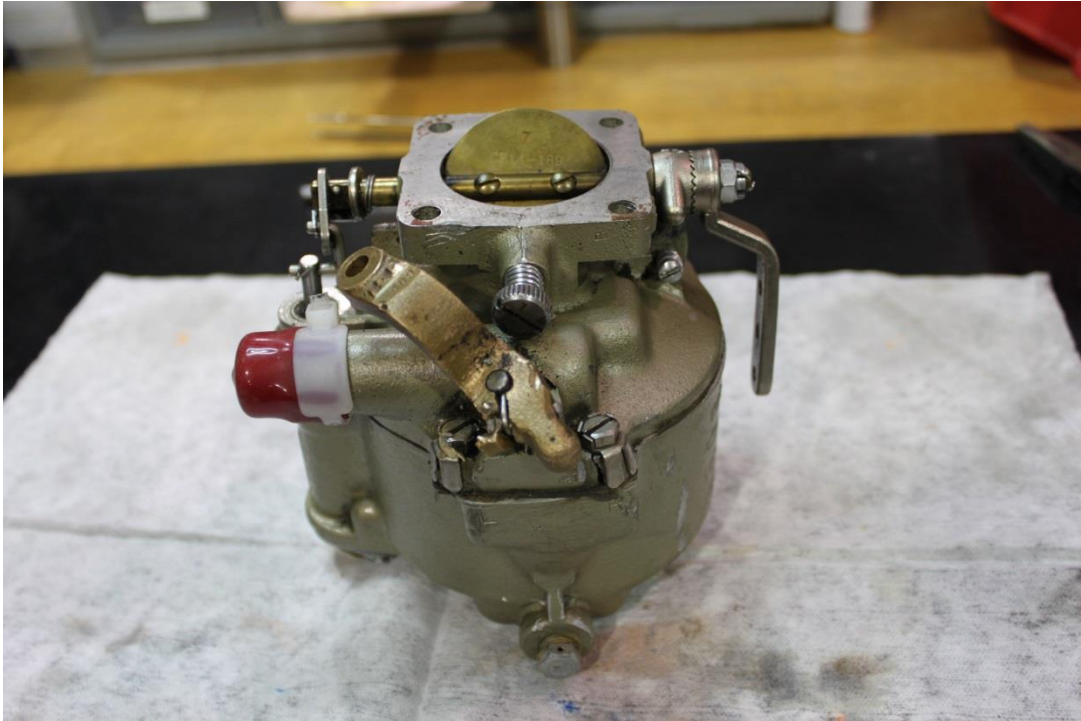
On October 22, 2015, the NTSB-IIC travelled with the carburetor to AVStar Fuel Systems, Inc., located in Jupiter, Florida, ([Figure 1](#)).

Figure 1: Carburetor As First Viewed

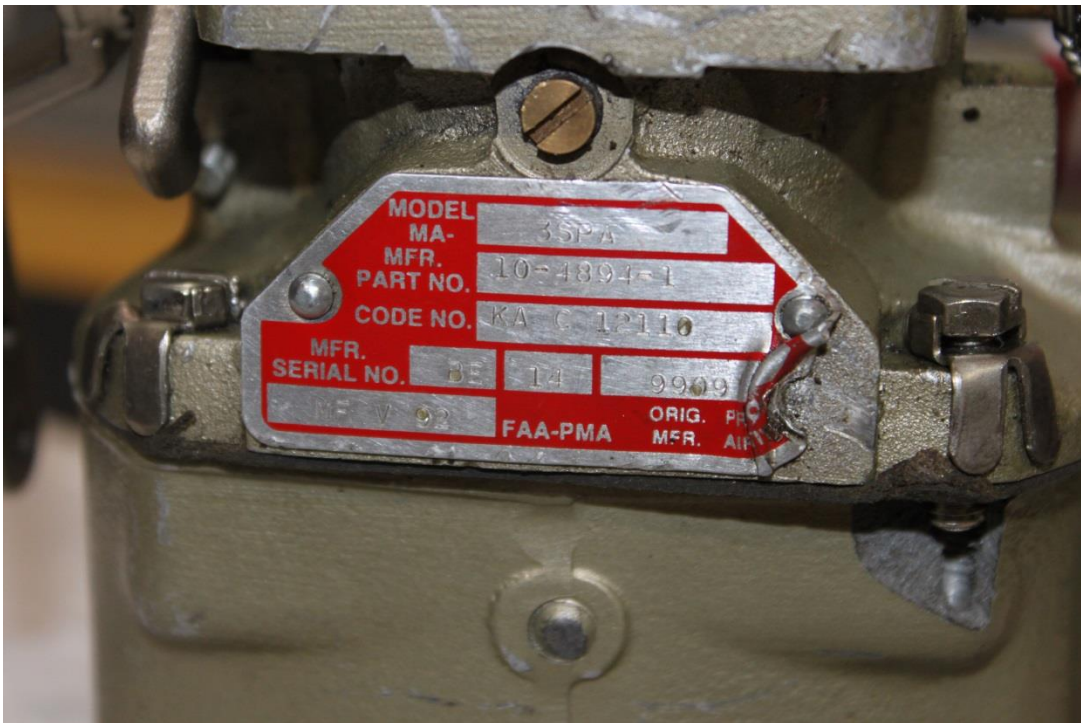
The carburetor was identified by its red colored data plate as model MA-3SPA, Manufacture Part Number 10-4894-1, Code Number KA C 12110, Manufacturer Serial Number BE 14 9909, marked with “MF”, “V”, and “92” ([Figure 2](#)). Visual external inspection revealed one body to bowl screw was broken from the bowl to the right of the data plate ([Figure 3](#)), and the Pump Discharge Check Valve Assembly was separated ([Figure 4](#)). The stop was broken off of the mixture control lever and an impact mark was noted on the boss of the throttle body adjacent to the “R” mark stamped in the carburetor bowl assembly ([Figure 5](#)). An impact mark was noted on the Pump Screen Housing ([Figure 6](#)). The carburetor bowl assembly was cracked on the back side of the bowl adjacent to the boss of the “L” and “R” marks stamped in the bowl assembly ([Figure 7](#)). Additionally, the throttle body assembly was not aligned with the carburetor bowl assembly ([Figure 8](#)). The mixture control valve and mixture control lever were bent, but the mixture control lever remained attached to the mixture control valve by the remaining section of mixture lever screw and mixture control shaft lock wire ([Figure 9](#)). The fuel inlet fitting was noted to have remains of anti-slippage material. The inlet strainer was removed and found to be clean ([Figure 10](#)).

Figure 2: Data Plate of Carburetor

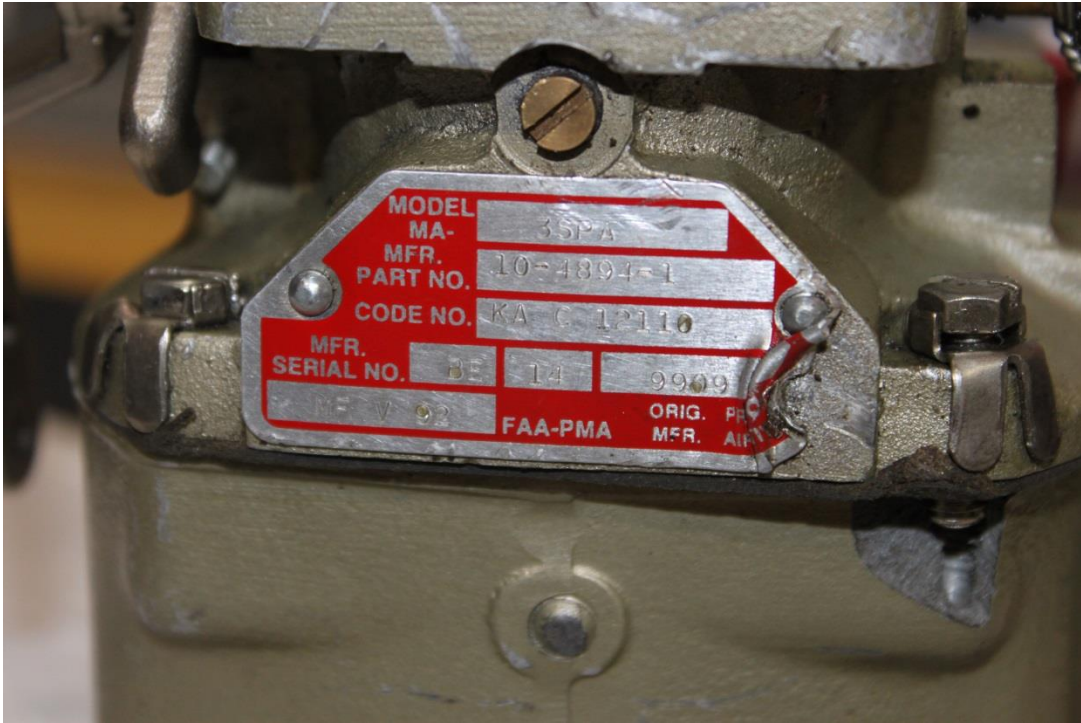
Figure 3: Data Plate and Bowl Damage Adjacent to Body to Bowl Screw

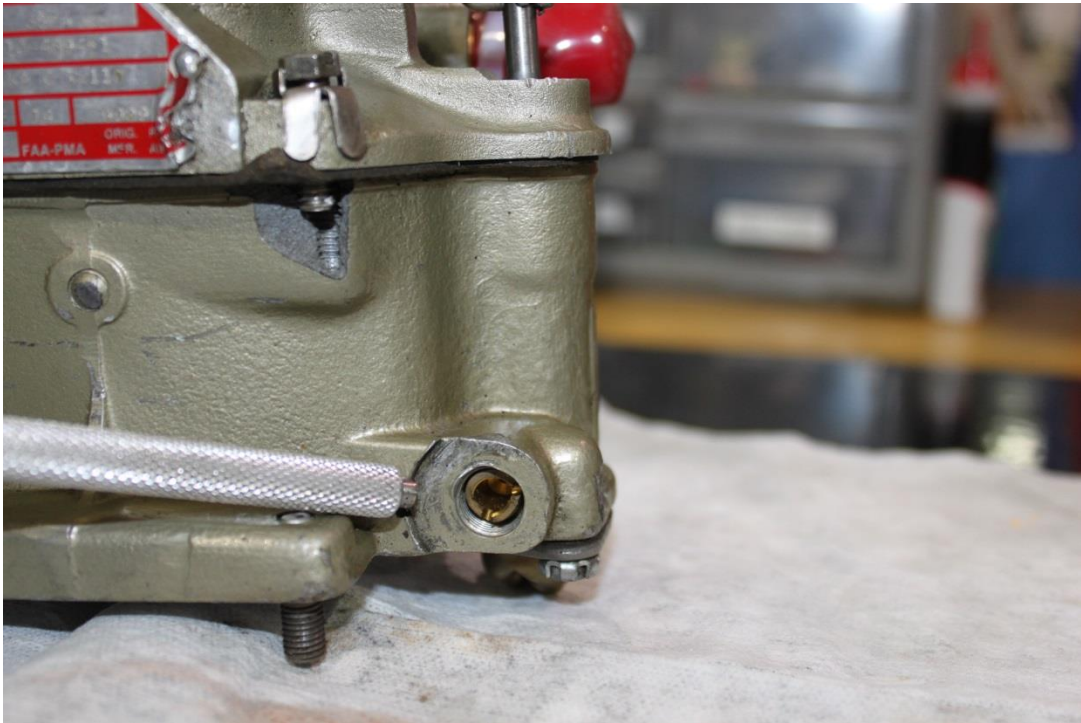
Figure 4: Missing Pump Discharge Check Valve Assembly

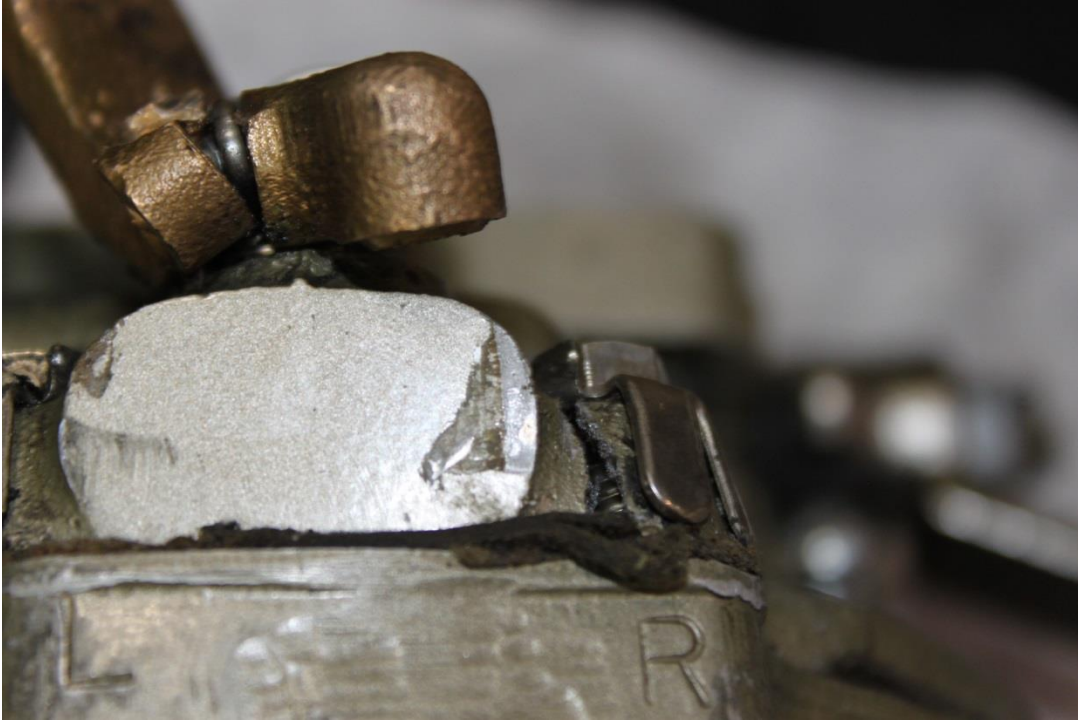
Figure 5: Impact Mark on Boss of Throttle Body Assembly Adjacent to “R” Mark

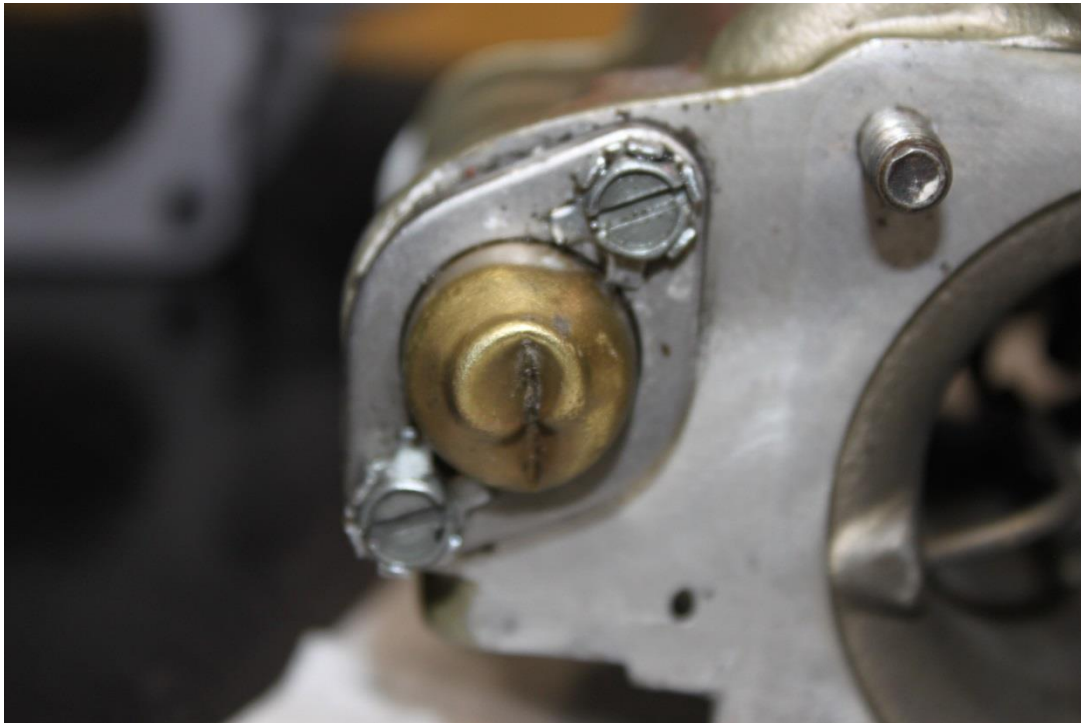
Figure 6: Impact Mark on Pump Screen Housing

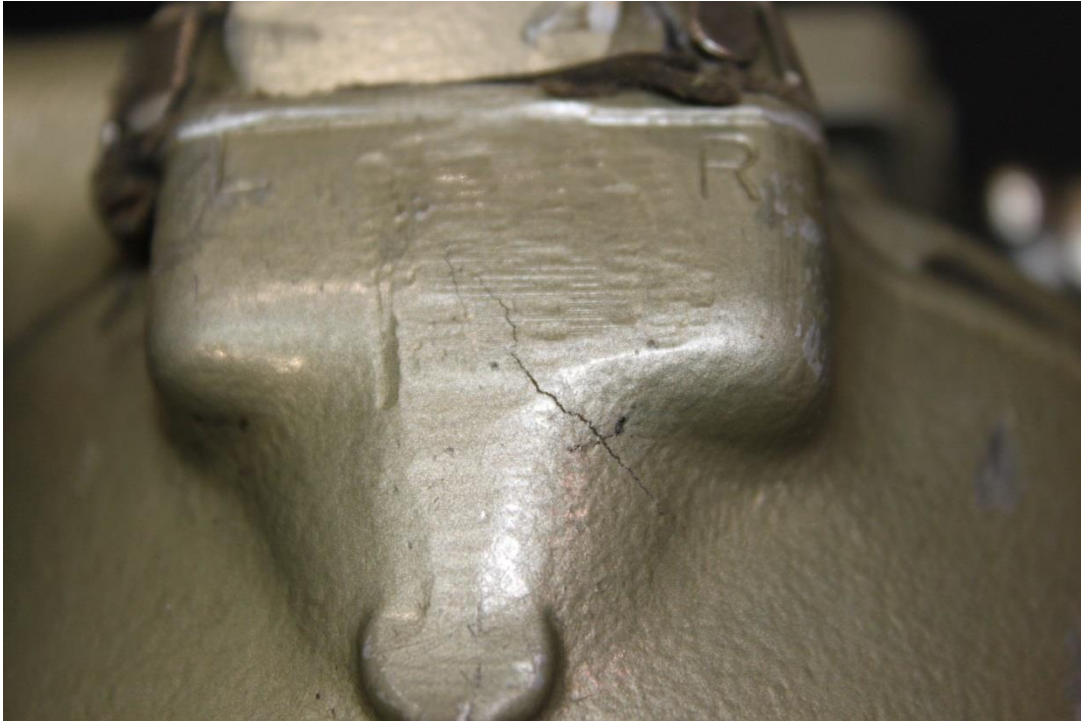
Figure 7: Crack in Carburetor Bowl Assembly

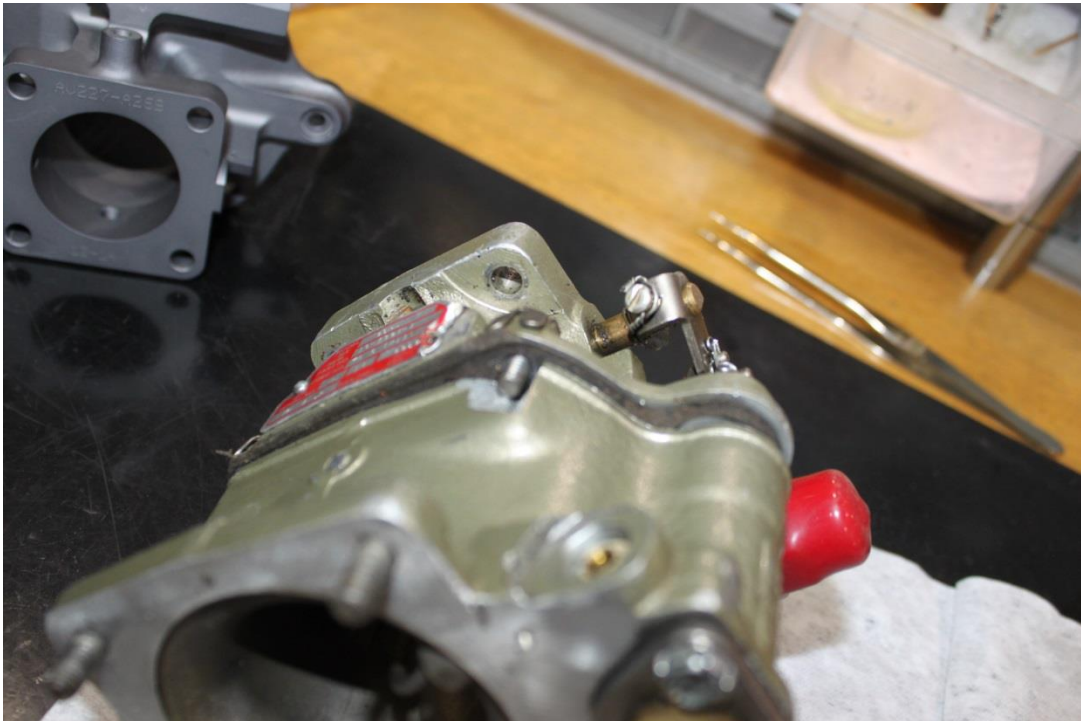
Figure 8: Misalignment of the Throttle Body and Carburetor Bowl Assemblies

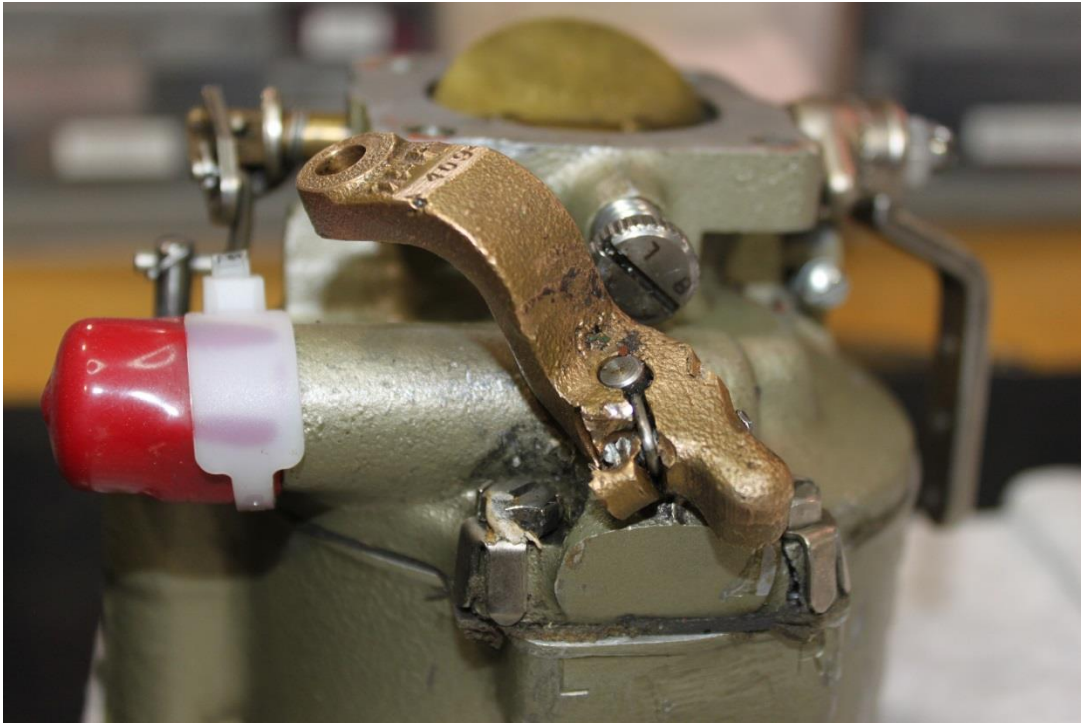
Figure 9: Bent Mixture Control Valve and Mixture Control Lever Assembly.

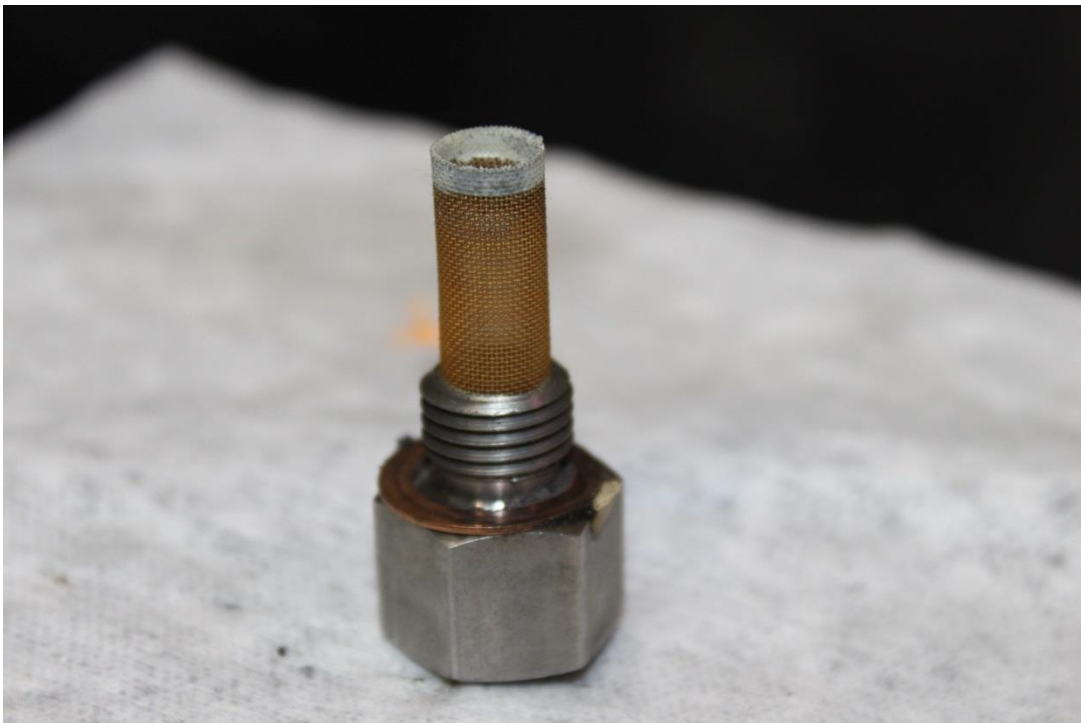
Figure 10: Fuel Inlet Strainer

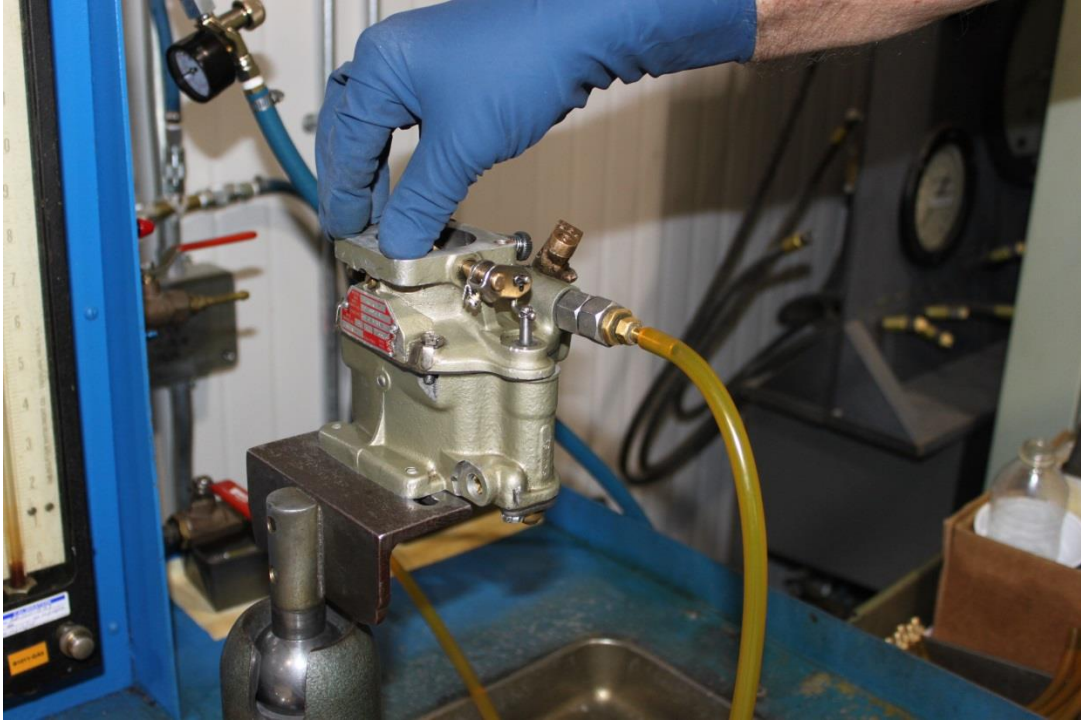
In preparation for bench testing, a different inlet fitting was installed. In addition, it was noted the float would not move with movement of the carburetor. The carburetor was placed on the test bench as received ([Figure 11](#)), and with 6 psi applied at the inlet, leakage was noted at the parting surfaces of the throttle body and bowl assemblies, and from the missing pump discharge check valve assembly ([Figure 12](#)). The carburetor was removed from the test bench for disassembly.

Figure 11: Carburetor Before Bench Testing

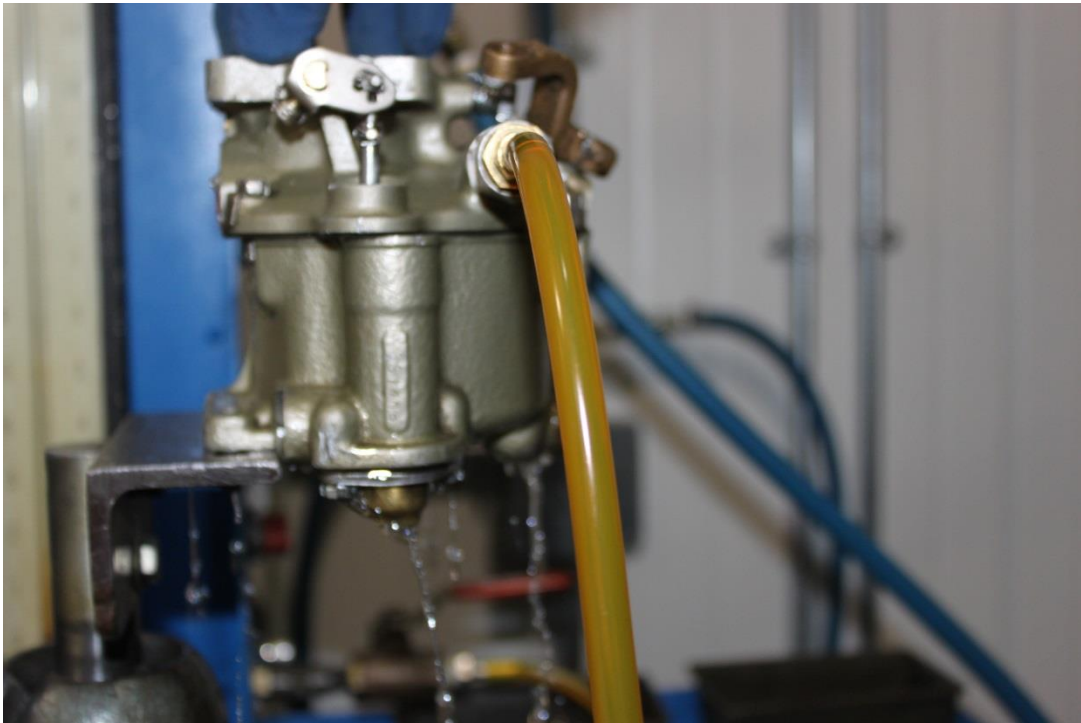
Figure 12: Leakage During Bench Testing

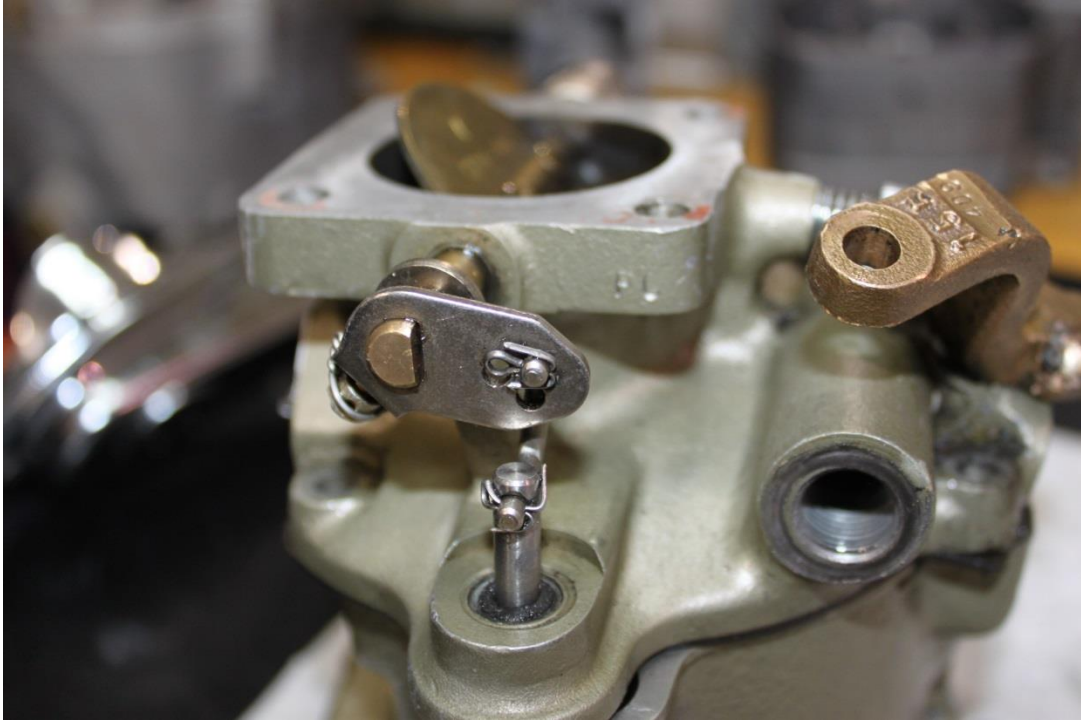
The throttle valve did not move freely, but the pump plunger remained connected to the throttle shaft ([Figure 13](#)). After separation of the pump plunger from the throttle shaft, the throttle valve was noted to move freely. Inspection of the body to bowl screws was performed which revealed all 4 had 4 of the tabs of the body to bowl screw washer against a flat of the body to bowl screw. A tightening torque check was performed on 2 of the 4 body to bowl screws; the 3rd body to bowl screw to the right of the data plate exhibited missing screw boss, and the 4th body to bowl screw adjacent to the “L” was noted to be sheared at the parting surface of the carburetor bowl assembly. The remaining 2 body to bowl screws were found to move 30 inch pounds less than the minimum value specified. The carburetor bowl and throttle body assemblies were separated, and the outboard sides of both pontoons of the float were noted to be crushed in ([Figure 14](#)). The interior of the carburetor bowl assembly was clean, and the distance between the bowl gasket and the tip of each float pontoon was within limits. Further inspection of the carburetor bowl interior and the bottom of each pontoon of the float revealed no evidence of contact by either pontoon or the stud bosses. Additionally, there was no evidence of contact with the either pontoon and the sides of the carburetor bowl. The pump plunger was noted to be bent ([Figure 15](#)).

Figure 13: Pump Plunger Connected to Throttle Shaft

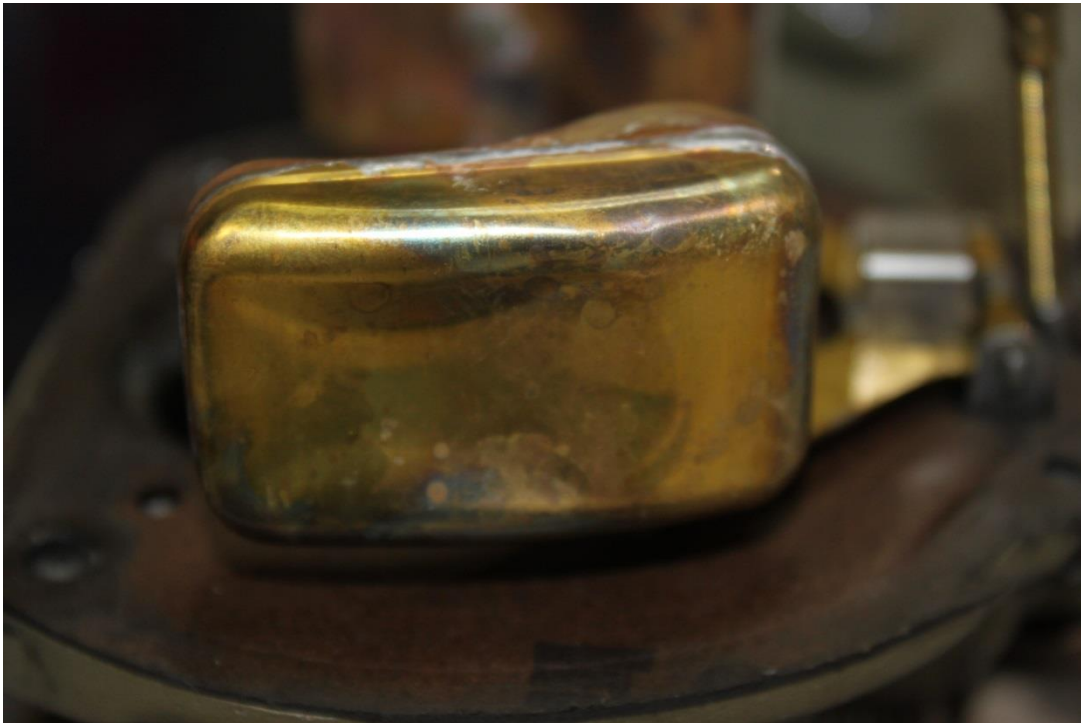
Figure 14: Inward Crush Damage to One of the Pontoons of the Float

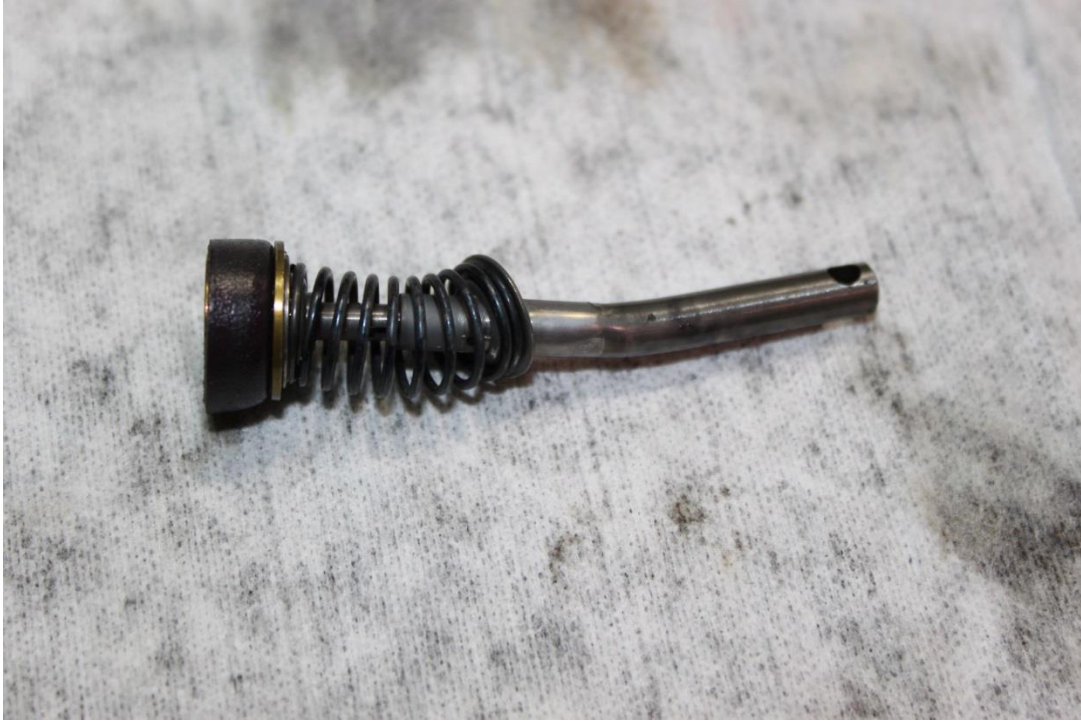
Figure 15: Bent Pump Plunger

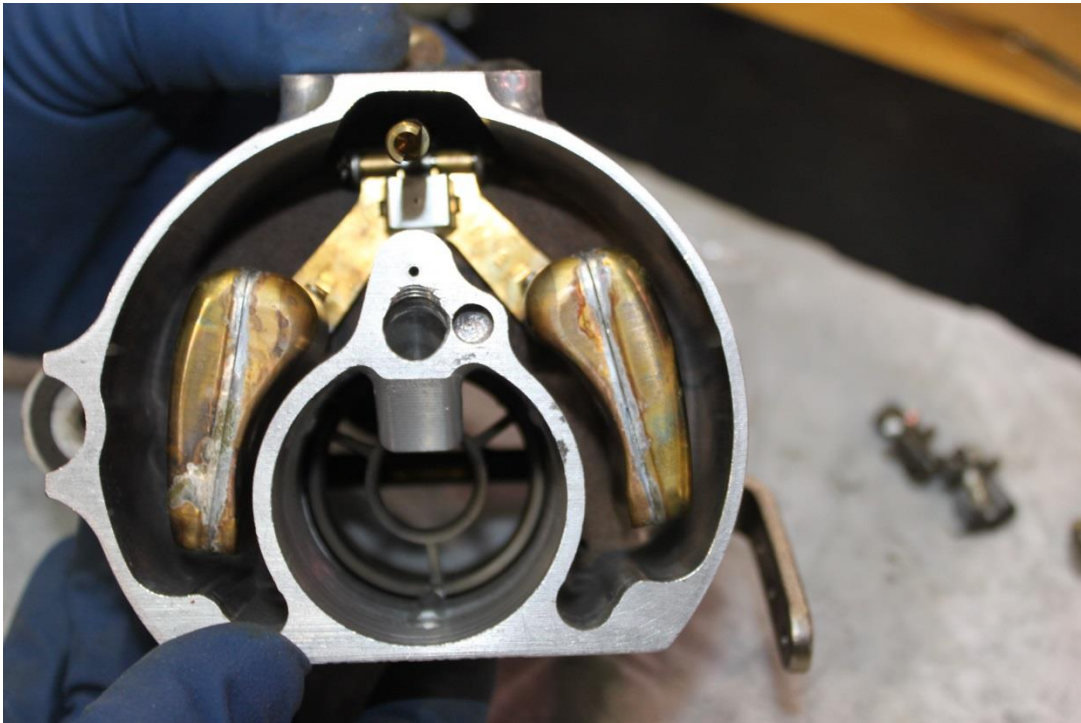
Further inspection of the float revealed that the pontoon of the throttle side was shifted away from the inner wall of the carburetor bowl assembly ([Figure 16](#)). Inspection of the wear dimple at the float revealed it was within limits. The float which weighed 0.8 ounce, was subjected to a hot submergence test and no bubbles were noted coming from either pontoon. The float was weighed after the submergence test and again weighed 0.8 ounce. Normal wear of the seat material of the needle valve was noted ([Figure 17](#)). Inspection of the seat of the needle valve and seat and interior portion of the carburetor bowl assembly adjacent to the seat revealed slight impact damage to both components ([Figures 18 and 19](#)). A tightening torque check was performed of the seat, and it was noted to move at 70 inch pounds less than the minimum specified value. No fuel stains were noted on the carburetor bowl, and the aluminum float valve seat gasket exhibited equal crushing along its circumference ([Figure 20](#)). The main nozzle was noted to be impact damaged ([Figure 21](#)), and 2 of the 6 tabs of the nozzle tab gasket were not touching the flats of the main nozzle. A tightening torque check was done of the main nozzle and it was noted to move at 5 inch pounds less than the minimum specified value. Following removal of the main nozzle, the nozzle tab gasket was inspected and found to exhibit equal crushing along its circumference ([Figure 22](#)). A one-piece venturi was installed. The main nozzle was air checked ([Figure 23](#)) and found to be within limits.

Figure 16: Displaced Pontoon of Float with Cutaway Test Carburetor Bowl Installed

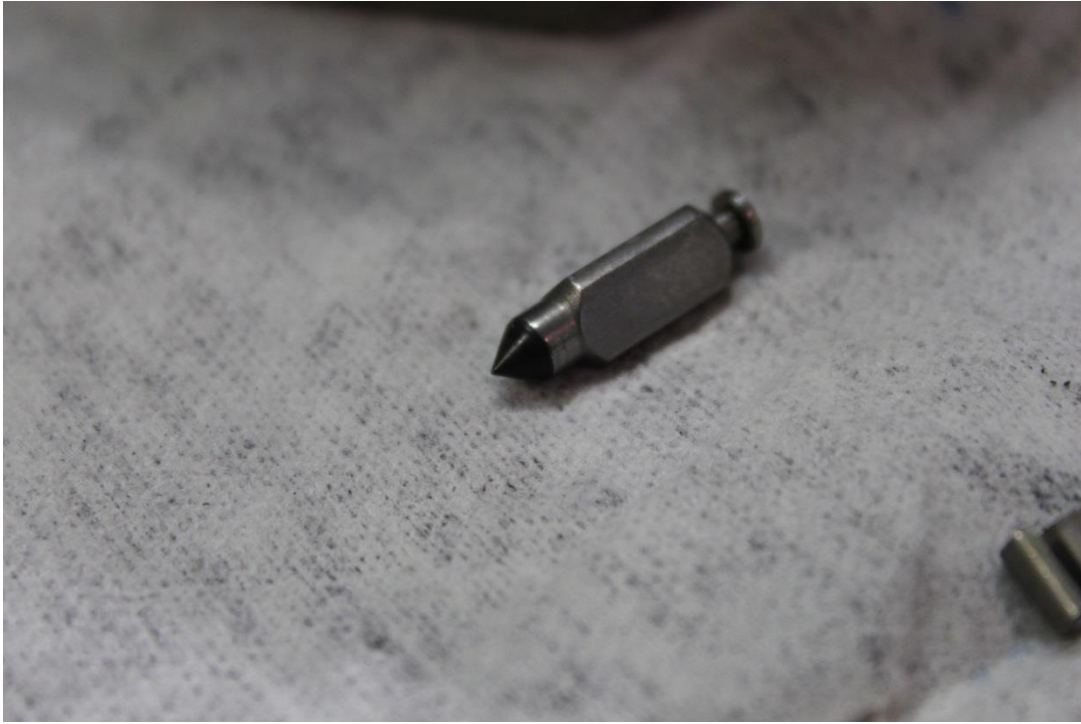
Figure 17: Needle Valve

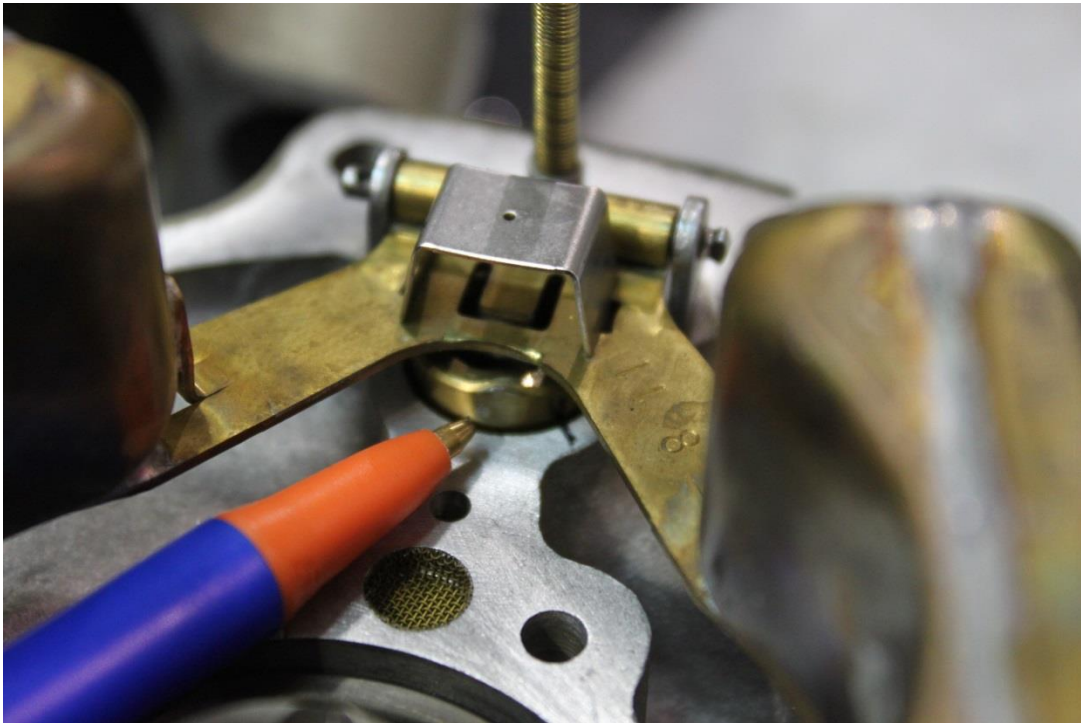
Figure 18: Impact damage to Seat of Needle Valve and Seat

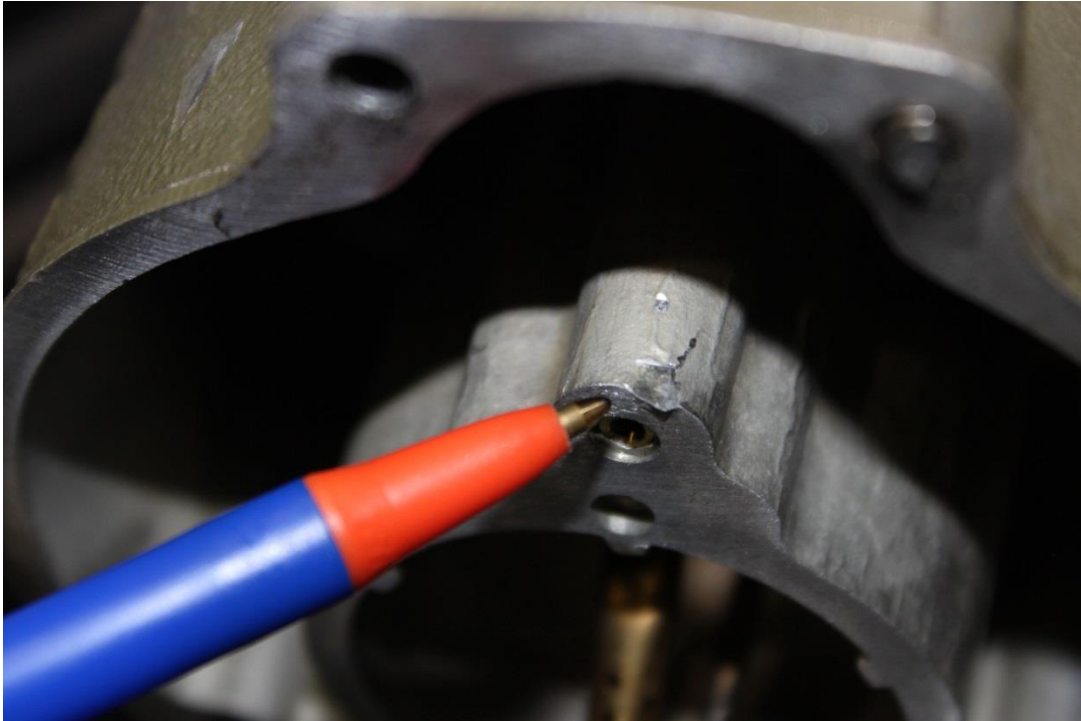
Figure 19: Impact damage to Interior of Carburetor Bowl Assembly

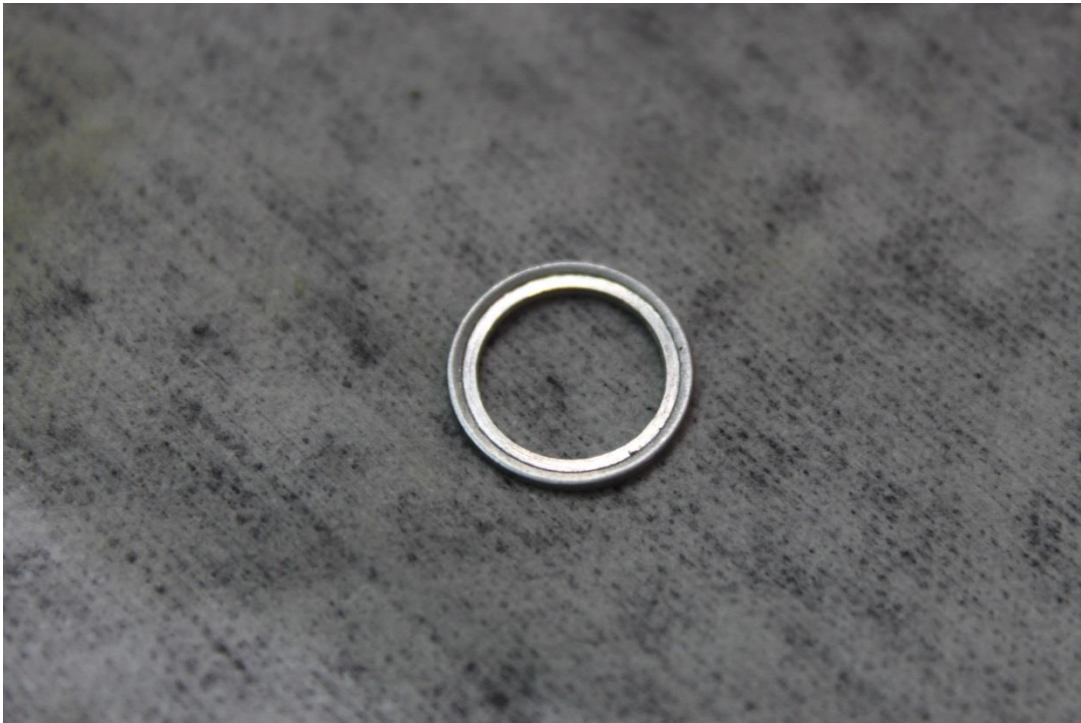
Figure 20: Float Valve Seat Gasket

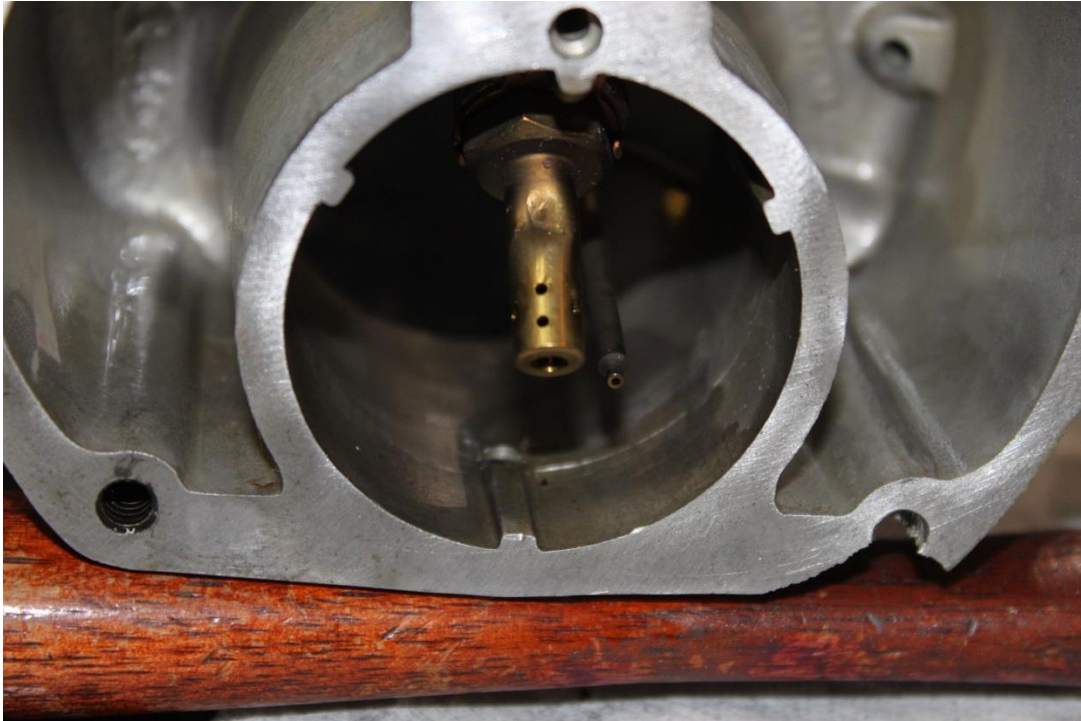
Figure 21: Impact damaged Main Nozzle

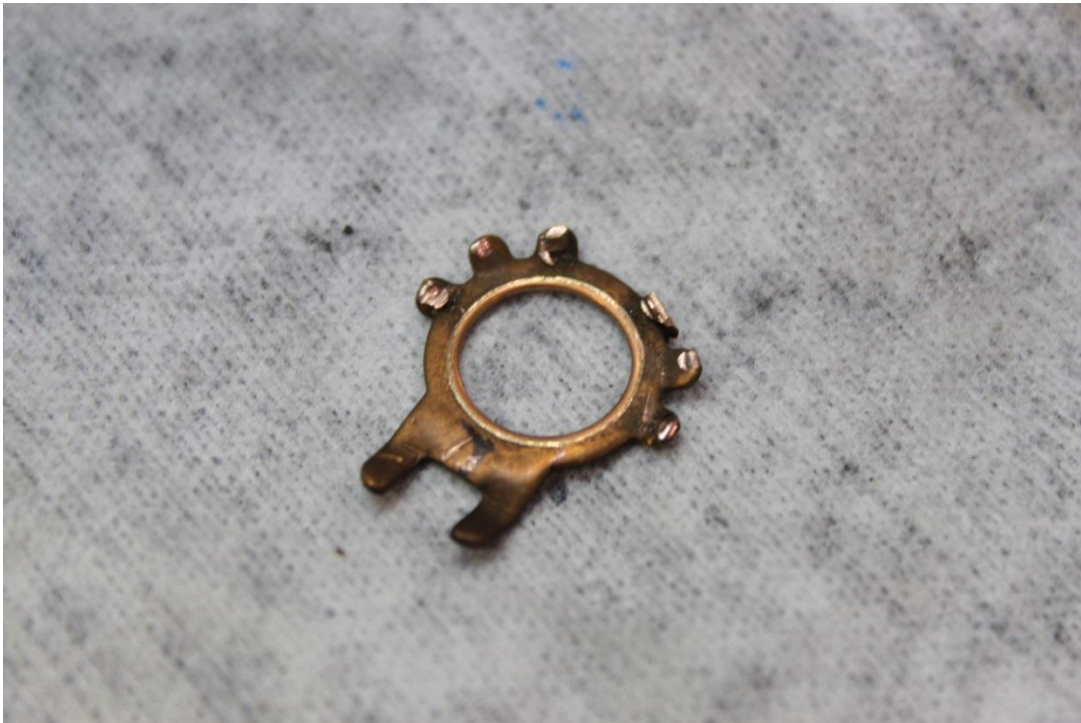
Figure 22: Nozzle Tab Gasket

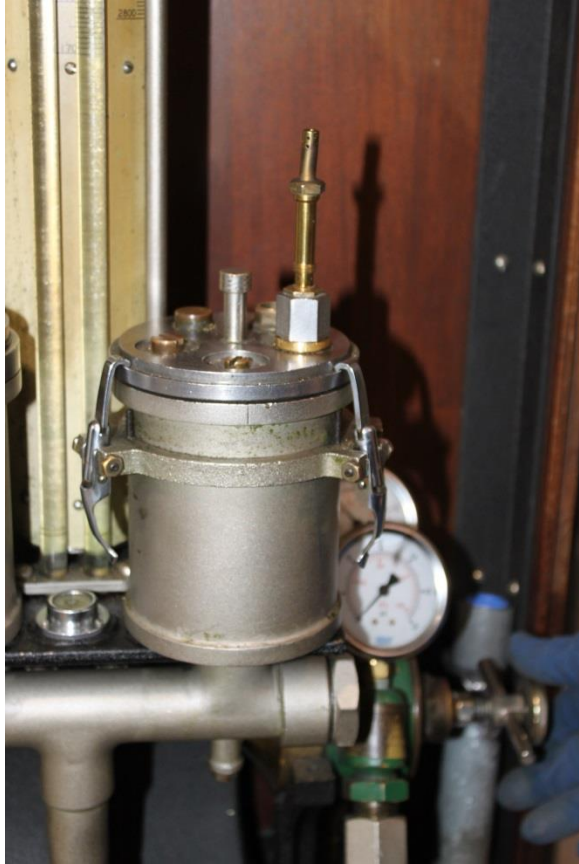
Figure 23: Air Check of the Main Nozzle
