Service Bulletin Fuel Systems

Bulletin No.: MSA-3
Revision No.: 1
Date: 11/16/90
Revised: 11/18/91

SUBJECT: OVERHAUL PERIODS FOR FLOAT CARBURETORS.

SUBJECT: BOWL CLEARANCE MA- SERIES CARBURETORS

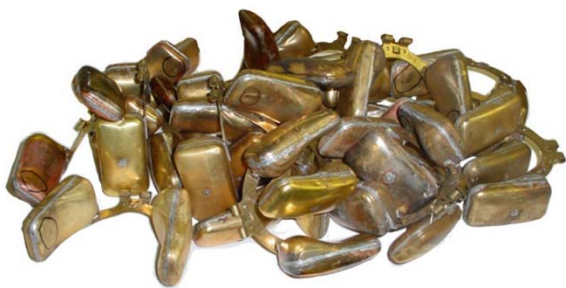
Fig. 1

1. **Reasons:** **Warning:** **Failure to follow this advice may result in engine malfunction, damage, injury or death.** Reports of sticking, leaking and/or worn floats have been received, see Figure 1. The specified float/bowl clearance **MUST** exist to ensure proper operation.

Floats with Rubbing Wear – FEB 2009

With the clearance tool M-510 used with the (MA-3, MA-4 series) or M-509 used with the (MA-5, MA-6, MA-4-5 Series) in place, orient the carburetor body with one pontoon uppermost, see Figure 2. Check the clearance between the float pontoon and the bowl wall. A .081 inch gage pin (models MA-2, MA-3 & MA-4), or a .051 gage pin (models MA-4-5, MA-4-5AA, MA-5, MA-5AA, MA-6 and MA-6AA) must pass between the lower surface of the upper pontoon and the throttle bore wall and between the lower surface of the lower pontoon and the lower bowl wall without touching either pontoon. Reorient the carburetor so that the other pontoon is uppermost, see Figure 3. Repeat the clearance check. If, as the gage pin is moved along between the float and the bowl wall the gage pin contacts either pontoon, float clearance is inadequate and the float assembly must be replaced.

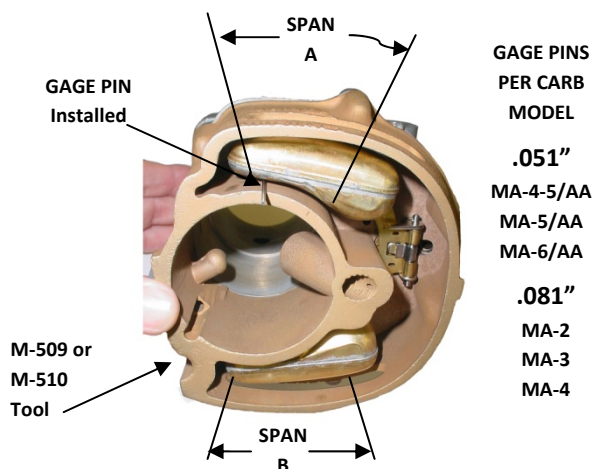
Fig. 3

Carb Orientation 2, Check Spans A & B

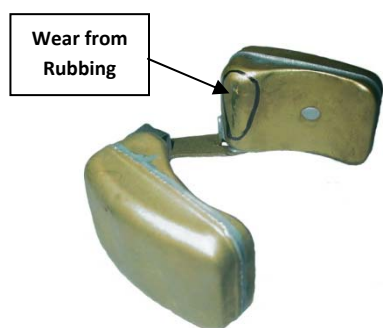
Fig. 5

Example: Wear from Rubbing on Small MA Float

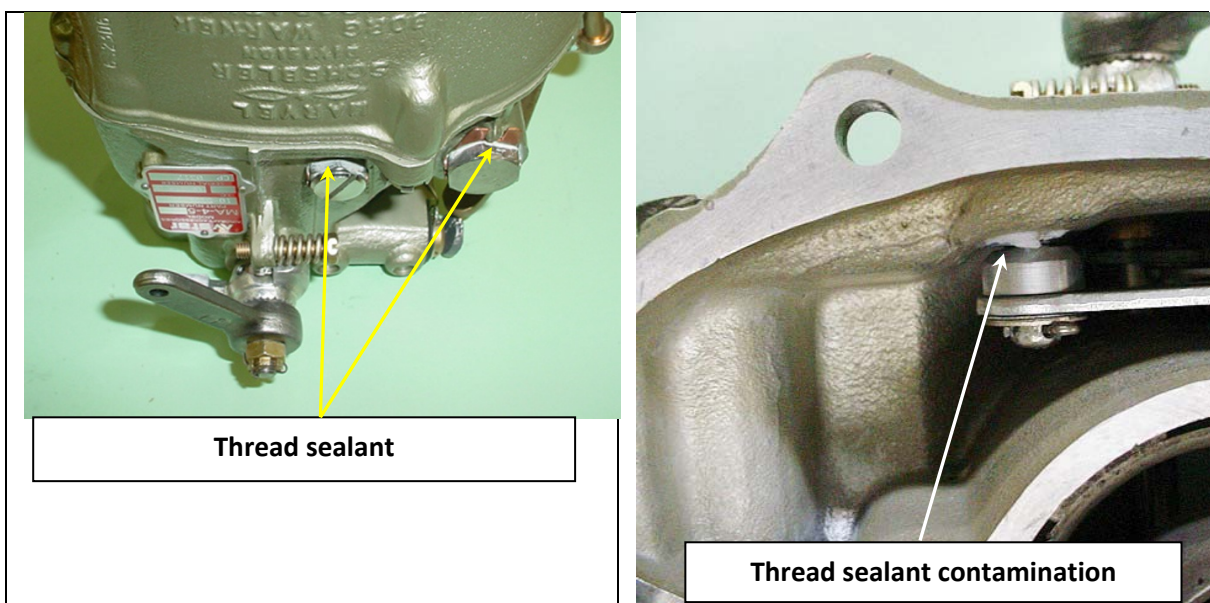
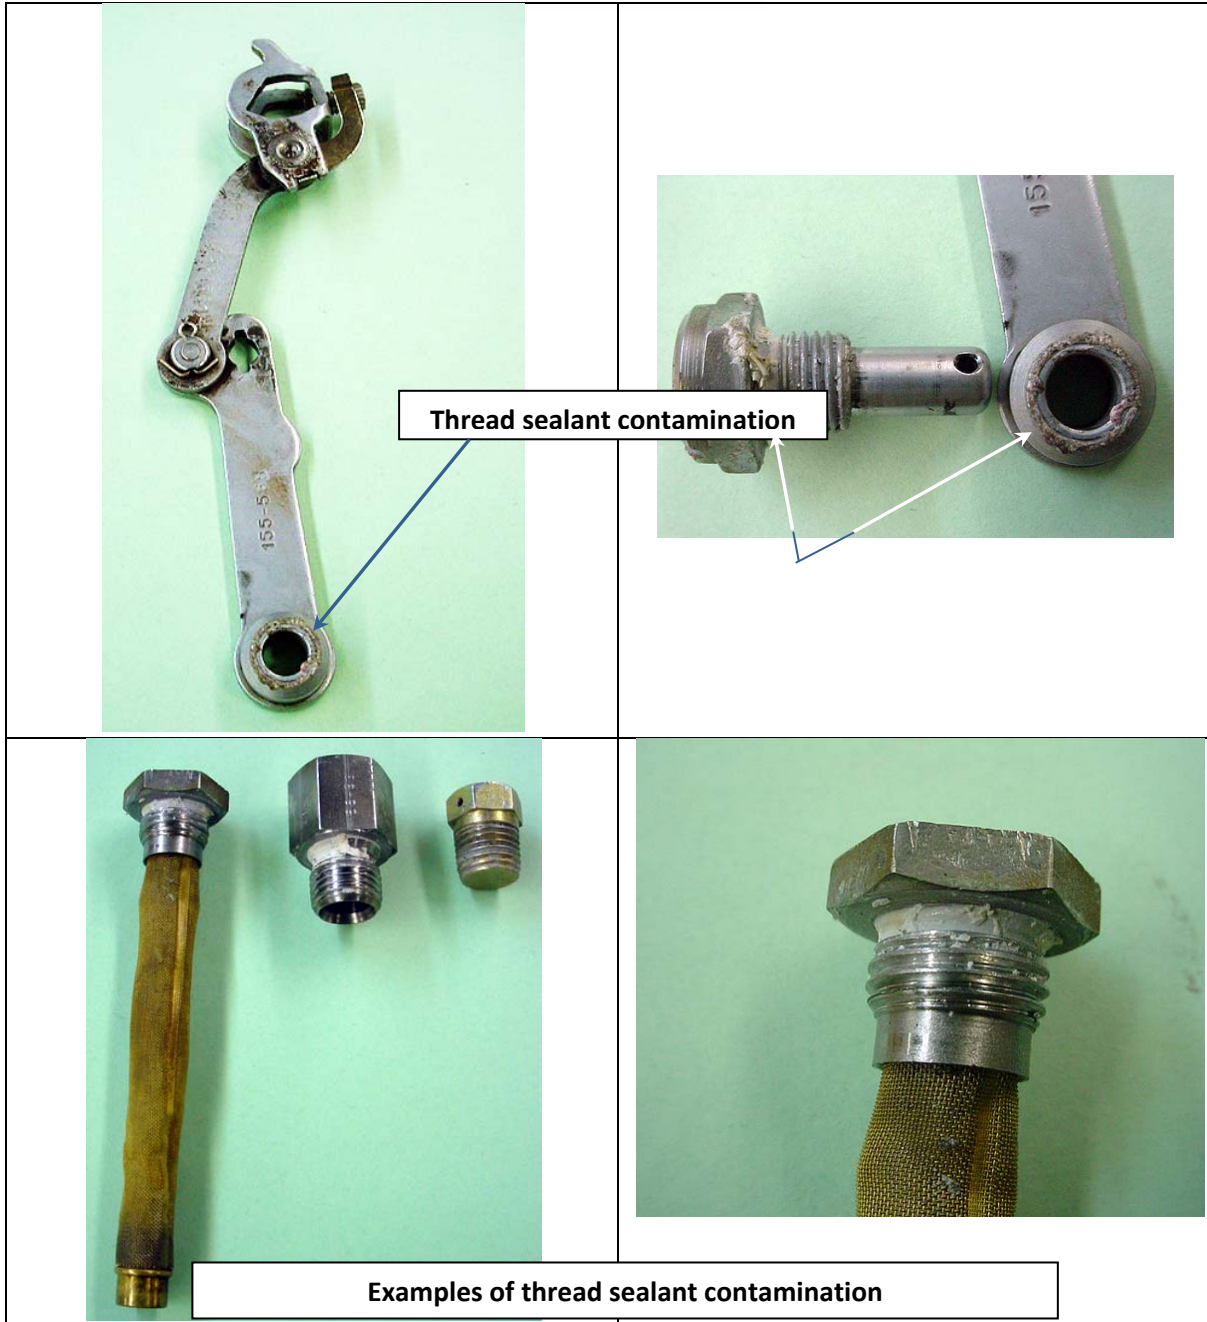
3. **Background:** During tear-down and inspection of Marvel-Schebler® Float Carburetors at the factory service center, Marvel-Schebler® has found thread sealant inside fuel passages. Marvel-Schebler’s examination of carburetors identified with AVstar data tags reveals extensive use of thread sealant on various fittings and the presence of thread sealant inside carburetor fuel passages. Other facilities may also be following the similar unauthorized practice.

Thread sealant can break away inside a carburetor, clog fuel passages, and result in partial or complete loss of engine power. A previous Marvel-Schebler Service Bulletin, A1-69 and Airworthiness Directive 69-24-03, dealt with a similar issue wherein thread lubricant was discovered in carburetors.

- a. Immediately inspect such carburetors for evidence of thread sealant around, but not limited to, various fittings particularly the inlet fittings, bowl drain plugs and, on MA-4-5™, MA-5™, and MA-6™ series carburetors, the accelerator pump pivot screw. Thread sealant can often be seen as a whitish appearing hard or semi-hard paste extruding from under a fitting (see photos) but removal of the fittings may be required to conclusively exclude the presence of unauthorized sealant.

- b. If thread sealant is present, immediately remove the carburetor from service, disassemble it, remove the thread sealant, and inspect all passageways, jets, mechanisms, screens, etc., for contamination by the sealant. Using the appropriate Marvel-Schebler® service manual and all applicable Service Bulletins for the carburetor model being repaired, confirm that all techniques and materials for repairs to be accomplished are Marvel-Schebler® approved. Clean, inspect, and reassemble the carburetor in accordance with the appropriate Marvel-Schebler® service manual. Marvel-Schebler® Service Bulletins can be accessed at Tempestplus.com.
