Carson Helicopters Flight Evaluation with S61N Helicopter

RE: Weaverville Helicopter Accident N612AZ; Summary of 3 November 2009 Flight Test

Sikorsky S-61N C-FHHD

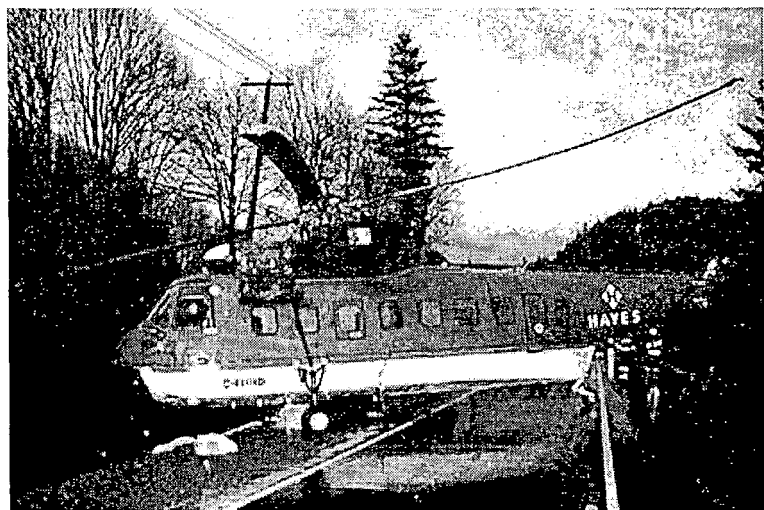
Photo 1. C-FHHD on Highway 7 after the accident

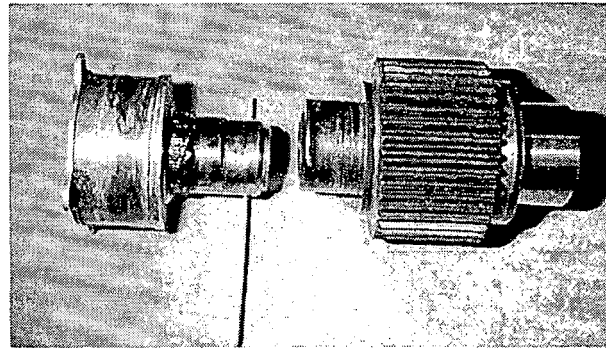
The MGB attachment fittings on the fuselage were intact. The MGB was undamaged, with the exception of the Number 1 (left)¹ input pinion gear (Photo 2) which had fractured just forward of the forward bearing journal, and its associated forward plain bearing (located in the MGB cover) which had mostly disintegrated. The splined coupling showed severe rub on the gimbal ring.

Photo 2. Fractured left input pinion

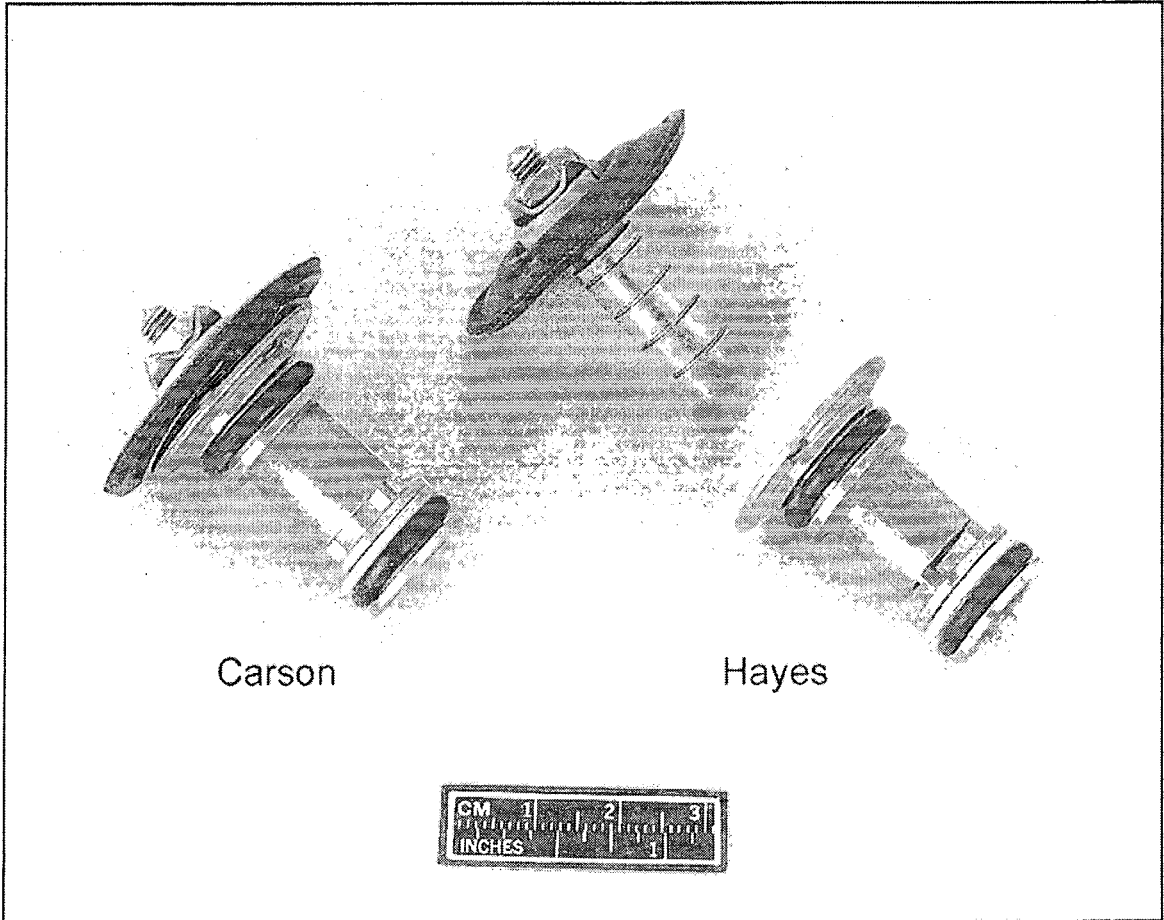
Figure 1

Discussion. The above examinations have shown that both JFC26 Pressure Regulating Valves exhibited abrasive wear patterns, and contained contamination comprised mainly of (1) hard, angular oxides of aluminum and silicon and (2) silica (glass) fibers. The presence of such contamination indicates a source(s) foreign to the control as the design of the JFC26 components does not include these materials. Entrapment of this debris in the diametral clearance of the valve is the likely cause of the sticking and/or jamming of the spool within its sleeve. Simultaneous small-amplitude (resonance) axial motion of the spool relative to the sleeve when the valve was in the open position likely produced the observed axial scoring/abrasion that mirrored the spool configuration. The examinations revealed no evidence that the malfunction of either valve was related to a metallurgical defect or improper heat treatment.

Overview of the two submitted JFC26 Pressure Regulating Valves.

It is recommended that the system filtration be reviewed to ensure that adequate measures are in place to minimize the size of contaminants that can be carried to the tight clearances within the control. The cleanliness of the fuel supply itself should also be investigated, as should the source of the relative abundance of unusual silica (glass) fibers observed on both PRV spools.

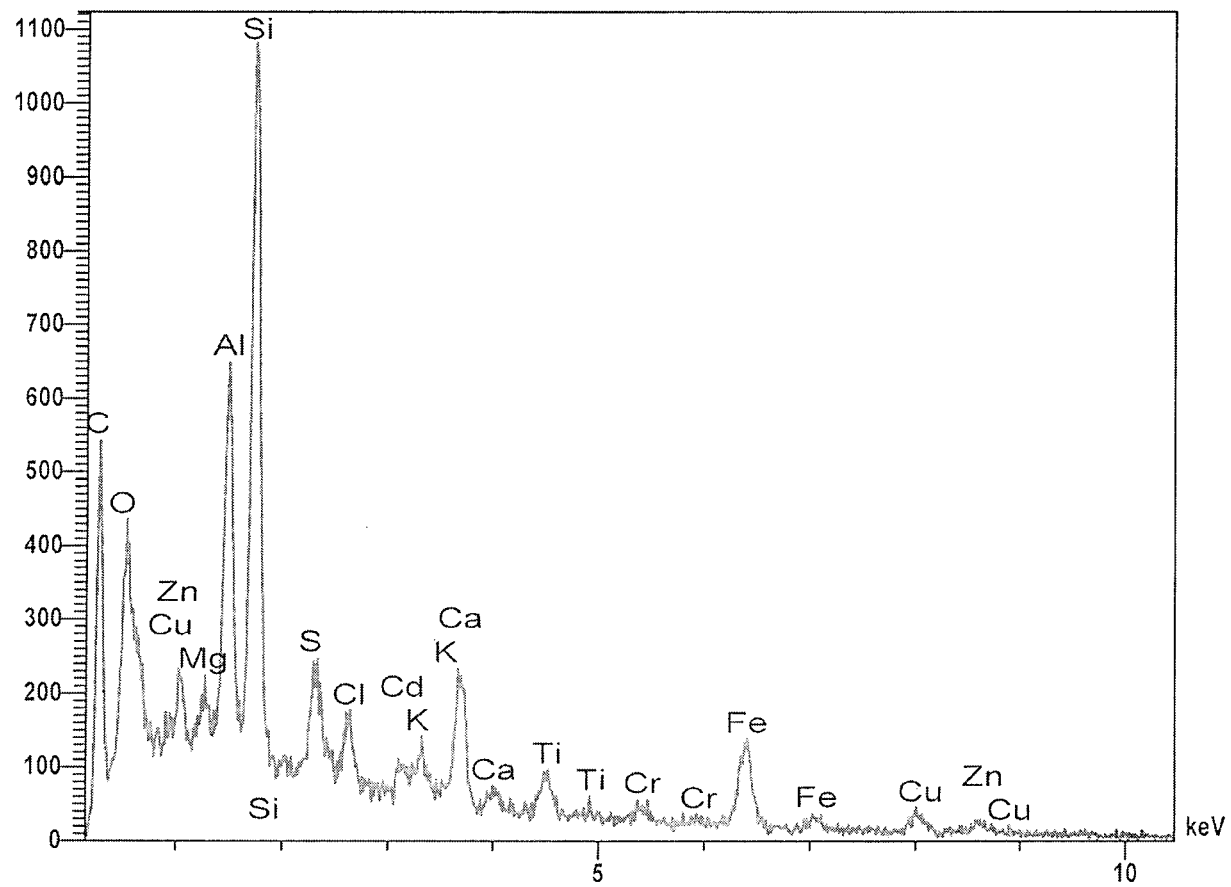
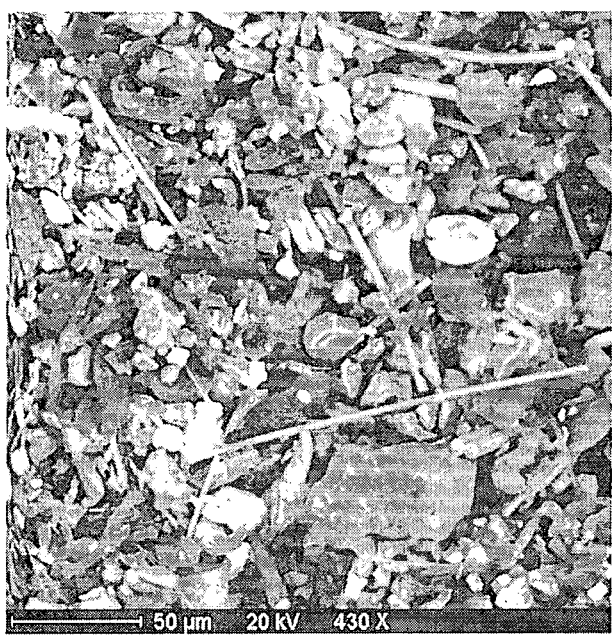
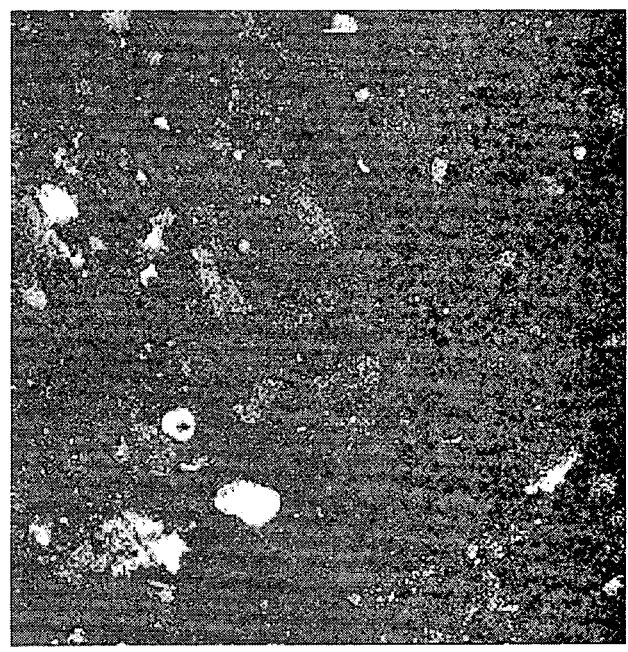
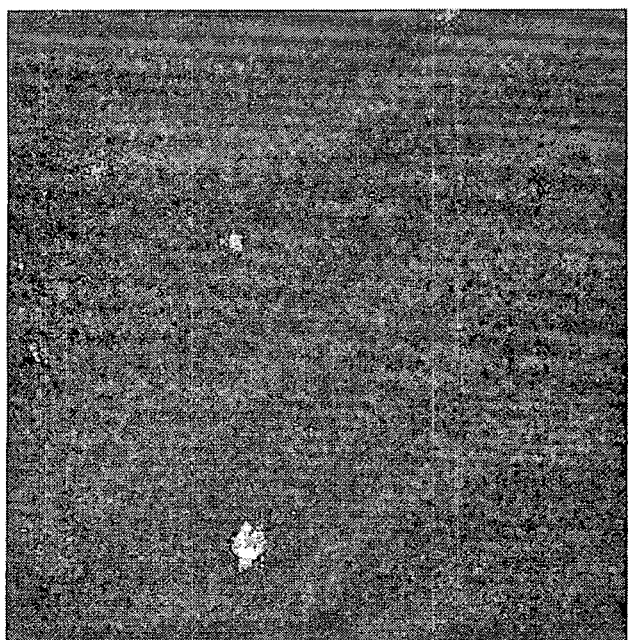
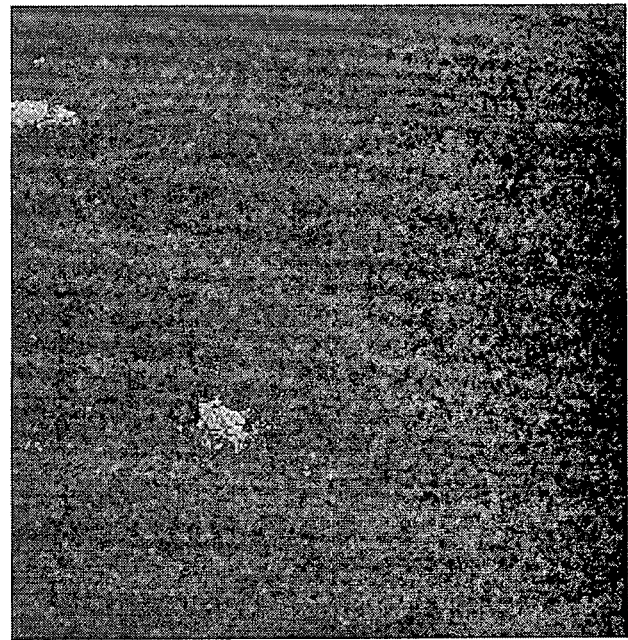
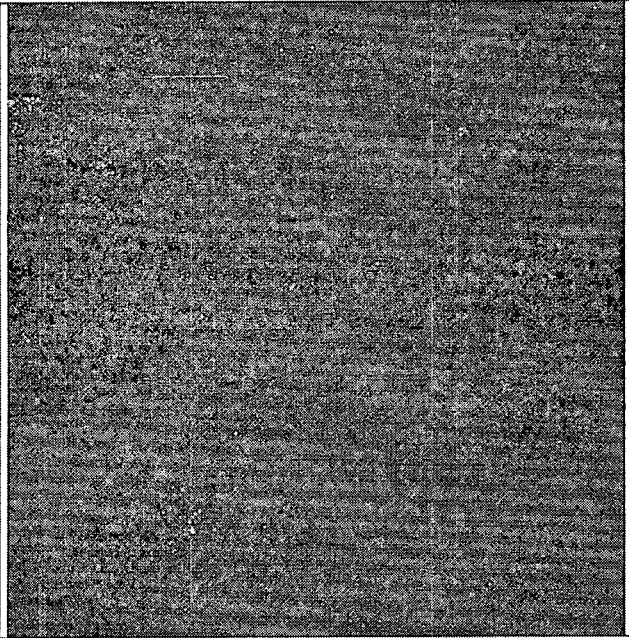
Figure 3
EDS spectrum obtained for contamination collected from the Hayes PRV spool.

Back-scattered electron image of debris and associated elemental distribution maps.

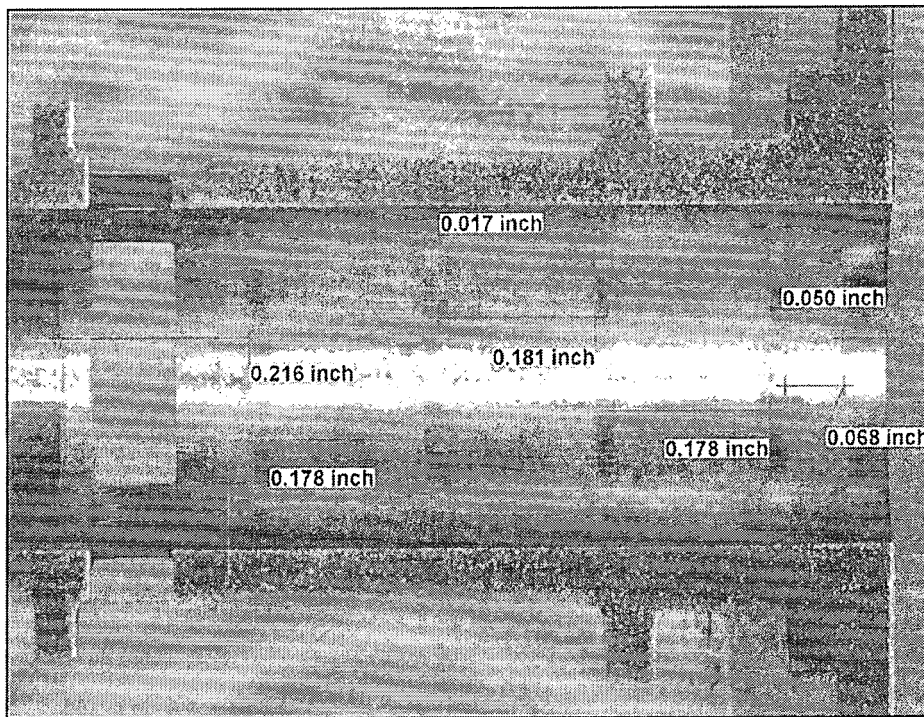
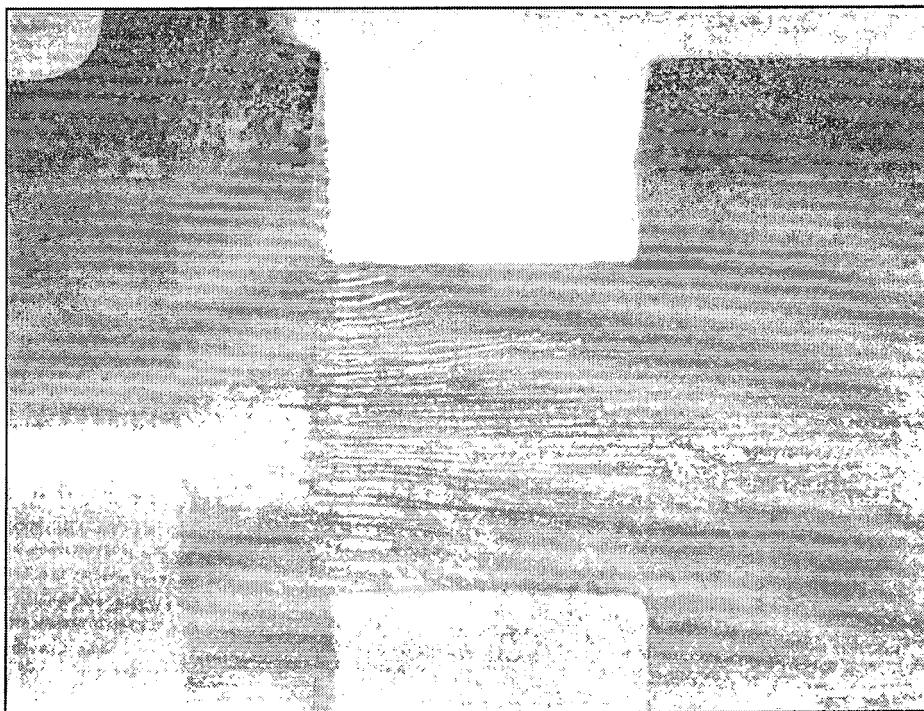
Figure 4

Upper image: Wear pattern on the inner diameter surface of the Hayes PRV sleeve. With the exception of the left band, the width of the wear rings corresponded to that of the spool lands (the wider band on the left is attributed to abrasive wear at the spool end interface as the valve opened and closed). *Lower image:* Erosive wear on one of the window "ligments".

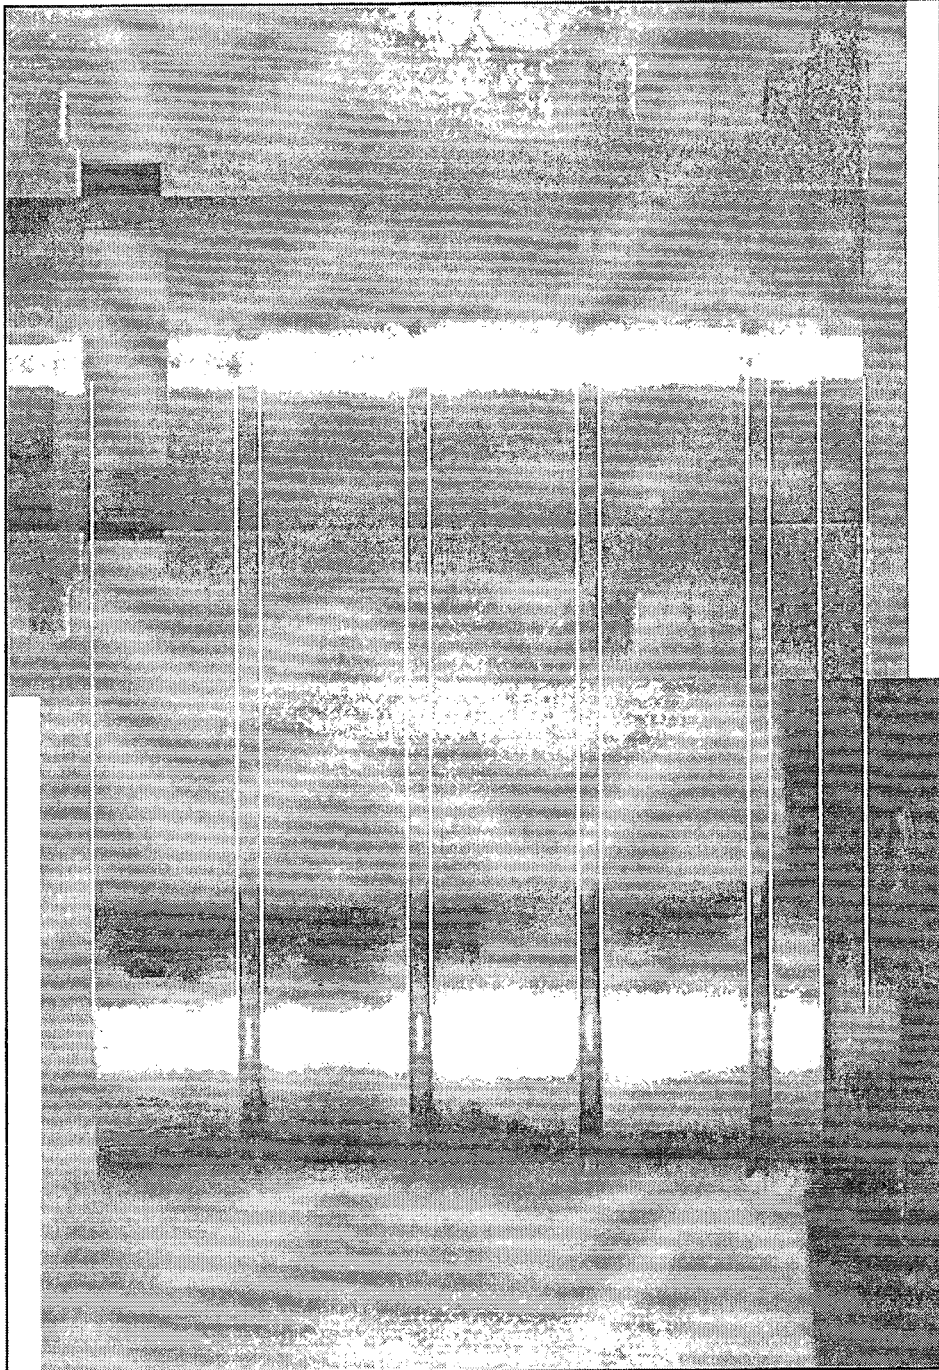
Figure 5

Aligning of the wear pattern on the sleeve inner diameter to the spool lands for the Hayes PRV showing that the wear on the sleeve was produced when the valve was in the open position (reference - rightmost line is inboard of spool seating surface).

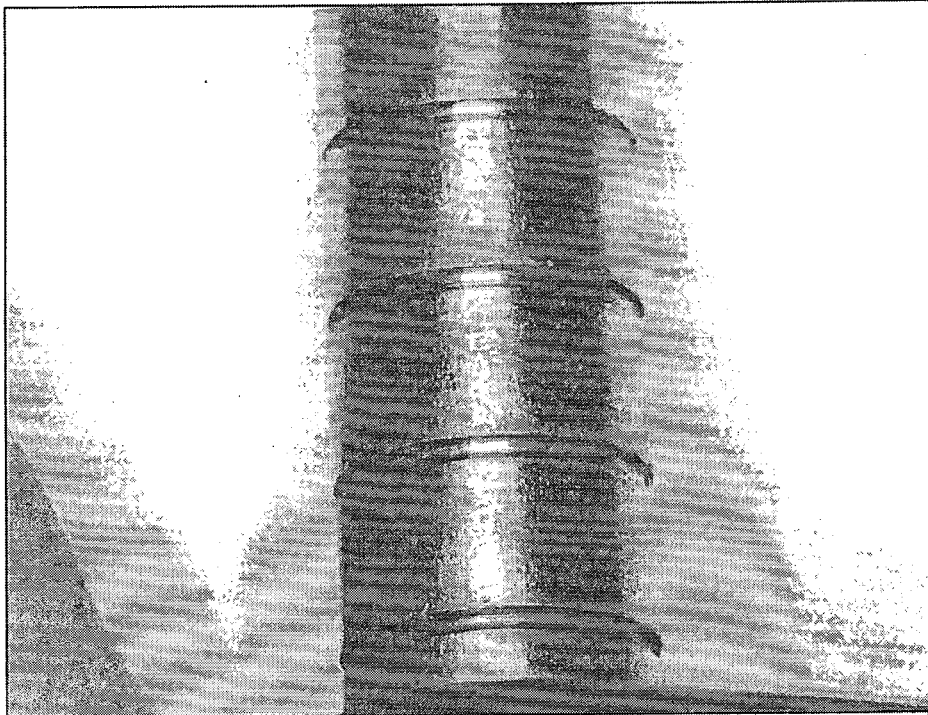
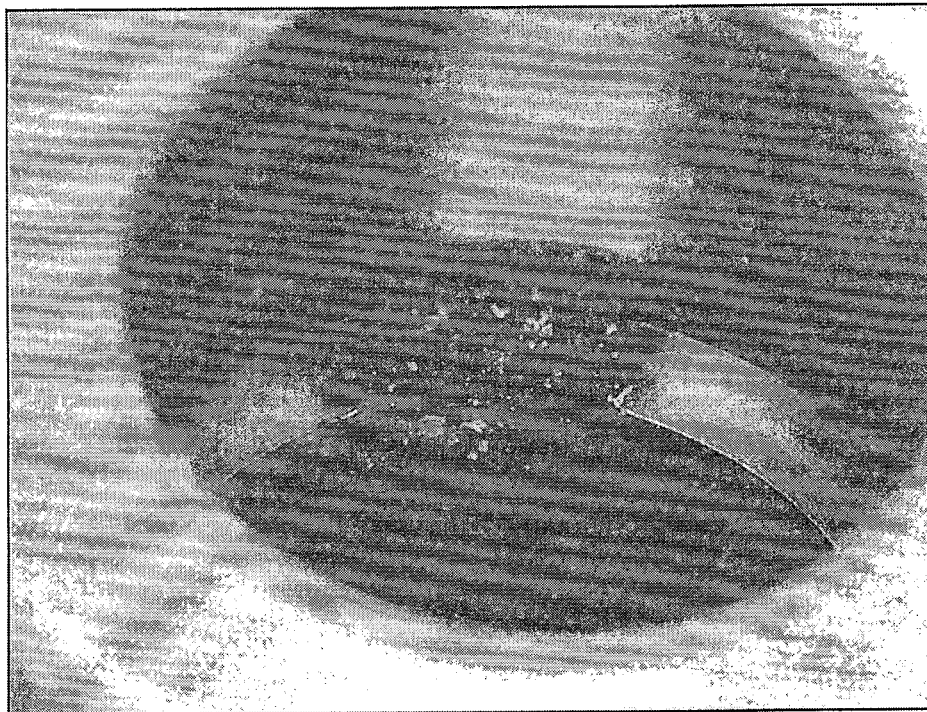
Silt-like debris on the mating diameters of the Carson PRV.

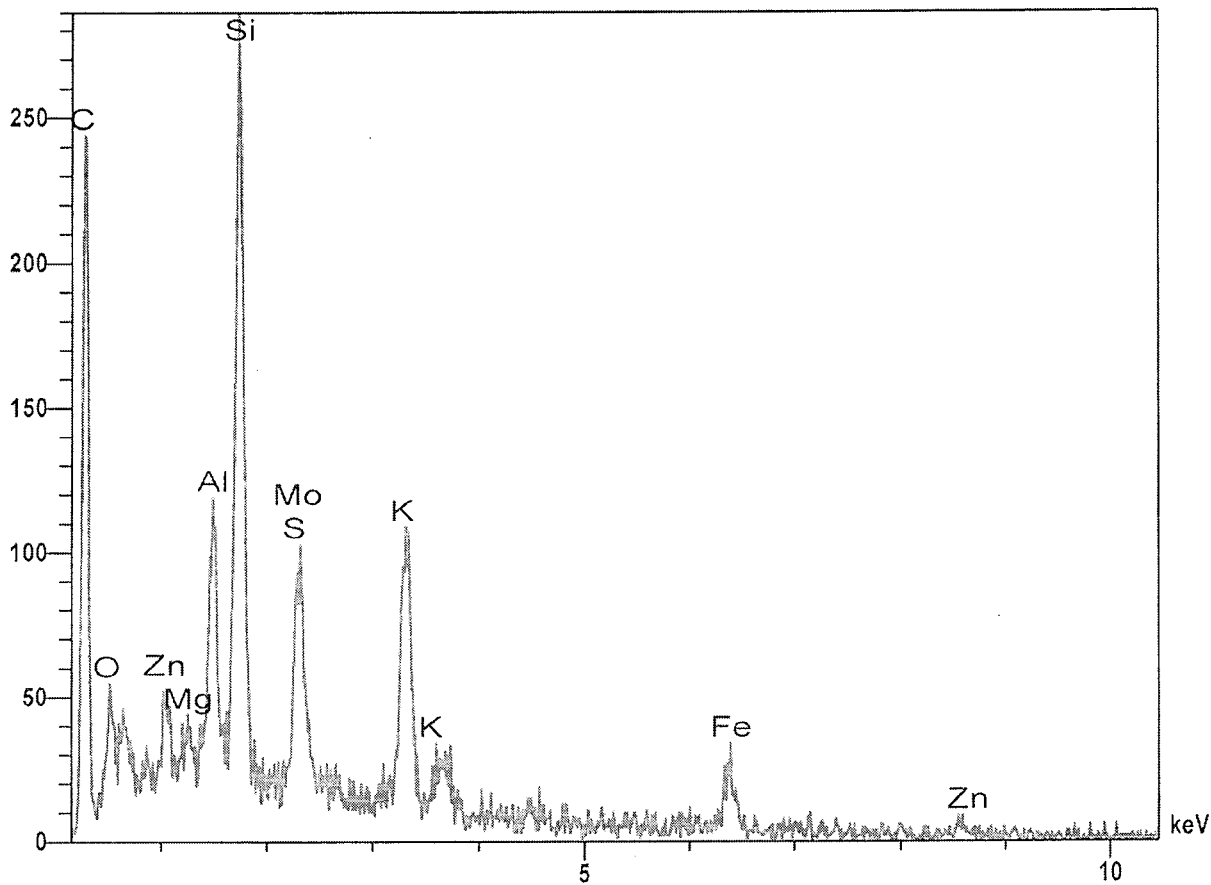
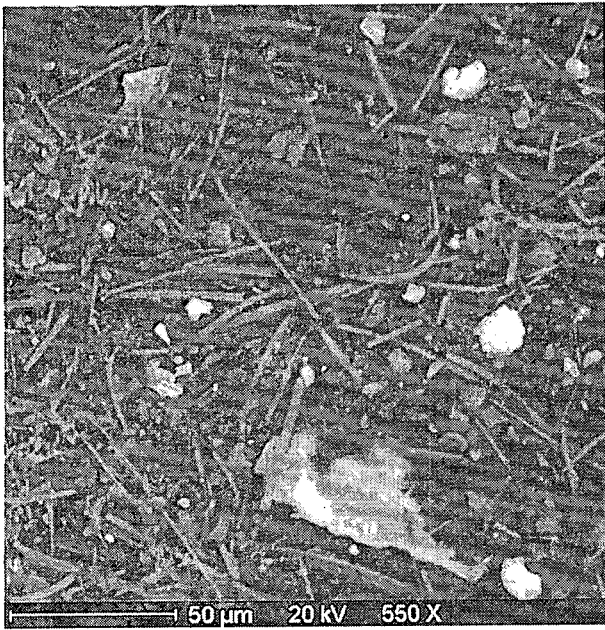
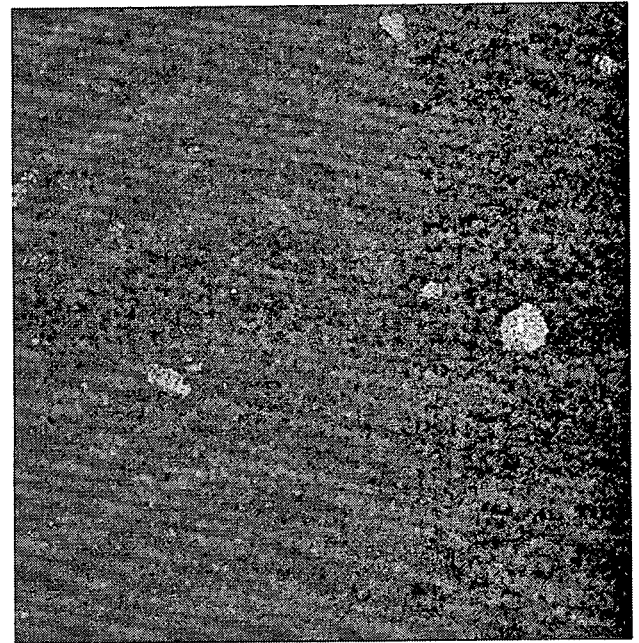
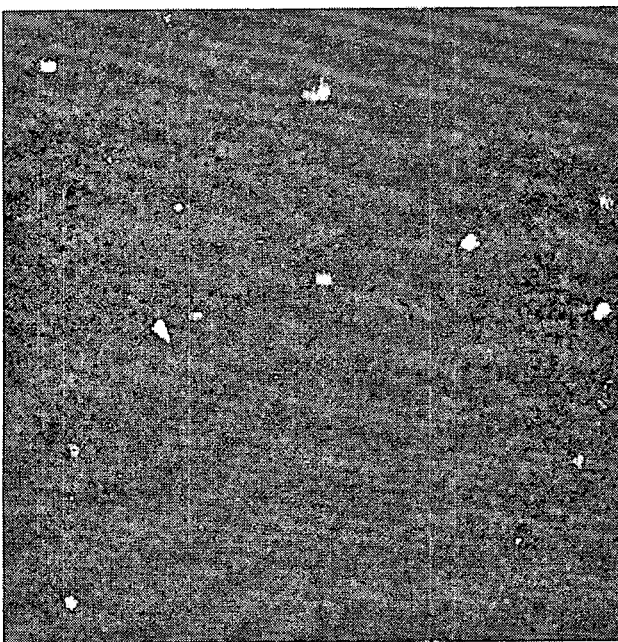
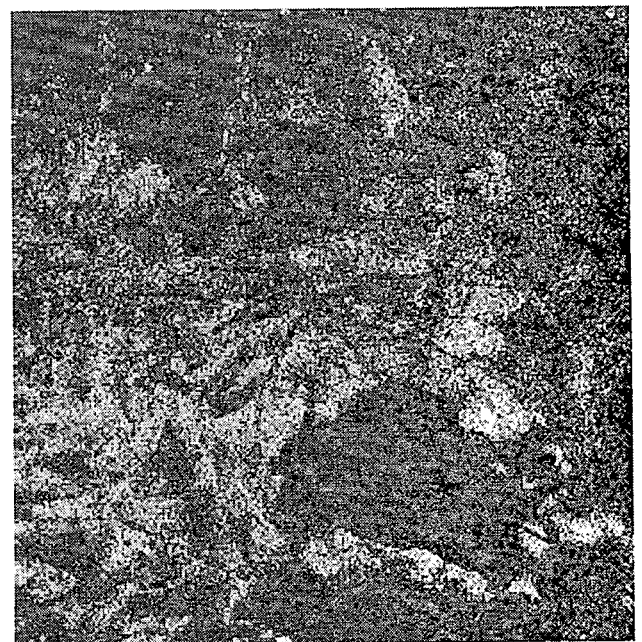
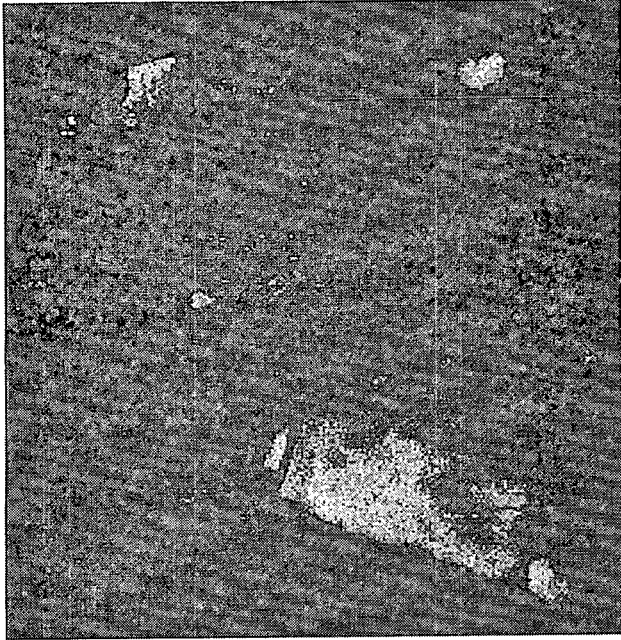
Figure 8
EDS spectrum obtained for contamination collected from the Carson PRV spool.

Back-scattered electron image of debris and associated elemental distribution maps.
