CT58-140

TURBOSHAFT ENGINE

Subject: FUEL - Fuel Control Systems - Fuel System Installations - 40 Micron Fuel Filter Element and Packing, One-Time Replacement of

ADMINISTRATIVE INVESTIGATION:
LAX08PA259 - WEAVERVILLE, CA

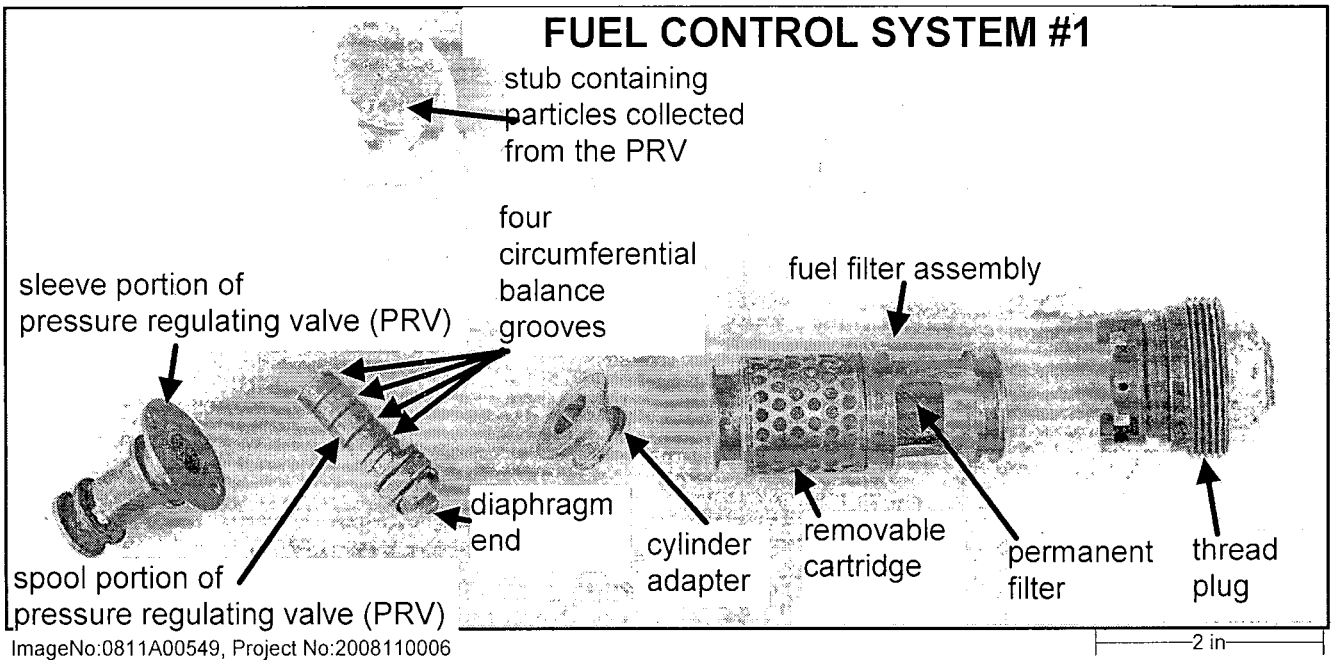
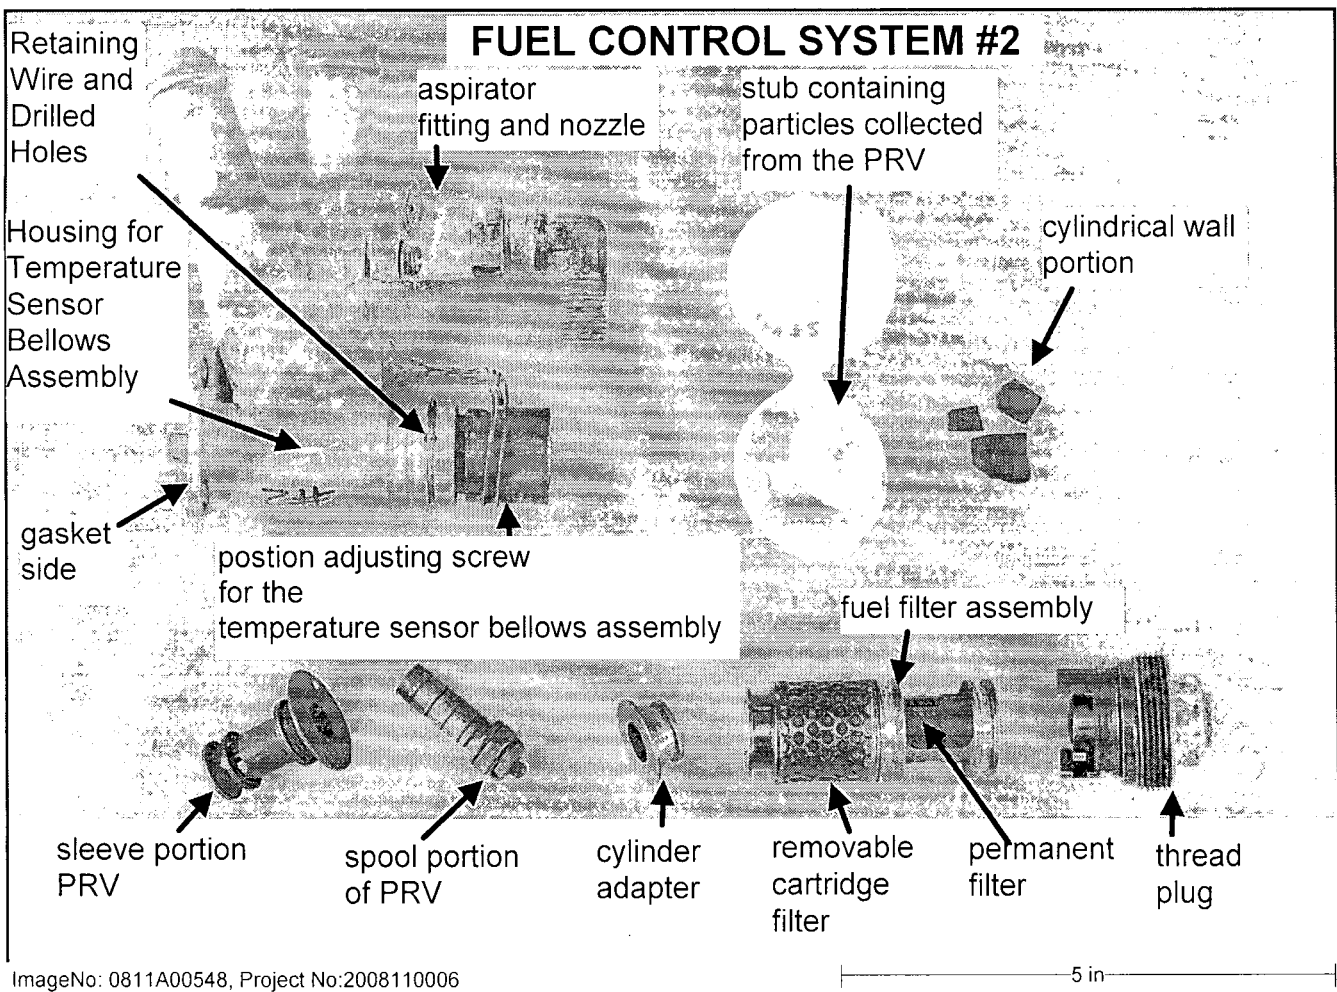
Figure 1. As-received pieces from fuel control systems 1 (upper photograph) and system 2 (lower photograph).

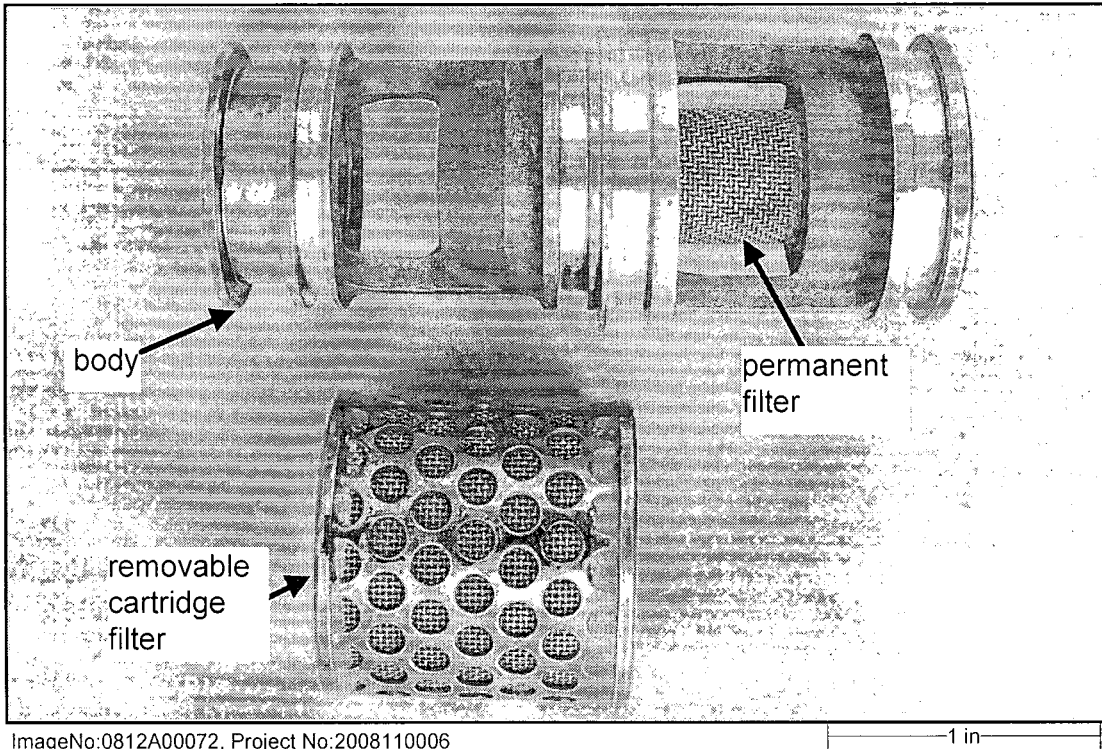
Figure 4. Photograph of the fuel filter assembly from system 2 after the cartridge filter assembly was disassembled from the body.

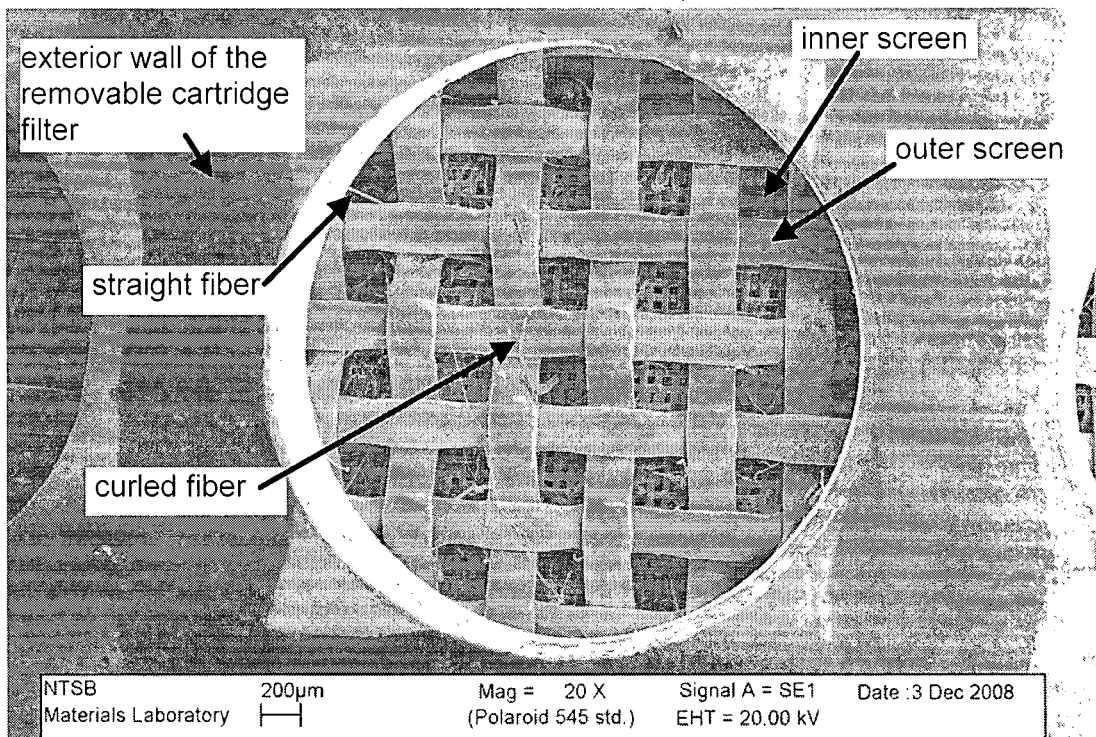
ImageNo:0902A00114

Figure 5. Scanning electron microscope (SEM) photograph of a portion of the external face of the removable cartridge filter for fuel control system 1. This view shows one of the holes in the wall of the cartridge filter. The bore of the cartridge filter contained two layers of wire screen (referred as the inner and outer screens).

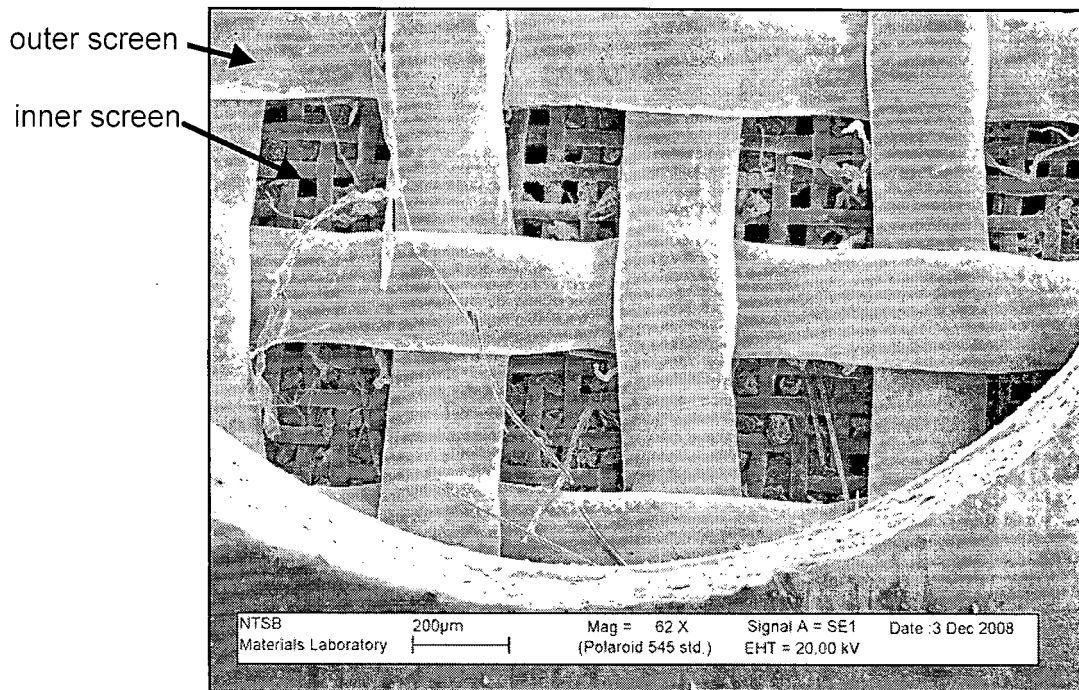
ImageNo:0902A00084, Project No:2008110006

Figure 6. Higher magnification SEM photograph of a portion of the removable cartridge filter for fuel control system 1 that was shown in figure 5. This view shows particles embedded in the inner and outer screens.

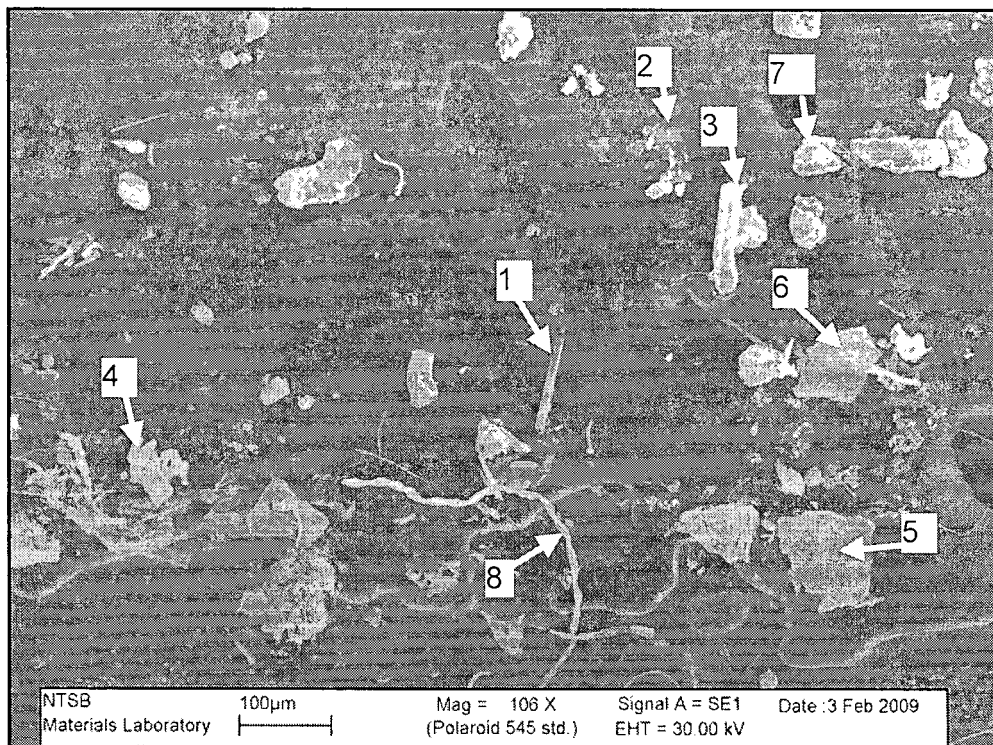
ImageNo:0902A00099

Figure 7. SEM photograph of particles that were removed with carbon adhesive tape from the inner screen portion of the removable-cartridge filter from fuel control system 1. Background is carbon adhesive tape.

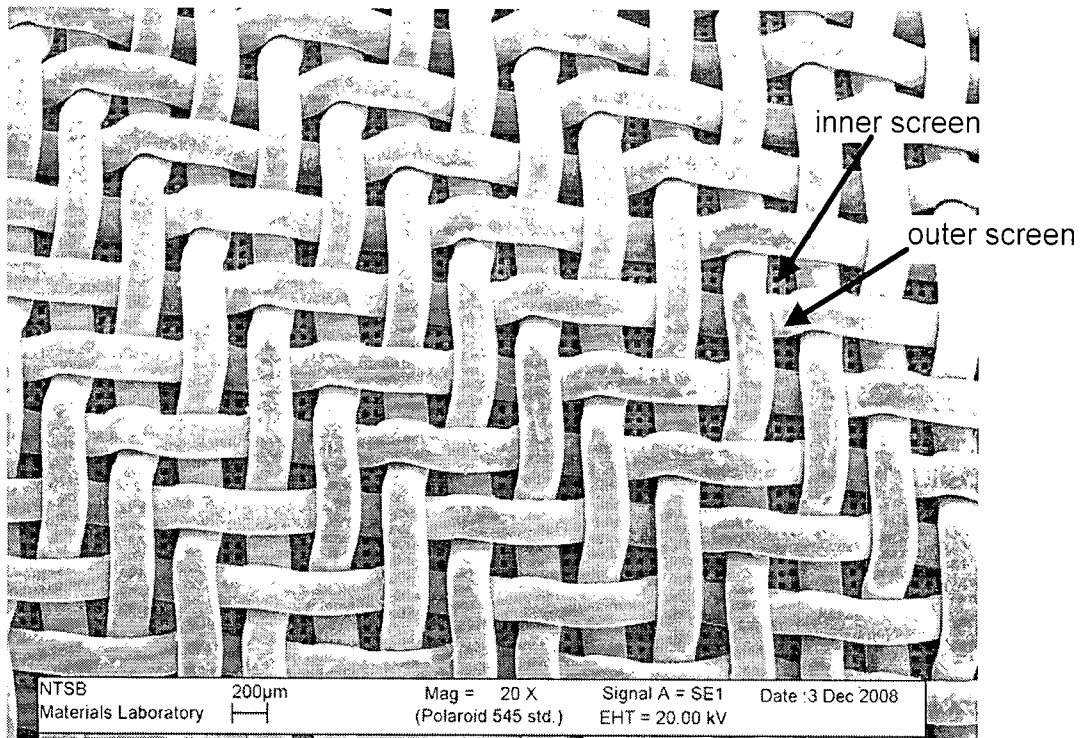
Figure 8. SEM photograph of a portion of permanent filter from fuel filter system 1 showing the outer and inner wire screens.

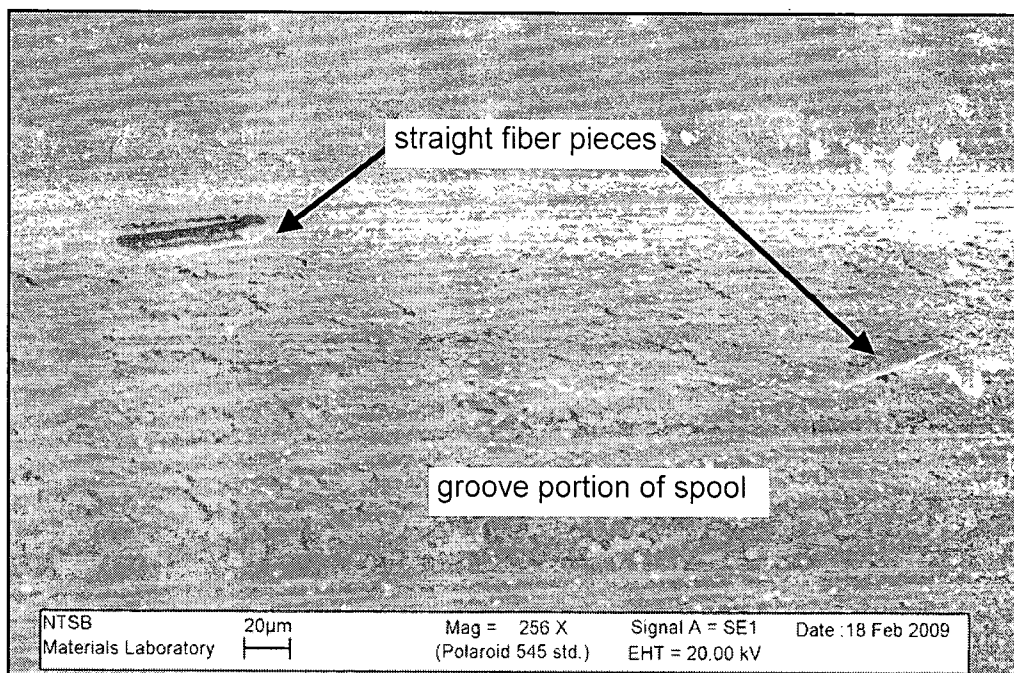
ImageNo:0904A00002, Project No:2008110006

Figure 9. SEM photograph of a portion of a circumferential balance groove from the spool of PRV system 1. This view shows two straight fibers located in the groove.

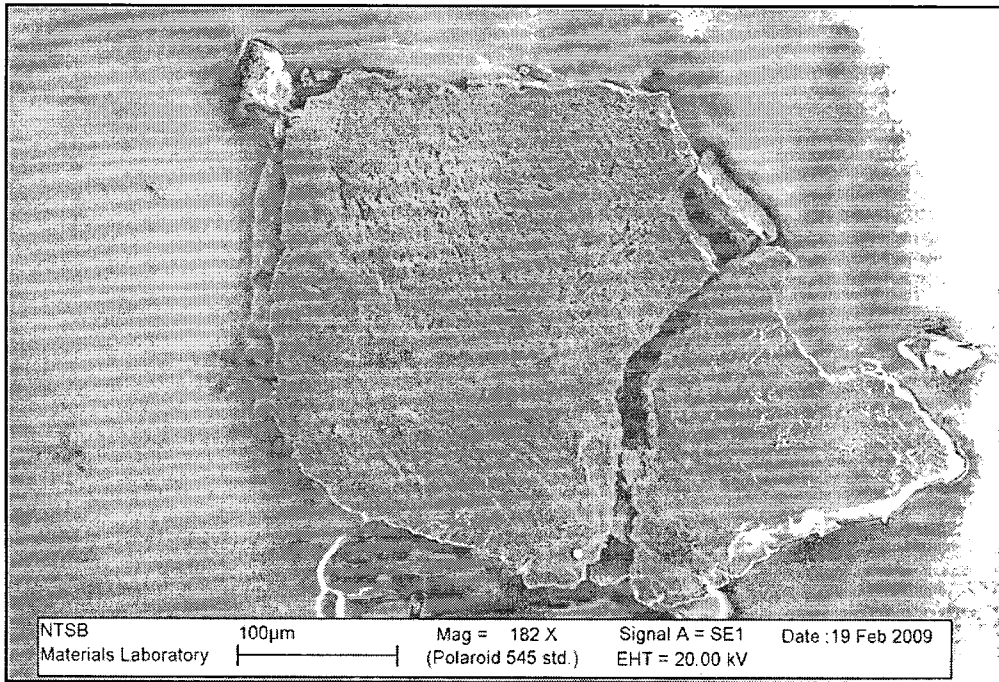
ImageNo:0904A00016, Project No:2008110006

Figure 10. SEM photograph of one of the particles found on the stub for PRV system 1. The particle fractured into two major pieces. The EDS spectrum from this particle contained elemental peaks of fluoride and carbon.

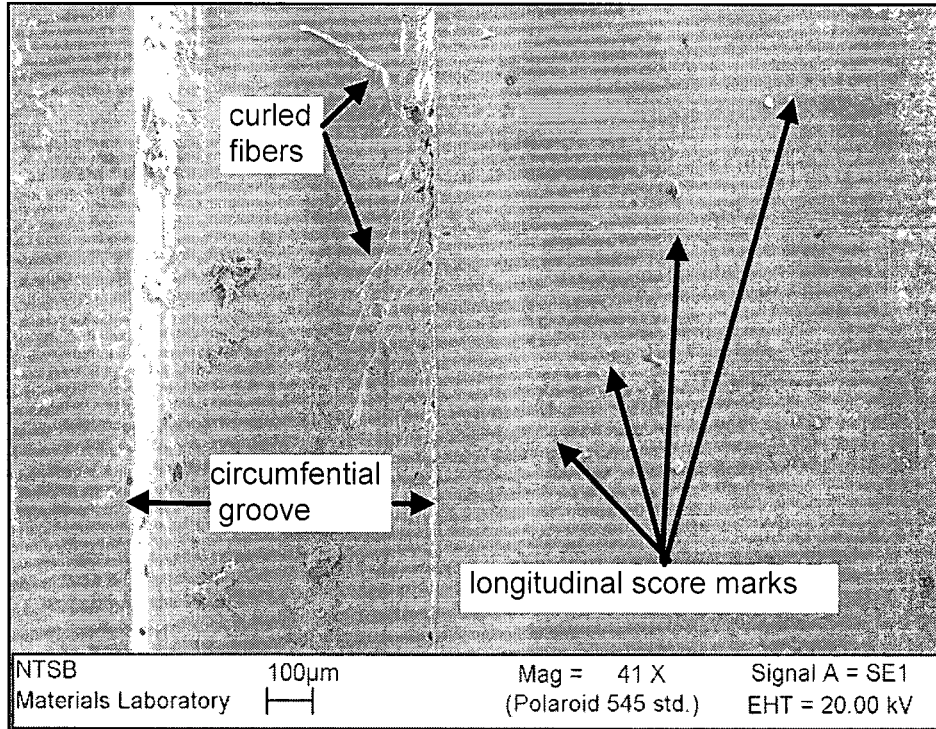
ImageNo:0904A00012, Project No:2008110006

Figure 11. SEM photograph of a portion of the pool from the pressure regulation valve of system 2 showing one of the circumferential balance grooves. This view shows fibers within the groove in an area located adjacent to the spool surface. The surface also contain several longitudinal score marks that extend from the circumferential balance groove.

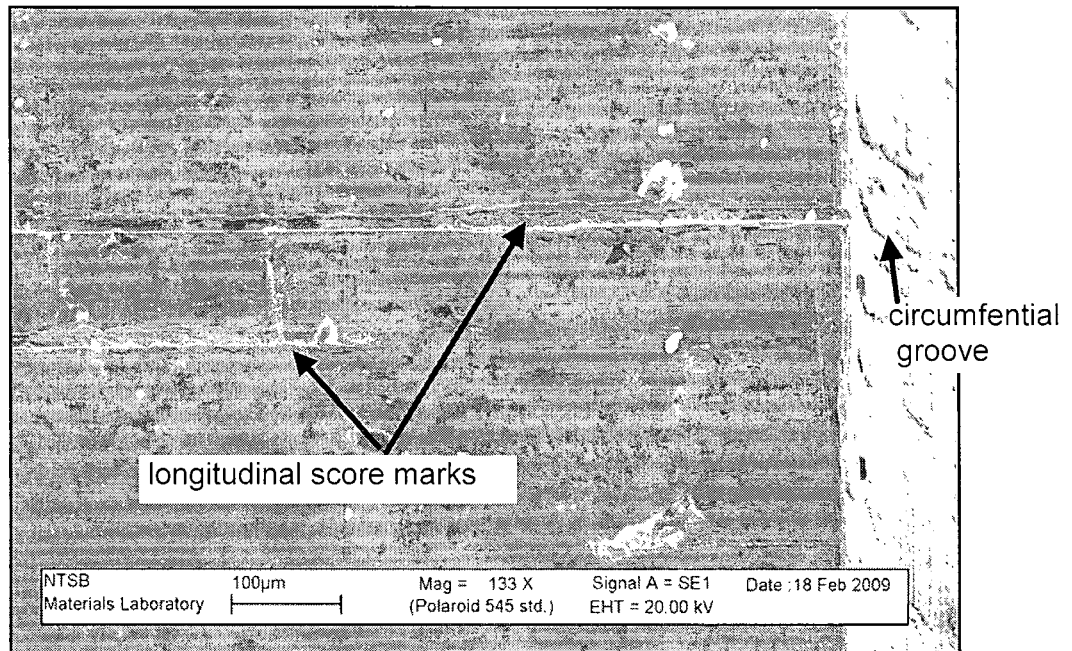
ImageNo: 0904A00007, Project No:2008110006

Figure 12. SEM photograph of a portion of the pool from the pressure regulation valve of system 2 showing one of the circumferential balance grooves. A longitudinal score mark extended from the circumferential balance groove.

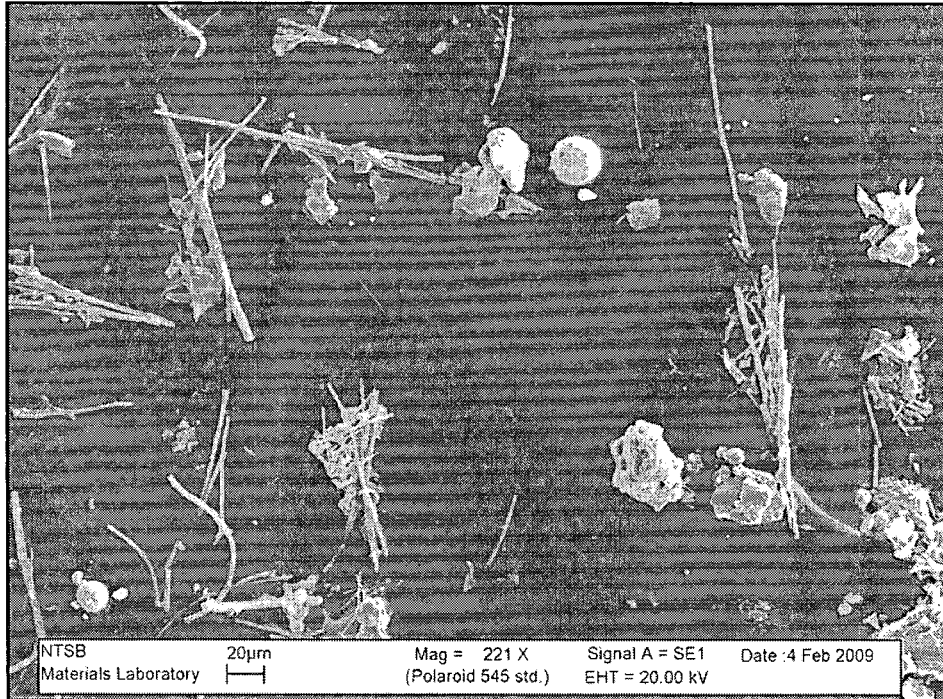
ImageNo:0902A00105, Project No:2008110006

Figure 13. SEM photograph of particles that were removed from the permanent filter of fuel control system 2. Background is the carbon replica tape.

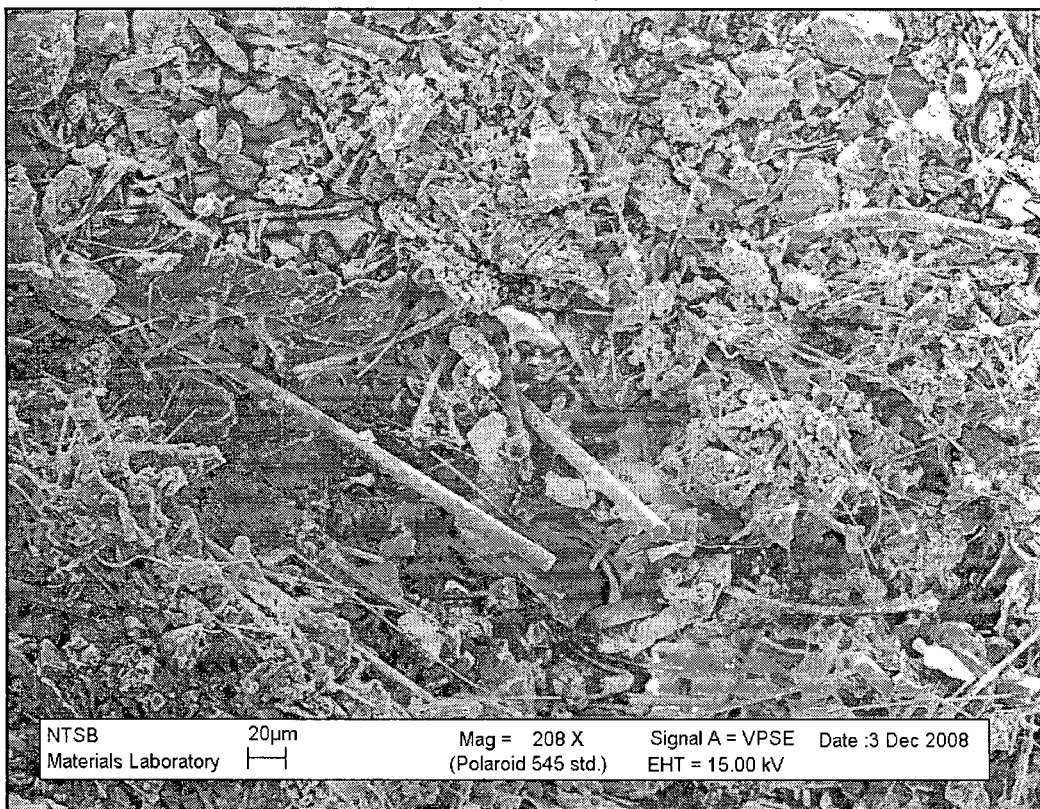
ImageNo: 0902A00094, Project No:2008110006

Figure 14. SEM photograph of particles found on the as-received stub that contained particled collected from PRV of system 2. The particles are embedded in adhesive bonded tape.

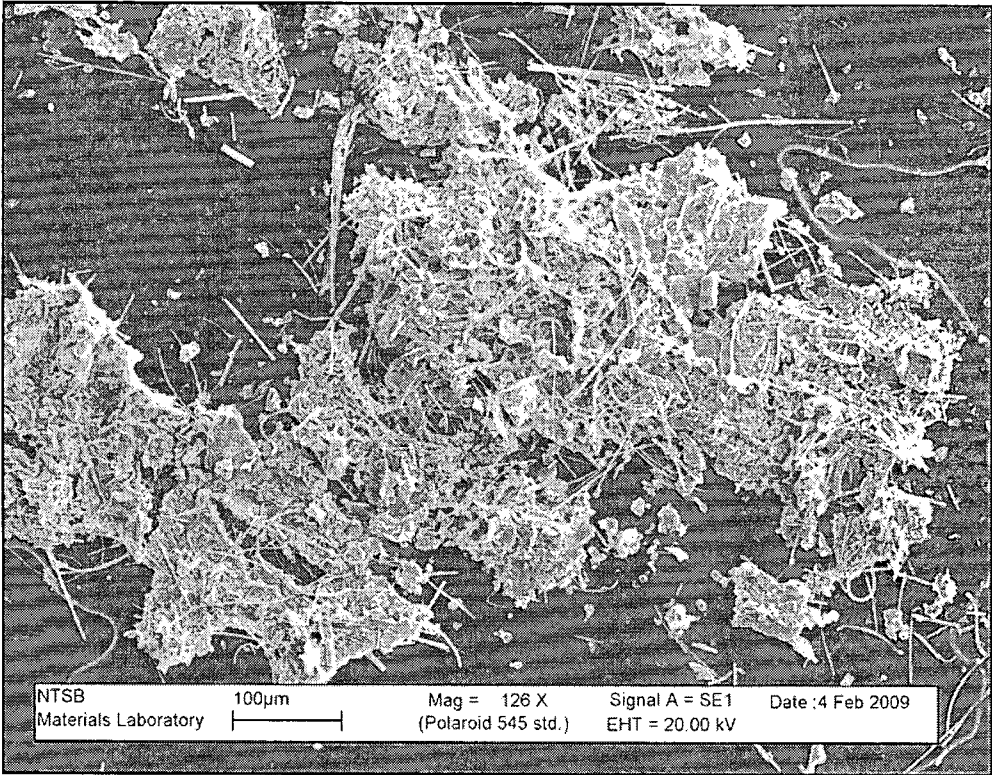
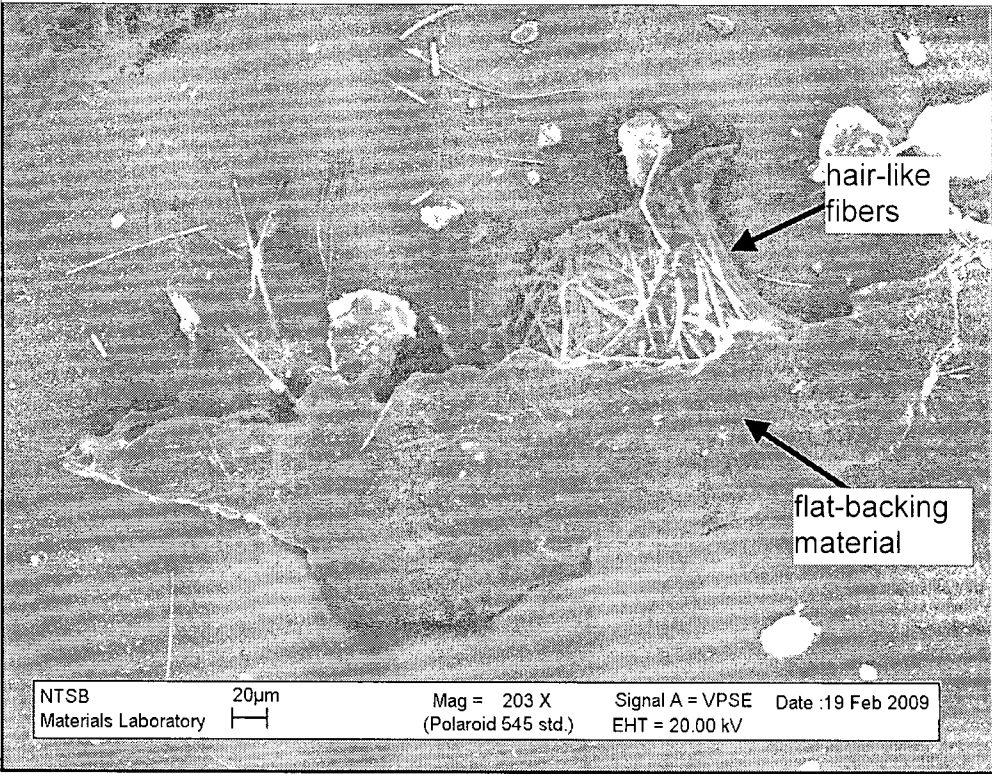
Figure 15. SEM photograph of particles on the tub of PRV system 2 (upper side of page) and a slightly higher magnification view one of the same particles after it was turned upside down to show the hidden back side. The majority of the particles appear to have a flat-backing material with hair-like fibers extending from the flat-backing material portion.

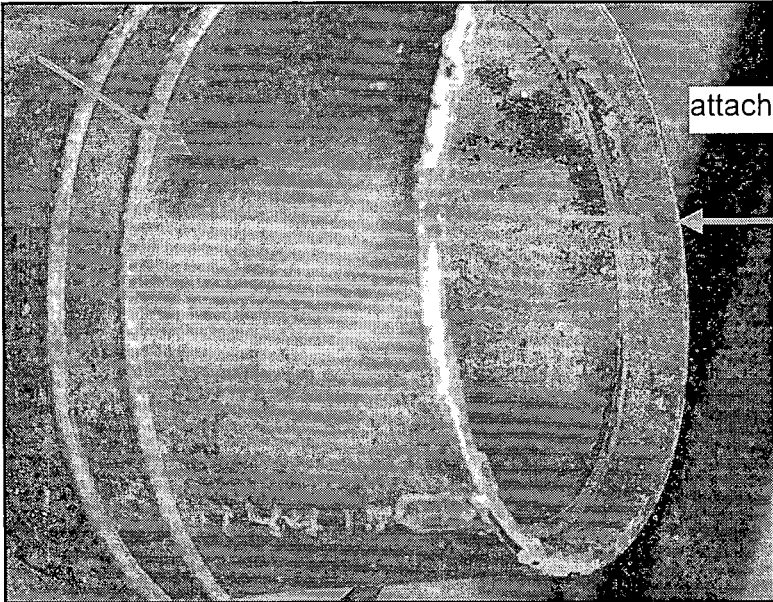
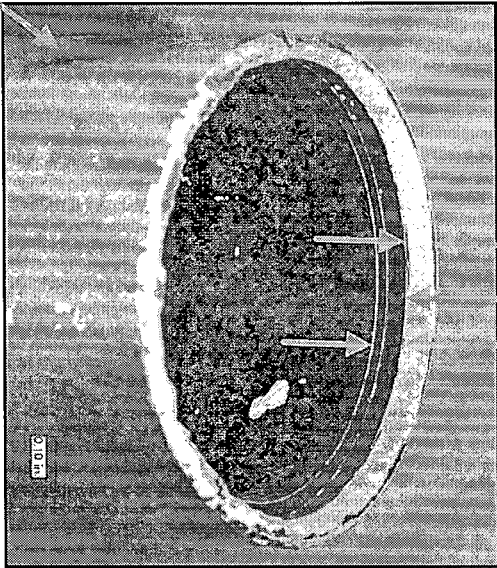
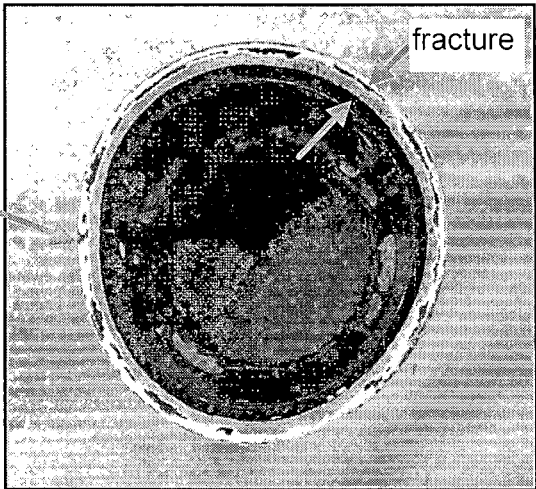
Figure 16. View of the position adjusting screw for the temperature sensor bellows assembly in the as-received condition (upper photograph); side view after disassembly and ultrasonic cleaned with detergent (center photograph); and view looking into the position adjusting screw (bottom photograph). Note the dent in the area indicated by an unmarked arrow. In the assembled condition, an internal retaining ring would have been inserted into the square groove.

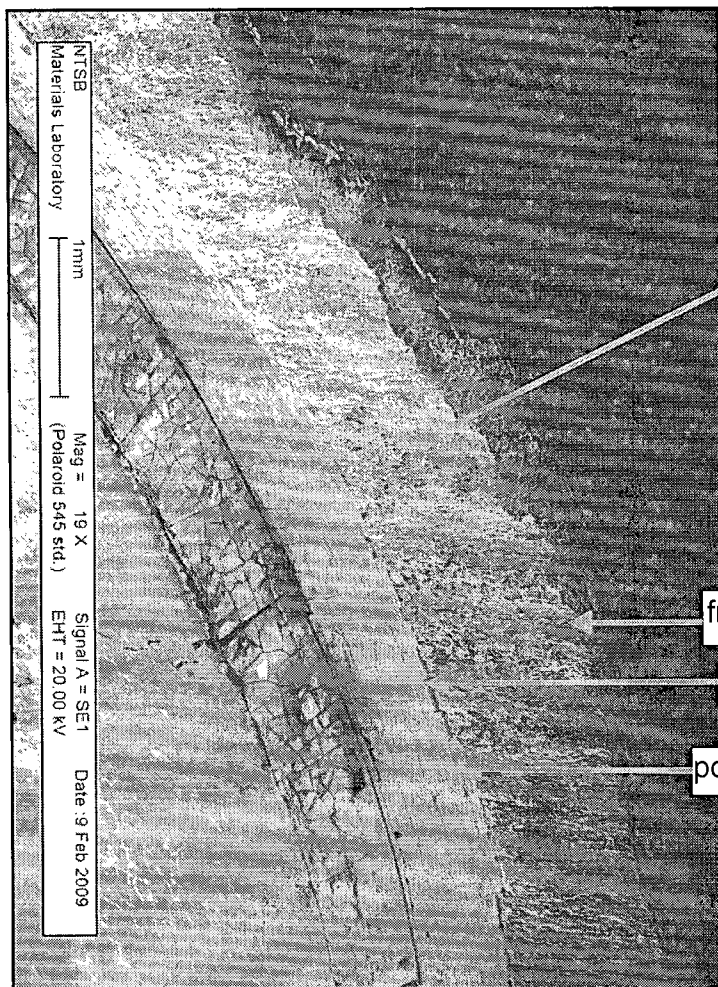
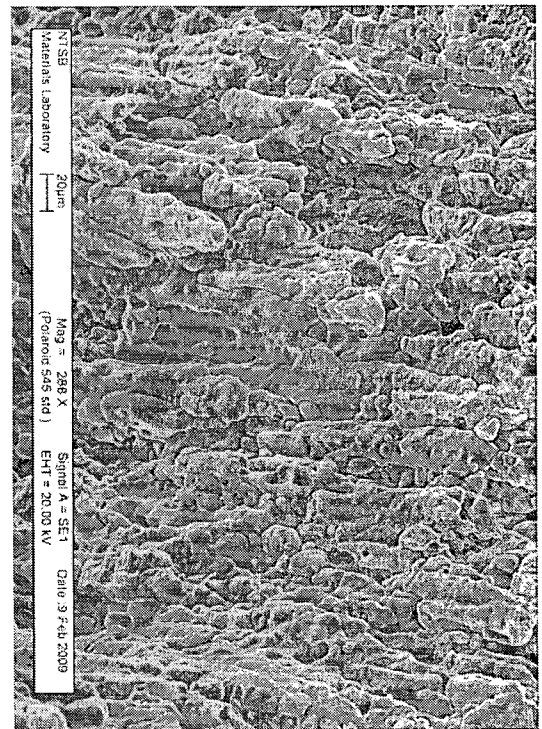
- fracture portion
- inside corner of square groove
- portion of circumferential internal square groove

Figure 17. SEM photographs of a portion of the position adjusting screw for the temperature sensor belows assembly (lower left corner of page) and a higher SEM photograph of the fracture face (upper right corner of page). In the assembled condition, an internal retaining ring would have been inserted into the square groove.

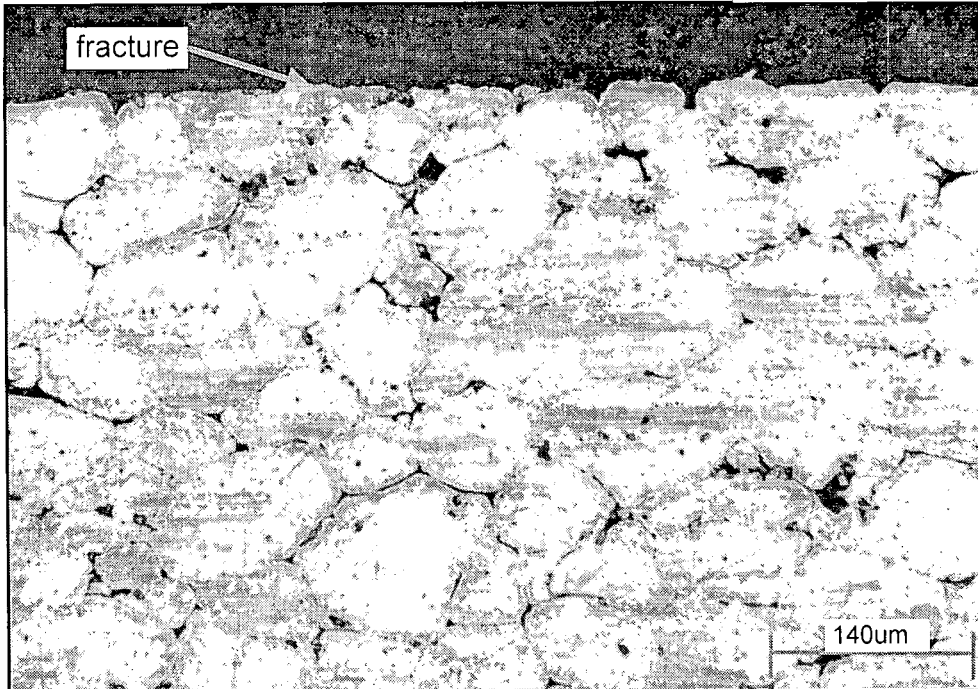
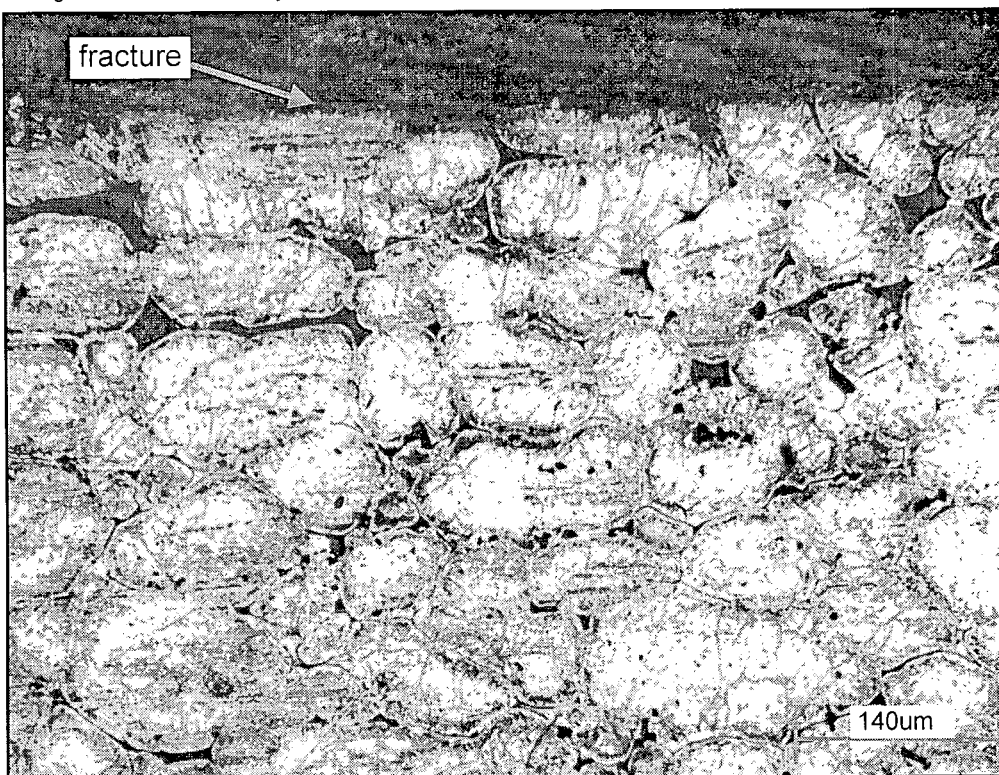
Figure 18. Longitudinal-radial section of the wall portion of the position adjusting screw from the temperature sensor bellows assembly. The microstructure shows an overheated aluminum alloy with solid solution melting at the grain boundaries. The two photographs were taken in an area that was located near each other and adjacent to the fracture face. The area shown on the bottom photograph was etched for a longer period of time compared to the area on the upper photograph. Etched with Keller's reagent.

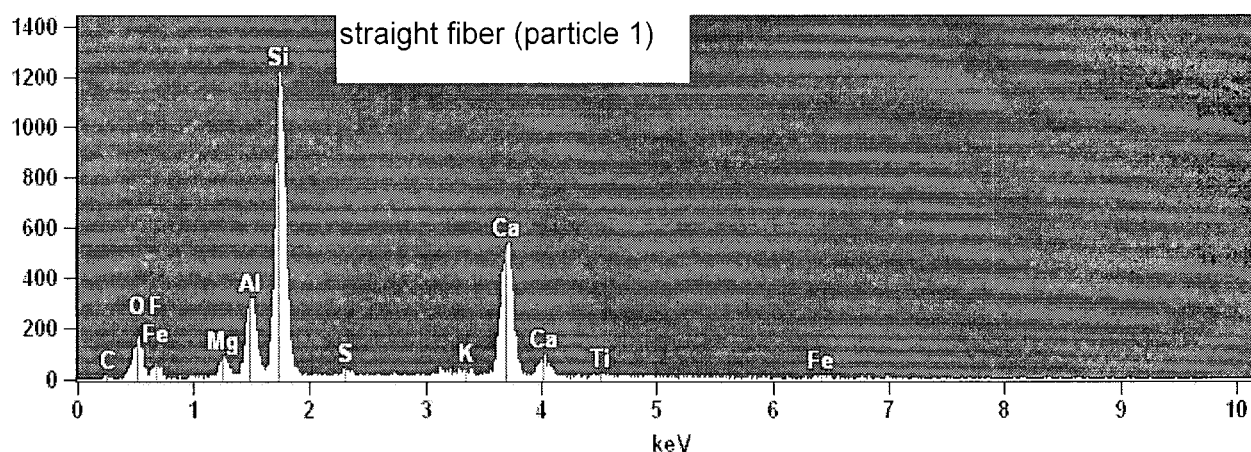
EDS spectrum of the straight fiber (particle 1 in figure 7) contained major elemental peaks of silicon, aluminum and calcium with minor elemental peaks of iron, magnesium, carbon, and oxygen, consistent with e-glass.

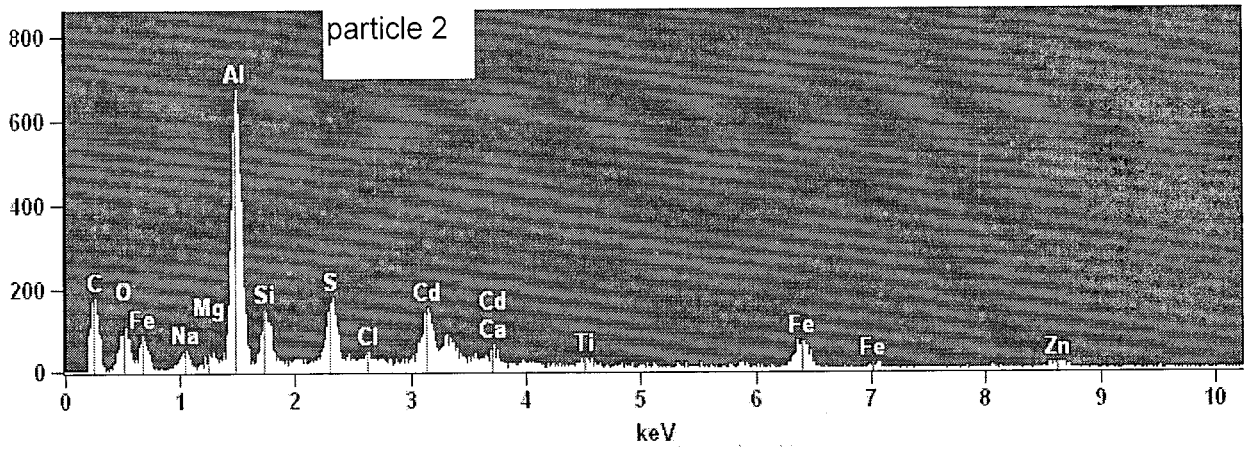
EDS spectrum of particle 2 in figure 7 contained a major peak of aluminum and minor peaks of carbon, oxygen, iron, sodium, magnesium, silicon, sulfur, chloride, cadmium, titanium, iron, and zinc.

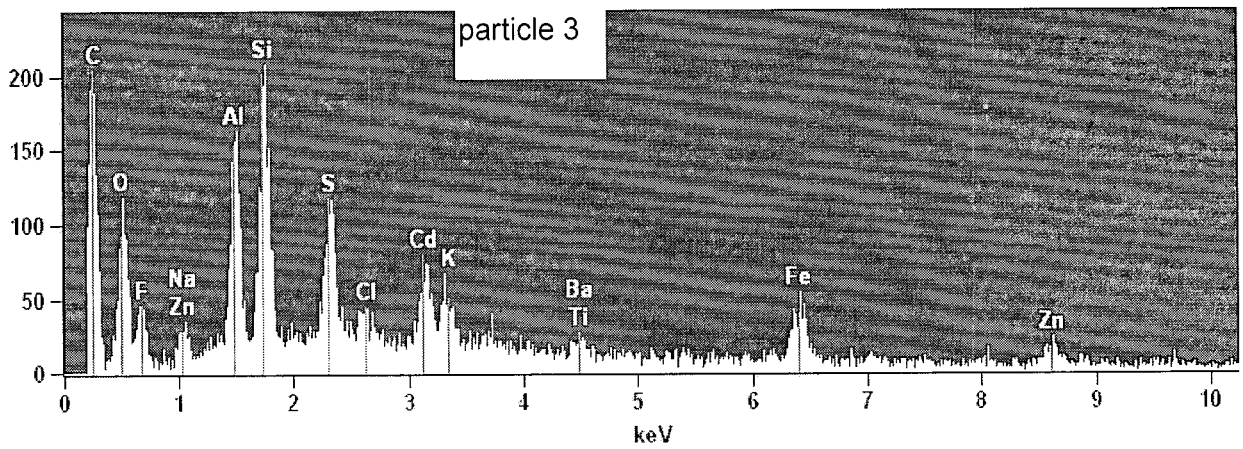
EDS spectrum of particle 3 in figure 7 contained major elemental peaks of silicon, aluminum, and carbon, and minor peaks of fluoride, sodium, zinc, sulfur, chloride, cadmium, potassium, titanium, iron and zinc.

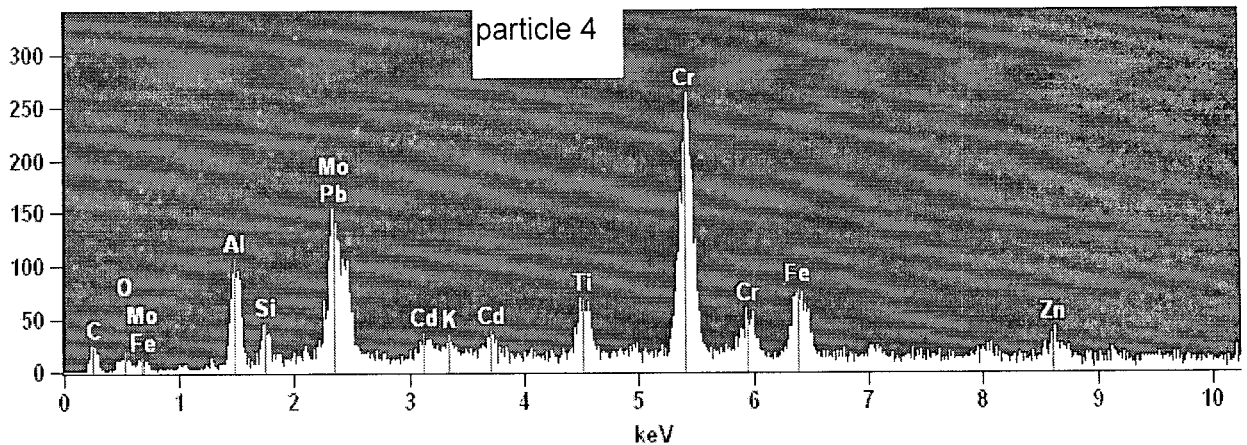
EDS spectrum of particle 4 in figure 7 contained element peaks of iron, nickel, chromium (present in the body of the filter assembly), and elemental peaks of lead, aluminum, silicon, zinc, titanium, carbon, cadmium, and potassium.

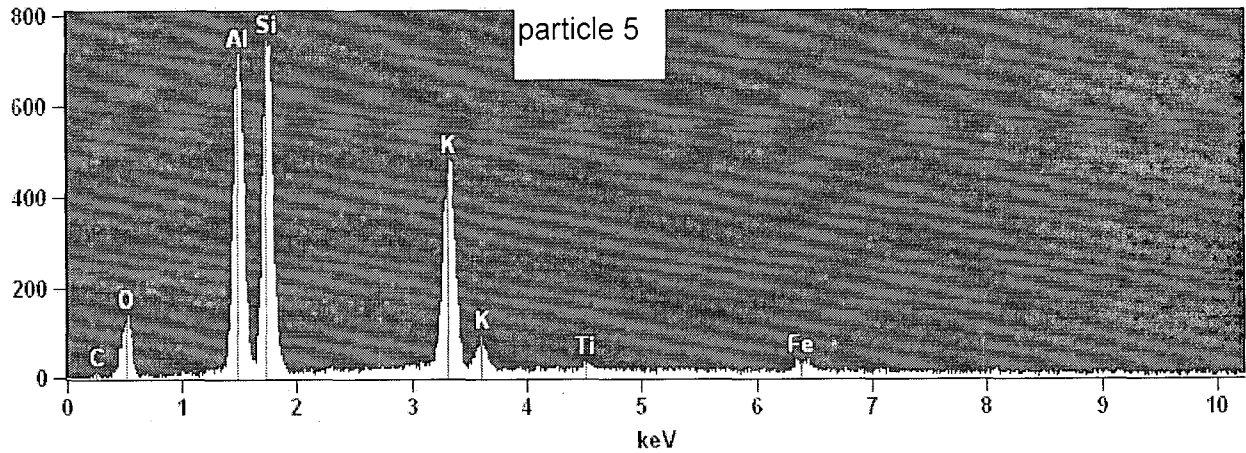
EDS spectrum of particle 5 in figure 7 contained major elemental peaks of silicon, aluminum, and potassium (consistent with Feldspar) and minor elemental peaks of iron, carbon, and oxygen.

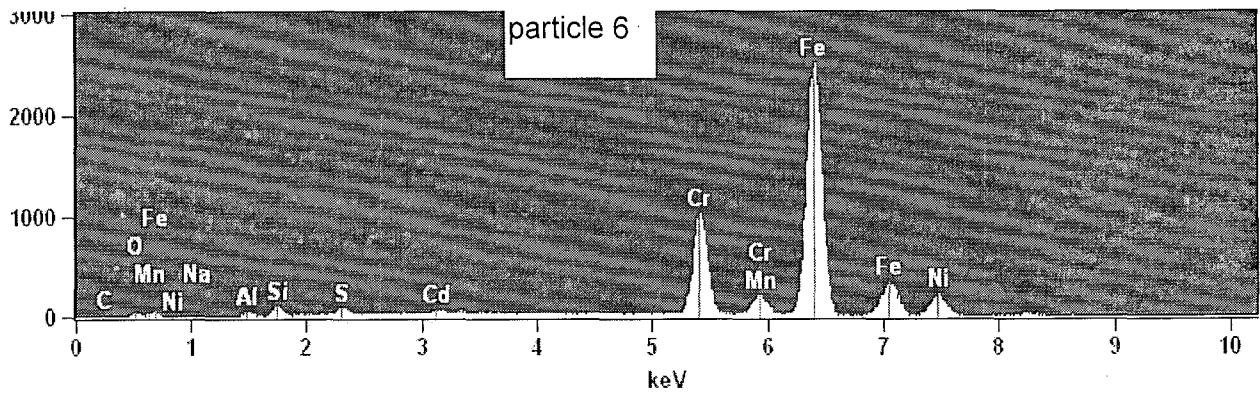
EDS spectrum of particle 6 in figure 7 contained major elemental peaks of iron, chromium, and nickel consistent with stainless steel, and minor elements of oxygen, aluminum, silicon, sulfur, and cadmium.

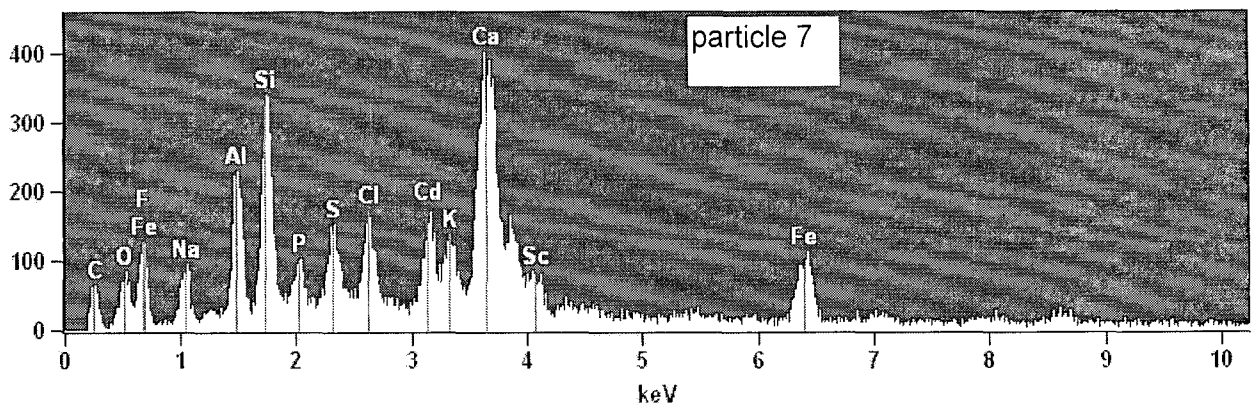
EDS spectrum of particle 7 in figure 7 contained the same elemental peaks as in particle 3 with the exception that the major elemental peaks in this particle were calcium, silicon, and aluminum.

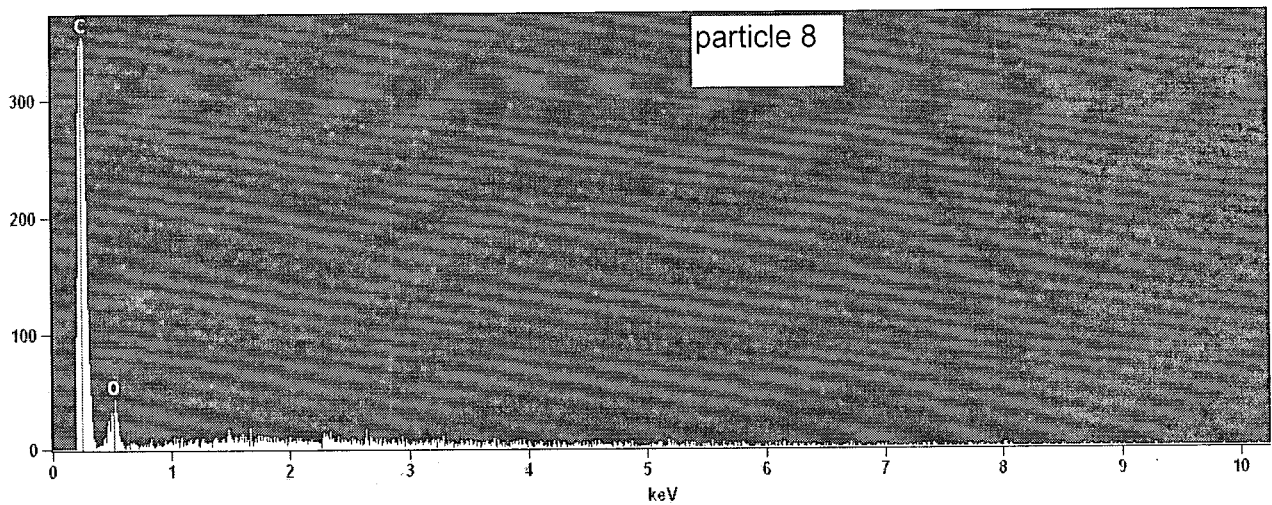
EDS spectrum of particle 8 (curled fiber) in figure 7 contained a major elemental peak of carbon and a minor peak of oxygen.

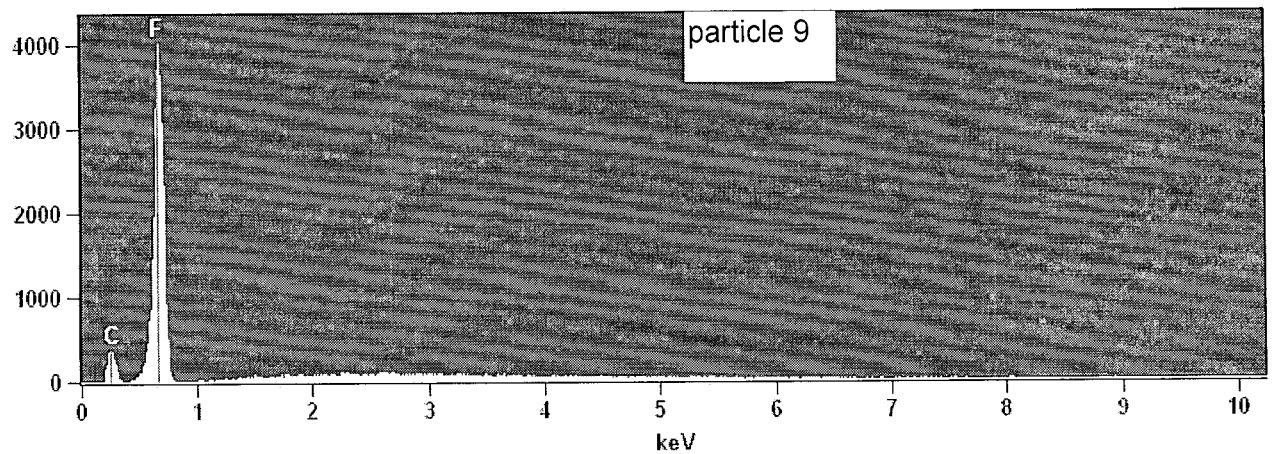
EDS spectrum of particle 9 in figure 7 contained a major elemental peak of fluoride and minor peak of carbon.

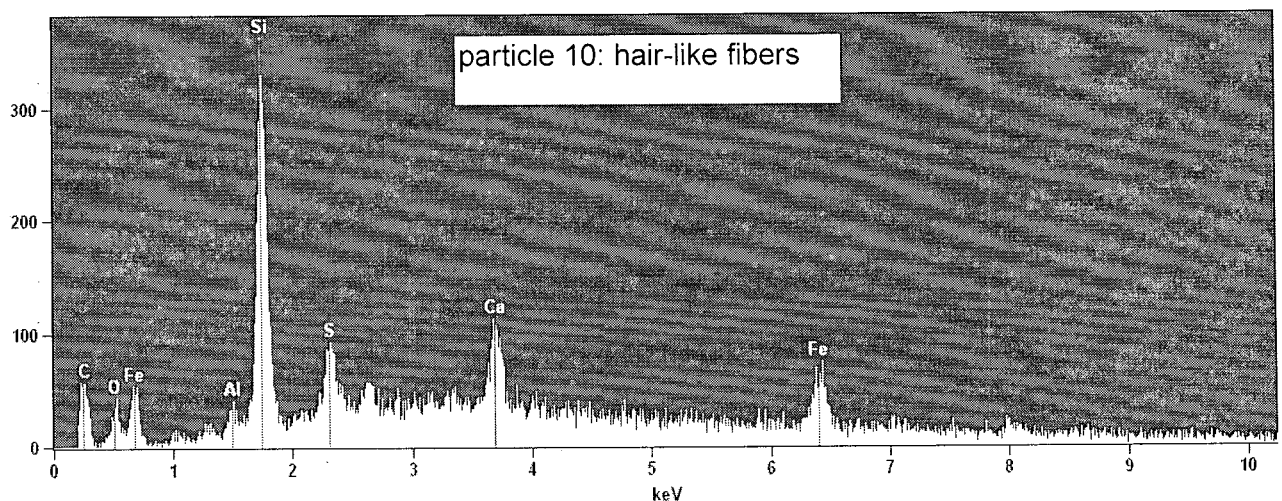
EDS spectrum of particle 10 in figure 7 in the area that contained hair-like fibers showed a major elemental peak of silicon and minor peaks of carbon, oxygen, aluminum, sulfur, calcium and iron.
