CT58-140

TURBOSHAFT ENGINE

Subject: FUEL - Fuel Control Systems - Fuel System Installations - 40 Micron Fuel Filter Element and Packing, One-Time Replacement of

ADMINISTRATIVE INVESTIGATION:
LAX08PA259 - WEAVERVILLE, CA

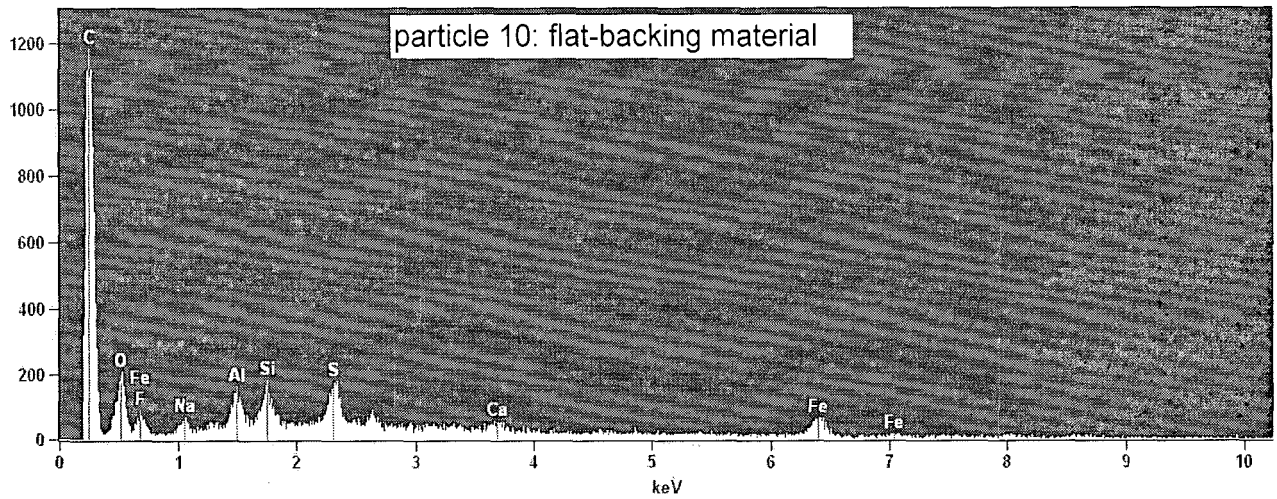
EDS spectrum of particle 10 in figure 7 in the area that contained a flat wall showed a major elemental peak of carbon and minor peaks of oxygen, fluoride, sodium, aluminum, silicon, sulfur, calcium, and iron.
