**CERTIFICATE OF INSPECTION**

Item	Rec.	Insp.	Part No.	Process	Accepted	Rejected	Inspector
1	1	1	WING SKIN C-130 <sup>A</sup>	X-ray RIVET LINES OF STRINGERS TO LOWER WING SKINS ON FRACTURED SECTIONS PER ASTM-E1742-00.	0	0	Paul Lopez NDT LEVEL-III TEST EXAMINER

**Material** ALUM<sup>A</sup>  
(2 PCS.) WING SKIN C-130<sup>A</sup>

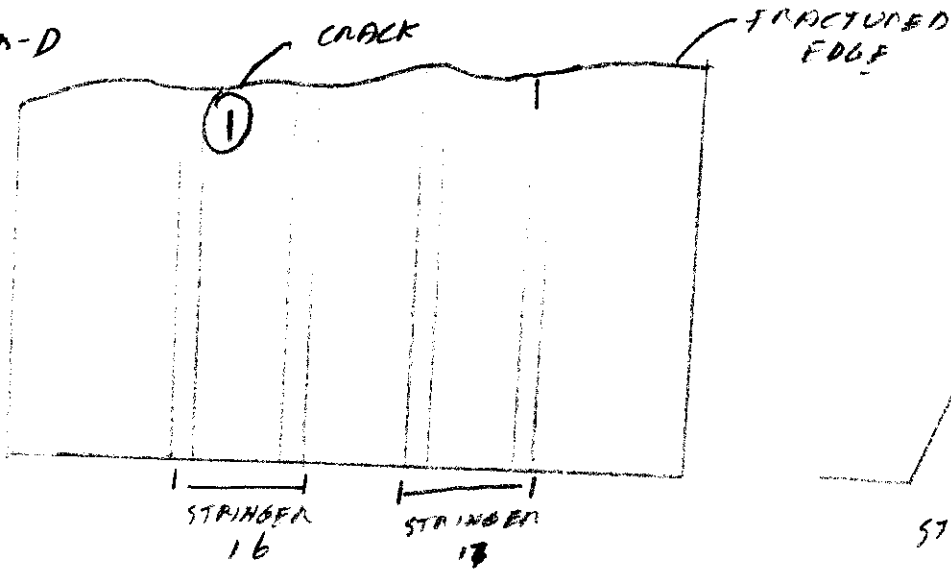
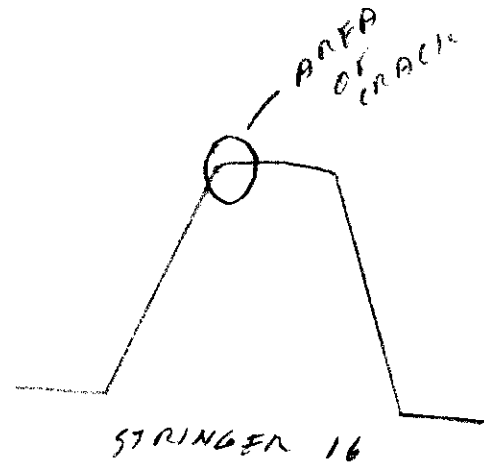
17A-D

- ITEM (D)** A .50" crack detected in radius of stringer - 16, at the narrow point of the stringer. Crack is at a 90° angle to the fractured edge and in line with the stringer. No visual correlation with the crack could be made. Crack was detected on view A & view C.
