REPORT TITLE: Examination of a Bellcrank Assy-Roll Control p/n 6260347-12 and Box Assy-Spoiler Mixer p/n 6261282-1; 650-7063; N877G

REPORT #: 12-359-072

DATE: 3/19/12

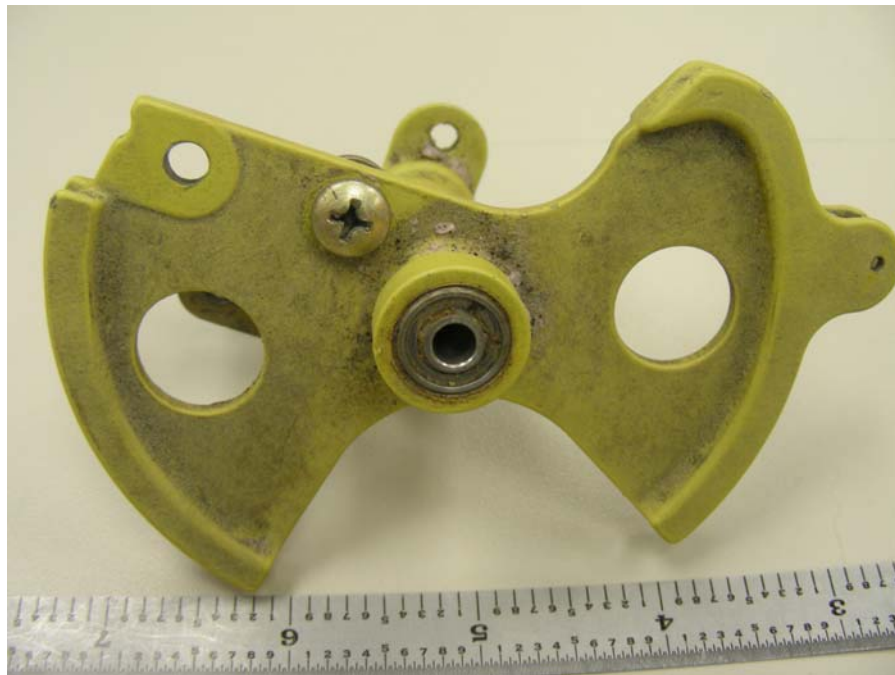
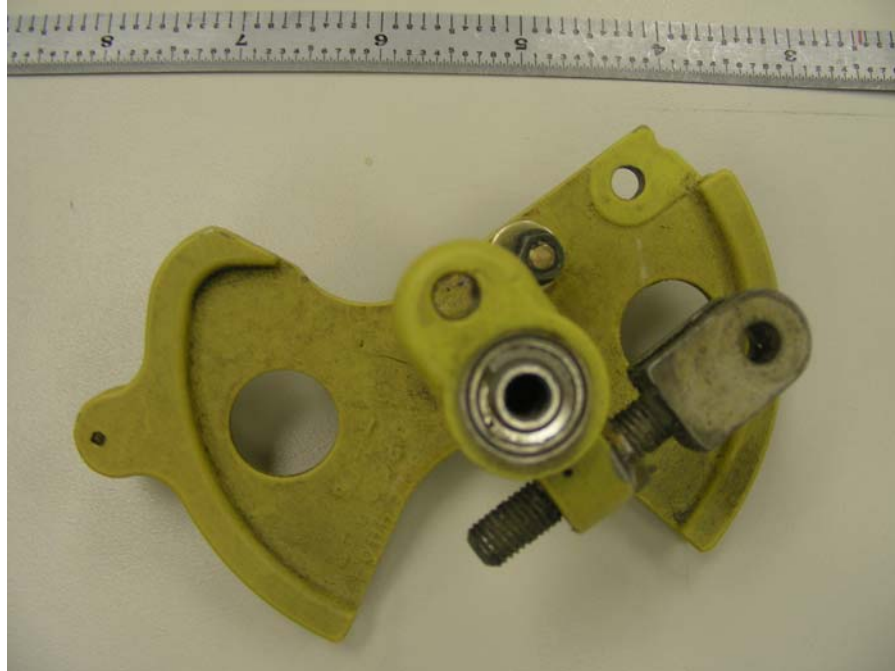
The bellcrank was removed from the aircraft and was brought to Cessna 3-6-2012 in a sealed shipping carton by a representative of the FAA as shown in Figure 2. Views of the as-received bellcrank are shown in Figures 3 and 4. The bellcrank had a slightly dirty appearance, but did not display any visible damage or corrosion. Some slight wear of the cable groove was noted due to contact with the cable (Figure 5), but this did not appear to be excessive. Press fit into the upper and lower surfaces of the bellcrank were two KP3AL bearings. Both of these bearings had a somewhat greasy appearance with some dirt present, however the snap ring and bearing seals appeared to be intact, Figure 6. The lower bearing displayed the ball insertion grooves which are machined into the inner and outer bearing races, as shown in Figures 6b) and 7. The upper and lower KP3AL bearings appeared to rotate freely by hand through approximately 90 degrees of rotation, at which time they could not be made to rotate any further by hand, see Figure 8. No effort beyond manual hand pressure was applied to force bearing rotation. Rotation of the upper bearing coincided with rotation of the lower bearing, likely due to frictional contact of both bearing inner races with the NAS43HT3-125 spacer situated between the two bearings.

Figure 3. View of the upper surface of the 6260347-12 bellcrank in the condition in which it was received.

Figure 4 View of the lower surface of the 6260347-12 bellcrank in the condition in which it was received.

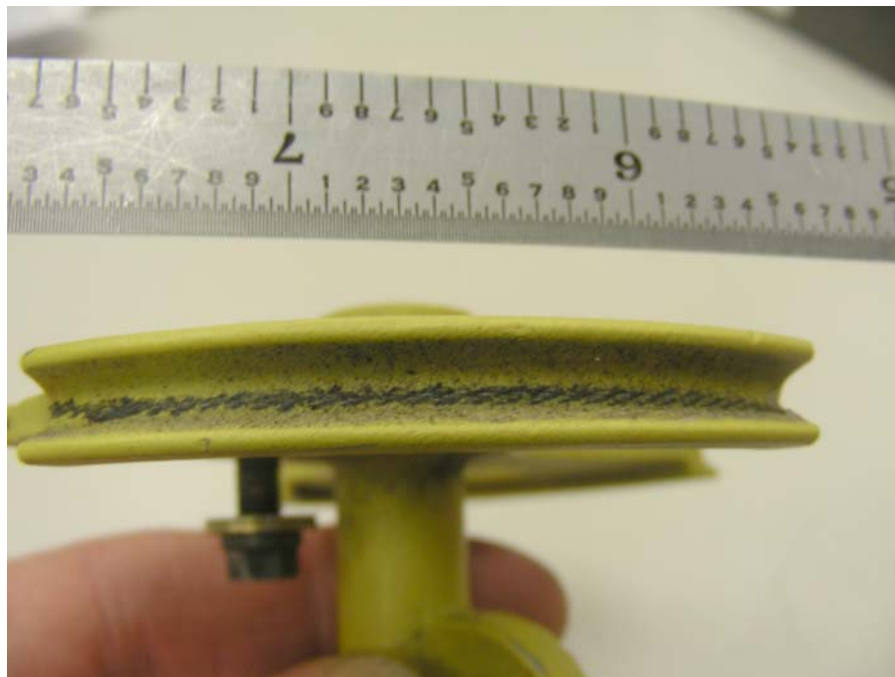
Figure 5 View of the cable groove on the bellcrank showing wear due to contact with the control cable.

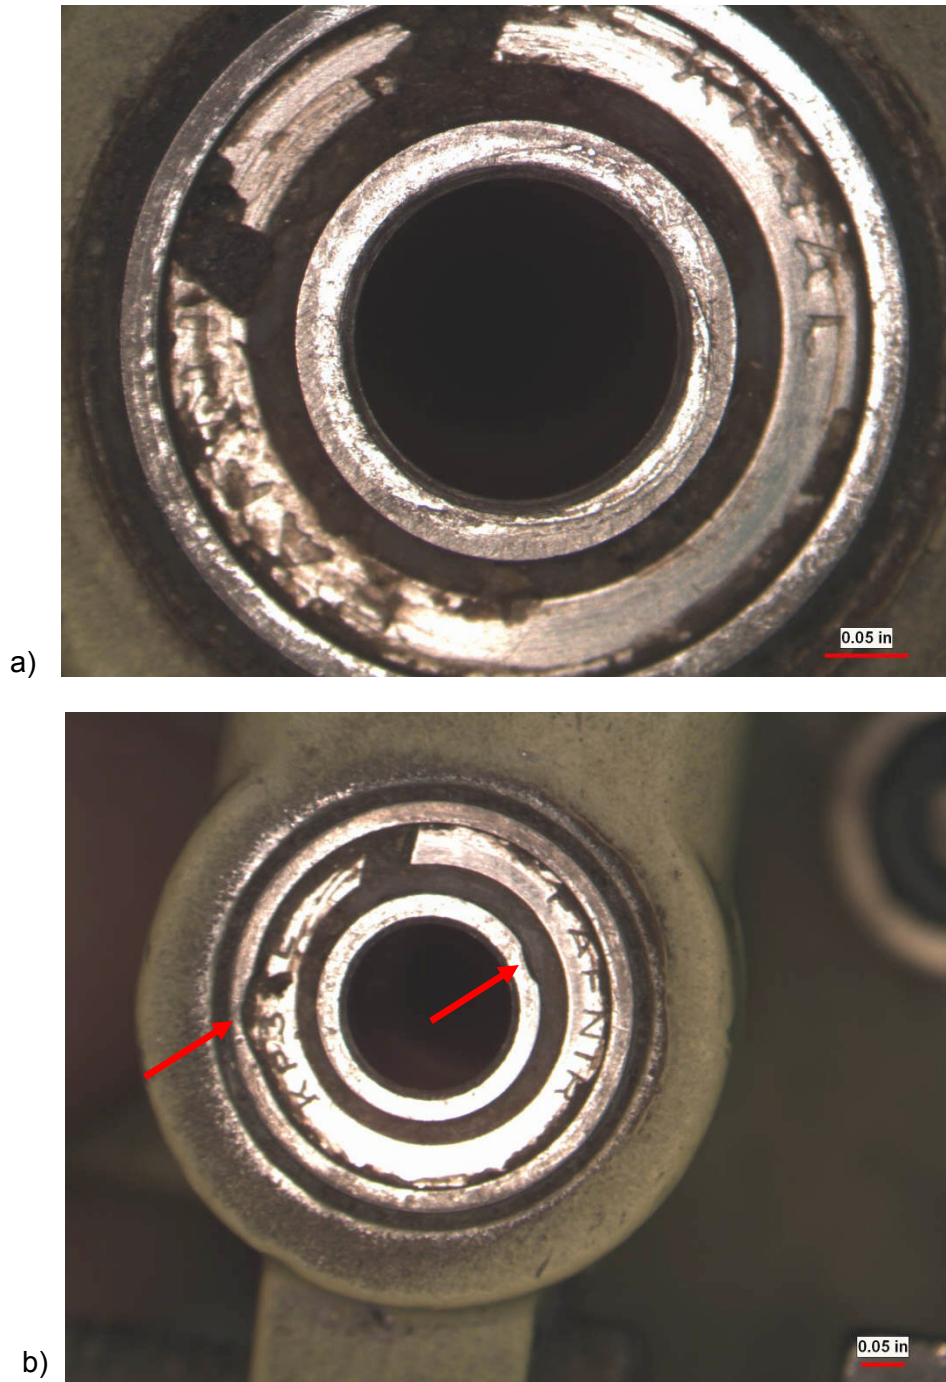
Figure 6 Magnified views showing the bellcrank upper bearing (a) and lower bearing (b). The snap ring and seal appear to be intact on both bearings. Note the presence of grooves on the lower bearing races (arrows). Magnification: x8.5 at (a) and x4.7 at (b).

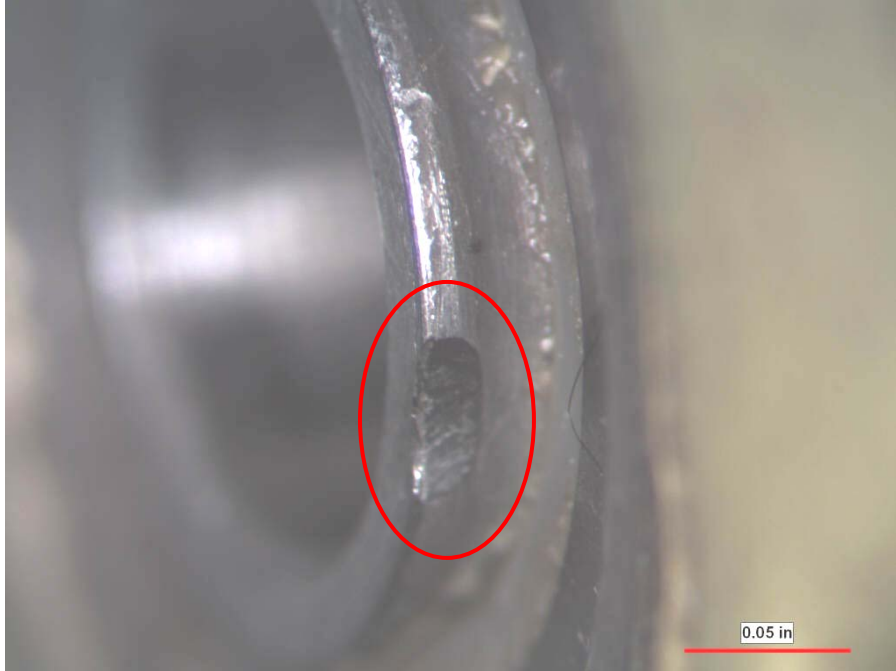
Figure 7. High magnification view of ball insertion groove on the inner race of the lower bellcrank bearing (Figure 6 b). Magnification: x17.3.

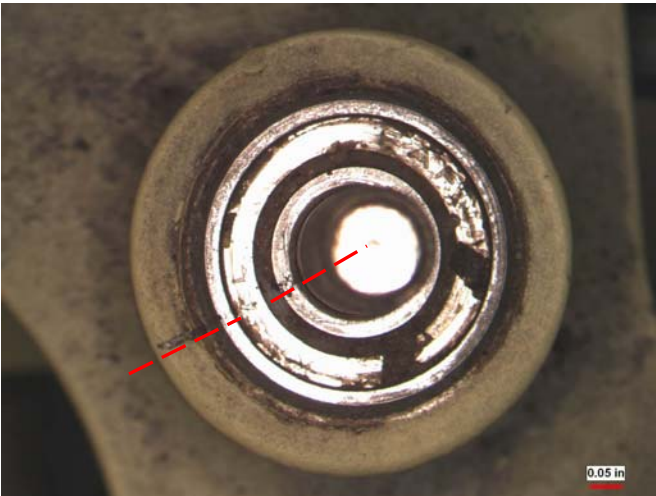
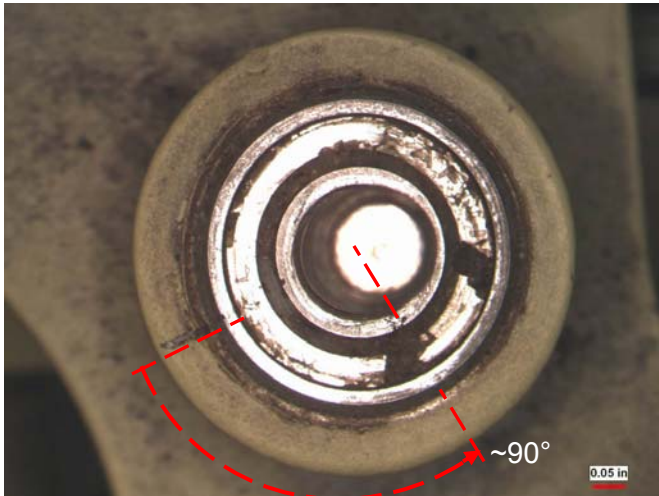
1. The 6260347-12 Bellcrank Assy-Roll Control did not display any unusual wear or significant corrosion.
2. Rotation of the bellcrank bearings by hand in excess of 90° was not possible.
3. The 6261282-1 Box Assy-Spoiler Mixer did not display any usual wear. The internal mechanism of the mixer box moved easily by hand with no noticeable sticking or binding.

Extreme clockwise position of inner bearing race with respect to the outer race.

Extreme anti-clockwise position of inner bearing race with respect to the outer race.

Figure 8 Views of the upper KP3AL bearing demonstrating the limits of manual rotation of the bearing, as indicated by the pencil marks scribed across the inner and outer races and highlighted by the red dashed lines. The extent of rotation was approximately 90 degrees. The lower KP3AL bearing displayed similar results. Magnification: x3.3.

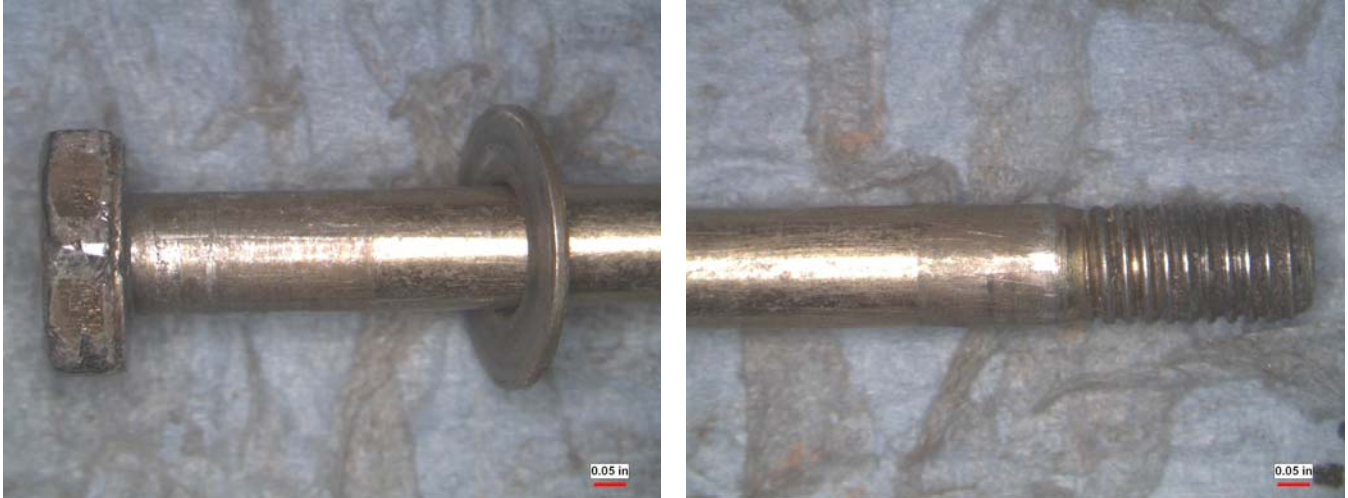
Supplied with the bellcrank was the AN3H27A bolt. The shank of the bolt did not display any significant wear damage, as shown in Figure 9. The bolt head displayed some scratching damage, as shown in Figure 10.

Figure 9. Magnified views showing both ends of the AN3H27A bolt. No significant wear damage was found on the bolt shank. Magnification: x3.3.

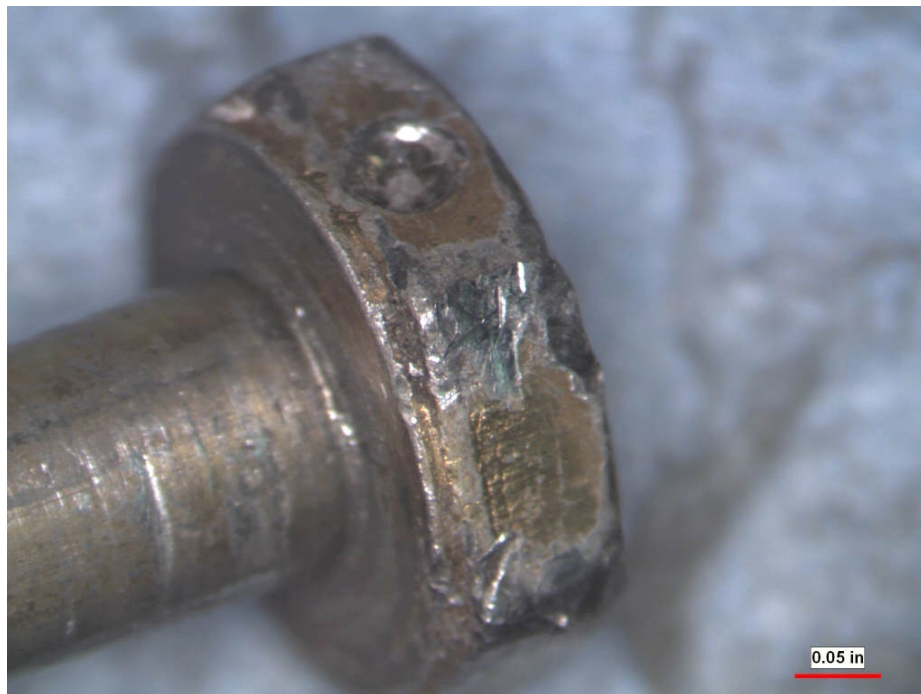
Figure 10. Magnified view showing scratching damage on the head of the AN3H27A bolt. Magnification: x9.

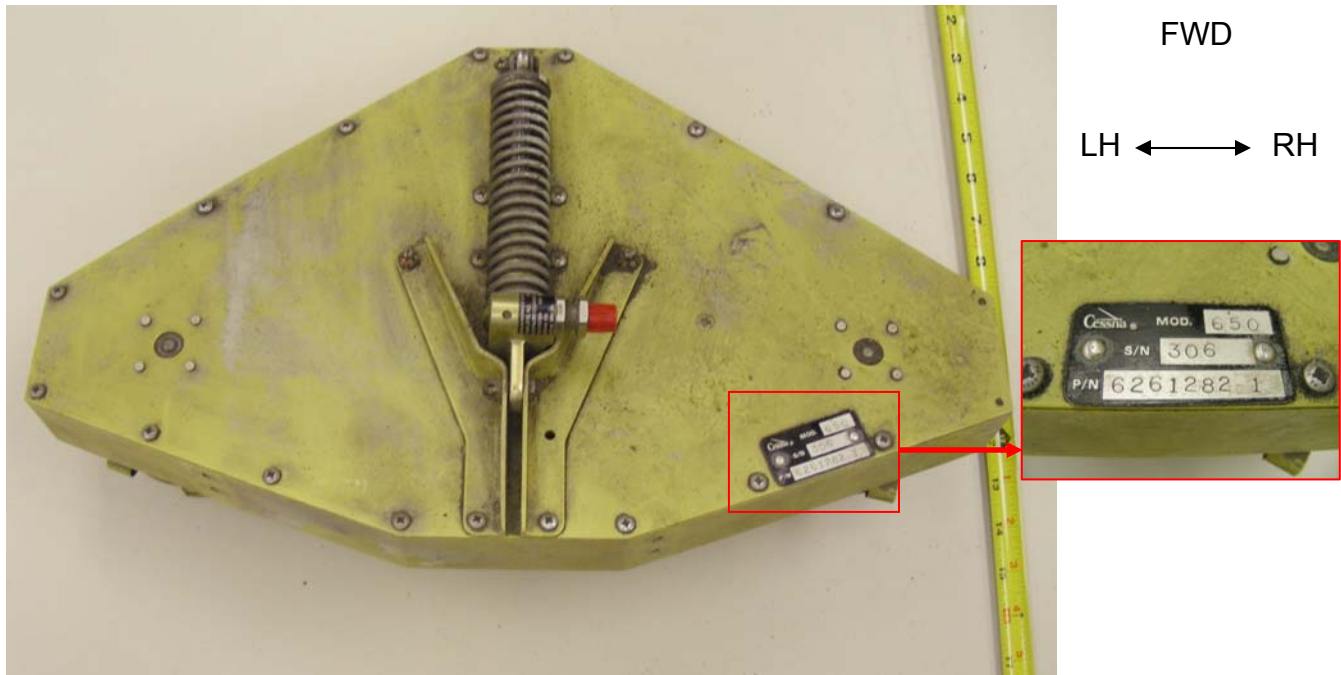
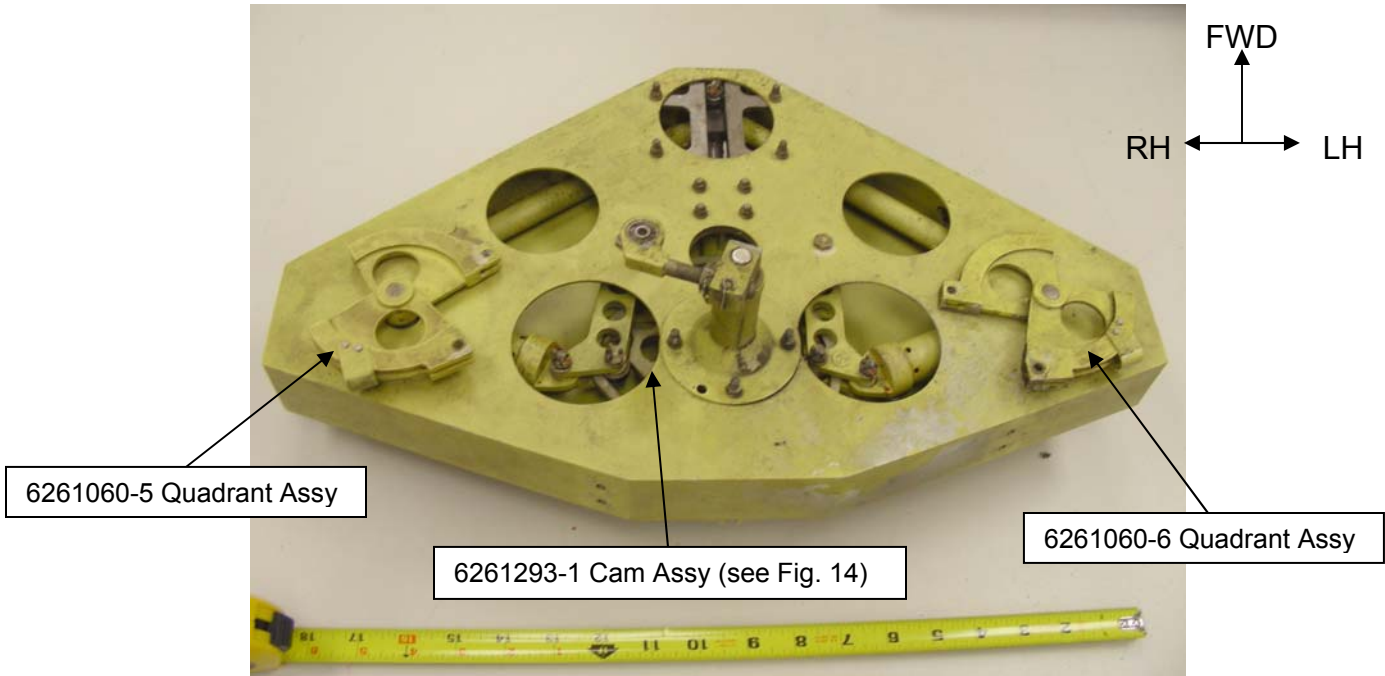
The Box Assy-Spoiler Mixer p/n 6261282-1 was removed from the aircraft and was brought to Cessna 3-12-2012 in a sealed shipping carton by a representative of the FAA as shown in Figure 11. Views of the as-received mixer box are shown in Figures 12 and 13. The mixer box had a slightly dirty appearance, with some grit material within. Visual inspection of the mixer box did not reveal any missing or loose component parts. Rotation of the 6261293-1 cam assembly was easily accomplished manually, with no perceived sticking or binding of the internal mechanism. Rotation of the 6261293-1 cam assembly resulted in the expected output movements of the 6261060-5, -6 quadrants. The nickel plated steel cam assembly (p/n

Figure 12. View of the upper surface of the 6261282-1 Box Assy-Spoiler Mixer, s/n 306 in the condition in which it was received.

Figure 13. View of the lower surface of the 6261282-1 Box Assy-Spoiler Mixer, s/n 306 in the condition in which it was received.

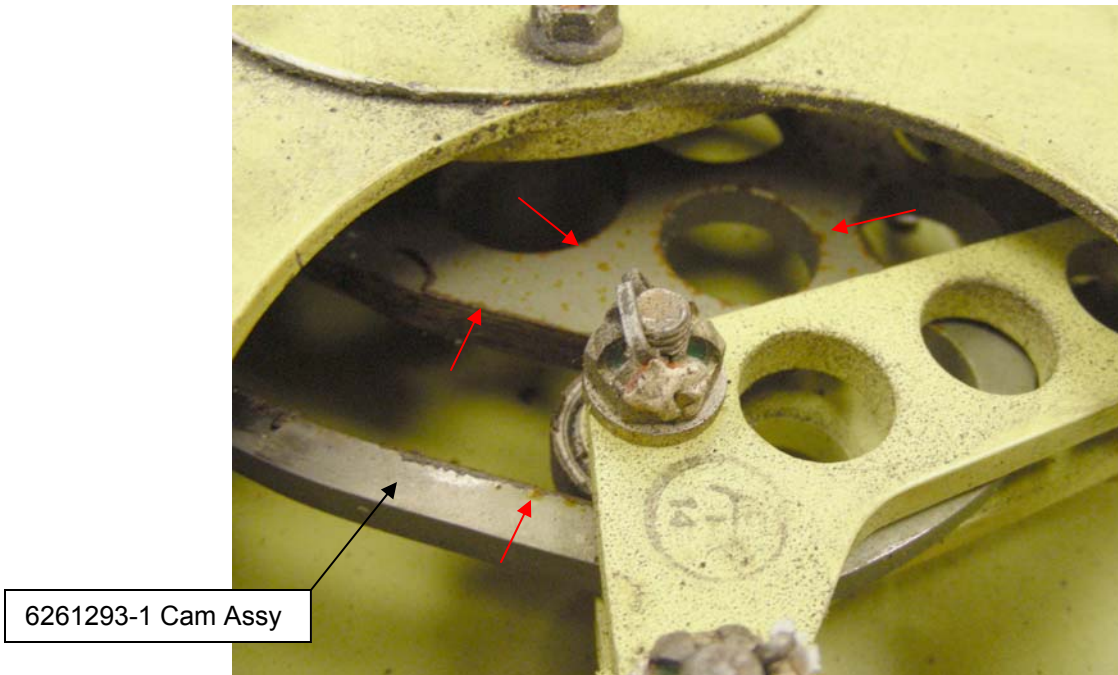
6261293-1) showed some small areas of local corrosion, Figure 14. Wear of the cable grooves in the 6261060-5, -6 quadrant assemblies was noted due to contact with the cable (Figure 15). No disassembly of the as-received mixer box was done during this examination.

Figure 14. View of the 6261293-1 Cam Assy showing small local areas of corrosion (red arrows).

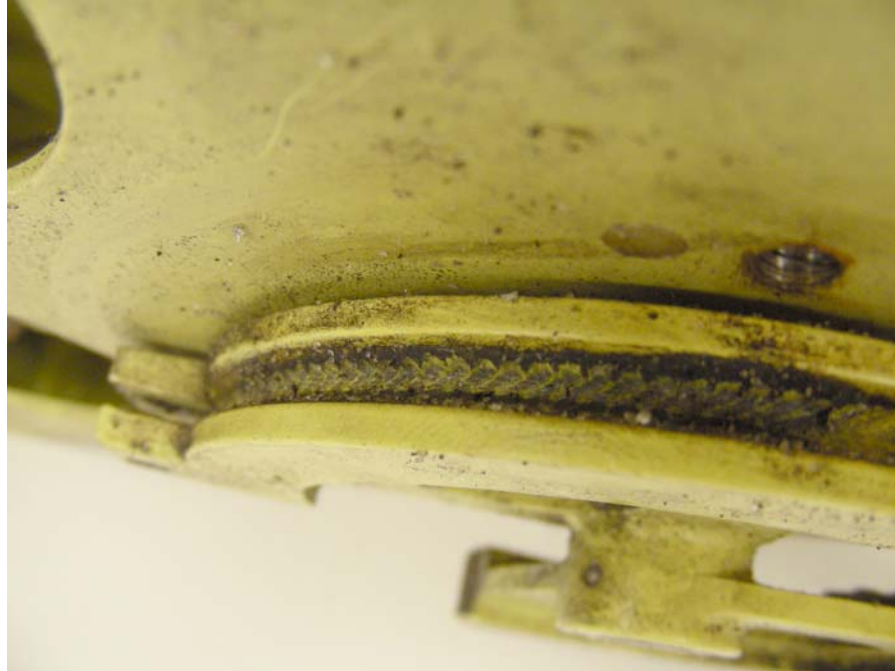
Figure 15. View of the cable groove on the 6261060-6 quadrant assembly showing wear due to contact with the control cable. Wear of the cable groove of the 6261060-5 quadrant assembly was similar.
