Aircraft Mishap Report Cessna Aircraft Company

Year: 1964 Model: 310I
Serial Number: 310I0145 Registration Number: N8145M
Mishap Location: San Dimas, CA Date: 07/04/02 Time: 1231 PDT
Registered Owner: Michael & Debbra Brand Operator: Same as Registered Owner
[Redacted]
Glendora, CA 91740

Cessna Investigator: Henry J. Soderlund NTSB Investigator: Jason Ragogna
Cessna Report Number: 02-BAUK NTSB Report Number: LAX02FA214
Report Date: 01/30/03 Party Status: Yes
Investigator's Signature: [Redacted]

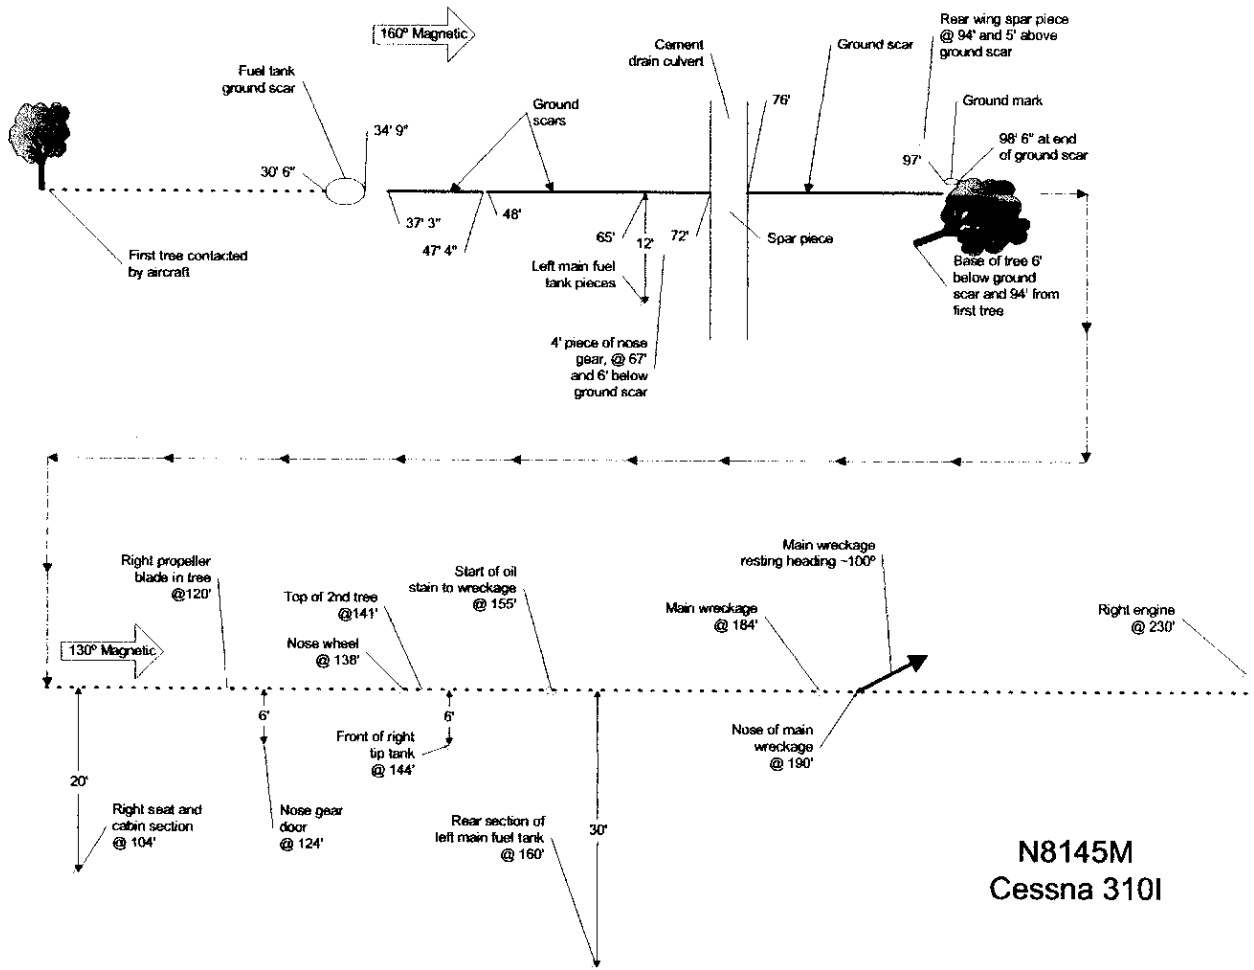
**N8145M
Cessna 310I**

Location: Off Airport Latitude: N 34° 5.0590' (GPS)
 Elevation: 920 Ft. MSL Longitude: W 117° 48.400' (GPS)
 Obstacles Struck Before Principal Impact: Trees
 Terrain Features: Wooded Level Shoreline
 Terrain Conditions: Dry Soft
 Light Conditions: Day
 Flight Path: Vertical Angle: Level ° Magnetic Heading: 160° to 130°
 Approx. Attitude at Impact: Roll: Left ° Pitch: Level ° Yaw: Left °
