THE CESSNA AIRCRAFT COMPANY  
P.O. BOX 7704  
WICHITA, KS 67277

MODEL NO: 560XL

REPORT NO: PR-560XL-009

560XL-5599 FOLLOW-ON INVESTIGATION  
(NETJETS TAIL N613QS)

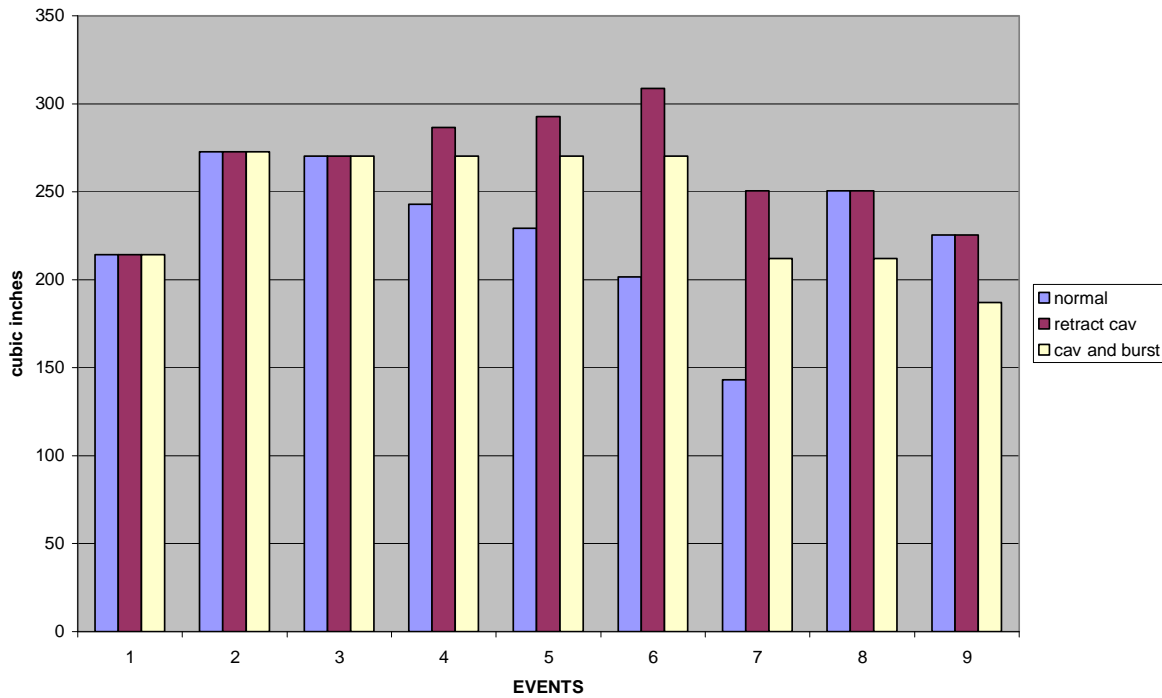
FIGURE 2-1: HYDRAULIC RESERVOIR VOLUME

The following analysis is not conclusive, but the fluid found in the reservoir after the incident is consistent with the amount that would be expected if the gear control valve were not in the extend position during the event. Volume analysis is also consistent with the likelihood that the gear retract side of the hydraulic landing gear actuators were filled with vaporized fluid resulting

from gear retraction without the hydraulic cylinders being filled with fluid. Low pressure forming as gear retract side volume increases without input of hydraulic fluid results in a fluid and fluid vapor mix that is restored to normal when the gear is blown down pneumatically. The analysis shows that the end reservoir volume is consistent with a normally serviced reservoir. If the reservoir had been overserviced to the 360 in<sup>3</sup> level, only 135 in<sup>3</sup> would have been available to leak overboard during the event. If the gear control valve had been commanding extend it is expected that it would have routed the entire volume into the fuel tank through the gear extend plumbing breach. The pumps would have been capable of pumping 285 in<sup>3</sup> from the time the aircraft was on the skid rail to when power was turned off. Therefore, fluid volume analysis concludes that the gear control manifold was not in the gear extend position after gear collapse. Reference Appendix I – Fluid Loss Addendum.

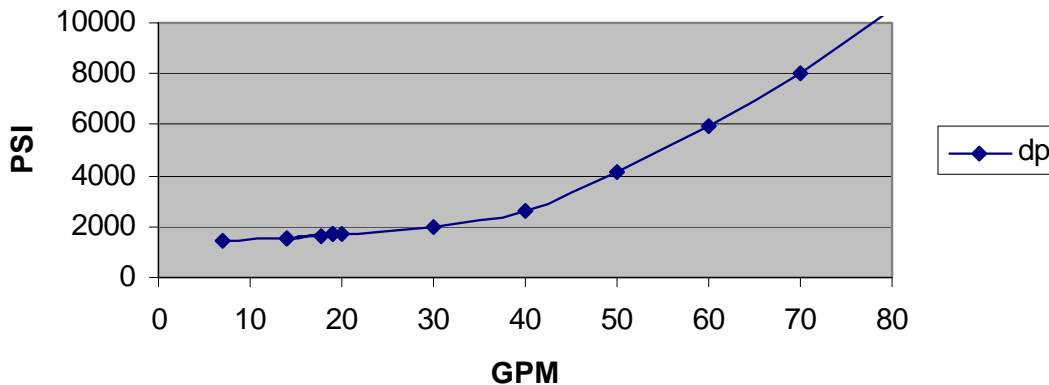
FIGURE 2-2:  $\Delta P$  EXTRAP EXTEND COMMANDED

Pressure drop data taken on incident gear extend manifold (reported in PR-560XL-008 Section 4.14 Aircraft landing gear system checkout – 09/04/08) was extrapolated. Composite curve based on hydraulic relief valve having equivalent area to 0.2 inch diameter orifice when in fully open position, per Pneu Draulics, Inc. The above graph assumes flow is coming from gear extend line back through gear control valve into system pressure, back through system relief valve, through manifold return back to hydraulic reservoir.

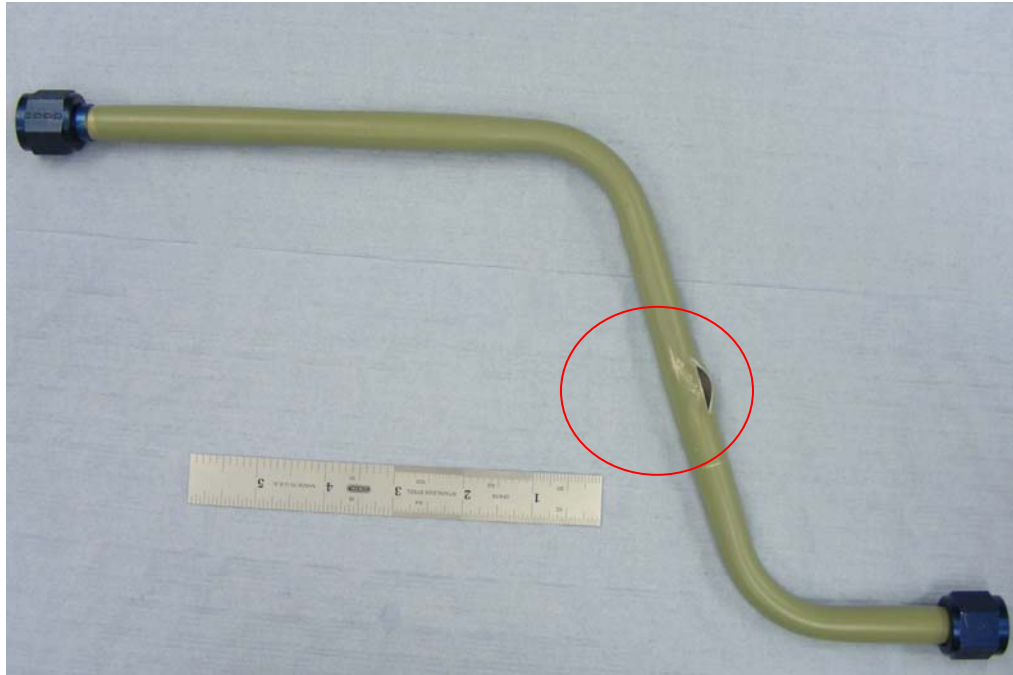
The tube assembly exhibited a longitudinal split measuring approximately 0.775 inches in length along the tube wall at the approximate mid-tube location. The tube was longitudinally sectioned at the burst. No visible tube defects or flaws were found on the ID surfaces that could have caused or contributed to the burst (Note: the tube was not examined at magnification in cross-section at this time). The fracture surface at the burst was characteristic of ductile overload. No pre-existing flaws were found.

Photo 1 Overall view of the burst 6627002-16 Tube Assembly. Location of burst is circled.

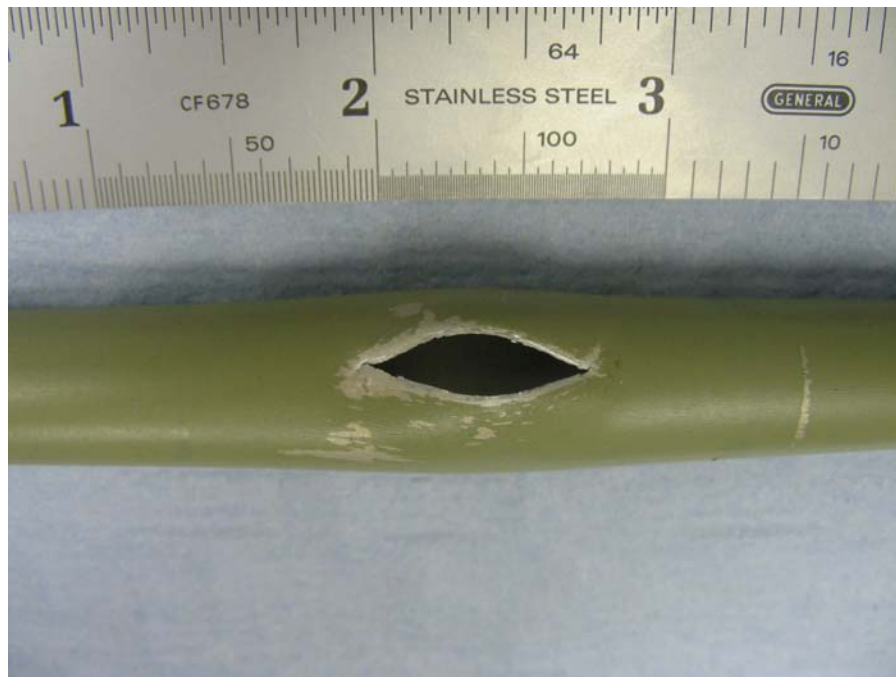
Photo 2 Close-up view of the tube burst. The shape and orientation of the burst was indicative of excessive internal pressure.

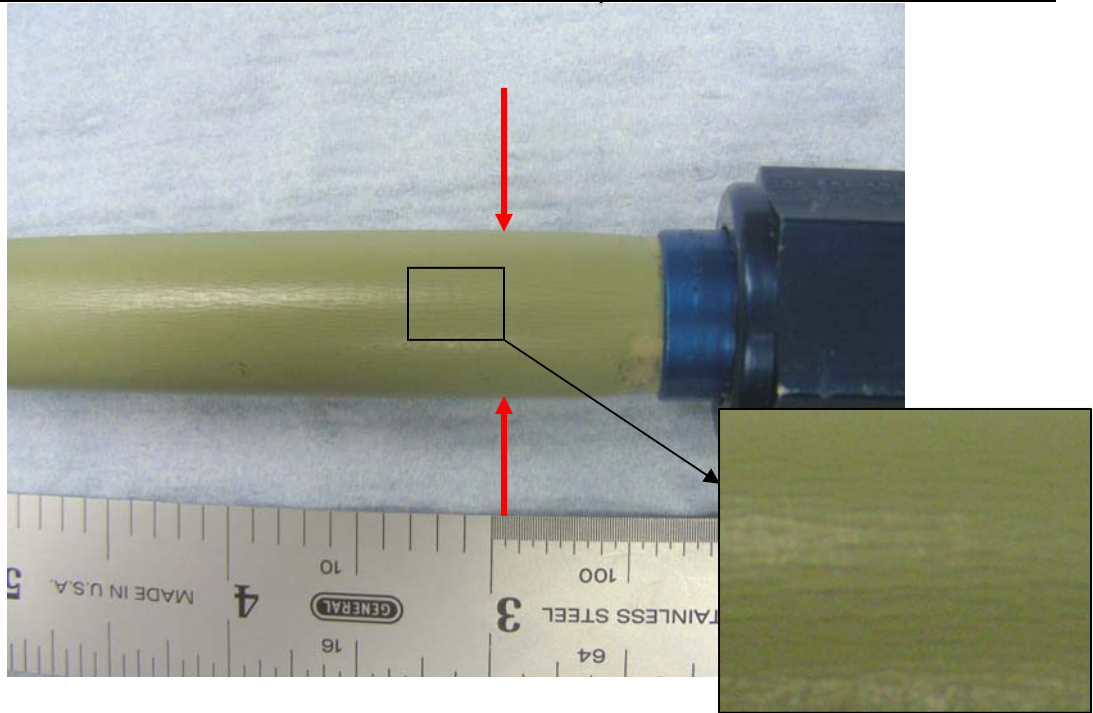
The wall thickness of this tube was approximately 0.042 to 0.045 in., (measured on areas where the primer was removed from the OD). The nominal wall thickness was specified to be 0.049 inches. According to ANSI H35.2, the tolerance on wall thickness for nominal 0.049" wall drawn aluminum tubing is 0.003", so this tube in its current condition is below minimum tolerance. The tube also displayed some bulging that expanded the tube OD from the nominal 0.500" diameter to approximately 0.560-0.570" in several areas. Longitudinal cracking of the OD primer coating is further evidence of tube OD expansion, which accounts for the reduction in wall thickness.

Photo 3 Close-up view of the tube near the aluminum sleeve, showing enlargement of the tube OD (red arrows) and longitudinal cracking of the primer (inset), indicative of excessive internal pressure.

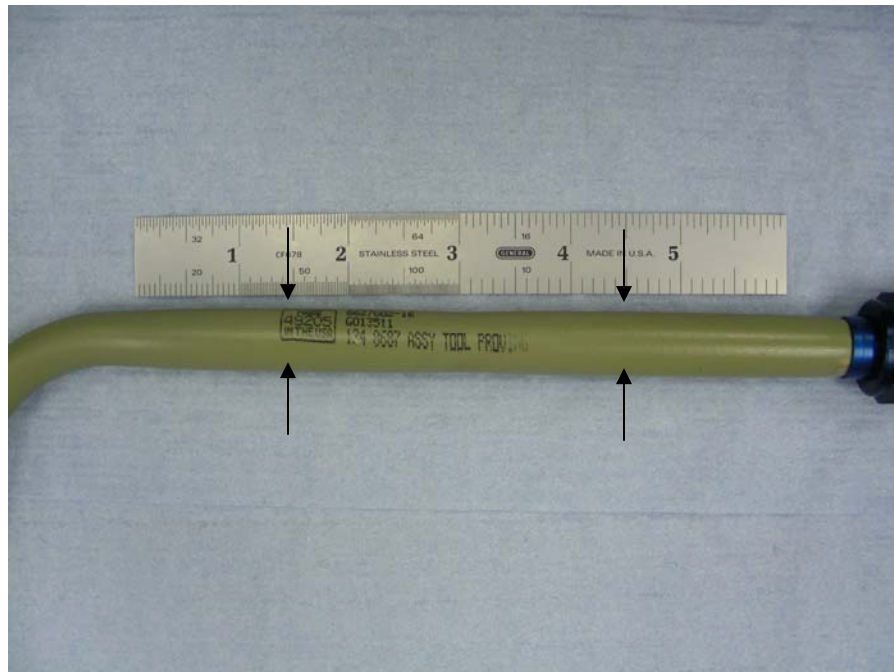
Photo 4 View showing enlargement of the tube OD (arrows).

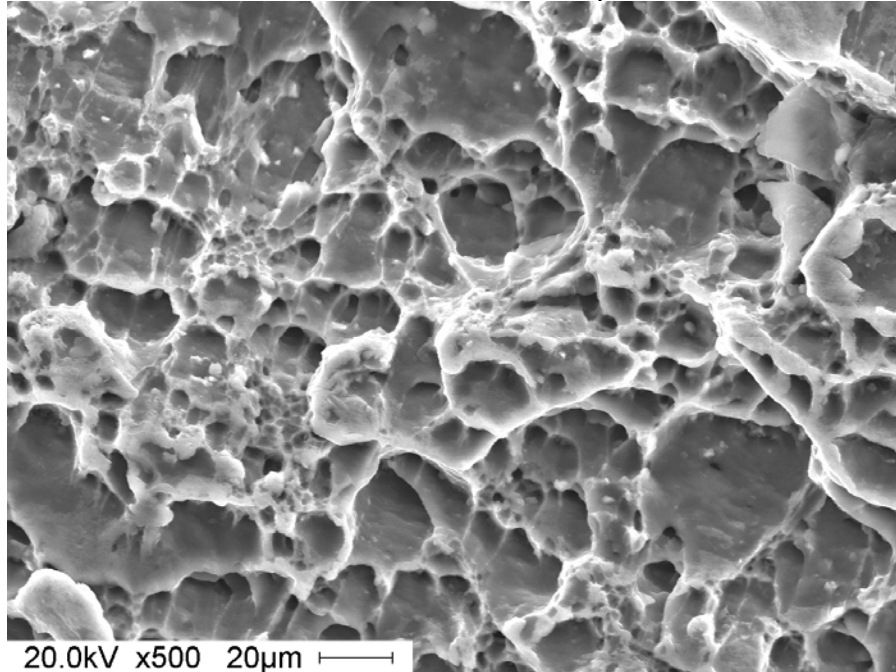
Photo 5 Scanning electron microscope view of the burst fracture surface, which was indicative of ductile overload. Magnification: x500.

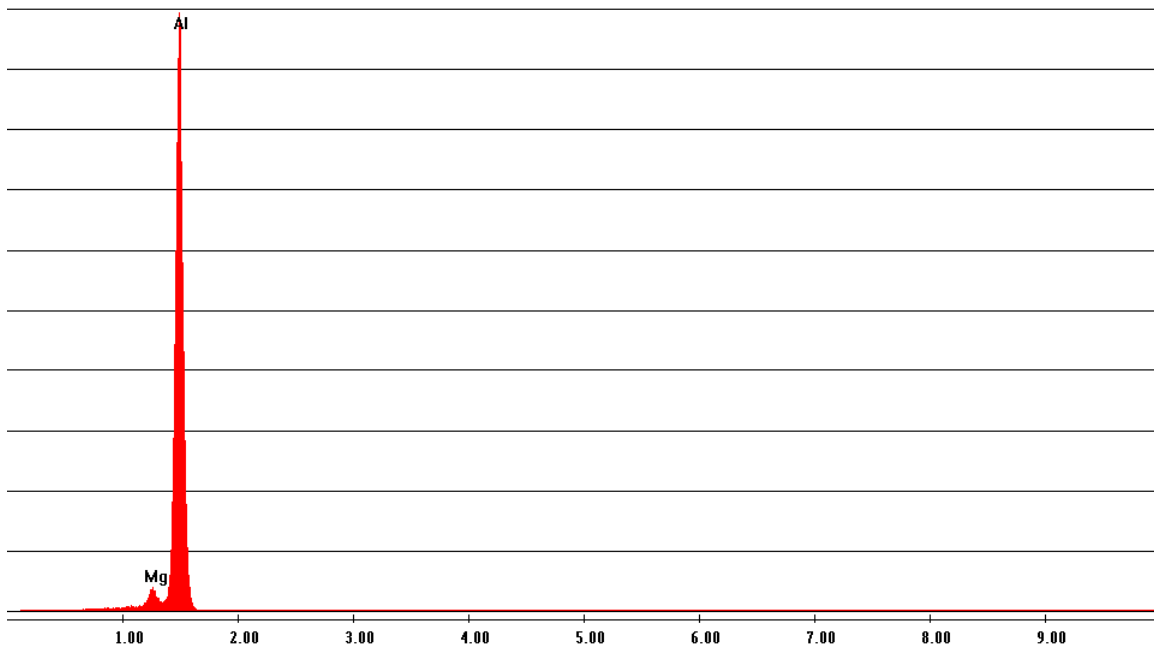
The chemical composition of the tube was determined using energy-dispersive x-ray spectroscopy in the electron microscope, and was found to be consistent with 5052 aluminum alloy, as specified in the engineering drawing parts list.

Photo 6 Chemical analysis spectrum of the burst tube metal. The chemical composition of the tube was consistent with 5052 aluminum alloy, containing mainly aluminum and magnesium. Note: 5052 should also contain chromium at 0.15-0.35 wt.%, which is below the detectable limits of this analysis technique.

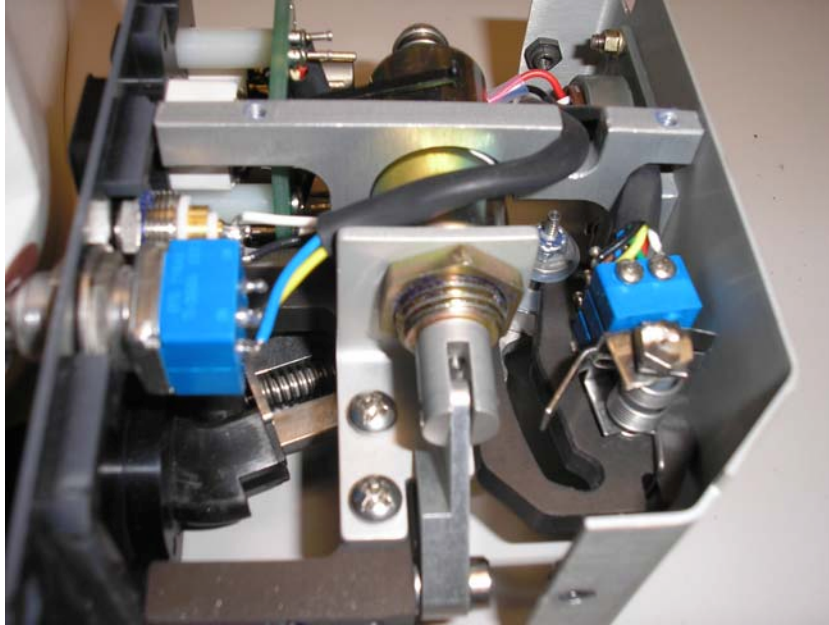
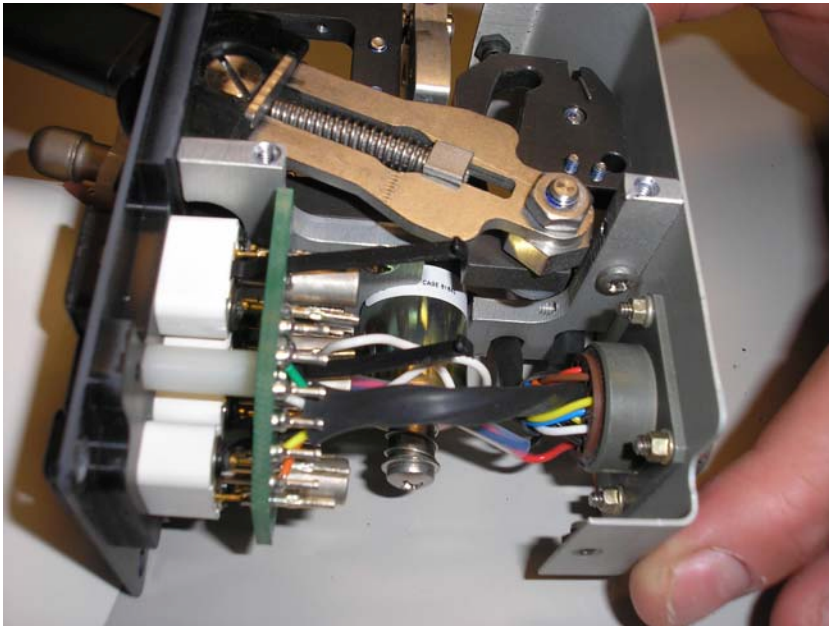
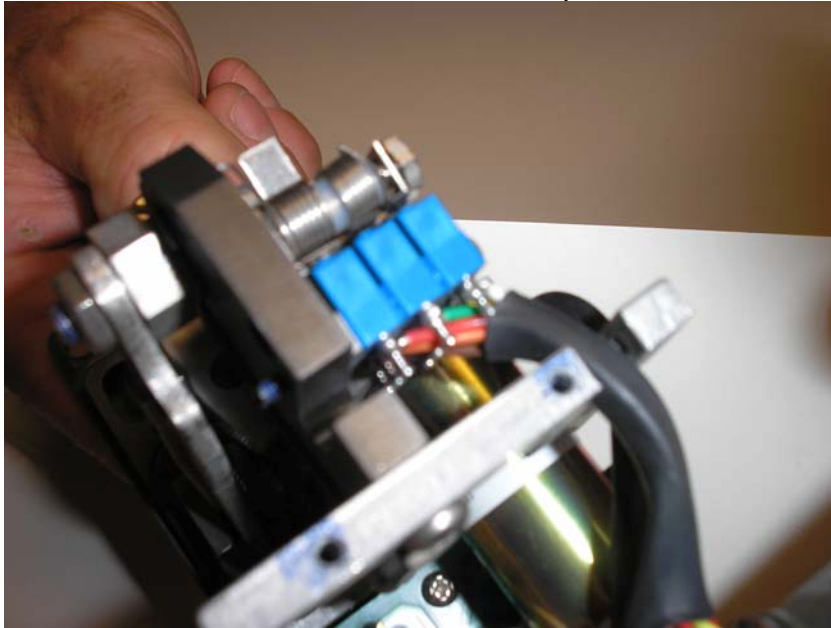
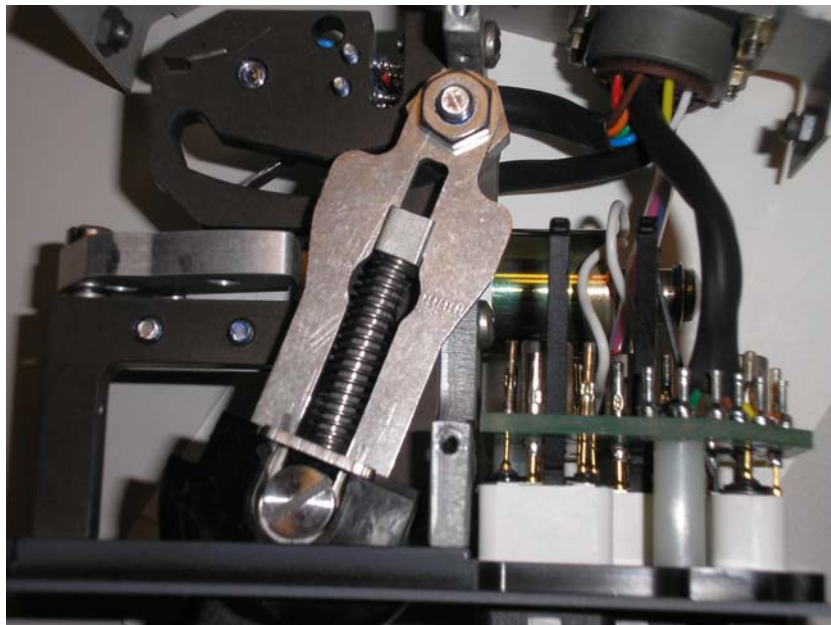
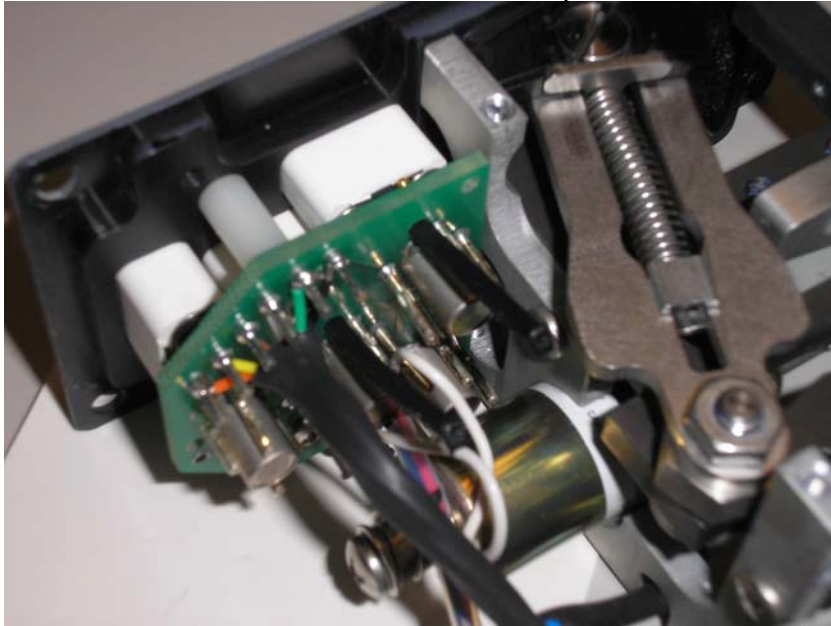
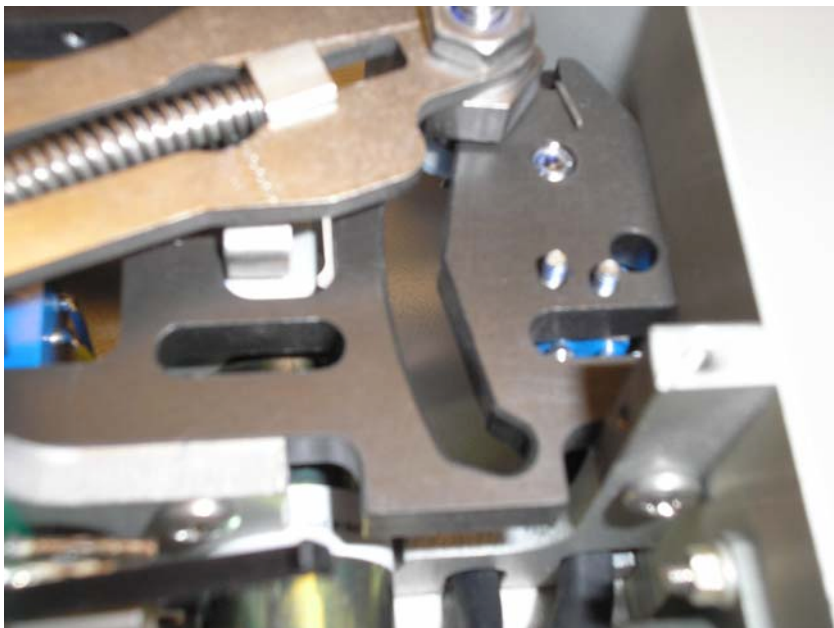
The gear control handle was partially disassembled to inspect for any visible damage either mechanical or electrical. The wires and electrical connectors were inspected for secure connections, chafing, or arcing. The mechanical portions were inspected for security and indications of wear or binding. Again, this was only for inspection purpose, no electrical tests were performed. No anomalies were found. Reference Appendix G - Gear Control Handle for pictures of the gear handle partially disassembled.

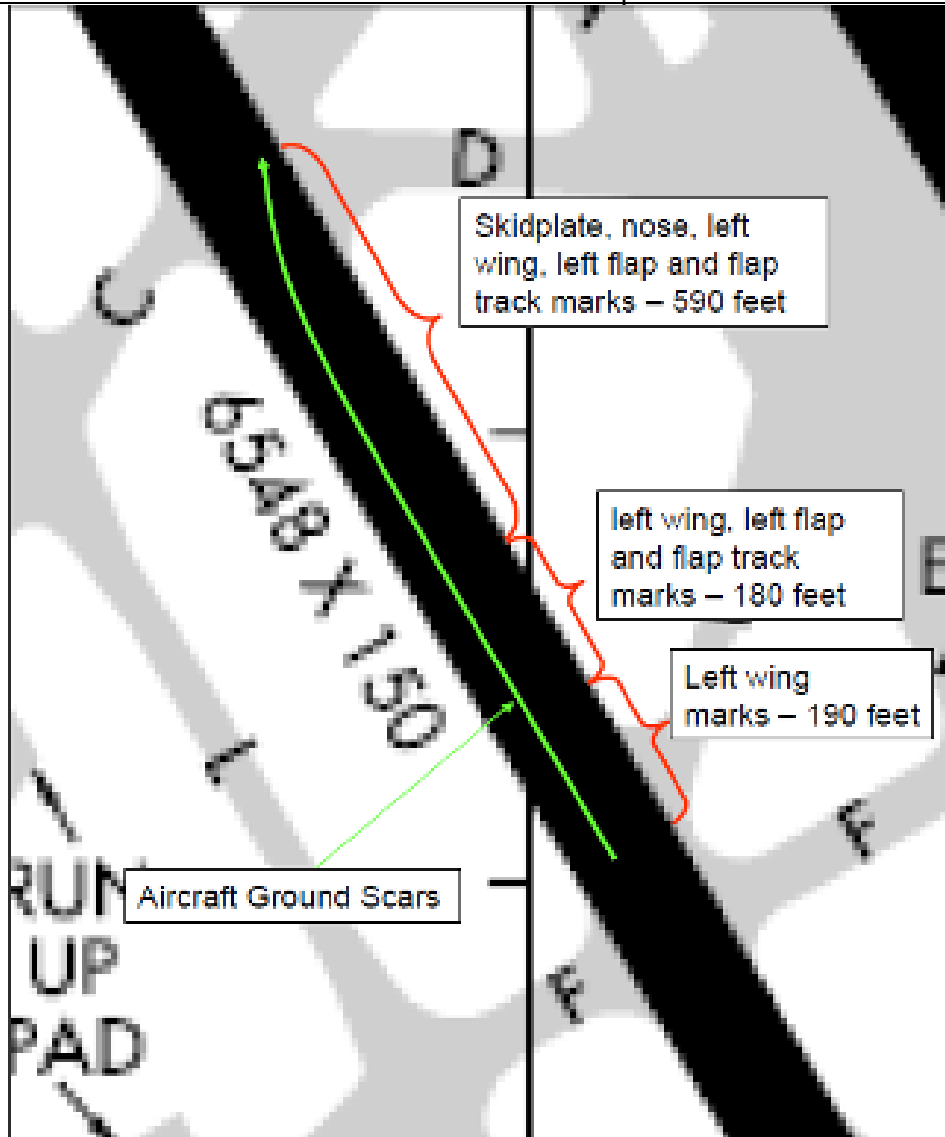
Runway Scars

Report PR-560XL-008 indicated potential investigation regarding the flap system, and clues that may help identify root cause. The only finding with respect to the flap system is that the runway scars are consistent with crew statements regarding commanded flap position. The ground loads acting on the flaps overpowers the hydraulic pressure to put the flaps closer to the zero position than commanded. The aircraft system result is to continuously command flap extend and energize the hydraulic system by closing the loading valve. Therefore, it is concluded from this condition that the aircraft hydraulic system was pressurized from the time of secondary runway contact (after the period where only the LH wing tip was contacting the runway) until power was turned off due to flaps were out of commanded position condition. Thrust reverser deploy also results in the same finding for the hydraulic system pressurization, so no significant insight is gained due to this correlation. It is concluded that the flap system were operating properly and did not contribute to the incident.
