TECH NOTE

No. 011

Cessna Pilots Association

Vapor Lock Problems in 210 Series From 1964 thru 1981 Model Year

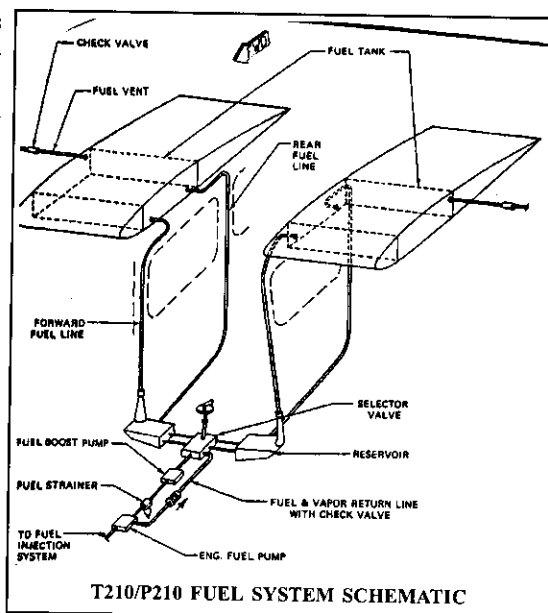
T210/P210 FUEL SYSTEM SCHEMATIC

Now lets go back to how vapor is handled by the 210 fuel system. The vapor is separated at the fuel pump and then sent back to the reservoir tank from which it goes up the forward fuel feed line to the fuel tank that is selected. However the turbocharged aircraft can, under certain circumstances, produce so much fuel vapor that the system is overwhelmed.

The reservoir tank fills with vapor faster than it can migrate up the forward fuel feed line. While restricting fuel flow down the forward fuel feed line the vapor is also being sucked into the line going forward to the engine driven fuel pump in increasing amounts. Eventually not enough liquid fuel is getting to the pump to meet the engine's demands and the fuel flow fluctuations start.

The important thing to remember in this situation is that the other reservoir tank associated with the other wing tank is sitting there full of fuel with no vapor in it. Simply switching tanks will correct the situation almost immediately.
