Cessna Aircraft Company Aircraft Incident/Accident Technical Report

Aircraft and Incident/Accident Information			
Year: 1977	Model: 182Q	Serial number: 18265584	Registration: N182PE
Location: Littleton, NC		Date: 06-27-14	Time: 0944 EDT
Aircraft Owner		Aircraft Operator	
Poe Incorporated 1300 Old Logan Rd Manakin Sabot, VA 23103-2724		Same as Aircraft Owner	
Report Information			
Senior Air Safety Investigator: Henry J. Soderlund		Report #: ASI-14-BC-T	Report date: 09-30-14

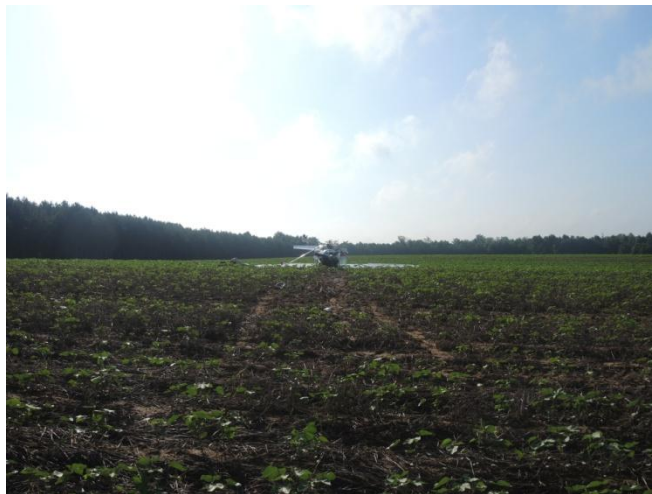
On Site ASI-14-BC-001

Based on 78 foot long ground scars, the aircraft contacted an open field in a nose up, wings level attitude. The aircraft's nose then contacted the soft terrain and the aircraft inverted coming to rest facing the initial ground contact point. The outboard portion of the right wing was bent down and the bottom of the engine cowling was pushed up into the engine compartment. The top of the vertical stabilizer was crushed down where it contacted terrain. Vertical wrinkles were present on the sides of the empennage.

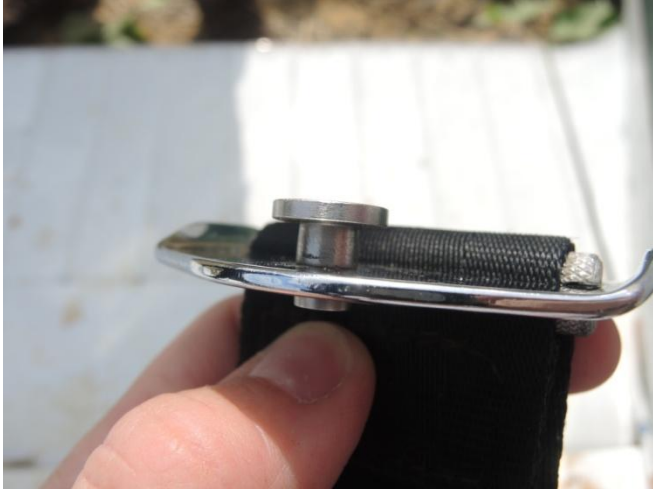
On Site ASI-14-BC-060

The seat 1 shoulder harness attachment rivet/post was missing its bushing.

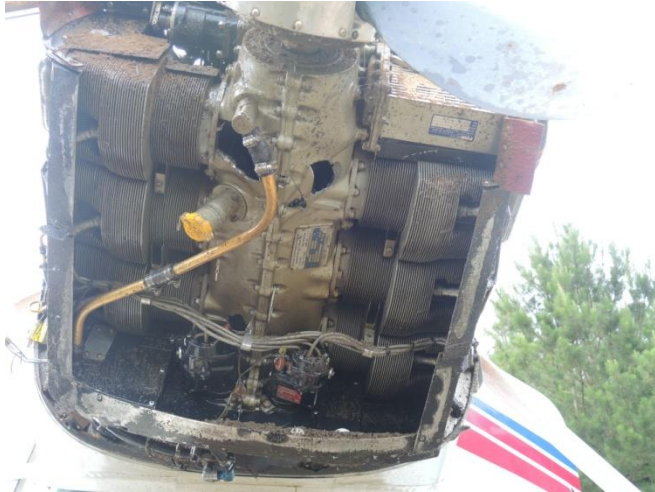
On Site ASI-14-BC-160.jpg

Multiple holes were observed in the crankcase. The rocker box covers on cylinders 4 and 6 were both missing screws. Multiple screws on all of the rocker box covers were loose.

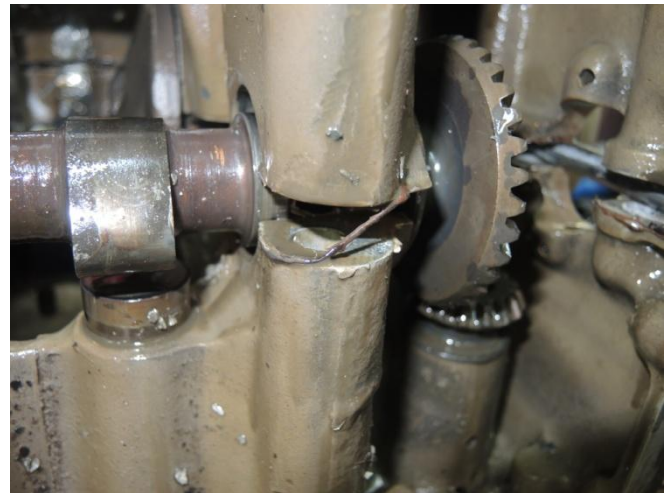
Wreckage review ASI-14-BC-105.jpg

The engine was disassembled after the aircraft was recovered. Metal particles and oil were observed in the oil sump. The connecting rods for cylinders 1, 2 and 4, were separated from the crankshaft and attached to their pistons. A rubbery type material was found on the crankcase halves when the engine was split. The material was also present on the through bolts. Crankshaft journals 1 and 2 exhibited discoloration similar to an over temperature signature due to a lack of lubrication. The oil port for main bearing 2 was damaged and the oil port was closed off. The bearing had spread outside of the bearing saddle. A number of other bearings exhibited heat discoloration.

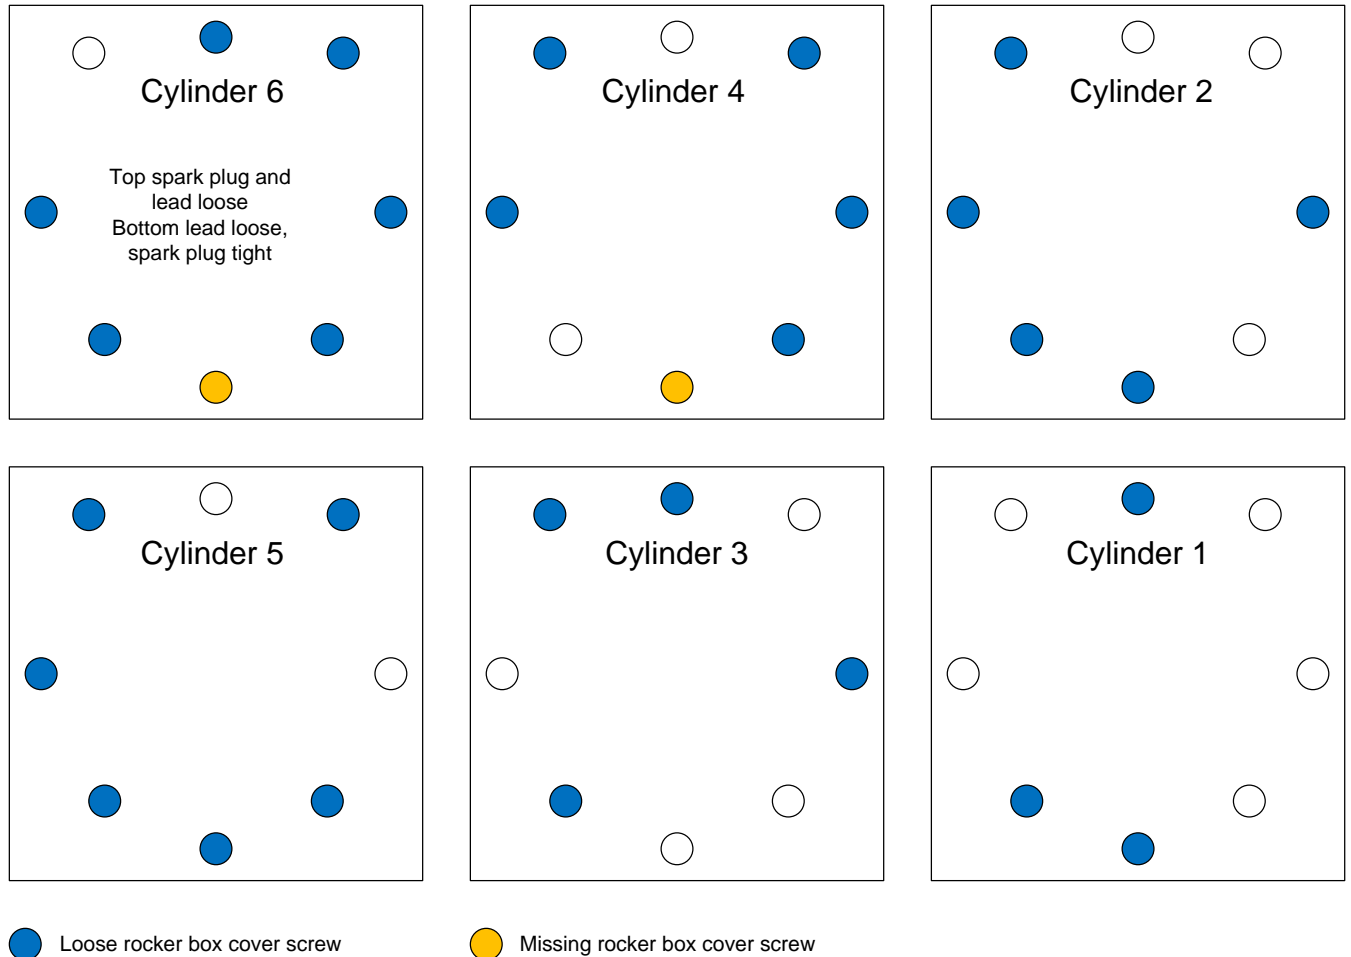
Drawing depicting loose and missing rocker box cover screws as found at the accident site.
