Cessna Aircraft Company Aircraft Incident/Accident Technical Report

Aircraft and Incident/Accident Information			
Year: 1999	Model: 172S	Serial number: 172S8255	Registration: N328SP
Location: Minden, NV		Date: 02-06-13	Time: 1709 PST
Aircraft Owner		Aircraft Operator	
James D. McFadden [REDACTED] [REDACTED]		Flying Start Aero [REDACTED] [REDACTED]	
Report Information			
Senior Air Safety Investigator: Andrew L. Hall		Report #: 13-CXDP-T	Report Date: 06-20-13

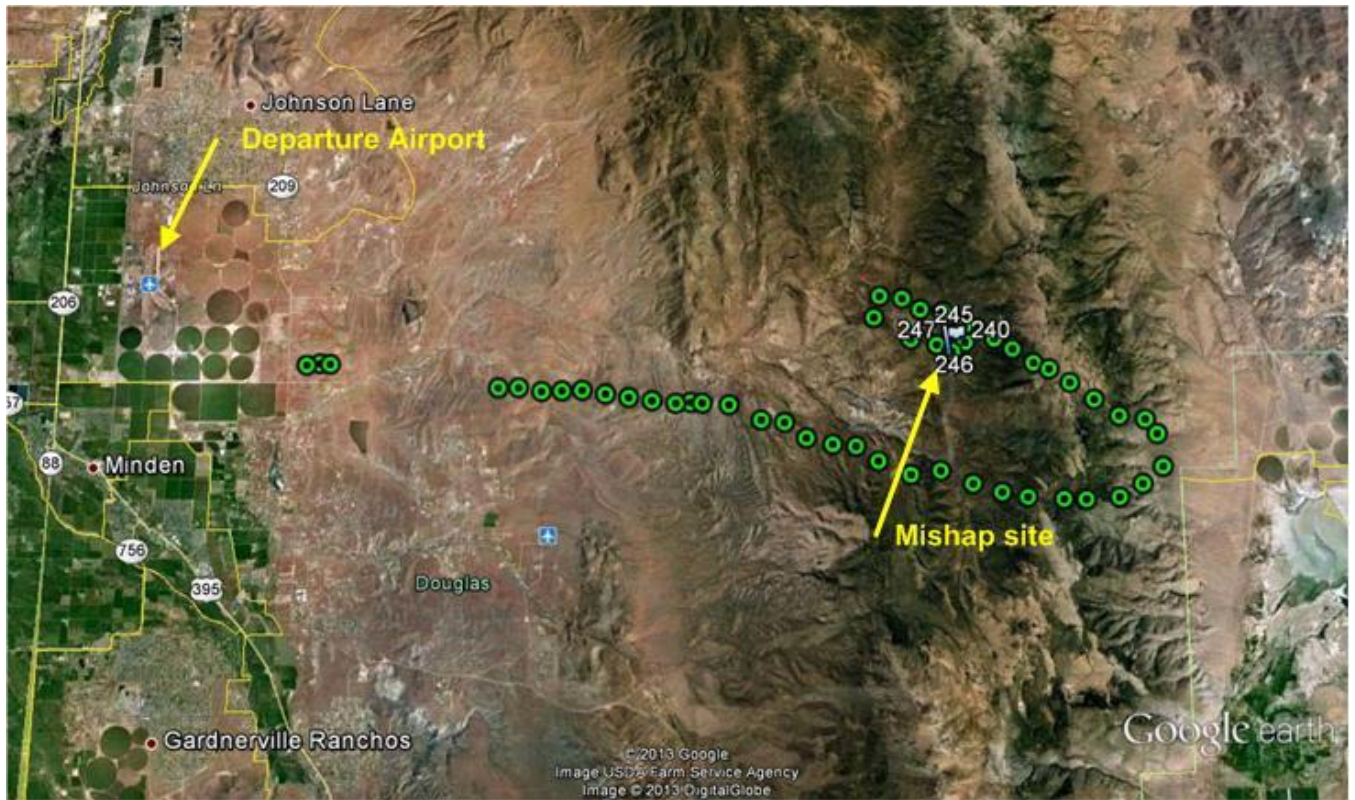
Radar data provided by Frank M. McDermott, Ltd
