CitationAir - NTSB event notification N547CS April 8th 2011 – Sec 830.5

Summary - loss of electric and manual trim tab control at top of climb 24,000 emergency declared and divert to KSAT

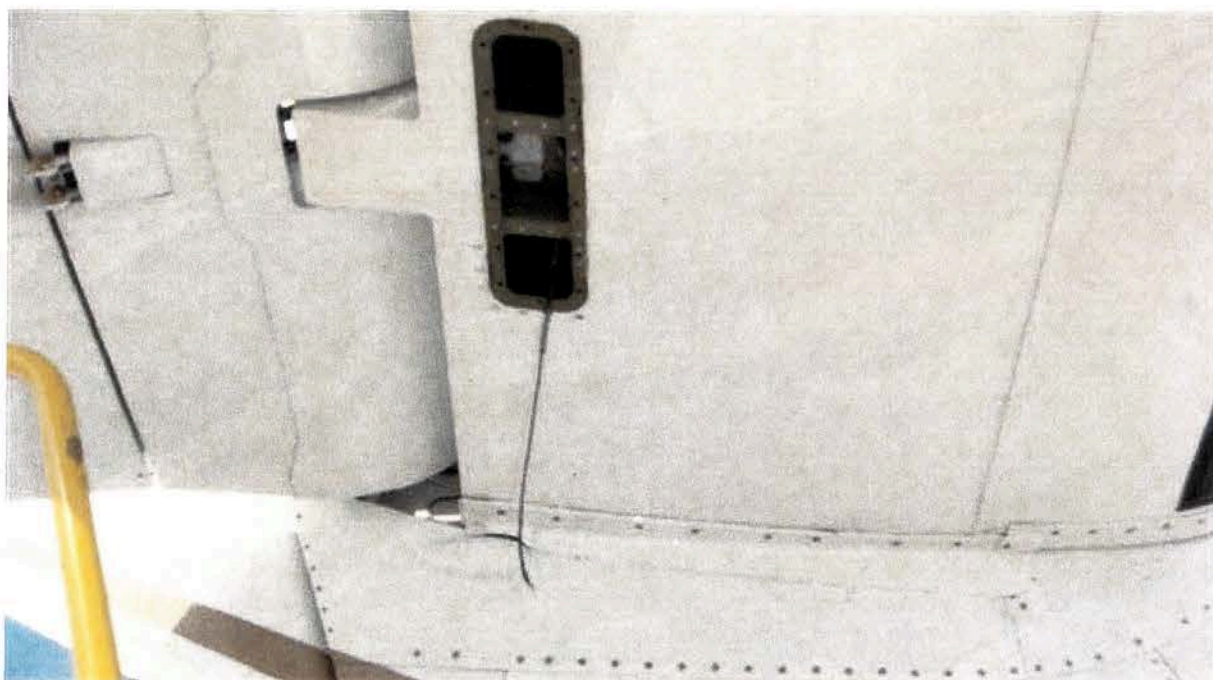
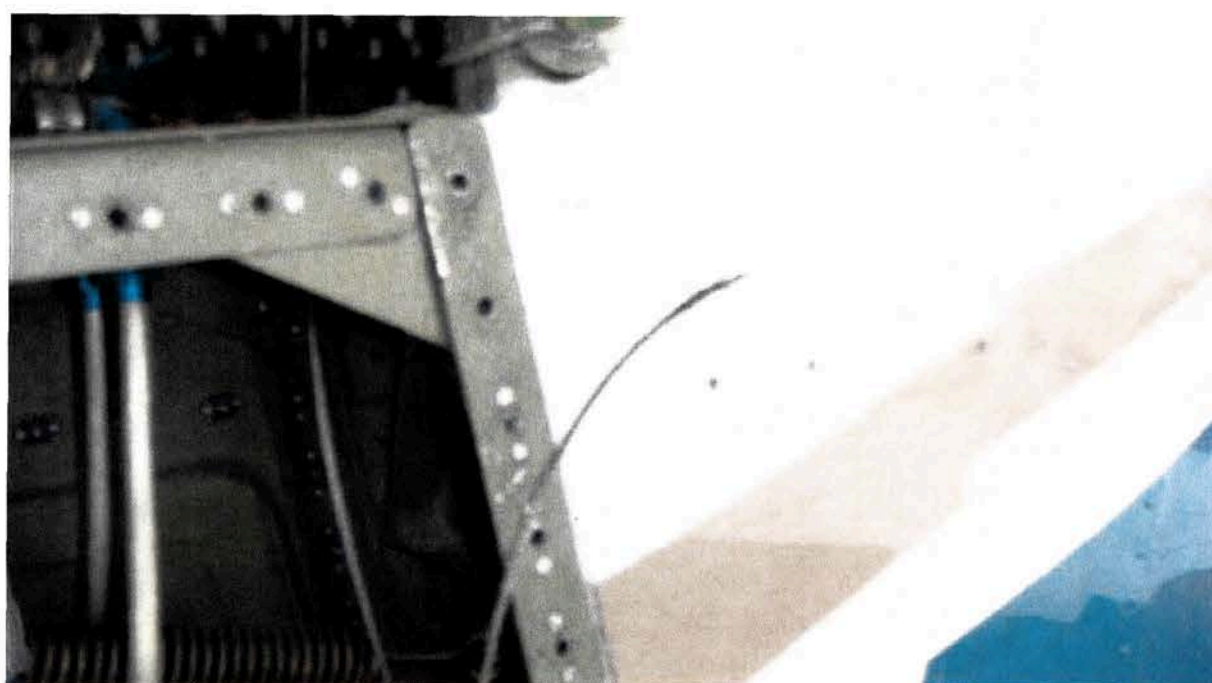
- i. Time of departure KMSY – 1950 Z, landing KSAT 2154Z total time flight 2.1 block time
- j. Information known as of 4.11.2011 – aircraft is at the Cessna Service center in KSAT. The trim tab cable broke at the position shown in the following diagram. Cable has been removed and is being shipped to Cessna in Wichita, KS for further engineering analysis.
