NATIONAL TRANSPORTATION SAFETY BOARD
Vehicle Recorder Division
Washington, D.C. 20594

Cockpit Display – Recorded Flight Data

Specialist's Factual Report
By Bill Tuccio, Ph.D.

Location: Abilene, Texas
Date: March 1, 2016
Aircraft: Vans Aircraft RV-6A
Registration: N419B
Operator: Private
NTSB Number: CEN16FA114

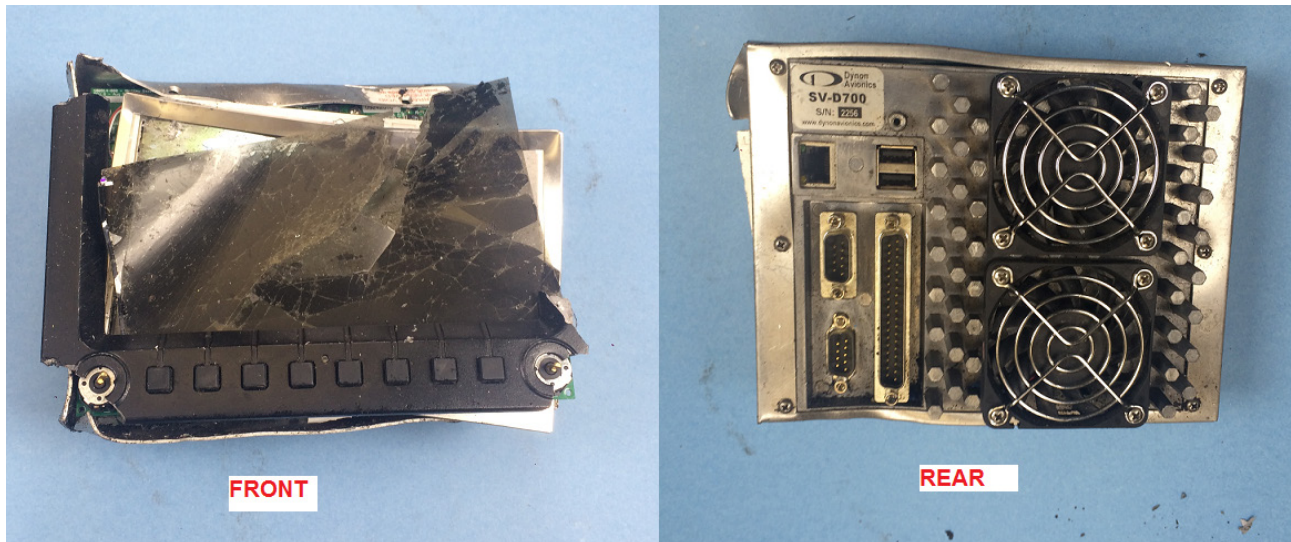
The recorder was damaged in the event. The extent of the damage is shown in figure 1. An interior inspection revealed damage to the components, however, the DOM was not damaged, as shown in figure 2. The non-volatile memory chip on the DOM (Samsung K9WBG08U1M PCB0) was removed from the DOM. A raw-data binary readout of the chip was obtained using a Xeltek SP-6000u EEPROM programmer.

Figure 1. Damaged exterior of Dynon SV-D700.

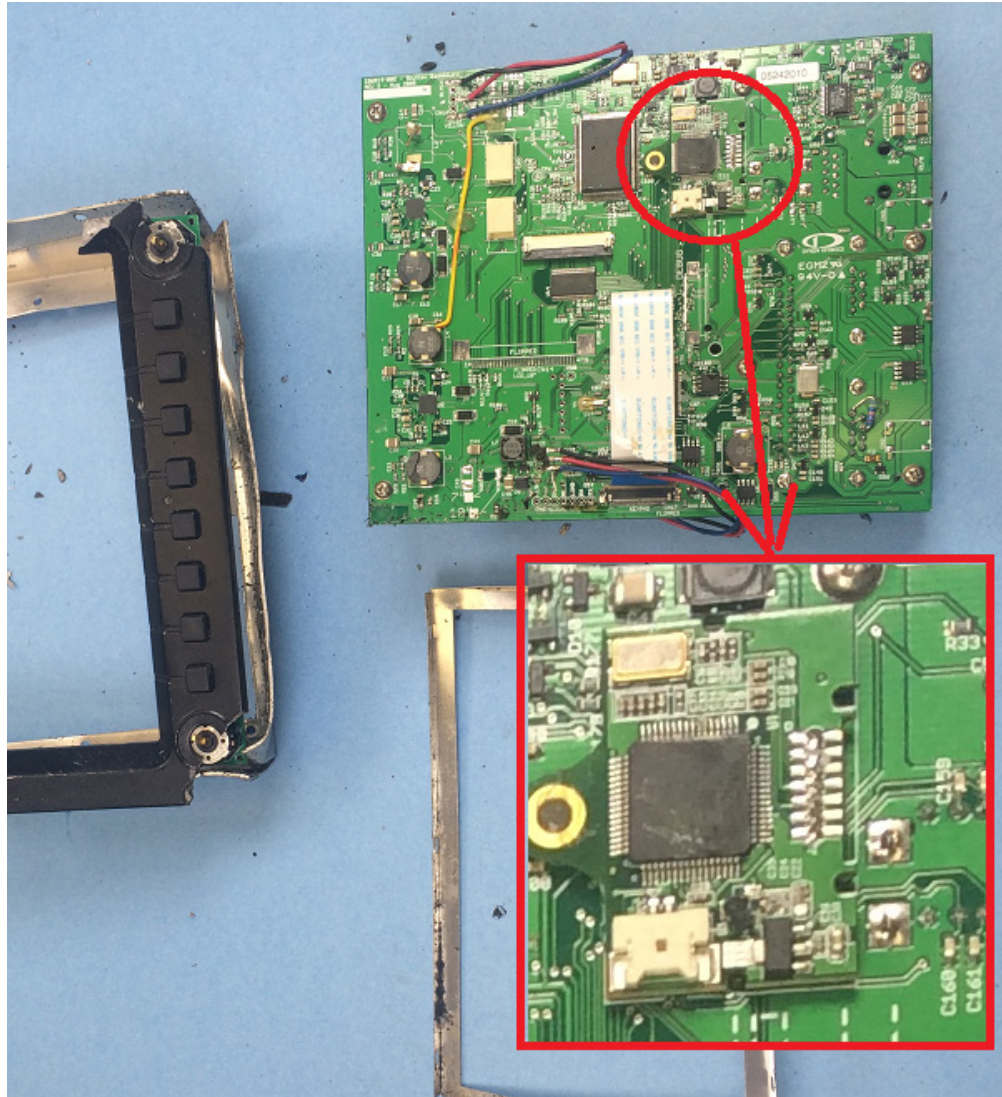
Figure 2. Internal memory board with DOM inset.

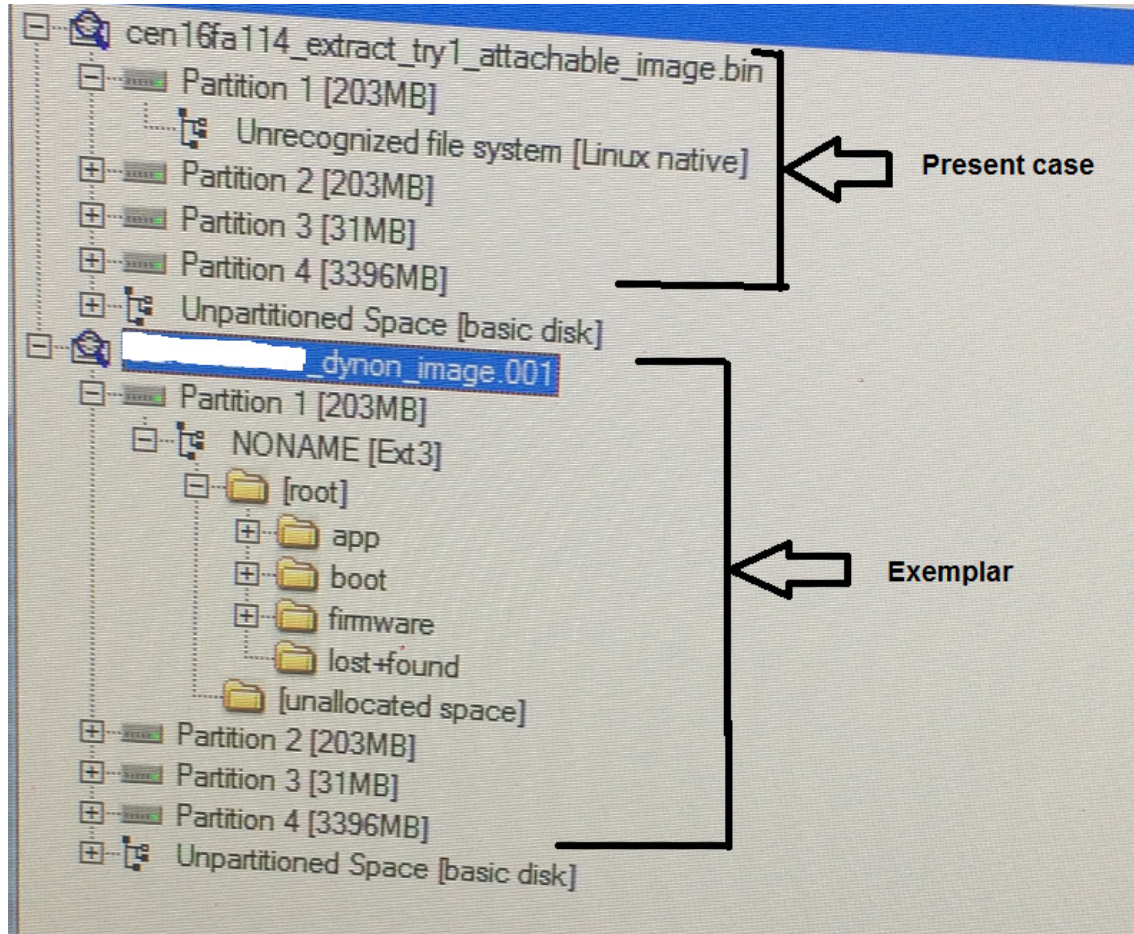
An attempt was made to read the binary readout of the chip as a Linux-based International Standards Organization (ISO) image, consistent with procedures used in other investigations; however, the binary readout would not mount. The header of the binary file was repaired and the binary readout did mount; however, the file system was corrupted. Figure 3 shows the expected file system representation from an exemplar and the corruption of the present case.

Figure 3. ISO image corruption.

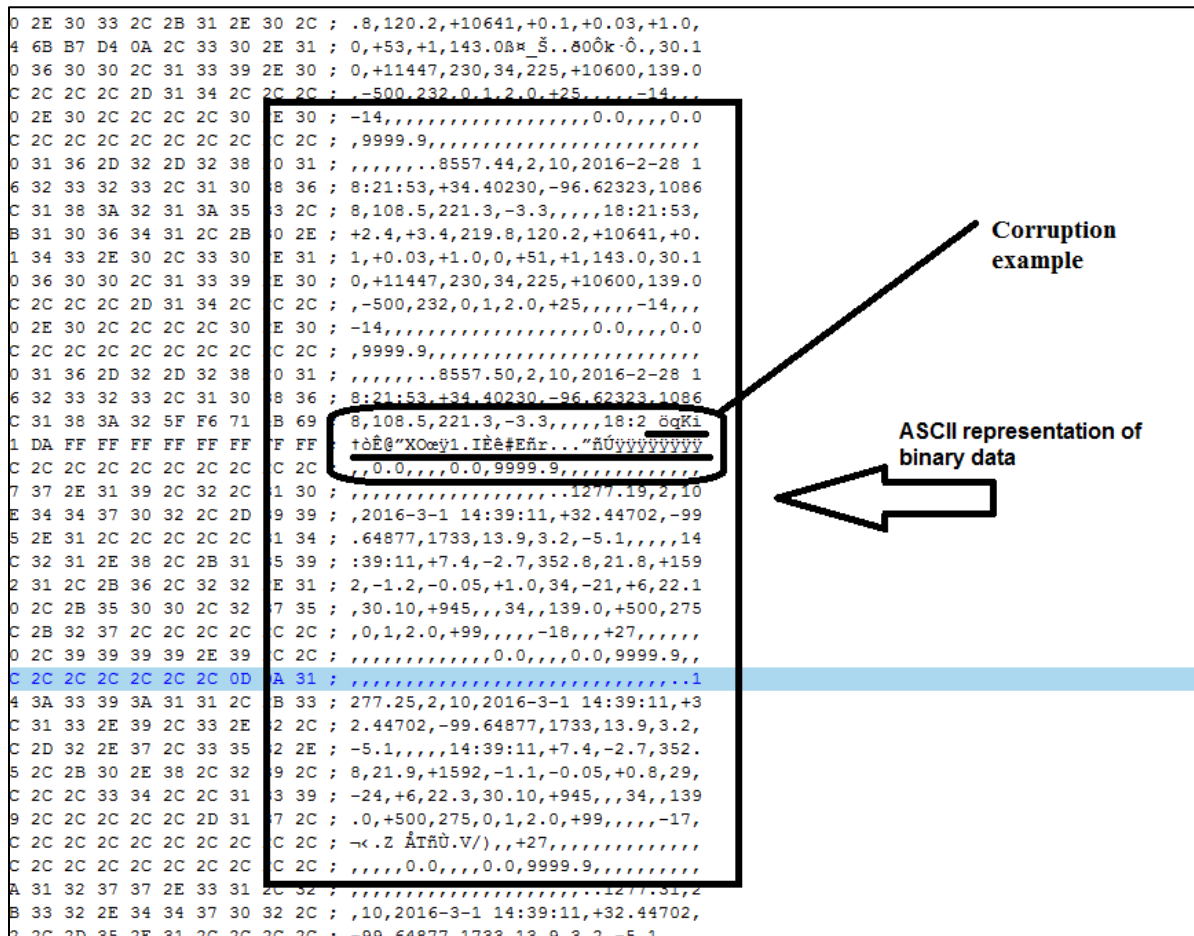
The binary readout was directly examined and fragments of text-based (ASCII) recordings were identified. The ASCII fragments contained areas of corrupted data interleaved with apparently uncorrupted data, as shown in figure 4. Valid data were manually carved out of the binary readout, corrupt data discarded, and the remaining data used in this report.

Figure 4. Valid and corrupted ASCII data.

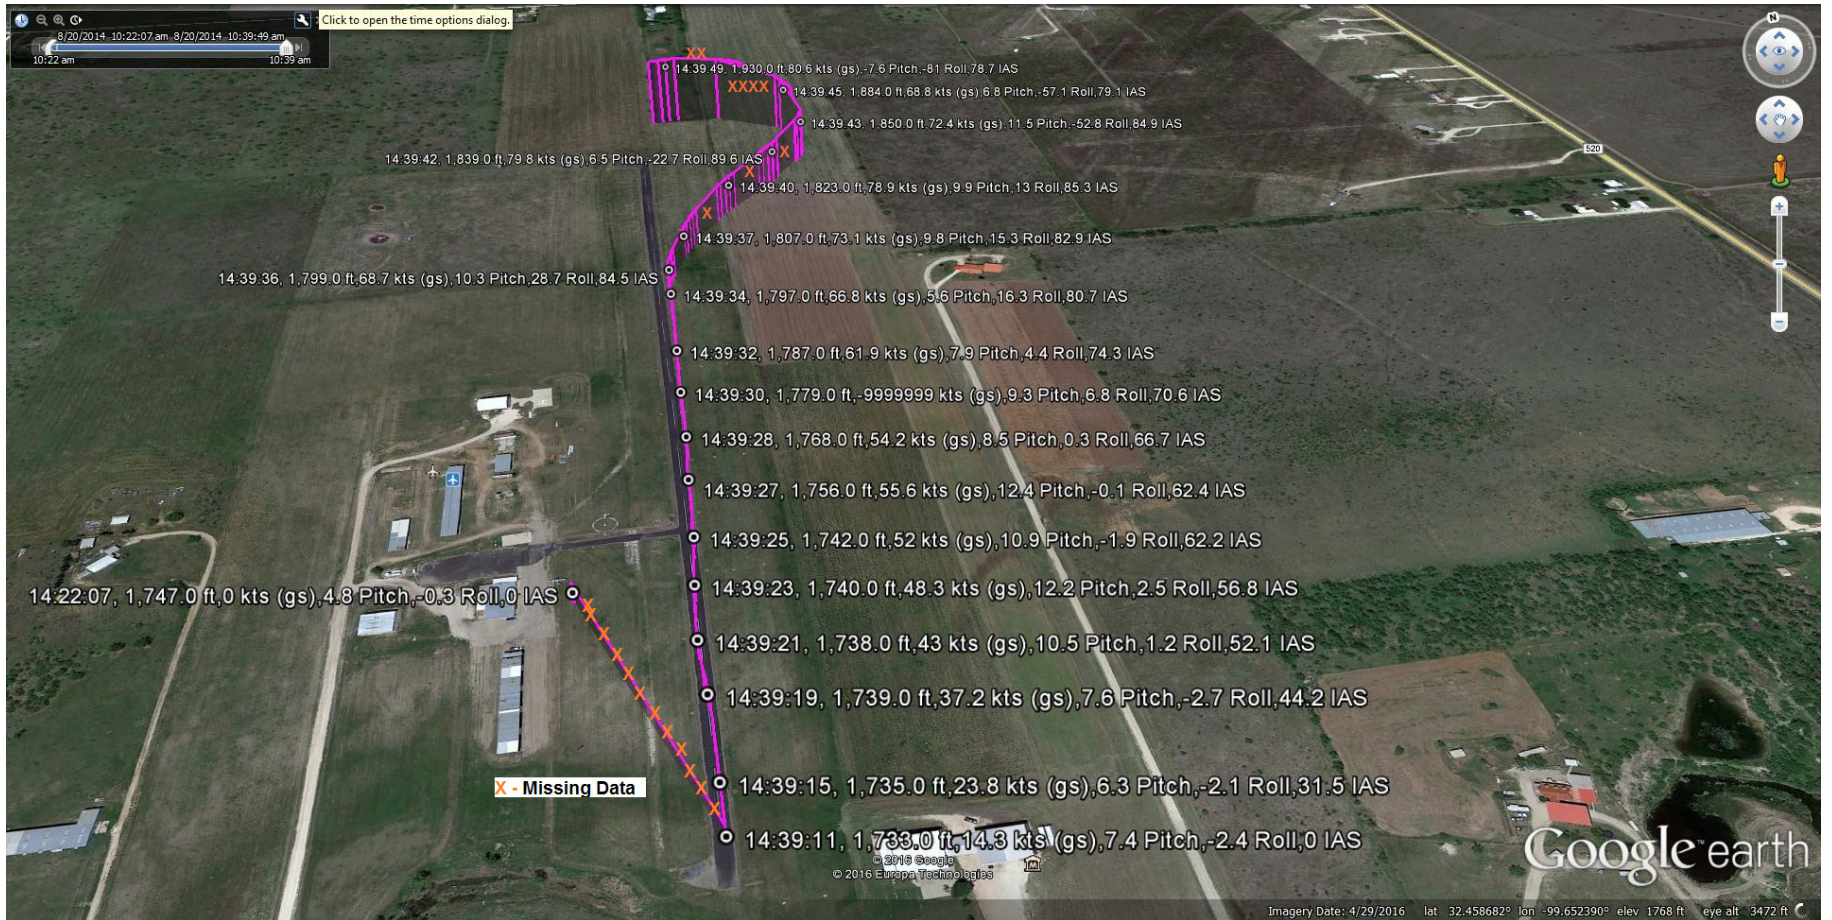
Figures 6 through 8 show the accident recording. The recovered recording began at 14:22:07 UTC on the ramp west of the runway. Due to non-recovered data between 14:22:07 UTC and 14:39:11 UTC, the taxi path to the end of runway 35 could not be determined. By 14:39:11 UTC, the aircraft began its takeoff roll on runway 35. Around 14:39:34 UTC, the aircraft began a climbing roll to the right. By 14:39:45 UTC, the aircraft began to roll left and track left. The last recovered point from the recording was at 14:39:49 UTC, and showed a pitch down attitude and left roll in excess of 60 degrees.

Figure 6. Satellite overlay of accident flight.

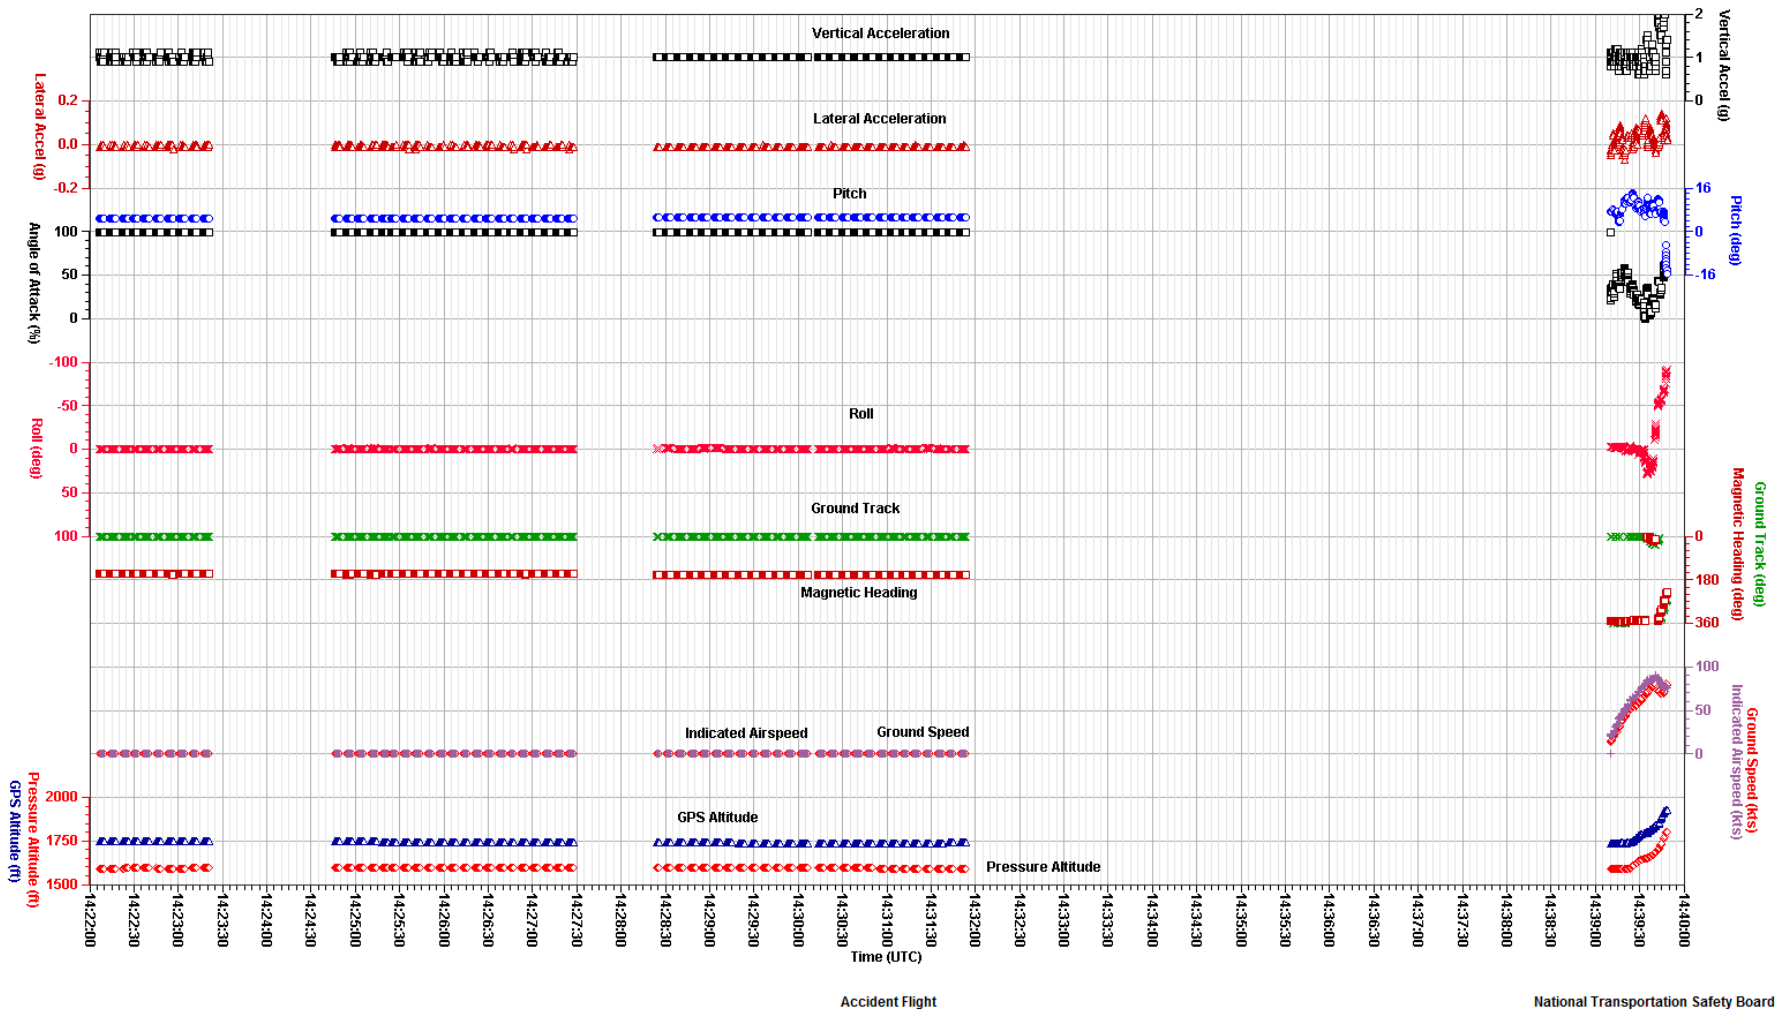
Figure 7. Plot of accident flight recording.

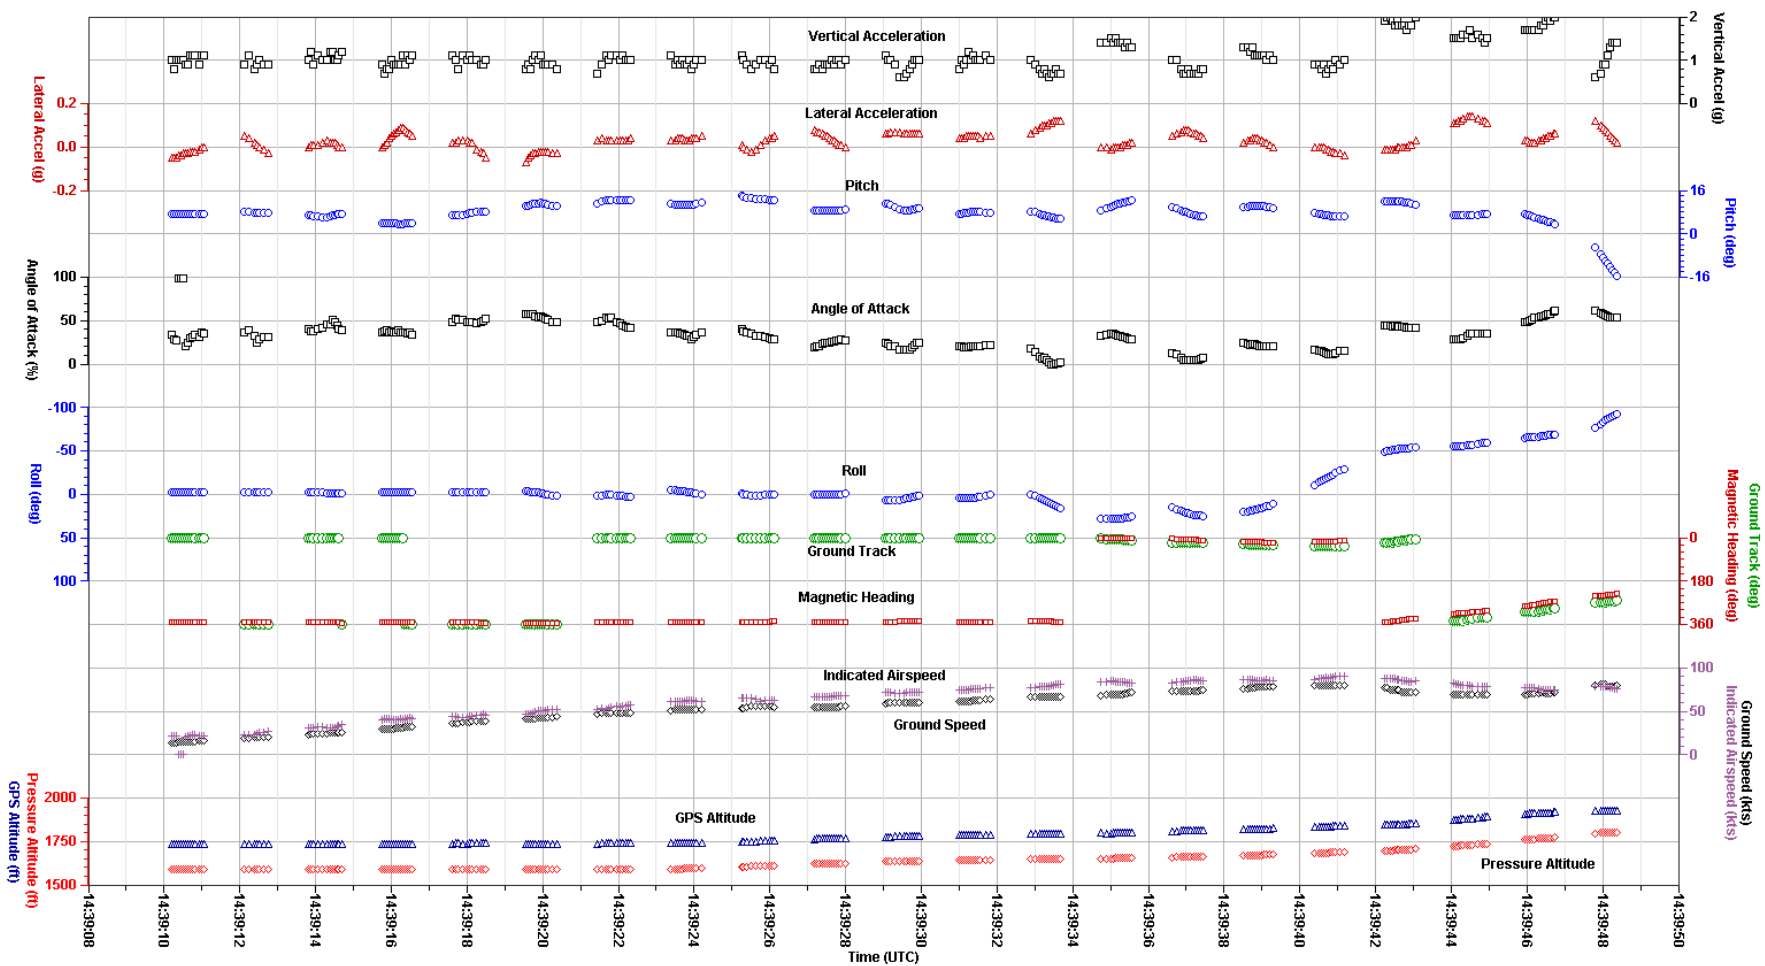
Figure 8. Plot of takeoff portion of accident flight until end of recording.

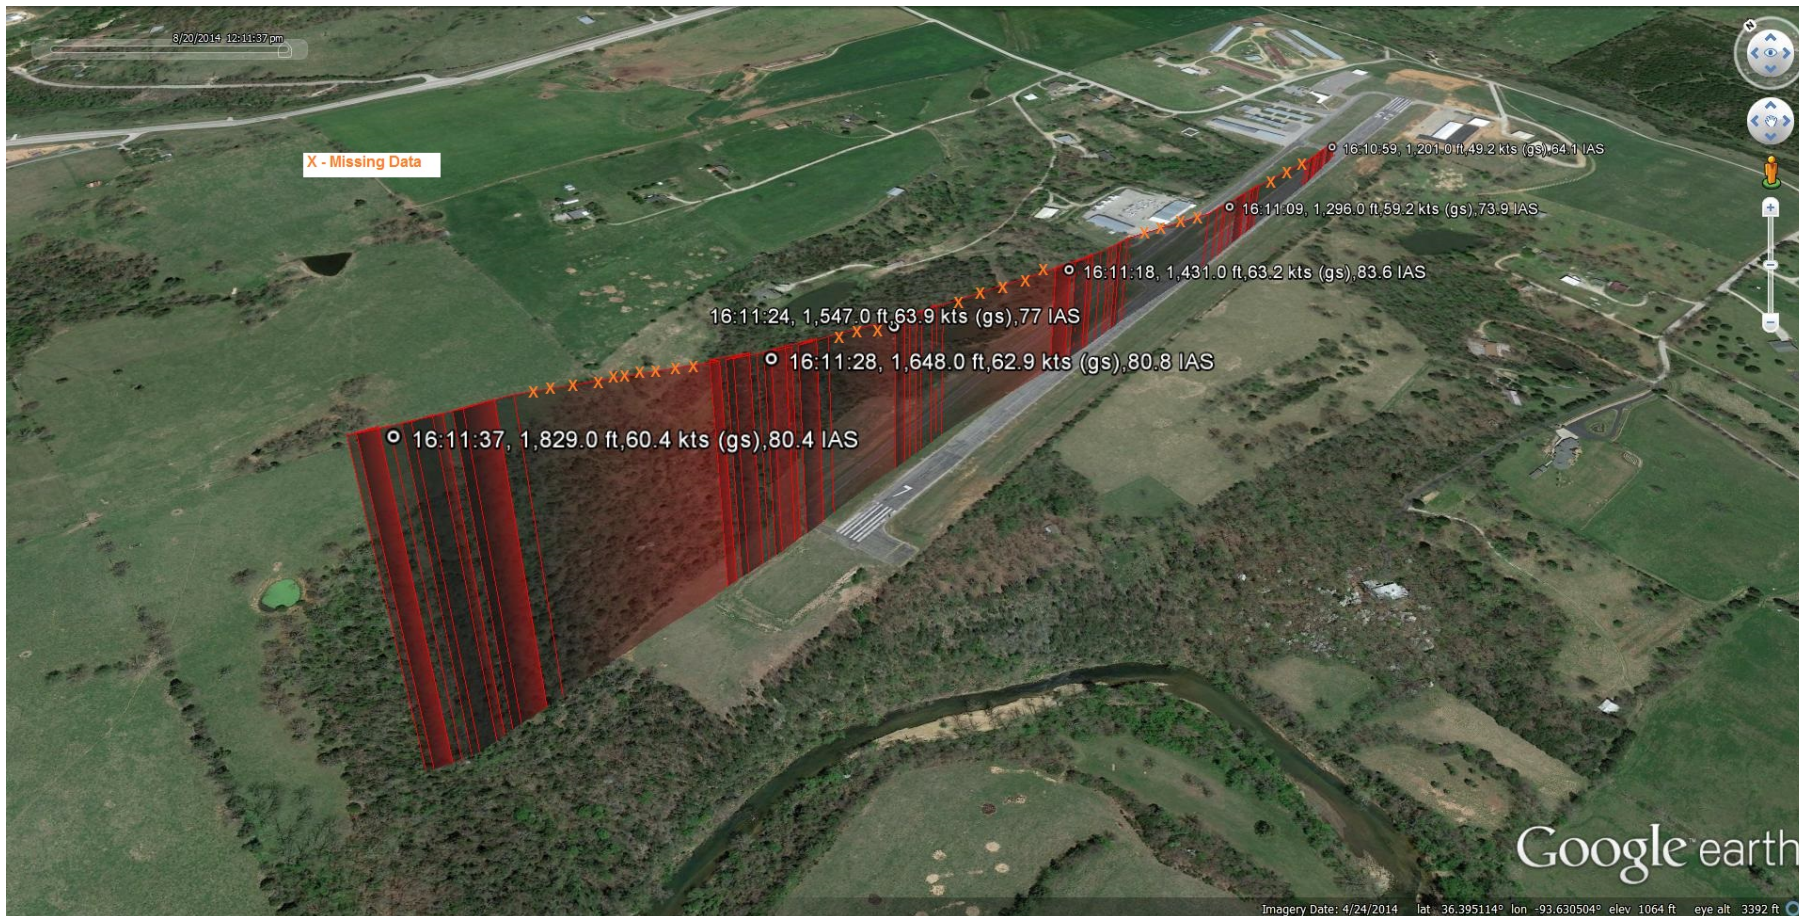
Figures 9 and 10 show the prior takeoff from 4M1 on February 28, 2016. The aircraft began a takeoff on runway 25 by 16:10:59 UTC at an initial GPS altitude of 1,201 feet. The aircraft climbed straight ahead until the end of the recovered data at 16:11:37 UTC at a GPS altitude of 1,829 feet. The indicated airspeed was in excess of groundspeed throughout the takeoff, consistent with a headwind; for example, at 16:11:30 UTC, the indicated airspeed was 80 knots and the groundspeed was 63 knots.

Figure 9. Satellite overlay of 4M1 takeoff.

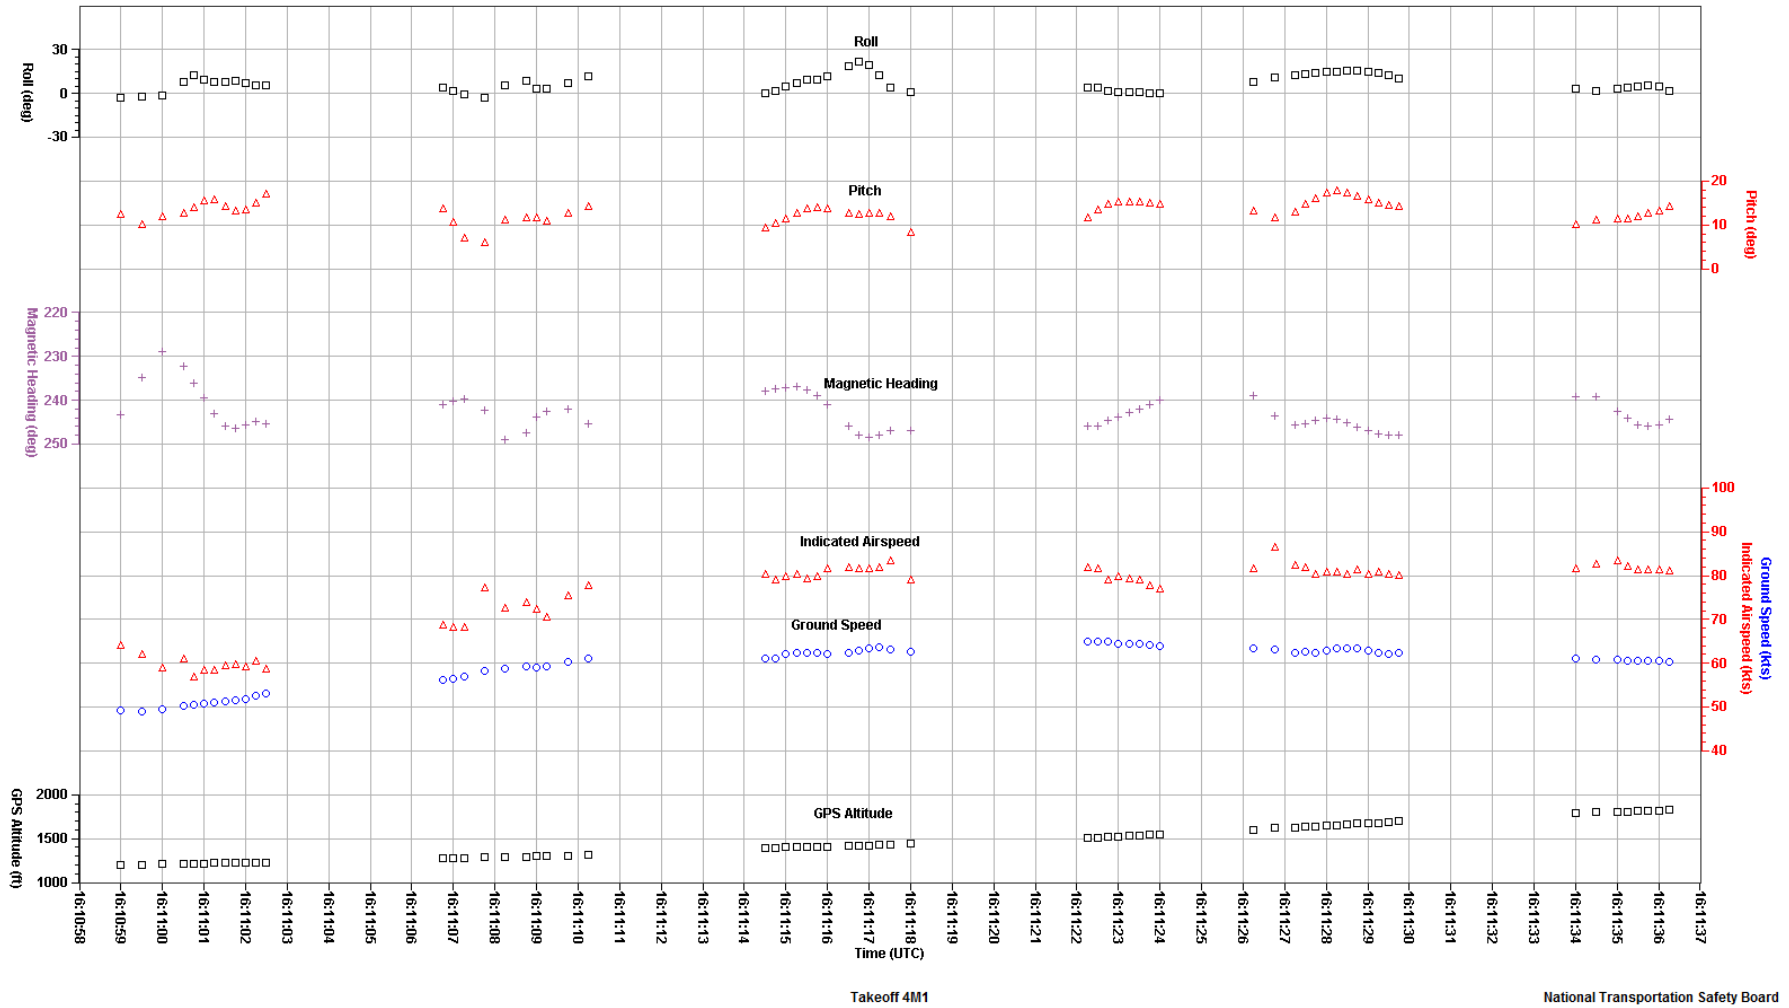
Figure 10. Plot of prior takeoff at 4M1.
