**NATIONAL TRANSPORTATION SAFETY BOARD
Office of Research and Engineering
Vehicle Recorder Division
Washington, D.C. 20594**

GROUP CHAIRMAN'S FACTUAL REPORT OF INVESTIGATION

ERA14MA271

Cockpit Voice Recorder

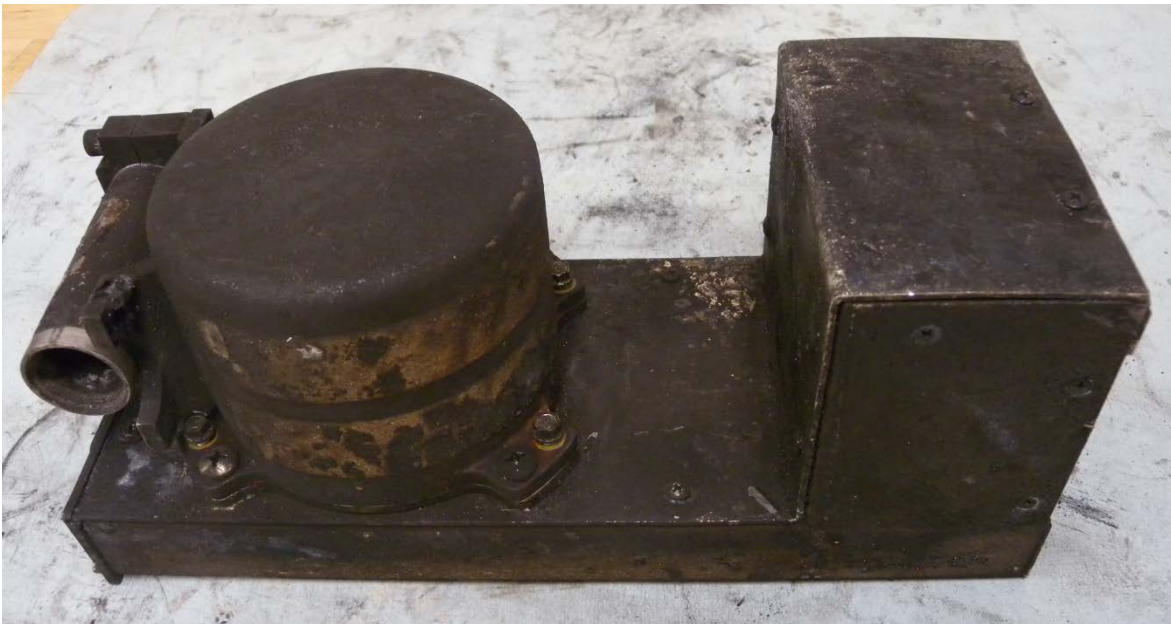
Upon arrival at the audio laboratory, it was evident that the exterior of the CVR had sustained significant heat damage (see Figure 1). The outer case was removed and the interior crash-protected memory module did not appear to have any heat or structural damage (see Figure 2). The memory board within the crash-protected case was checked for heat or structural damage and none was found. The digital audio was successfully downloaded from the memory board.

Figure 1. L-3/Fairchild FA2100-1020 CVR recovered from G-IV, N121JM.

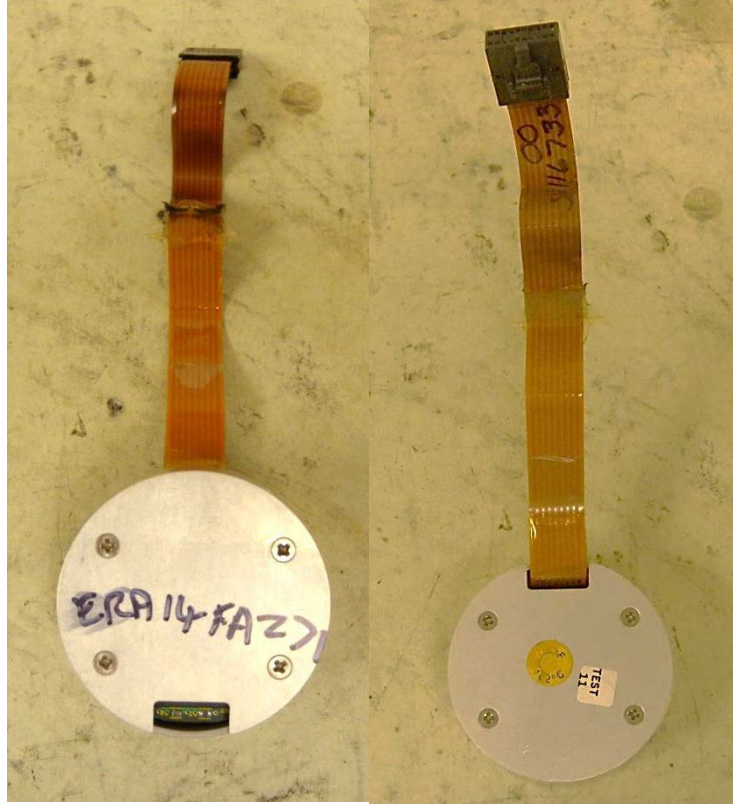
Figure 2. Memory module from the FA2100-1020 (after cable replacement).
