**NATIONAL TRANSPORTATION SAFETY BOARD  
Office of Research and Engineering  
Vehicle Recorder Division  
Washington, DC 20594**

**GROUP CHAIRMAN'S FACTUAL REPORT OF INVESTIGATION**

**CEN17FA072**

Location: Cleveland, Ohio  
Date: December 29, 2016  
Aircraft: Cessna 525C, Registration N614SB  
Operator: Private  
NTSB Number: CEN17FA072

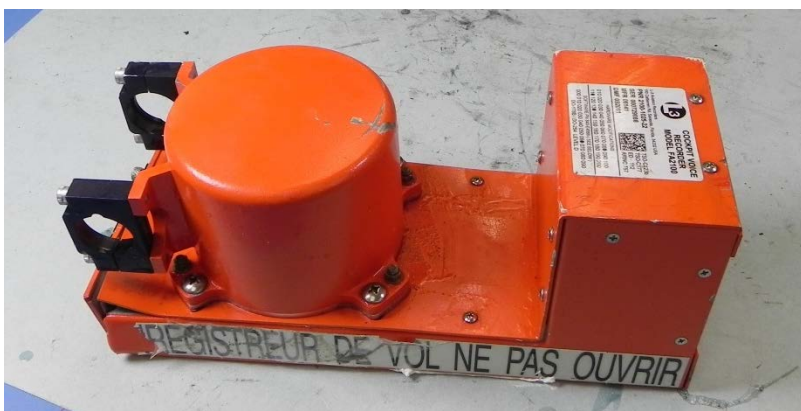
The CVR was submerged in Lake Erie for 8 days. Immediately after recovery, the CVR was packaged in fresh water and transported to the lab. The CVR exhibited minor impact damage (Figure 1). Upon arrival at the lab, the CVR was disassembled and the memory devices were inspected, cleaned, and dried (Figure 2). The memory device was connected to a laboratory surrogate unit and downloaded normally.

Figure 1. CVR upon arrival at laboratory.

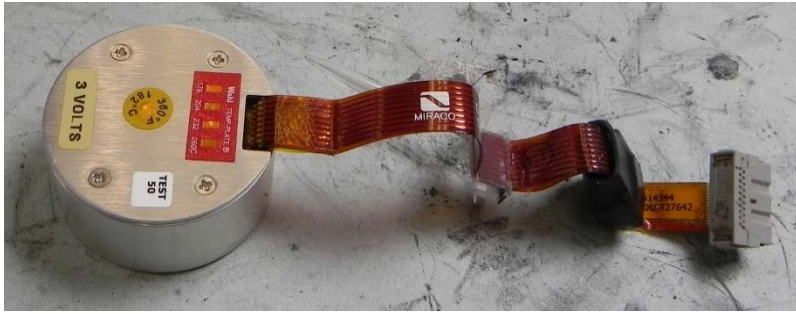
Figure 2. CVR memory device.
