NATIONAL TRANSPORTATION SAFETY BOARD
Vehicle Recorder Division
Washington, D.C. 20594

Addendum
Sound Spectrum Study Cockpit Voice Recorder - 12

Group Chairman's Report
By James Cash

Location: Weaverville California
Date: August 5, 2008, 1941 PDT
Aircraft: Sikorsky S-61N, N612AZ
Operator: Carson Helicopters, Helitanker 766
NTSB Number: LAX08PA259

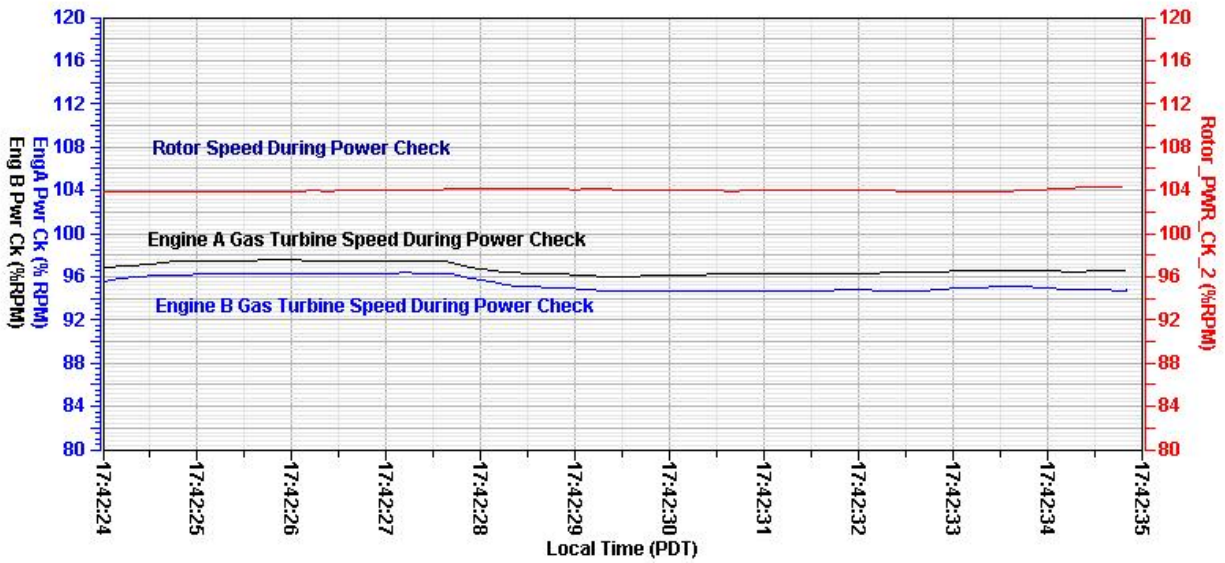
Carson S61 Gas Generator and Rotor Speeds During Power Check on Approach to H36

Additionally a chart 16 is being added to the Sound Spectrum Report. This chart depicts the "power check" that was accomplished at the very beginning of the CVR recording as the aircraft was inbound to the 1st landing at H36. The power check was accomplished at 17:42:29 PDT. Additionally the sound spectrum charts "A" and "B" that are associated with the "power check" are included:
