NATIONAL TRANSPORTATION SAFETY BOARD
Vehicle Recorders Division
Washington, D.C. 20594

Addendum to Sound Spectrum Study

Specialist's Report
by Anna W. Cushman

Location: Aberdeen, South Dakota
Date: October 25, 1999
Time: About 1713 universal coordinated time (UTC)
Aircraft: Learjet 35, N47BA
NTSB Number: DCA00MA005

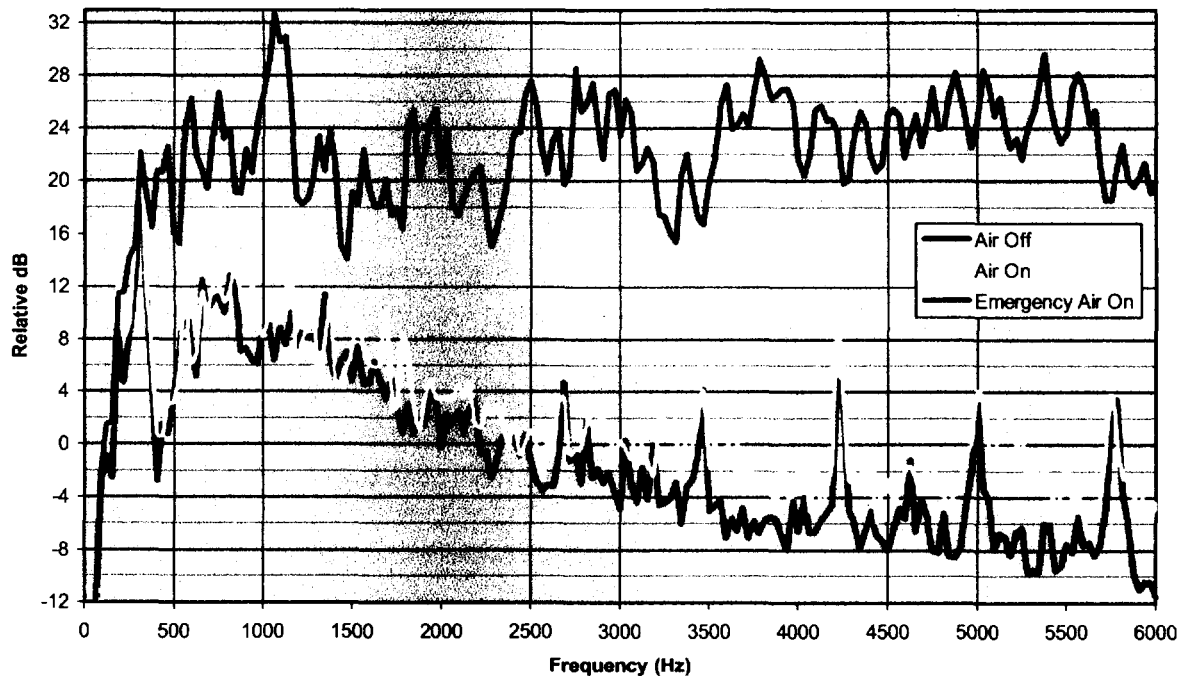
The initial focus in examining the data was to determine the difference in background noise levels of the three different scenarios: *Cabin Air OFF*, *Cabin Air ON*, and *Emergency Air ON*. Figure 1 shows the background noise level – without any warning tones or alerts – during the three flight conditions in the flight test. The *Cabin Air OFF* condition had two variants that were obtained at 25,000 feet: the *Freon ON* condition (air-conditioning system) and the $0 \Delta P$ condition. The $0 \Delta P$ condition was obtained when the cabin altitude air pressure equaled the outside air pressure. These additional flight conditions are shown with the *Cabin Air OFF* condition in Figure 2.

Figure 1: Flight test background noise levels – no warnings or alerts.

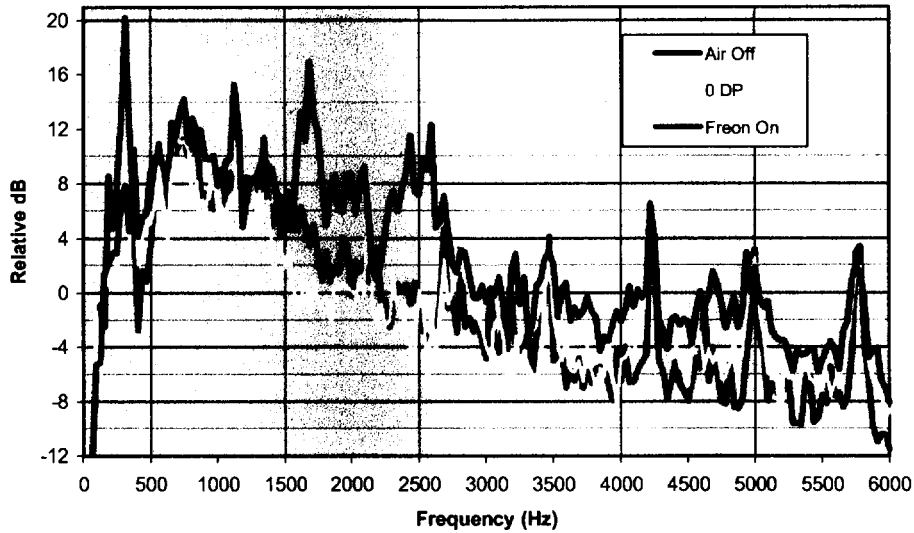
Figure 2: Flight test background noise of cabin air off flight conditions – no warnings or alerts.

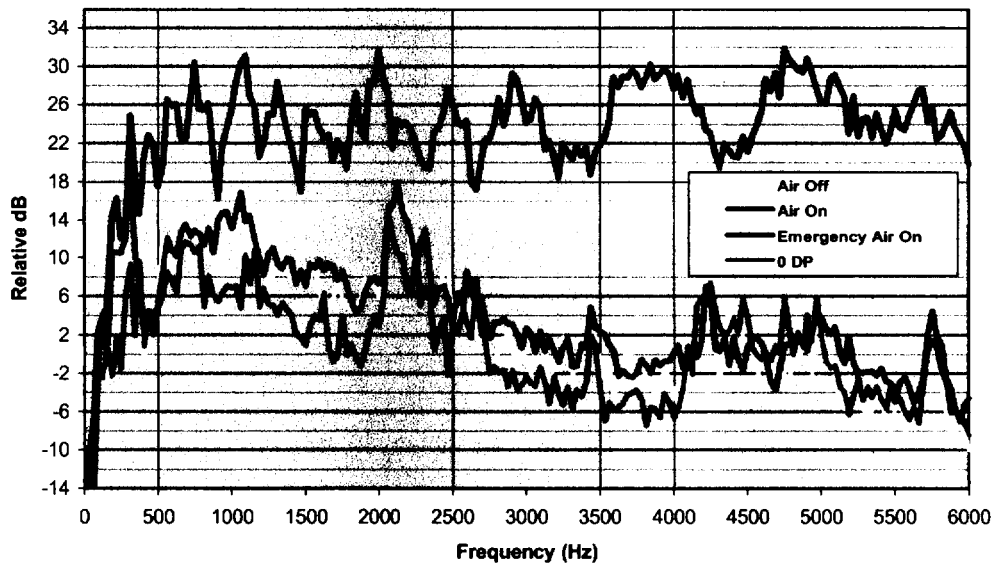
The cabin altitude warning was evident throughout the accident recording until the last few seconds of the flight. Recorded during the flight test, Figure 3 shows the overall noise levels of the flight test conditions with the cabin altitude warning ON. The *Freon ON* condition was not captured with the cabin altitude warning.

Figure 3: Flight test background noise levels with Cabin Altitude Warning.

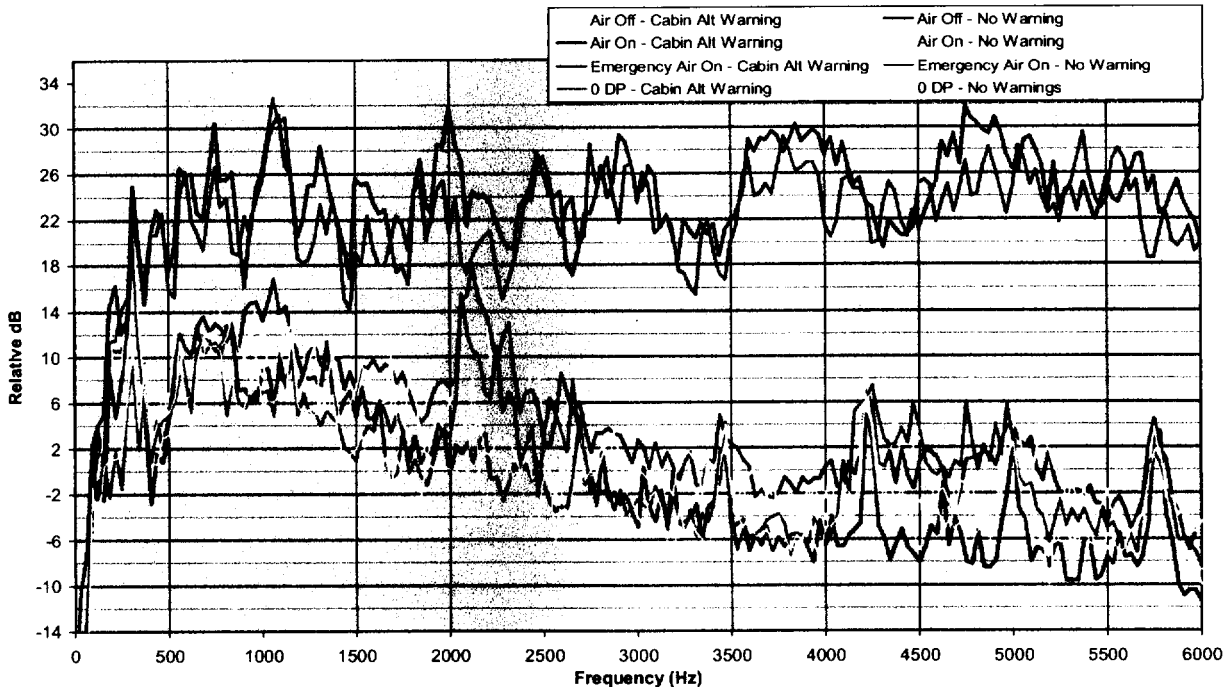
Figure 4 shows a comparison of background noise levels with and without the cabin altitude warning. With the cabin altitude warning on or off, it was evident that the *Emergency Air ON* condition had a significantly higher noise level than the other scenarios.

Figure 4: Flight test background noise levels - with and without cabin altitude warning.

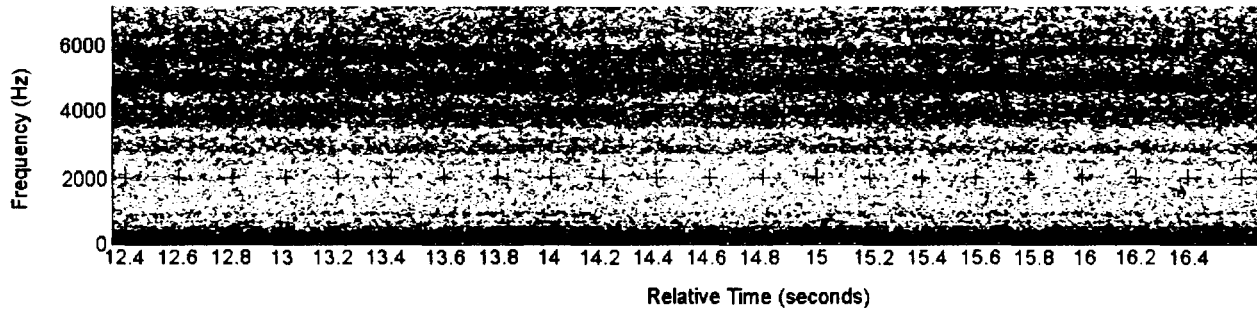
In comparing the differences in the flight test background noise levels, it was apparent that the *Emergency Air ON* flight condition was noticeably loud with respect to the other flight conditions. Aural evaluation of the recording of the *Emergency Air ON* with the cabin altitude warning ON revealed that the cabin altitude warning was not discernable amongst the noise. The spectrum of the recording – shown as a voiceprint in Figure 5 – also did not exhibit any characteristics of the cabin altitude warning, which had a 0.3 second cycle at about 2700 Hz. The accident recording, however, clearly showed the cyclic cabin altitude warning (Figure 6).

Figure 5: Voiceprint of Emergency Air ON with cabin altitude warning.

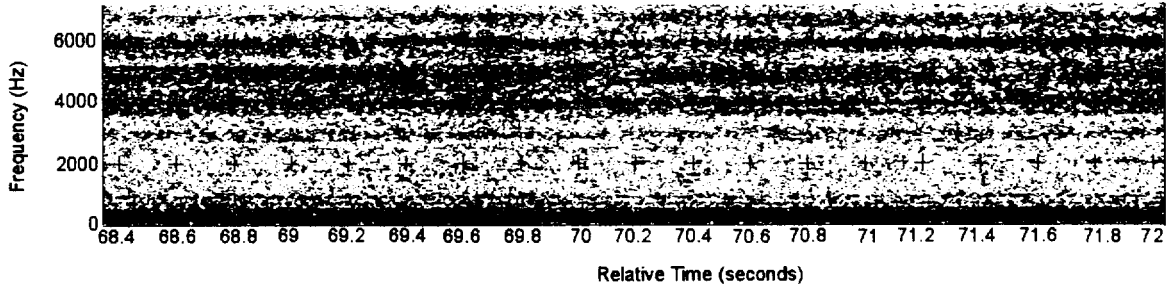
Additional comparison of signal to background noise level is shown in Figure 7 and Figure 8 with the altitude alert. The tone was heard on the pilot's channel and correlated to the CAM channel of the flight test recording; Figure 7 shows that the altitude alert was not evident while the emergency air was operating. The altitude alert was recorded on the accident CVR CAM channel and is shown in the voiceprint in Figure 8.

Figure 7: Voiceprint of Emergency Air ON with altitude alert.

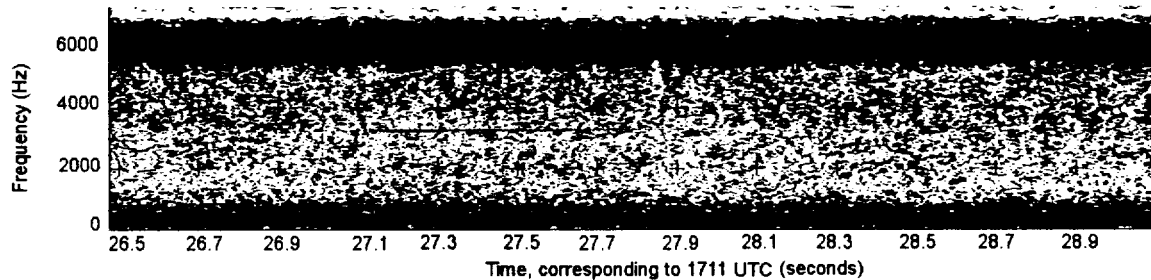
Figure 8: Voiceprint of accident recording altitude alert.

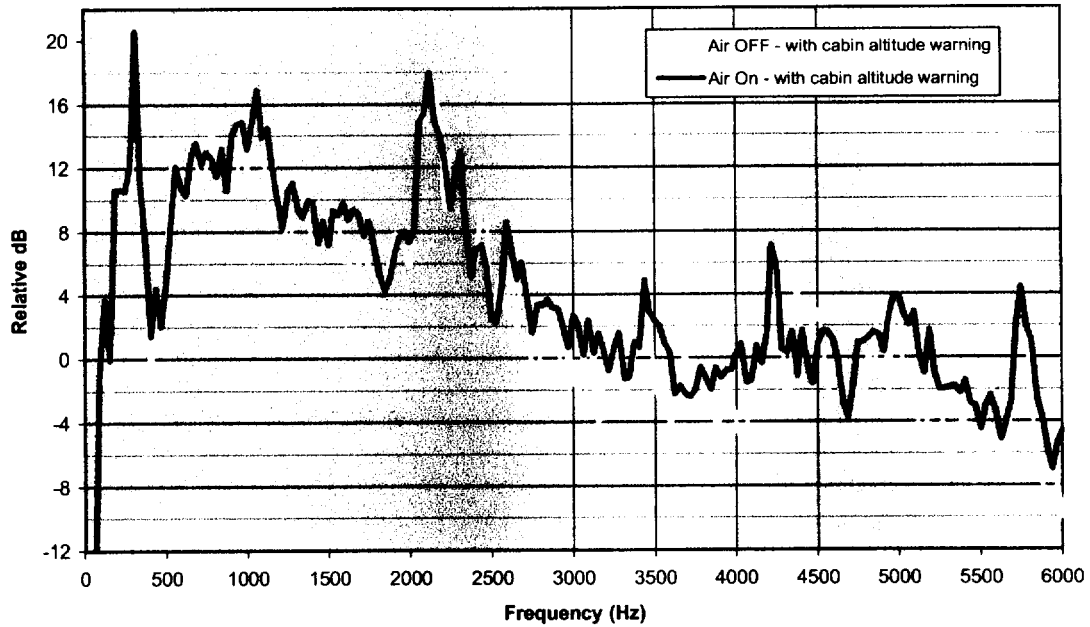
To evaluate the results of *Cabin Air OFF* and *Cabin Air ON*, it was important to examine the recordings that most closely matched the conditions present in the accident recording; the test recordings evaluated contained the cabin altitude warning, when possible. Figure 9 shows the difference in noise levels between the *Cabin Air OFF* and *Cabin Air ON* flight test conditions. In comparing the background noise with the signal strength of the cabin altitude warning, there was no appreciable difference. The plot of the altitude alert (Figure 10) also does not show a considerable difference between the altitude alert signal (at approximately 2700 Hz) and background noise strength. Additionally, there were three engine harmonics visible above 4000 Hz, but were not considered due to the fact that similar harmonics did not appear in the accident recording. Regardless, both plots show that there was a minor difference between the two flight conditions – Cabin Air OFF generally had a lower noise level than Cabin Air ON, by 2-5 dB at select frequencies.

Figure 9: Flight test background noise levels with Cabin Air OFF and Cabin Air ON.

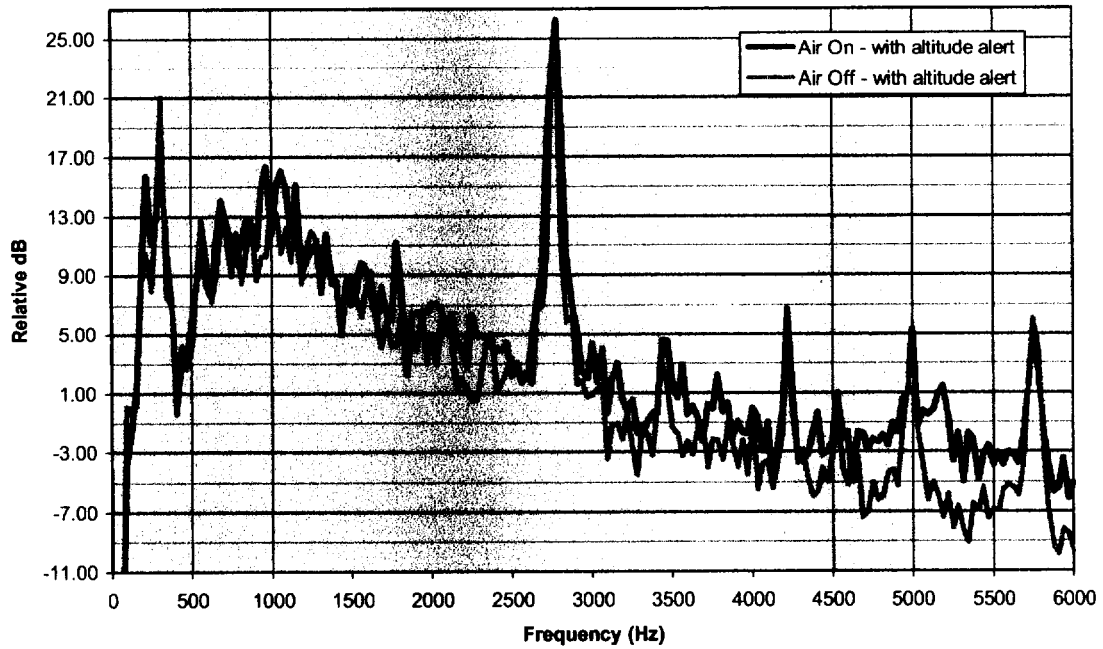
Figure 10: Flight test background noise levels with altitude alert.

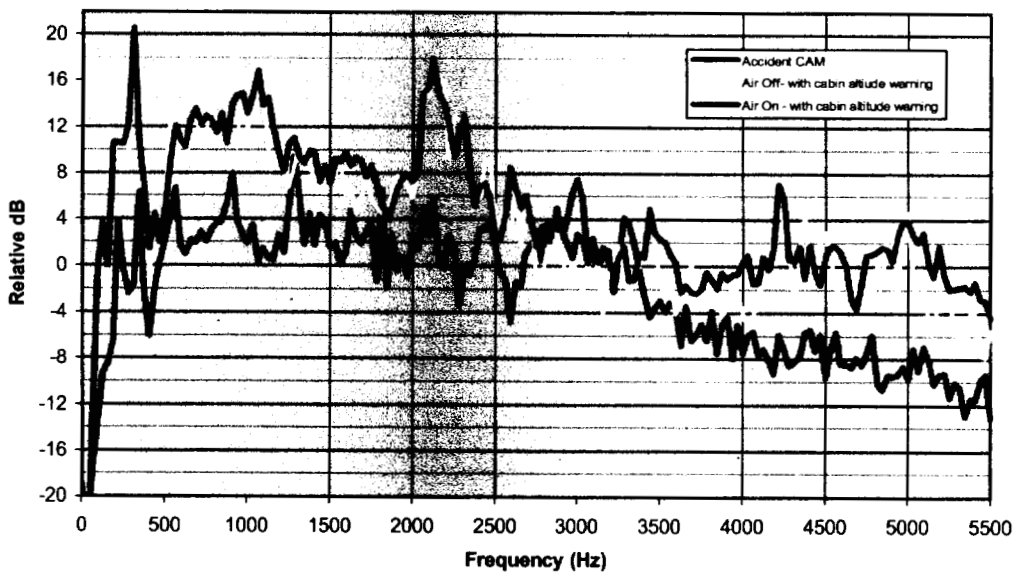
Figure 12: Background noise levels of Cabin Air OFF, ON, and accident recording.

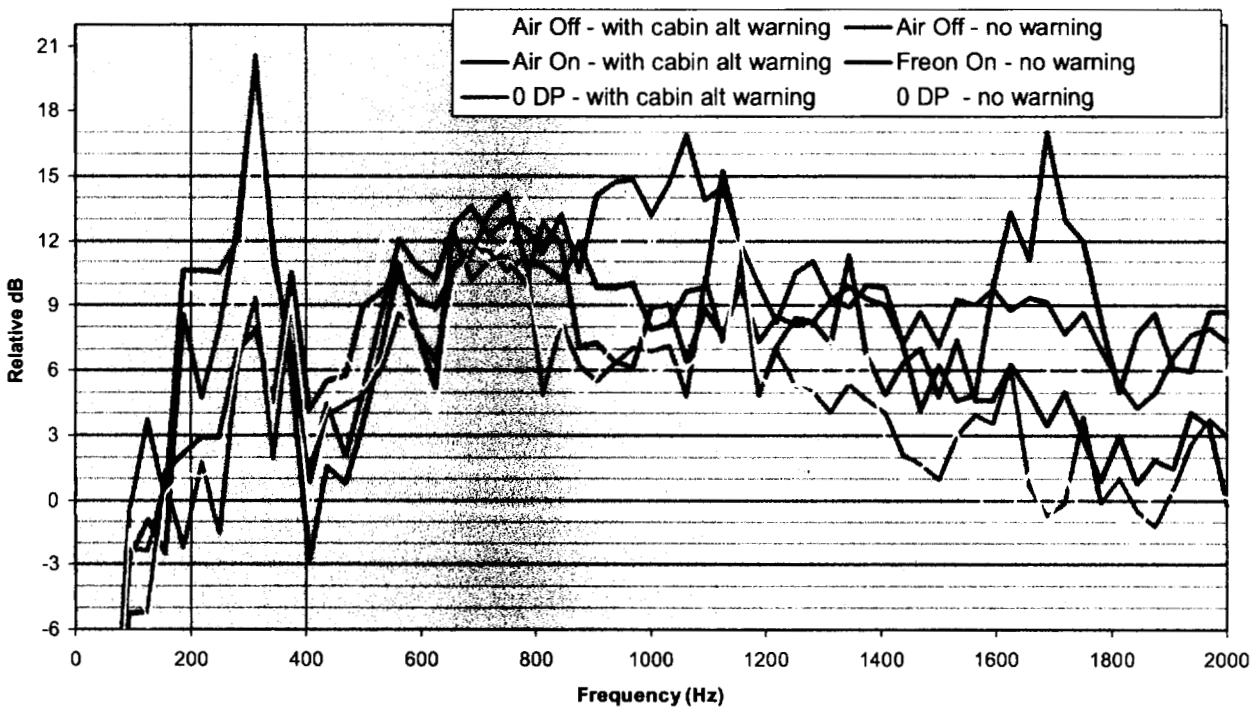
Figure 13 shows the plot of background noise levels of the flight test conditions from 0 to 2000 Hz. The unpressurized 0 ΔP flight conditions, including the Freon ON condition, exhibited similar characteristics.

Figure 13: Background noise levels of Cabin Air OFF, ON, 0 ΔP , and Freon ON below 2000 Hz.

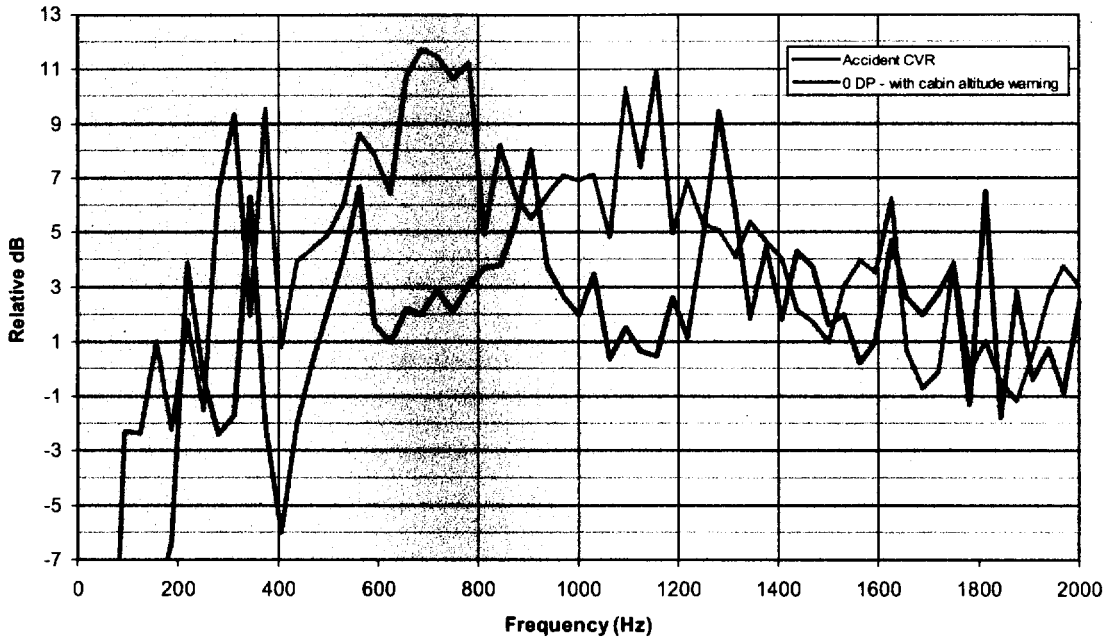
The following two plots (Figure 14 and Figure 15) show the background noise levels below 2000 Hz for the accident CVR and the flight test conditions.

Figure 14: Background noise level below 2000 Hz for accident CVR and 0 ΔP flight test condition.

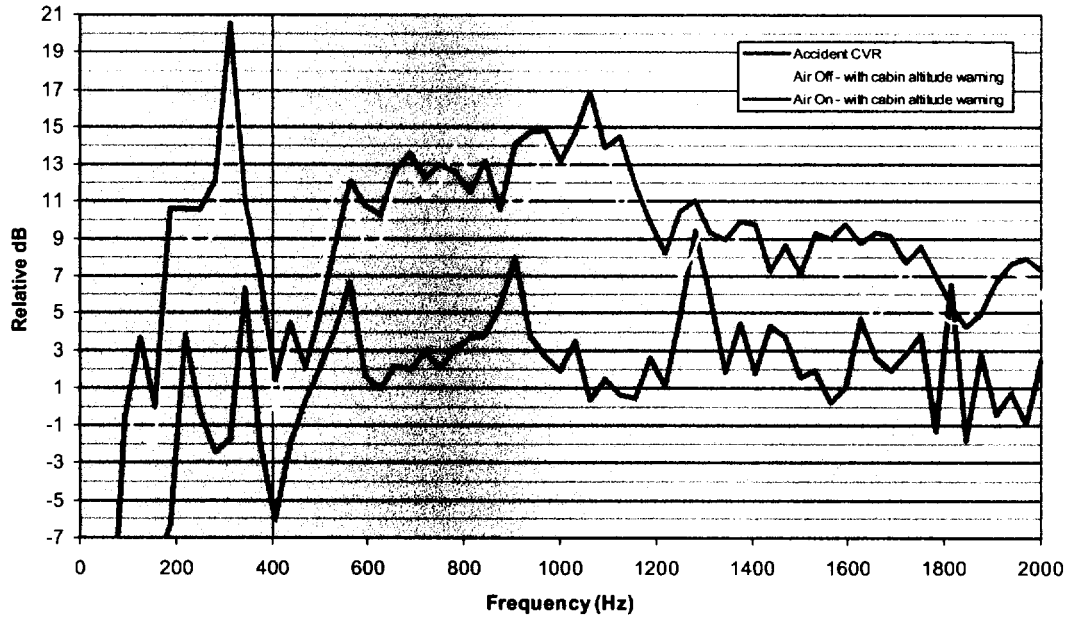
Figure 15: Background noise level below 2000 Hz of accident CVR and Cabin Air OFF/ON flight test conditions.

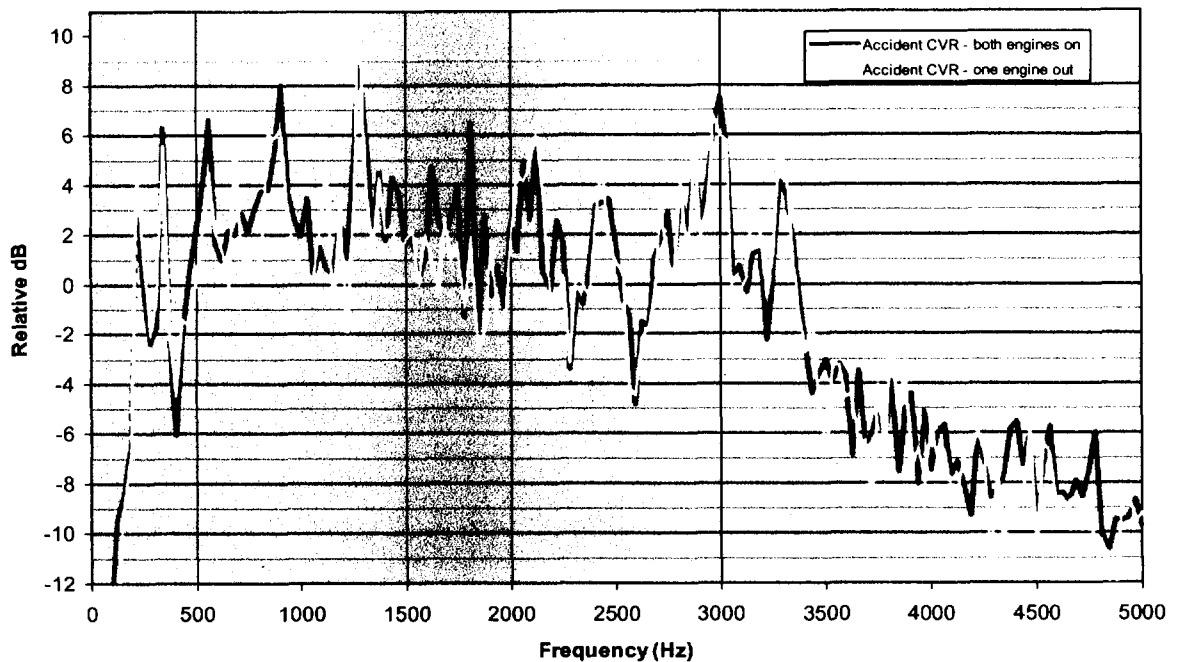
In the final two minutes of the N47BA's flight there were several changes in the background noise level. The changes were attributed to the changing flight characteristics of the aircraft. From the Group Chairman's Cockpit Voice Recorder Sound Spectrum Report, approximately two minutes before the end of the recording, a signature associated with one of the engines decreased in frequency and strength. This was an indication that one engine had spooled down. Immediately after the spool down, several warnings and alerts were recorded on the CVR, along with increasing and changing background noise levels. The spool down of one engine did not significantly impact the overall background noise level, as shown in Figure 16.

Figure 16: Background noise level of accident CVR with both engines operating and one engine operating.

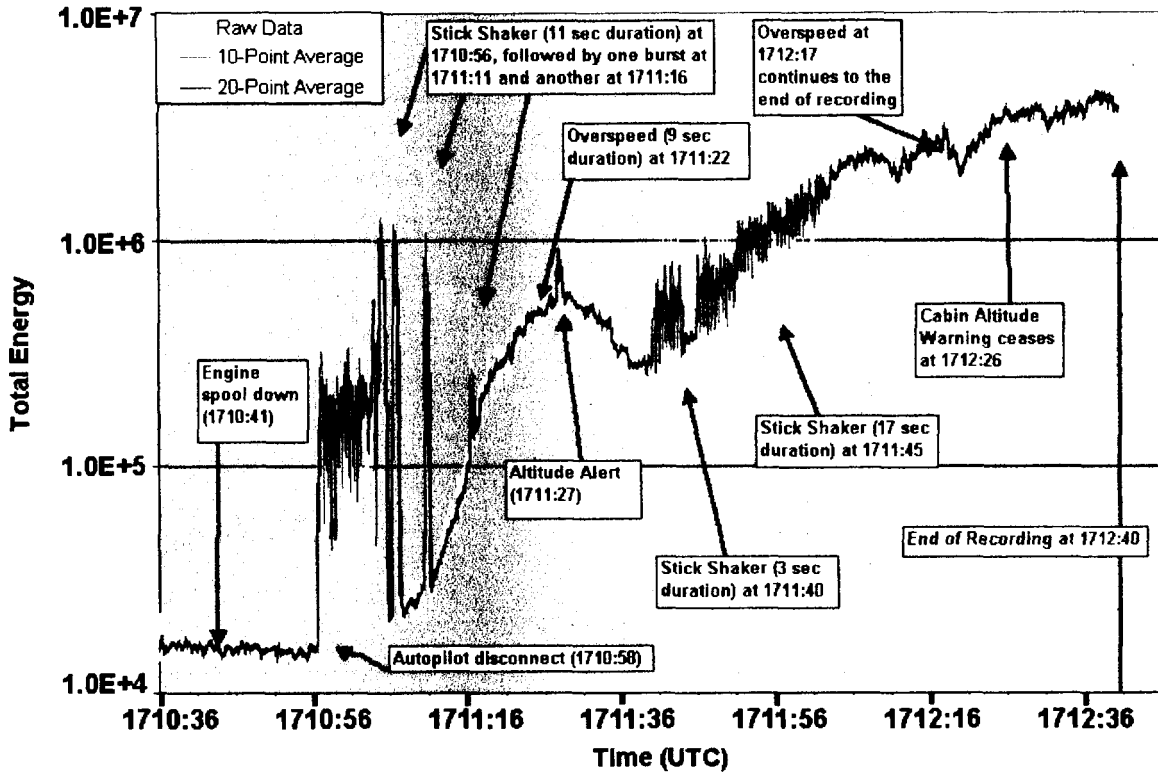
The overall energy distribution of a recording is a direct indication of the overall background noise level. There are factors that can contribute to the energy level and need to be accounted for. In the accident recording, the stick shaker and other aural warnings raised the energy level. Figure 19 shows the total energy of the last two minutes of the accident recording with overlays of CVR transcript events.

Figure 19: Total energy distribution of the last two minutes of the accident CVR recording.
