NATIONAL TRANSPORTATION SAFETY BOARD

Errata

Sound Spectrum Study Cockpit Voice Recorder - 12

Location: Weaverville California
Date: August 5, 2008, 1941 PDT
Aircraft: Sikorsky S-61N, N612AZ
Operator: Carson Helicopters, Helitanker 766
NTSB Number: LAX08PA259

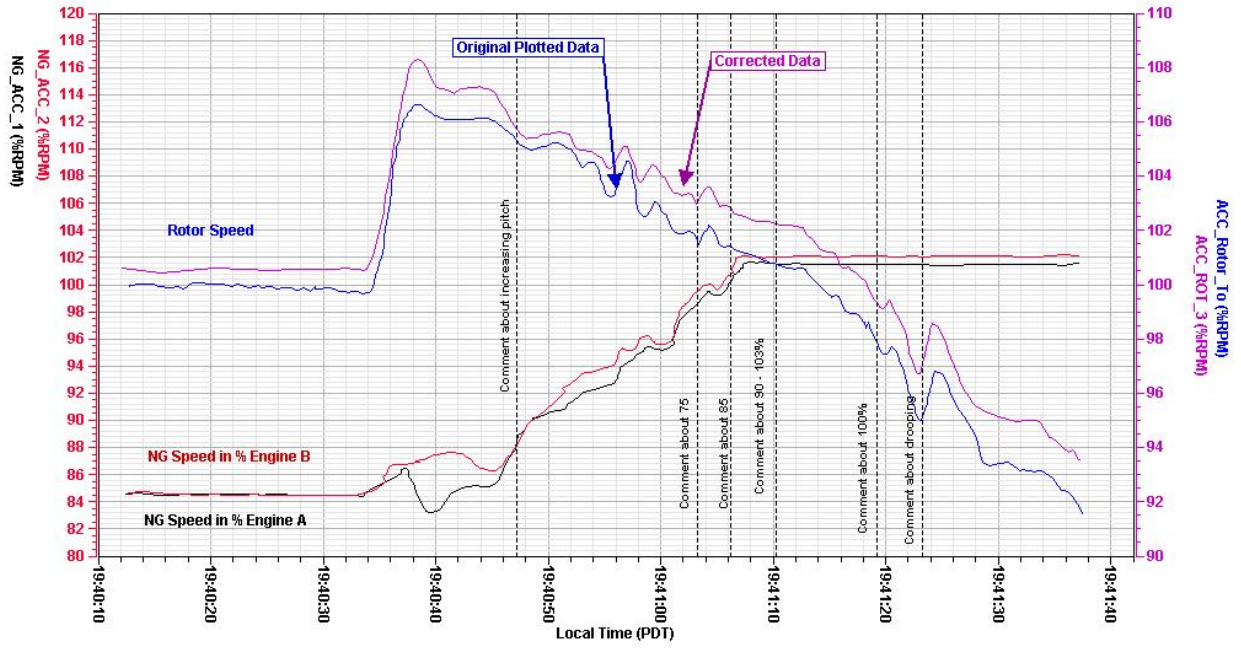
Chart 15 Main Rotor Speed and N_G Speed Comparison for Accident Takeoff

An error was made during the calculation of main rotor speed from the sound signatures recorded on the accident aircraft's CVR recorder. The conversion stated in the accident report of 100% main rotor speed equals a frequency of 663.1 Hz is incorrect. According to the manufacturer, the correct number should be 659.76 hertz when using the Planetary Mesh to calculate 100% rotor speeds. This error affected only the main rotor speed data shown on all of the plots in the original report. Using the new number results in an overall increase in approximately 1.00506% in the rotor system values depicted on the original plots. Please replace plots 3 thru 14 found in the original Sound Spectrum Report dated August 17, 2009 with the plots attached to this report. Additionally the accident takeoff data was reacquired to correct a minor measurement error that had been made in the original data. To illustrate the change in the rotor speed data for the accident takeoff, attached is an additional plot, labeled Plot 15 which depicts the original report data plotted with the corrected data for the accident takeoff from H44.
