NATIONAL TRANSPORTATION SAFETY BOARD

Cockpit Voice Recorder

Group Chairman's Sound Spectrum Study

Location: Aspen, Colorado
Date: March 29, 2001
Time: 1902 mountain standard time (MST)
Aircraft: Gulfstream III, N303GA
Operator: AVJET Corporation
NTSB Number: DCA01MA034

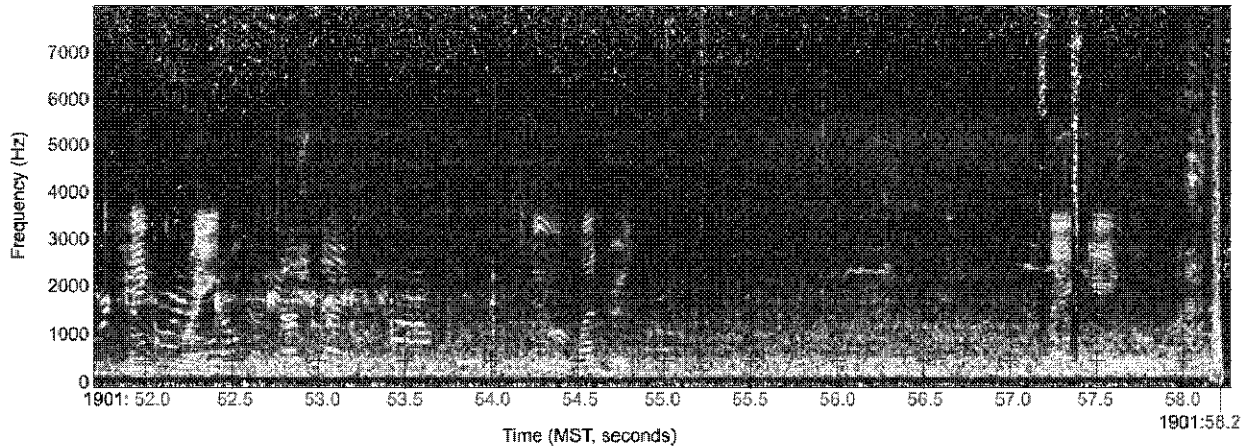
The CVR transcript shows an unidentified rumbling noise at 1901:52.7. The noise blends into the background after 1901:57.5. The third task of the sound spectrum group meeting on May 15, 2001 was to investigate this noise and further clarify its origins. The spectrogram² of the last seven seconds of the CAM channel recording reveals a cyclic, broadband noise that begins at approximately 1901:52.7 (see Figure 1). The noise has a cycle of approximately 16.5 Hz.

Figure 1: Sound spectrum of the last portion of the N303GA CVR CAM recording.

Because the stick shaker has a broad range of operating speeds and the noise encompasses the entire frequency range (as opposed to a specific single frequency), it is not possible to definitively conclude that the stick shaker produced the rumbling noise in the N303GA recording. However, historically CVR recordings of cyclic noises are generally produced by an on board aircraft system or a repeatable external factor, such as runway seams. Therefore, given the cyclic nature of the rumbling noise and its resemblance to the test stick shaker recording in its intensity across the bandwidth, the unidentified rumbling noise at 1901:52.7 is likely to have been N303GA's stick shaker.

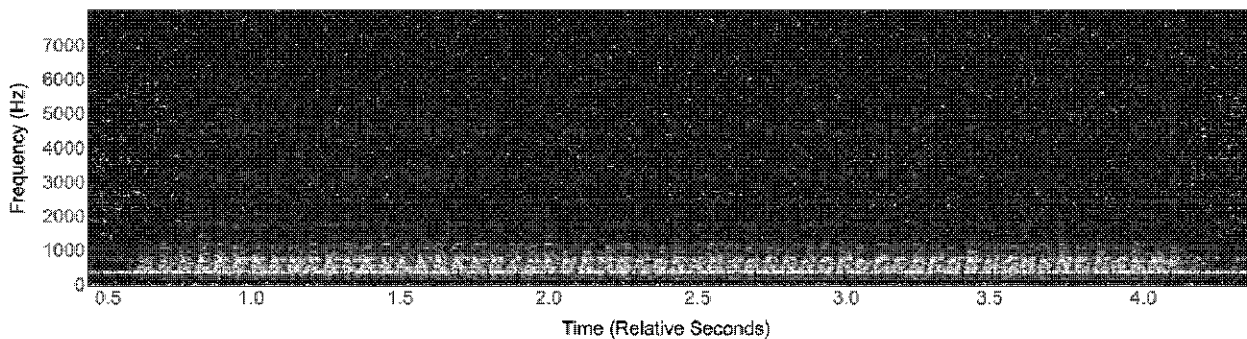
Figure 2: Stall warning test (system 1) - engines off.

Upon evaluating the test data, it was evident that the spectrograms contained characteristics similar to the rumbling noise on the accident recording. Specifically, the stick shaker tests revealed a broadband cyclic noise of medium intensity. The cycle of the test stick shaker was 16.1 Hz for system 1, and 17.2 Hz for system 2. The stick shaker motor has a specification for operating between 800 and 1400 RPM or 13.3 Hz to 23.3 Hz.

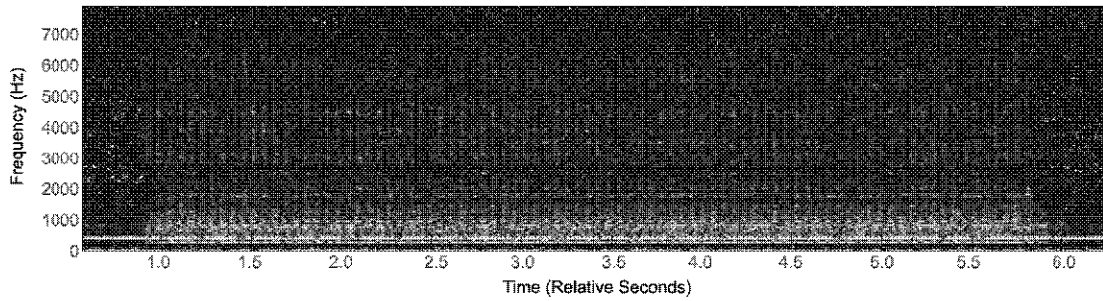
Figure 3: Stall warning test (system 2) - engines off.

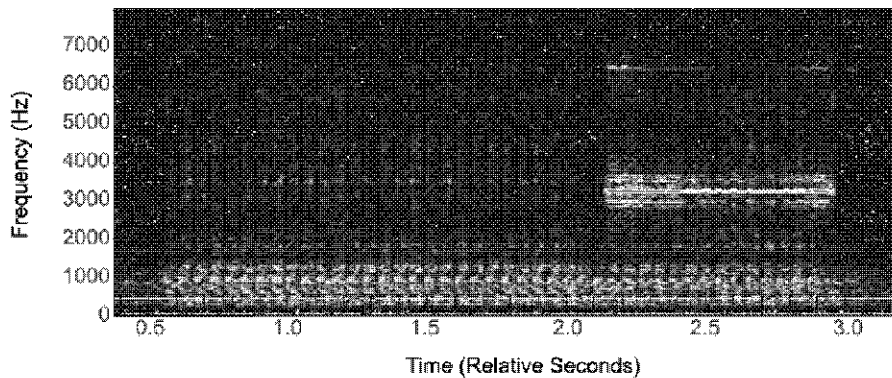
Figure 4: Stall warning (system 2) with pusher - engines on, hydraulics on.
