NATIONAL TRANSPORTATION SAFETY BOARD

Cockpit Voice Recorder

Specialist's Factual Report

Location: Camp Bastion, Afghanistan
Date: January 16, 2012, Afghanistan Local Time (AFT)
Aircraft: Bell 214, N5748M
Operator: AAR Airlift Corp.
NTSB Number: DCA12FA024

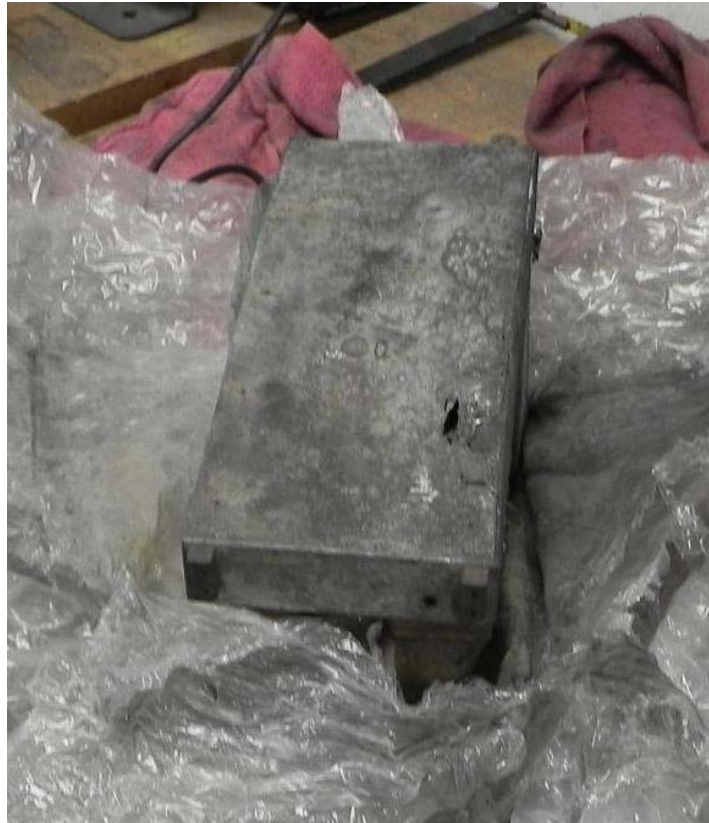
Upon arrival at the audio laboratory, it was evident that the CVR had sustained substantial heat and structural damage (see figures 1 and 2). The crash protected memory unit (CSMU) was removed from the CVR housing; Figure 3 shows the CSMU on the left and CVR housing on the right. The CSMU insulation was removed revealing damage to the ribbon cable connecting the memory modules to the CVR housing (see figure 4).

Figure 1. CVR upon arrival.

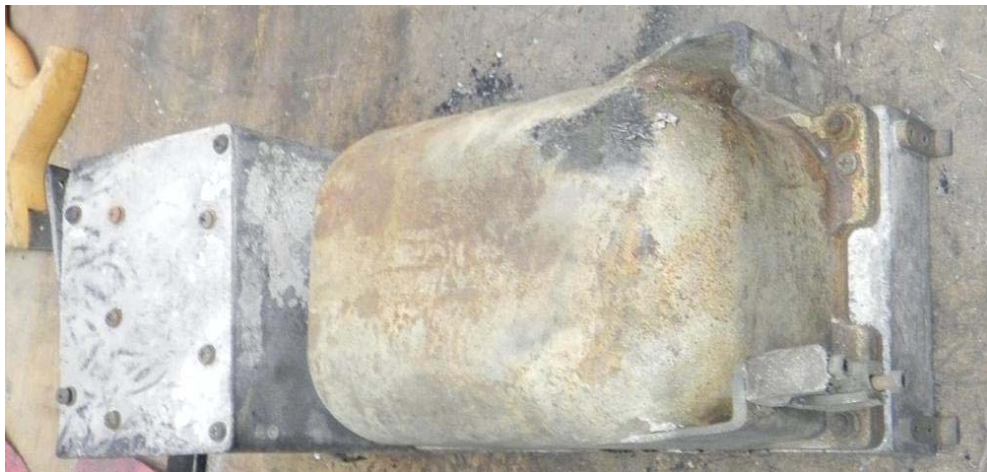
Figure 2. CVR before recovery process.

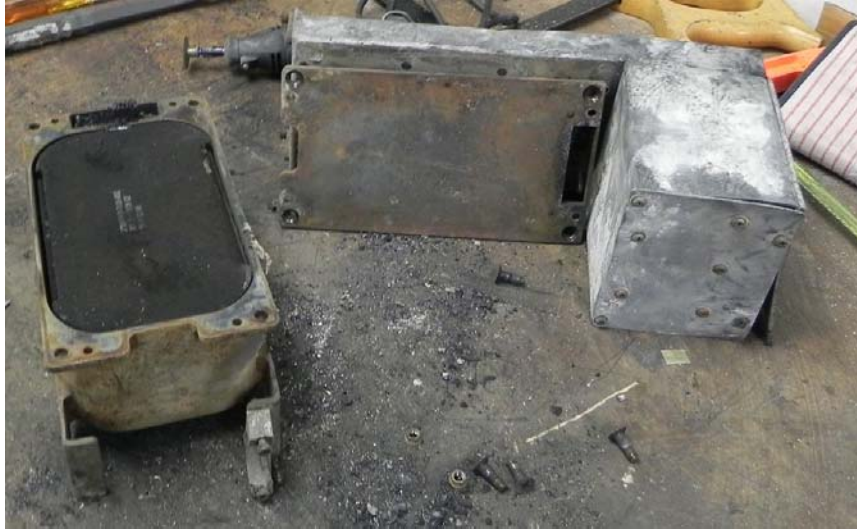
Figure 3. CSMU separated from CVR housing.

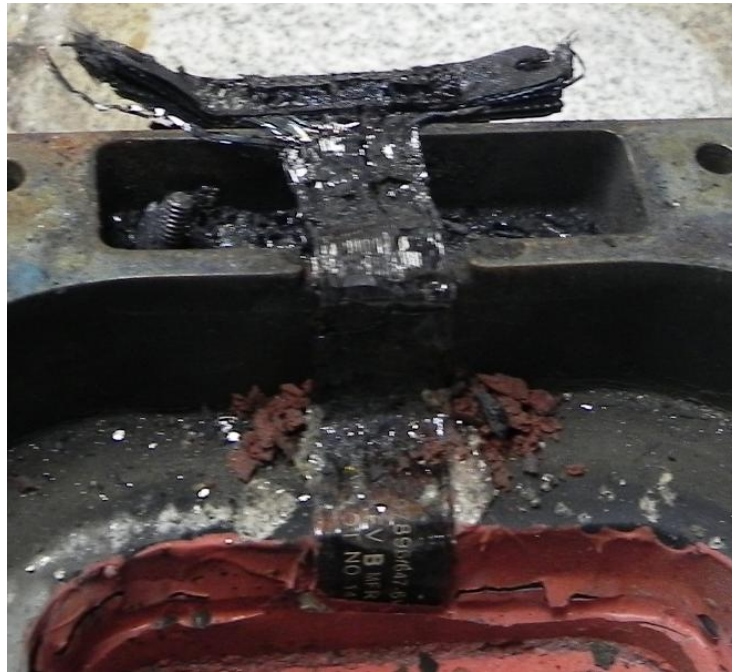
Figure 4. Memory ribbon cable.

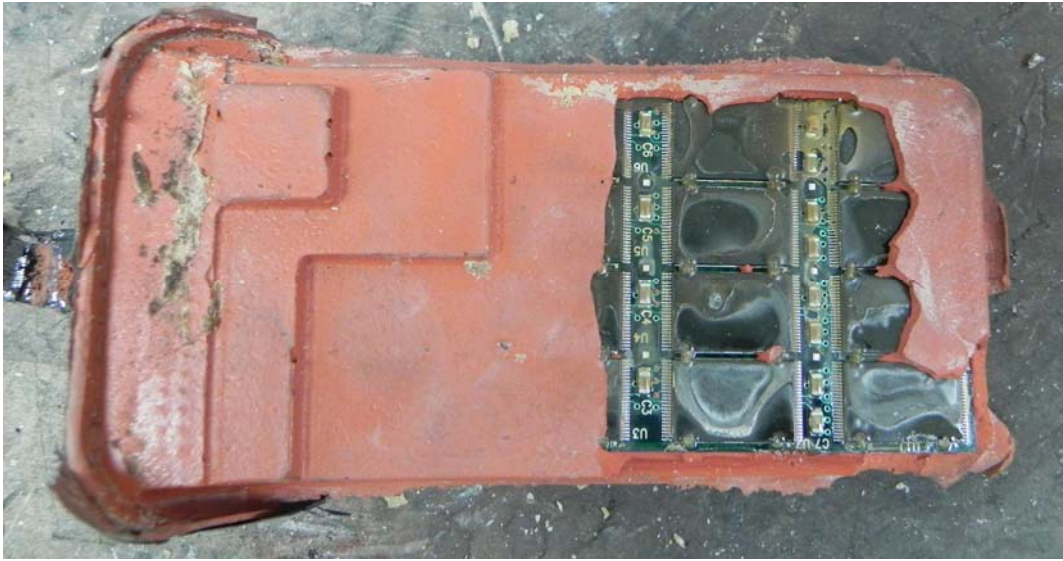
The memory module was extracted from the CSMU and is shown in figure 5. Upon further inspection, it was evident that some of the control and memory chip connections to the memory board had been compromised, as shown in figure 6. Based upon this information, a chip level recovery was accomplished.

Figure 5. Memory module.

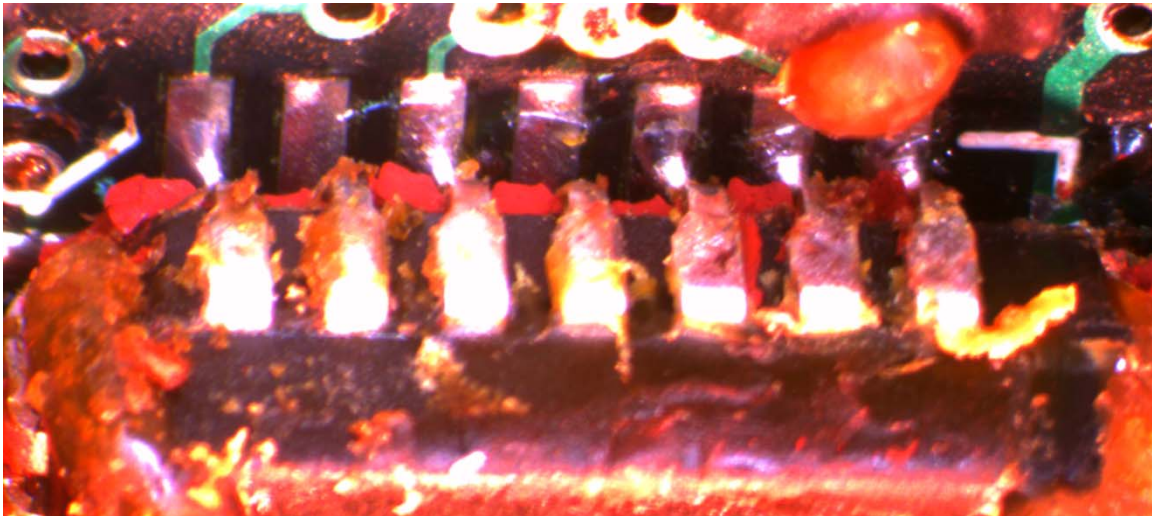
Figure 6. Damaged control chip connections to memory board.

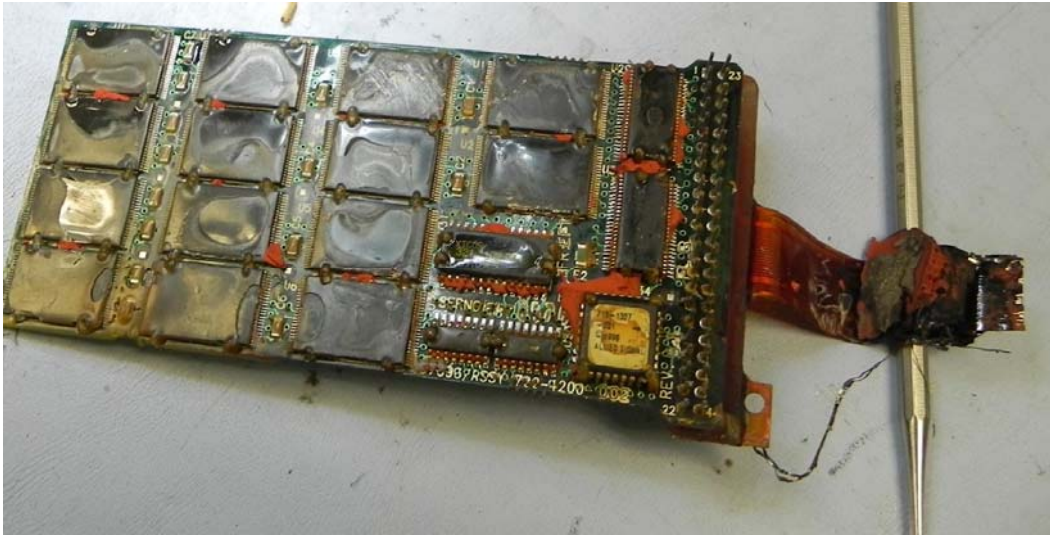
Figure 7 shows the memory board before flash memory chip recovery of the 14 memory chips on the board. Figure 8 shows the memory board during chip removal using precision heat application; 5 of the 14 chips have been removed in Figure 8. Figure 9 shows one of the flash memory chips in the chip reader socket.

Figure 7. Memory board before flash memory chip removal.

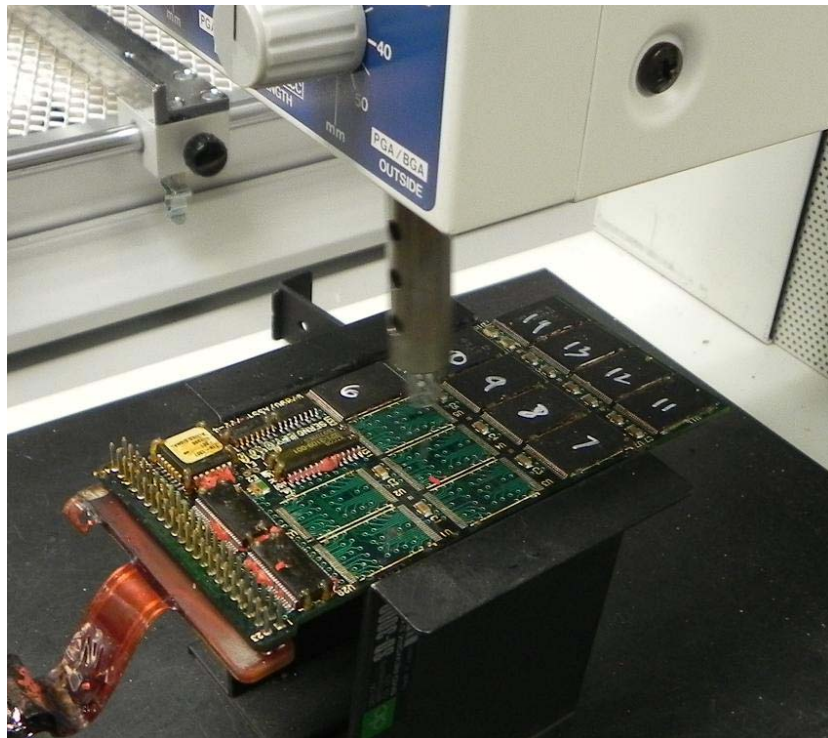
Figure 8. Memory board during flash memory chip removal.

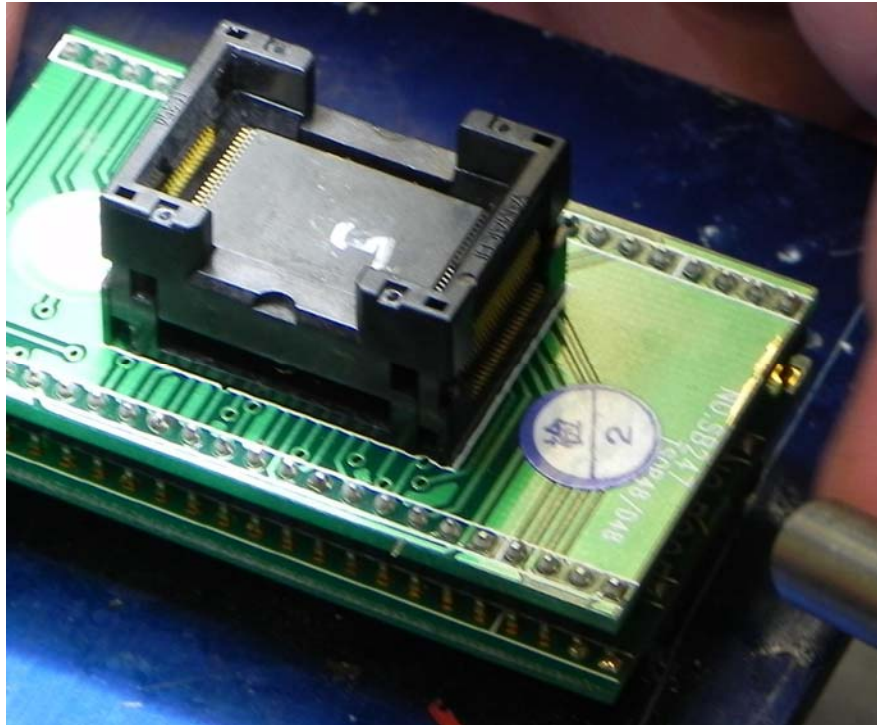
Figure 9. Flash memory chip in chip reader socket.
