NATIONAL TRANSPORTATION SAFETY BOARD

Group Chairman's Sound Spectrum Study
Cockpit Voice Recorder

Group Chairman's Sound Spectrum Study

Location: Rancho Cordova, California
Date: February 16, 2000
Time: 1951 pacific standard time (PST)
Aircraft: DC8-71F, N8079U
Operator: Emery Worldwide Airlines, Flight 17
NTSB Number: DCA00MA026

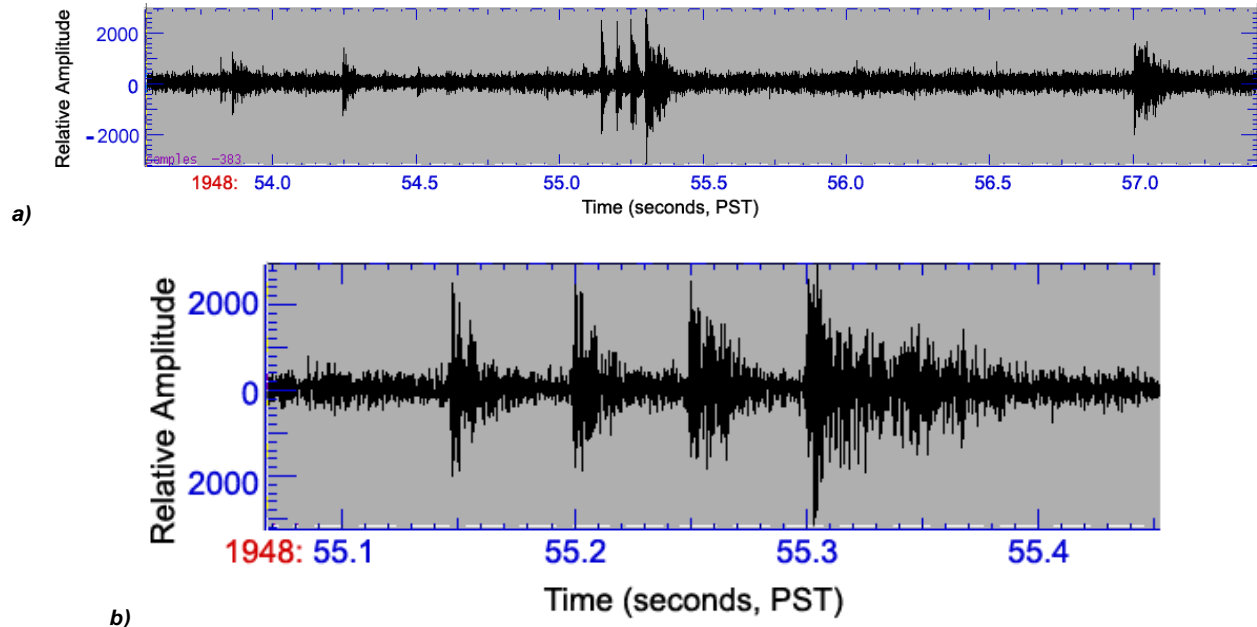
After the crew called “eighty knots” and “elevator check” at 1948:50, an unidentified ratchet noise was recorded on the CAM channel at 1948:55.15. At 1949:02 the Captain called “V one” and then “rotate.” The ratcheting noise recorded on the CAM channel is distinctive with particular characteristics, as shown in its waveform in Figure 1a and 1b. From the waveform, it appears that the noise is cyclic with a frequency of 18.8 Hz. Also, each ratchet is an impulse, with a sharp rise in amplitude—almost 400% higher than the background noise level at the peaks.

Figure 1: a) Waveform of ratchet noise from accident recording and b) zoom view.

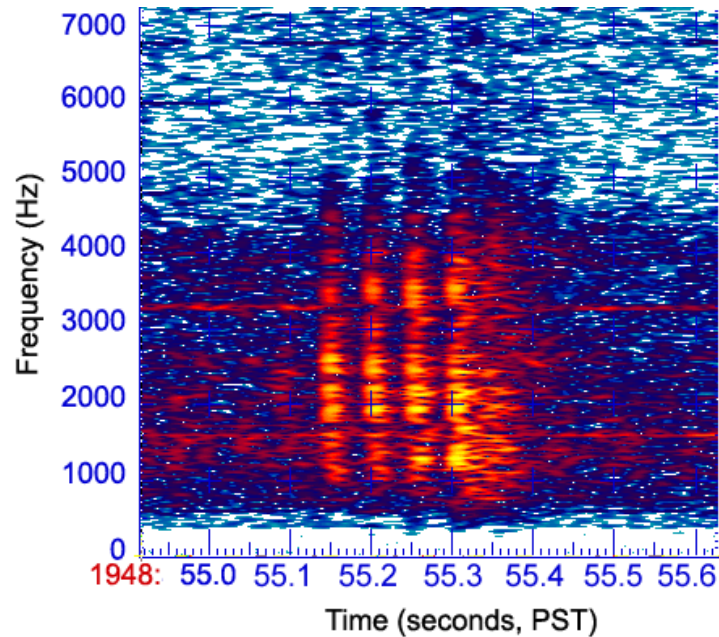
The spectrogram³ of the ratchet noise is shown in Figure 2. The noise appears to be broadband in frequency, with medium to high intensity. Because of its cyclic nature, short rise time and broadband frequency range, the noise can generally be characterized as a cyclic impulse produced relatively close to the recording source. Historically CVR recordings of cyclic impulse noises are generally produced by an on board aircraft system or a repeatable external factor, such as runway seams.

Figure 2: Spectrogram of ratchet noise.

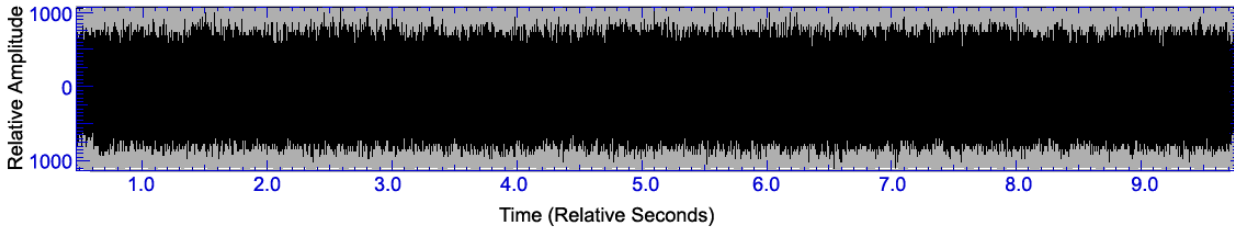
The results from the audio tests revealed that the movement of the ULD and pan in the cargo positions closest to the front of the aircraft—with the cockpit door open or closed—was not significantly pronounced from the background noise. That is, on the CAM channel CVR recordings, the amplitude of the noise of the cargo load rolling over the rollers and slamming into the position locks was imbedded within the amplitude of the background noise. The waveform of a weighted ULD rolling into position 4, recorded with the cockpit door open, is shown in Figure 3, and a weighted pan, recorded with the cockpit door open, is shown in Figure 4.

Figure 3: ULD rolling from cargo hold position 3 to 4. The beginning of the roll occurs at 1.6 seconds and ends with a slam into the position locks at 6.6 seconds. Recorded with the cockpit door open.

Figures 3 and 4 are indicative of the amplitude shown throughout the test data of load movement within the cargo hold, as recorded on the CAM channel—regardless of the specific test scenario. Although the rolling noise has a similar cyclic, ratchet-type effect while rolling over the rollers to the accident’s ratchet noise, the amplitude of the signal is not greater than the overall background noise level, as recorded by the CVR via the CAM. The unidentified ratchet recorded by the accident CVR was impulsive with a distinct rise in amplitude above the background noise. Based on the recorded audio test data, cargo load movement is not acoustically similar to the unidentified ratchet noise recorded on N8079U’s CVR.

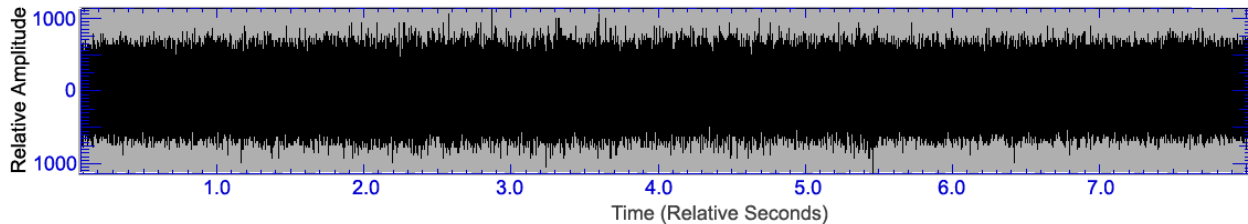
Figure 4: Pan rolling from cargo hold position 1 to 2. The beginning of the roll is at 0.5 seconds and ends with a slam into the position locks at 5.5 seconds. Recorded with the cockpit door open.

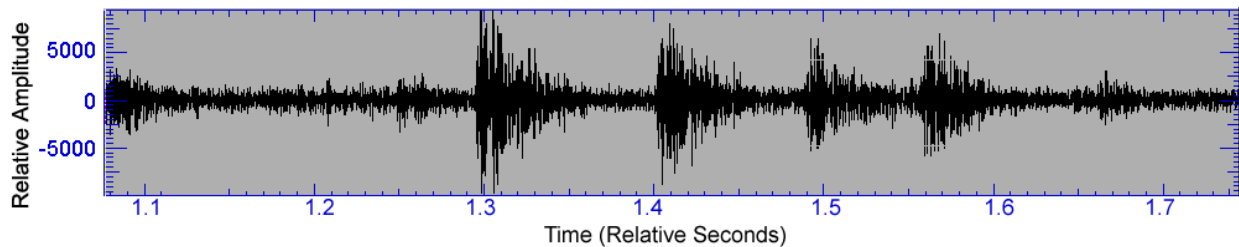
Because the rudder pedals are spring-loaded, it is possible to produce a ratcheting noise when adjusting the rudder pedal setting. During the audio tests, a ratchet noise was created once, but could not be executed again. In subsequent trials it was possible to produce an impulse noise, but not in a series resembling the cyclic nature of the unidentified noise in the accident recording. Moreover, the single occurrence of the ratchet-type noise from the audio test was not truly cyclic, in that the period of the impulses varied, as shown in Figure 5.

Figure 5: Waveform of rudder pedal adjustment from audio test.

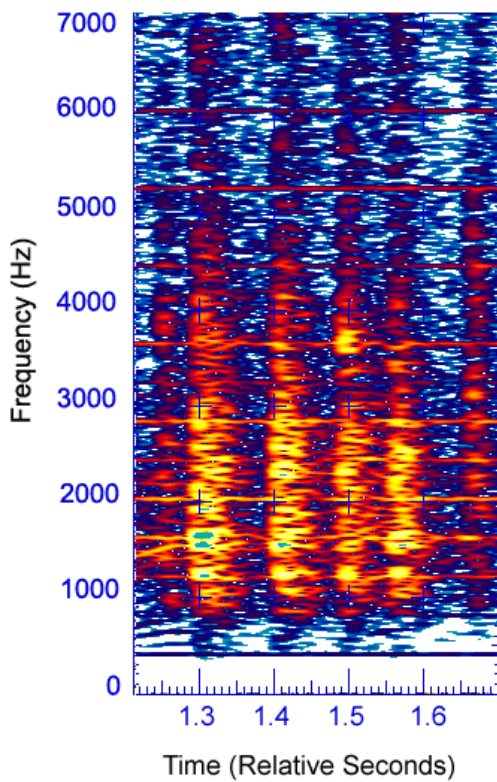
The spectrogram (Figure 6) of the rudder pedal adjustment shows a broadband impulse noise with a high intensity of signal strength. Although similar to the unidentified ratchet noise from the accident, there is a higher concentration of frequency strength between 1000 and 2000 Hz in the test recording. The accident ratchet's intensity level is relatively even throughout the bandwidth, with a slightly higher concentration in the 2000 to 3000 Hz range. Although the audio test resulted in capturing a series of impulse noises during rudder pedal adjustment, the acoustic data was insufficient to make a determination as to the likelihood that the rudder pedal adjustment was the source of the accident ratcheting noise.

Figure 6: Spectrogram of rudder pedal adjustment impulses.

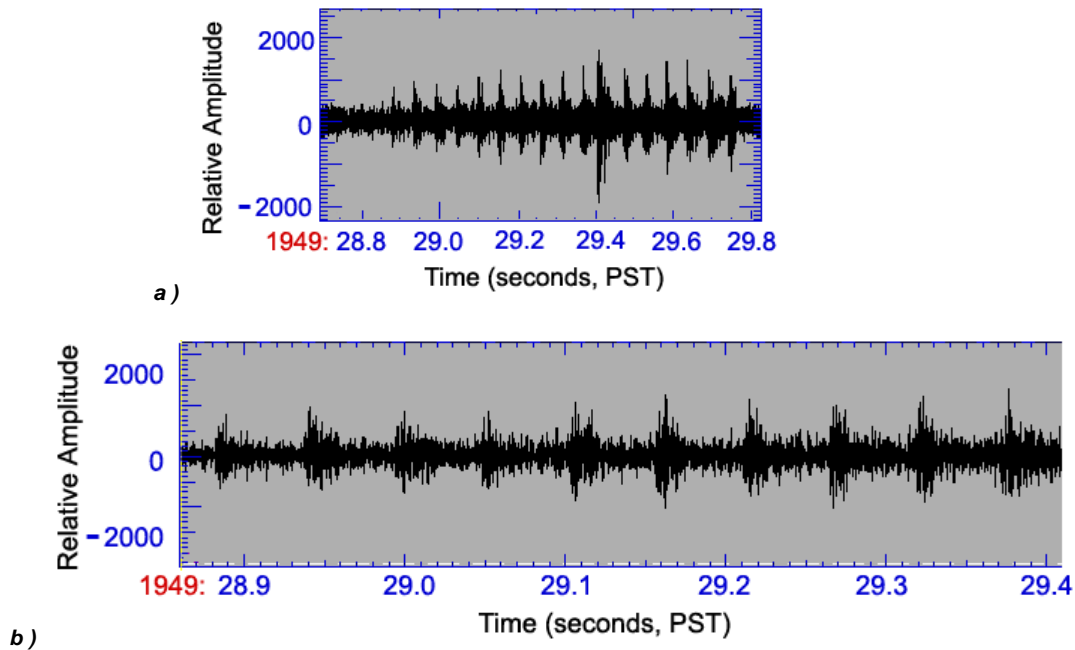
The CVR group was able to identify the stick shaker within the accident recording. The accident aircraft's stick shaker recording shows a cycle of 18.7 Hz, as shown in Figure 7. The stick shaker's cycle falls within the operating range of the stick shaker motor, which is specified to run between 800 and 1200 RPM (or 13.3 Hz to 20.0 Hz). From the waveform it is evident that the stick shaker noise is impulsive with a relatively sharp rise in amplitude that has peaks close to 250% of the level of the background noise—slightly lower than the peaks shown in the waveform of the ratcheting noise.

Figure 7: a) Waveform of the stick shaker recorded on the accident aircraft's CVR and b) the zoomed view.

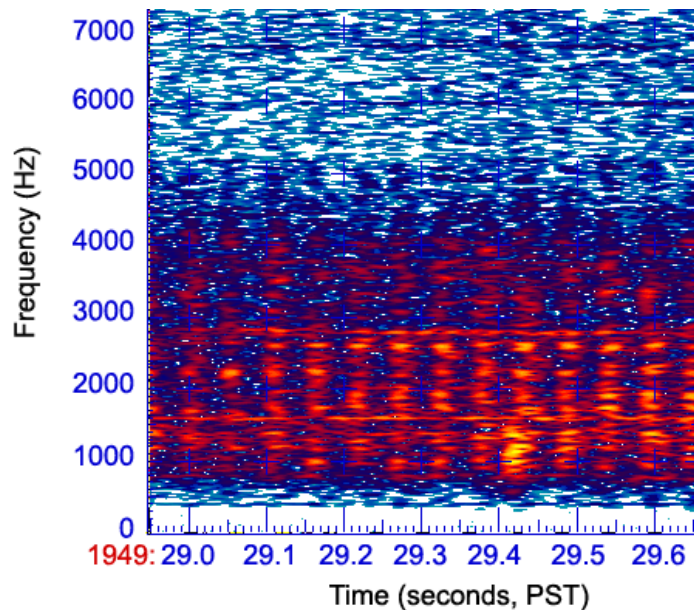
The spectrogram of the stick shaker, Figure 8, reveals a broadband noise of medium intensity. The intensity distribution of the impulse differs slightly from the ratcheting noise in that the strength appears to drop off after about 2750 Hz. Regardless it is notable that the stick shaker cycle is 18.7 Hz, whereas the ratcheting noise has a cycle of 18.8 Hz.

Figure 8: Spectrogram of stick shaker from accident recording.
