Comparative analysis of documented damage to tank cars containing denatured alcohol or crude oil
exposed to pool fire conditions

A White Paper
By
Karl Alexy
Office of Safety, FRA

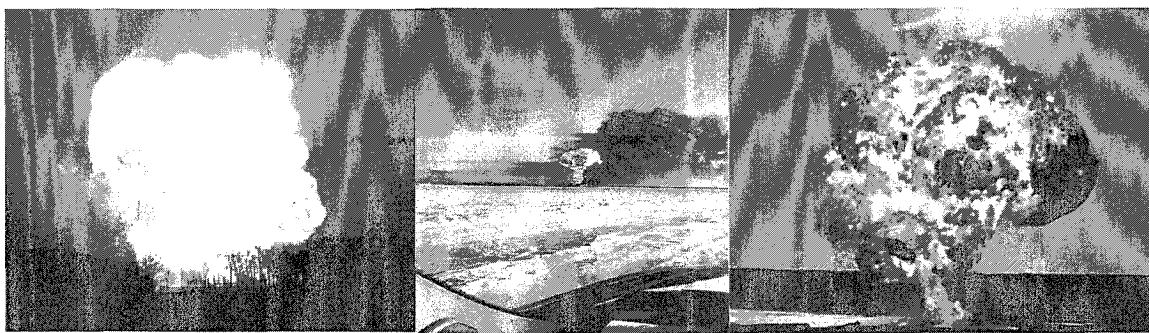
Figure 2: Photographs of explosions at recent derailments; Arcadia, OH (denatured alcohol); Casselton, ND (crude oil), and Plevna, MT (denatured alcohol).

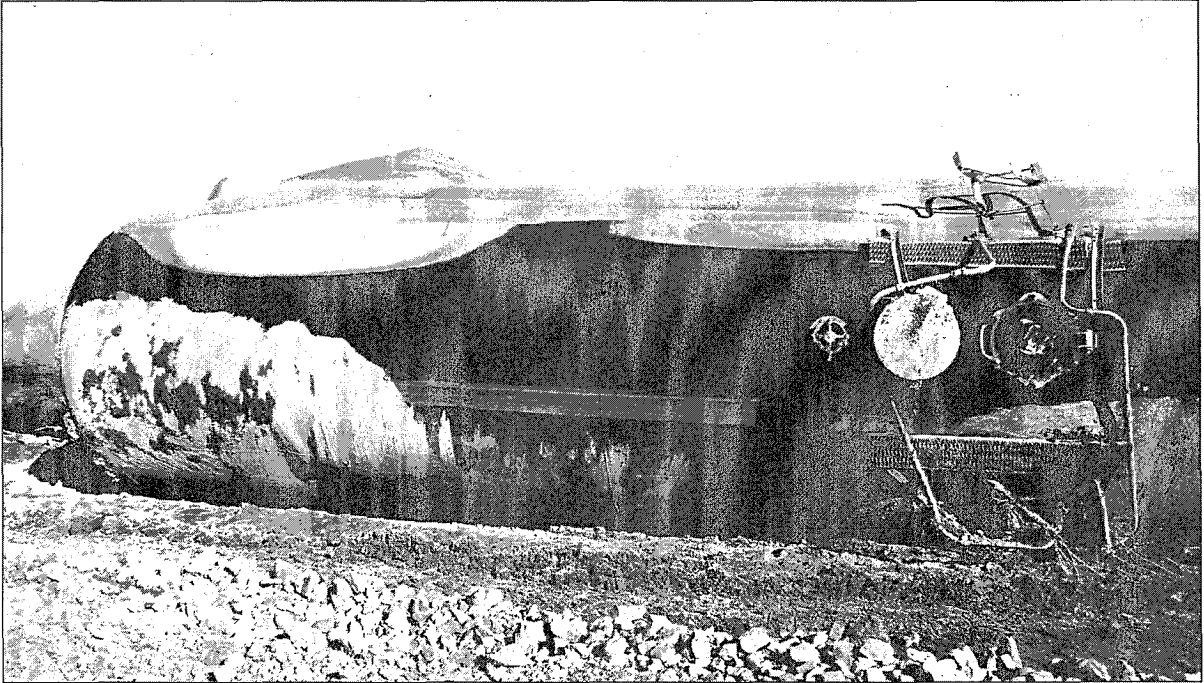
Figure 2: Arcadia, OH derailment ADMX30917

- Thinning of steel
 - Measurements - The original thickness of the steel is 0.4375" (nominal)
 - Arcadia (ADMX30917) – Thickness measurements were taken circumferentially (perpendicular from the longitudinal fracture surface.

Measurement Number	Edge	1"	1'	2'	3'	2'	1'	5"	Edge
thickness	.282	.307	.406	.428	.431	.427	.429	.359	.267

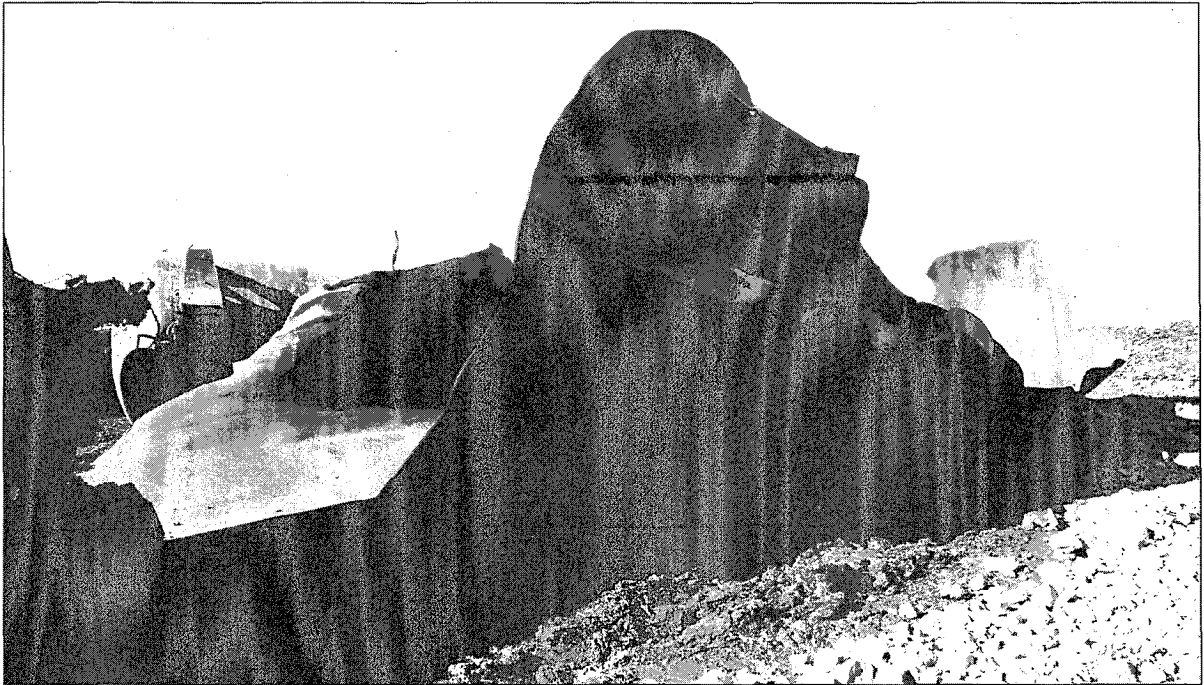
Figure 4: Arcadia, OH derailment UTLX211623 ("dance floor")

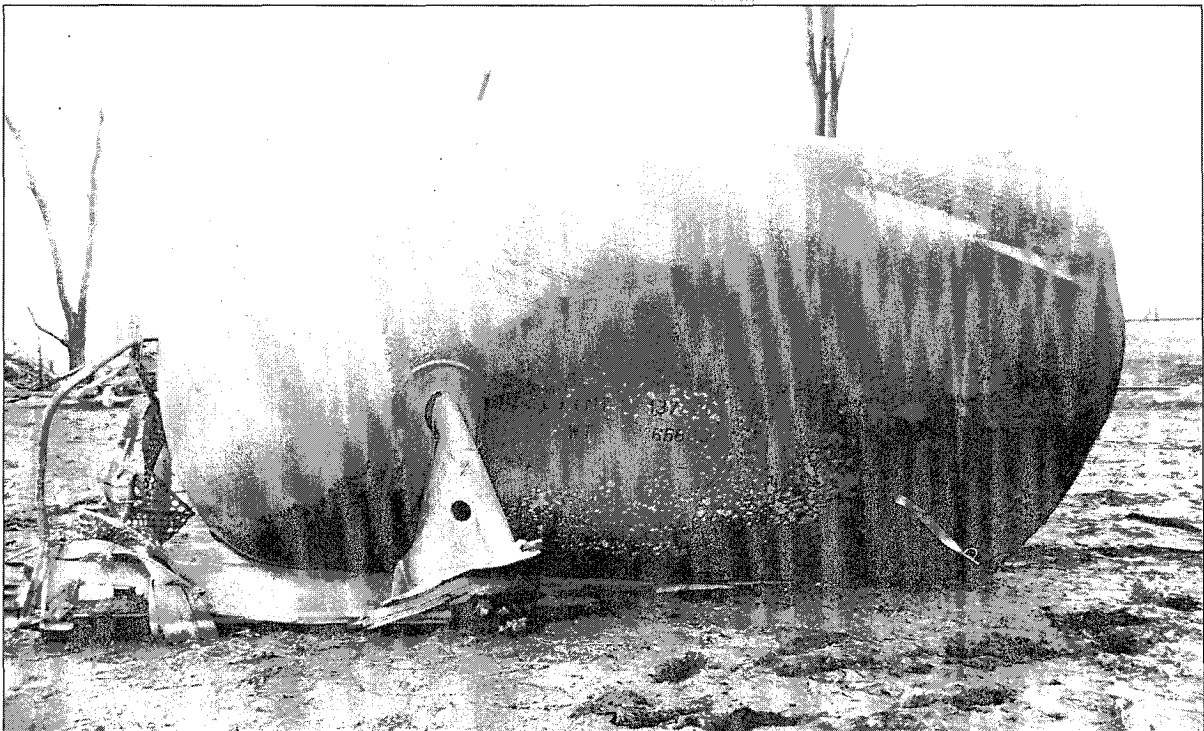
Figure 5: Arcadia, OH derailment UTLX211623 ("rocket" landed approximately 100 yards from "dance floor")

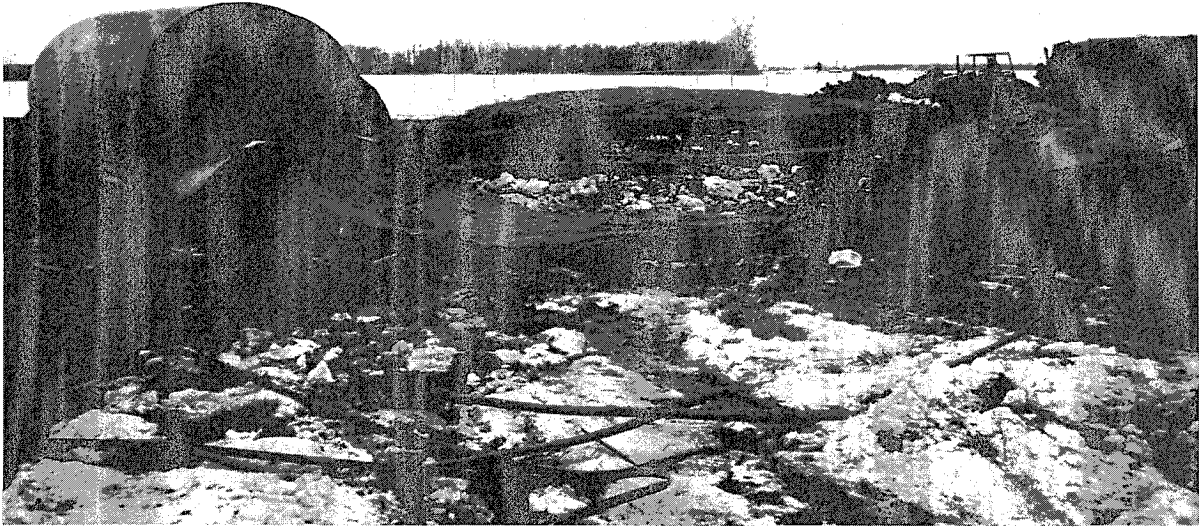
Figure 6: Arcadia, OH derailment ADMX29420 ("dance floor")

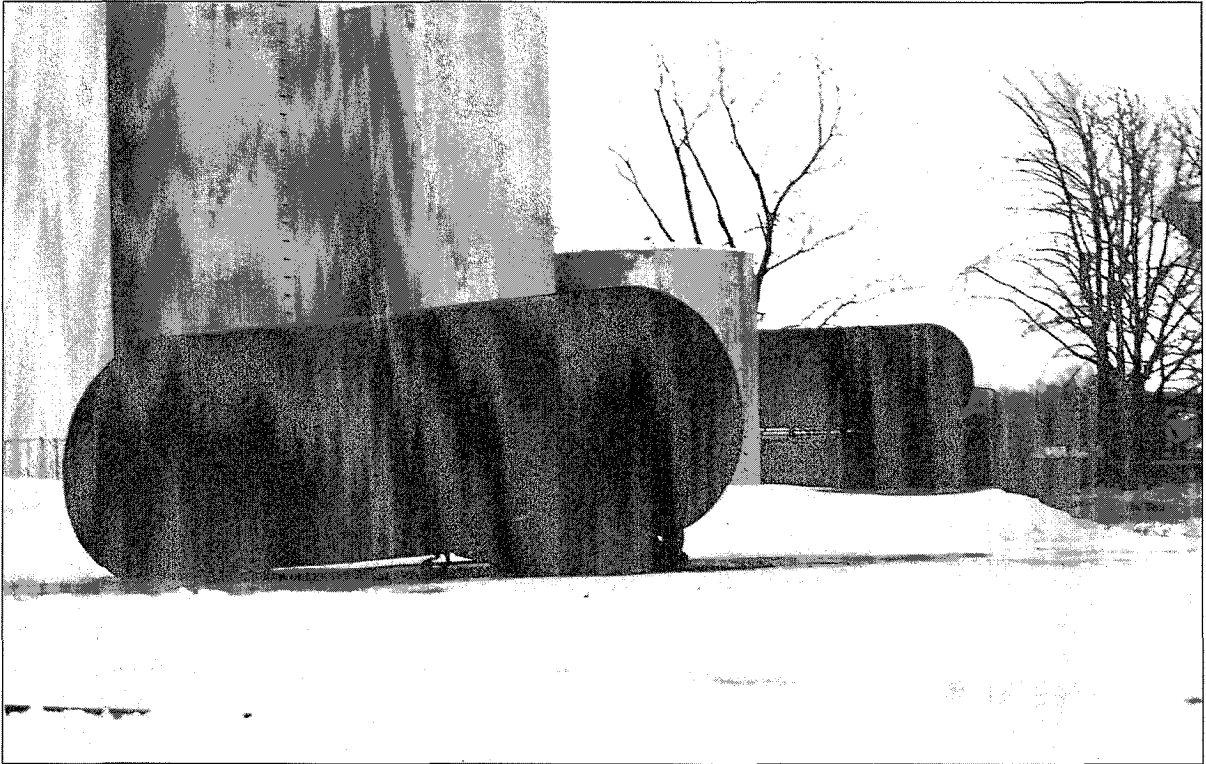
Figure 7: ADMX29420 ("rocket") landed approximately 300 feet from "dance floor")

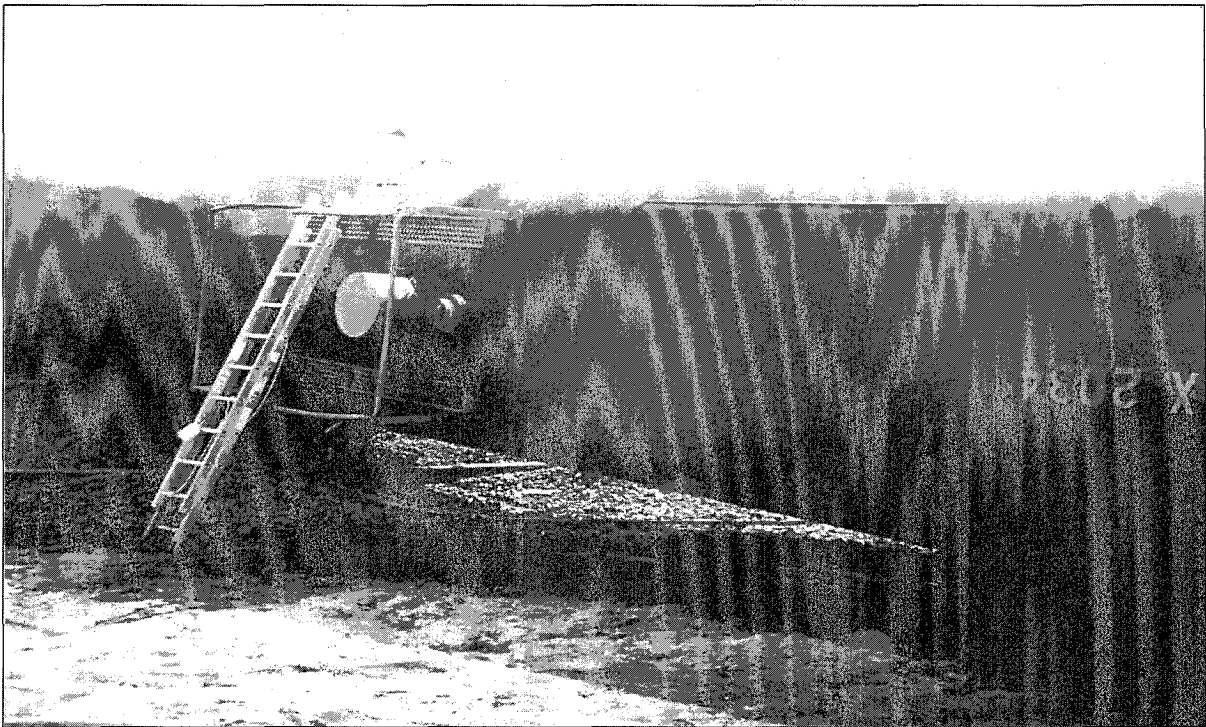
Figure 10: Plevna, MT derailment UTLX203411

Between 4:45 and 6:30 PM, three tank cars (UTLX 203411, UTLX 211777, and NATX 303405) experienced heat induced tears resulting in fiery explosions. Between 6:30 and 7:00 PM, two more tank cars (ACFX 200416 and UTLX 204772) experienced heat induced tears and also exploded. The fire firefighters on hand reported hearing some of the pressure relief devices "whistle" for 5-10 minutes before seeing the fireballs of the explosion.

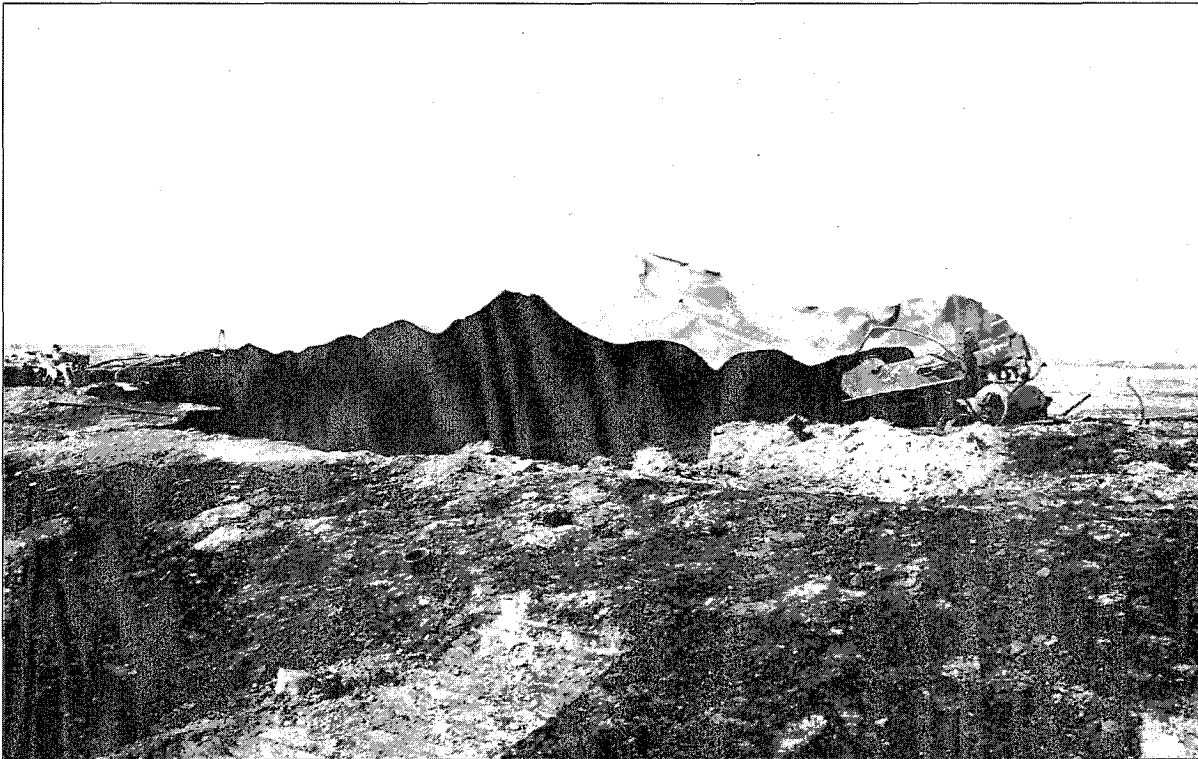
Figure 14: Plevna, MT derailment GATX200855

Approximately 90 minutes after the derailment around 4:30 PM, the fire chief reported that a tank car (GATX 200855) experienced a heat induced tear which separated the tank car into 3 parts. 2/3 of the tank car (B-end) was propelled approximately 400 feet southeast of the track and the head of the car (A-end) ended up approximately 450 feet northeast of the track. The 1/3 portion of the A-end of the car was split wide open and laid flat about 50 feet north of the track.

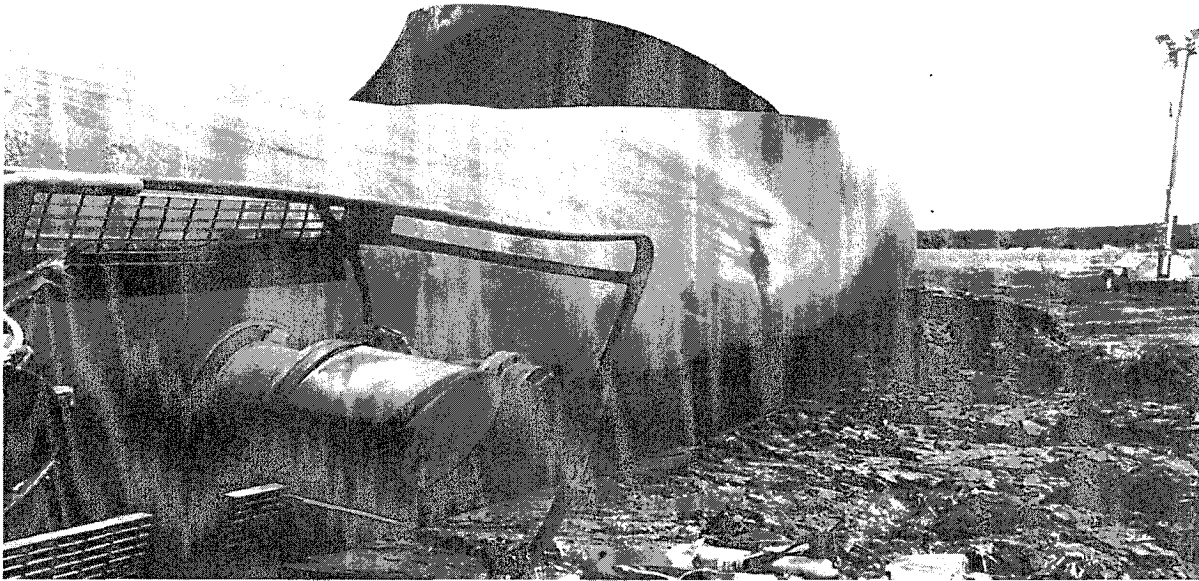
Figure 1: Luther, OK derailment UTLX 201925

- Luther, OK (TILX201925) - Sampling of thickness measurements taken along edge of fracture surface.

Measurement Number	1	2	3	4	5	6	7	8	9
thickness	.285	.285	.312	.322	.356	.300	.275	.220	.220

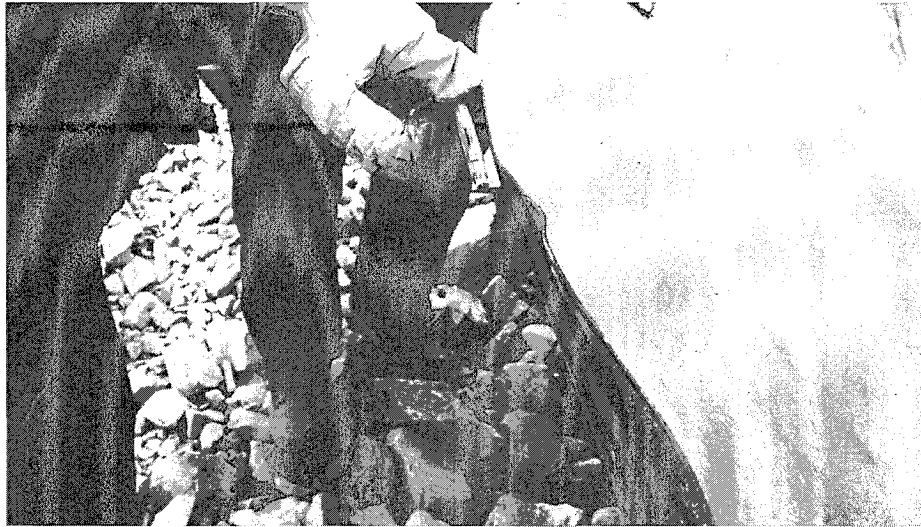
- Photographs – Below is a photo of the “knife edge” of the fracture surface of tank car UTLX211623 involved in the Arcadia, OH derailments. A pencil with a width of 5/16" is used as a reference. The measured thickness was less than 1/8".

Figure 1: Thinning of shell of UTLX211623
