## **NATIONAL TRANSPORTATION SAFETY BOARD**

# **COMPONENT EXAMINATION OBSERVATIONS**

**WPR17LA202**

Location: Roy, Utah  
Date: September 12, 2017  
Aircraft: Beechcraft A24R, Registration N9798L, Serial #MC-117  
NTSB IIC: Samantha Link

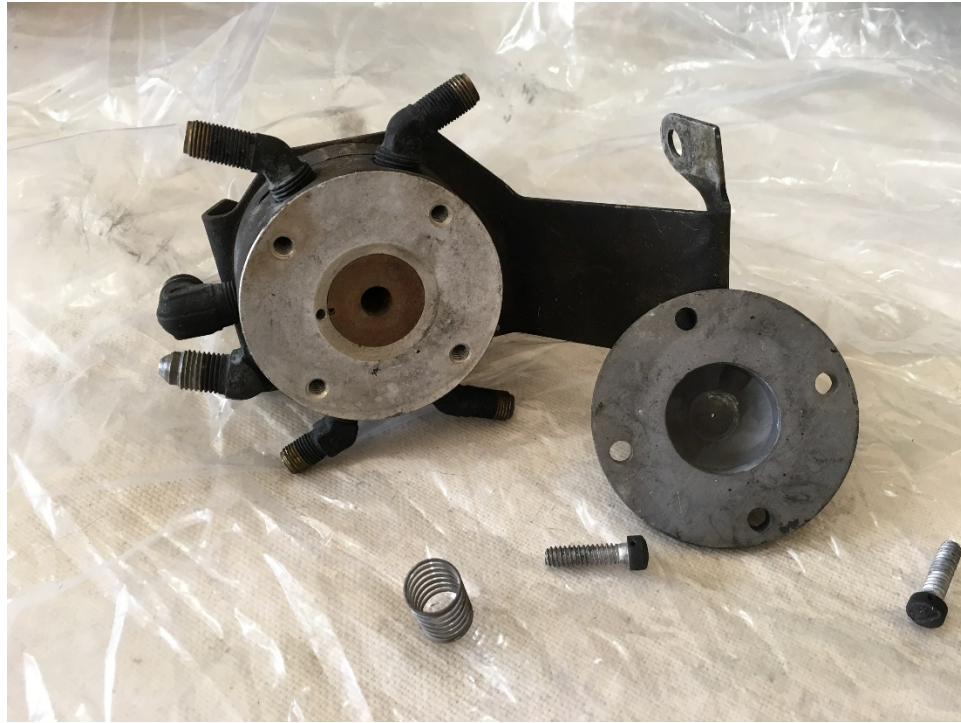
Figure 1: Fuel Distributor

- The fuel distributor exhibited heavy thermal damage. It was disassembled prior to it being shipped and it was loosely secured together with two screws.
  - The screws were removed and there was only a spring. The diaphragm and metal plunger were missing.
    - The engine would be unable to run without these items.
- The unit was disassembled
  - Spring was malleable
  - Free of corrosion or abnormal debris
- The fuel line out puts were examined and clear of debris

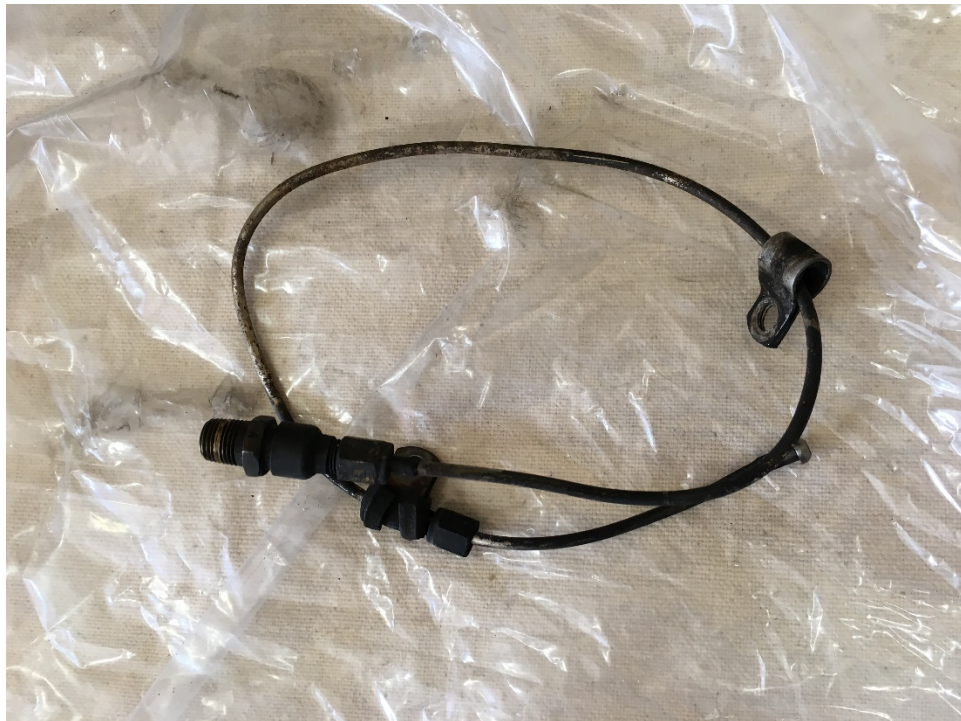
Figure 2: Fuel Injection Line

- The fuel injection line exhibited a small section of corrosion, but no other visual anomalies were noted
- Air was blown through the line and it was clear of debris.

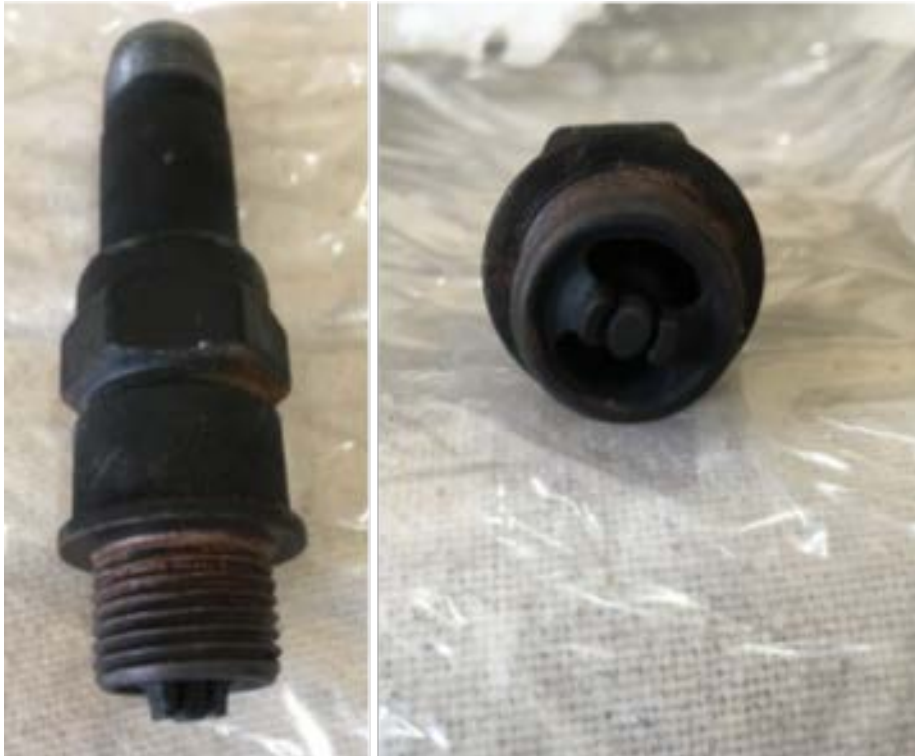
Figure 3: Upper Spark Plug #4 Cylinder

- The spark plug was exhibited normal operational signatures when compared to the Champion Check-a-Plug Chart.
- The electrodes were clear and evenly spaced
- Some corrosion was noted on the outside of the spark plug and on the three outer most threads
  - No damage to electrodes.

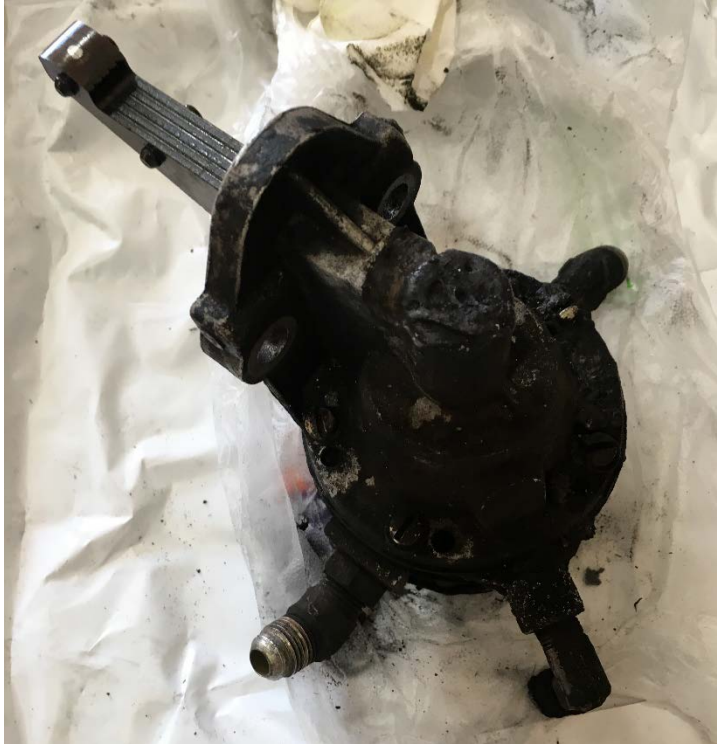
Figure 4: Fuel Pump

- The fuel pump exhibited heavy thermal discoloration and damage
- The Fuel pump was manipulated by hand and moved freely
- Fuel was noted at the engine attachment point
- Disassembly could not be completed due to damage; however, the casing was loosened and the internal spring appeared intact and fuel was noted throughout.

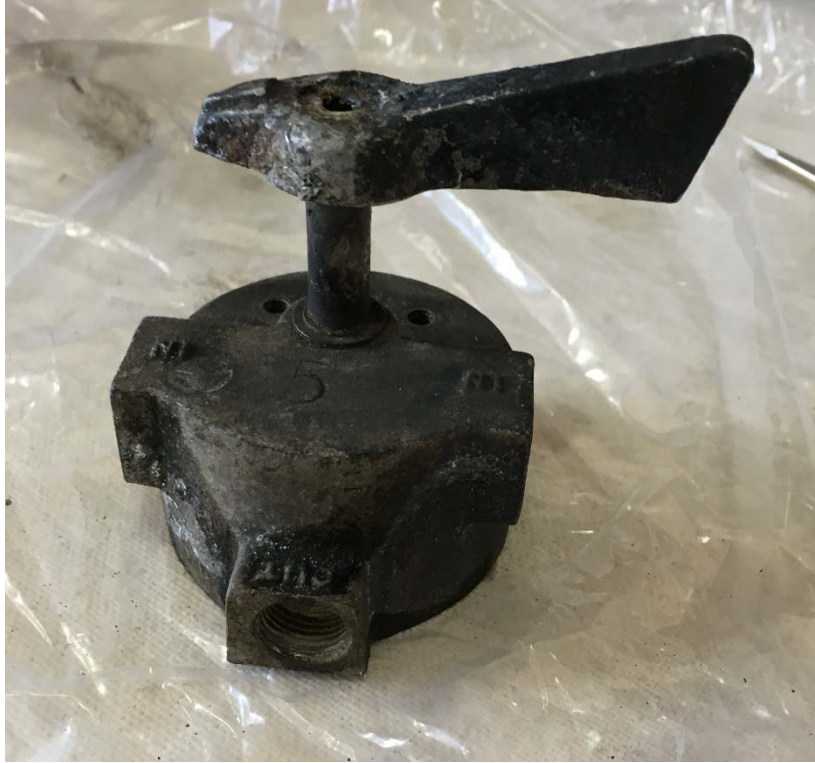
Figure 5: Fuel Selector Valve

- The fuel selector sustained heavy thermal damage
- The fuel selector handle operated smoothly and had obvious detents.
- Air was blown through the fuel selector inlet and the handle was rotated between each position. Air was felt at the corresponding output.
  - The fuel selector was clear of debris
