**NATIONAL TRANSPORTATION SAFETY BOARD**  
Office of Aviation Safety  
Washington, D.C. 20594

**Computed Tomography Specialist's Factual Report**

CEN-11-IA-193

Operator: Gulfstream Aerospace  
Location: Outagamie County Regional Airport (ATW), near Appleton,  
Wisconsin  
Date: February 14, 2011  
Time: Approximately 1315 local time  
Airplane: Gulfstream Aerospace GV-SP airplane, N535GA

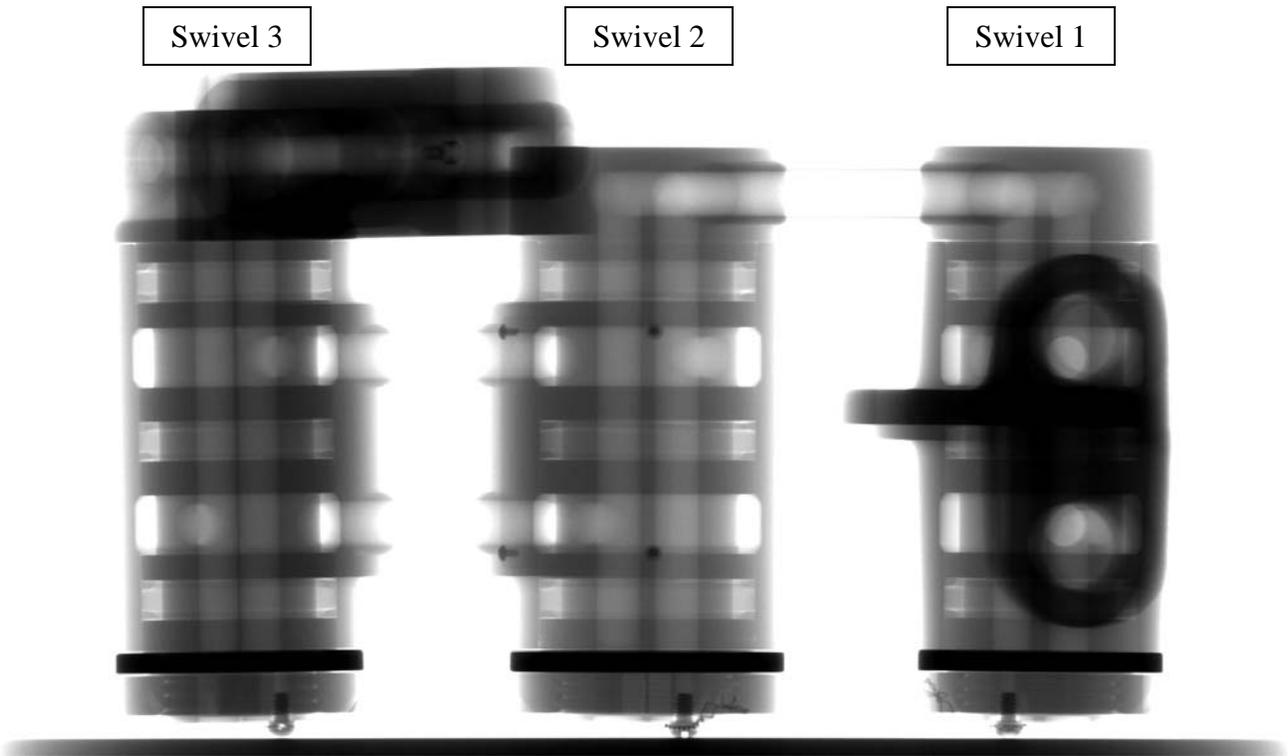
Figure 1  
Digital Radiograph – Entire Swivel Assembly

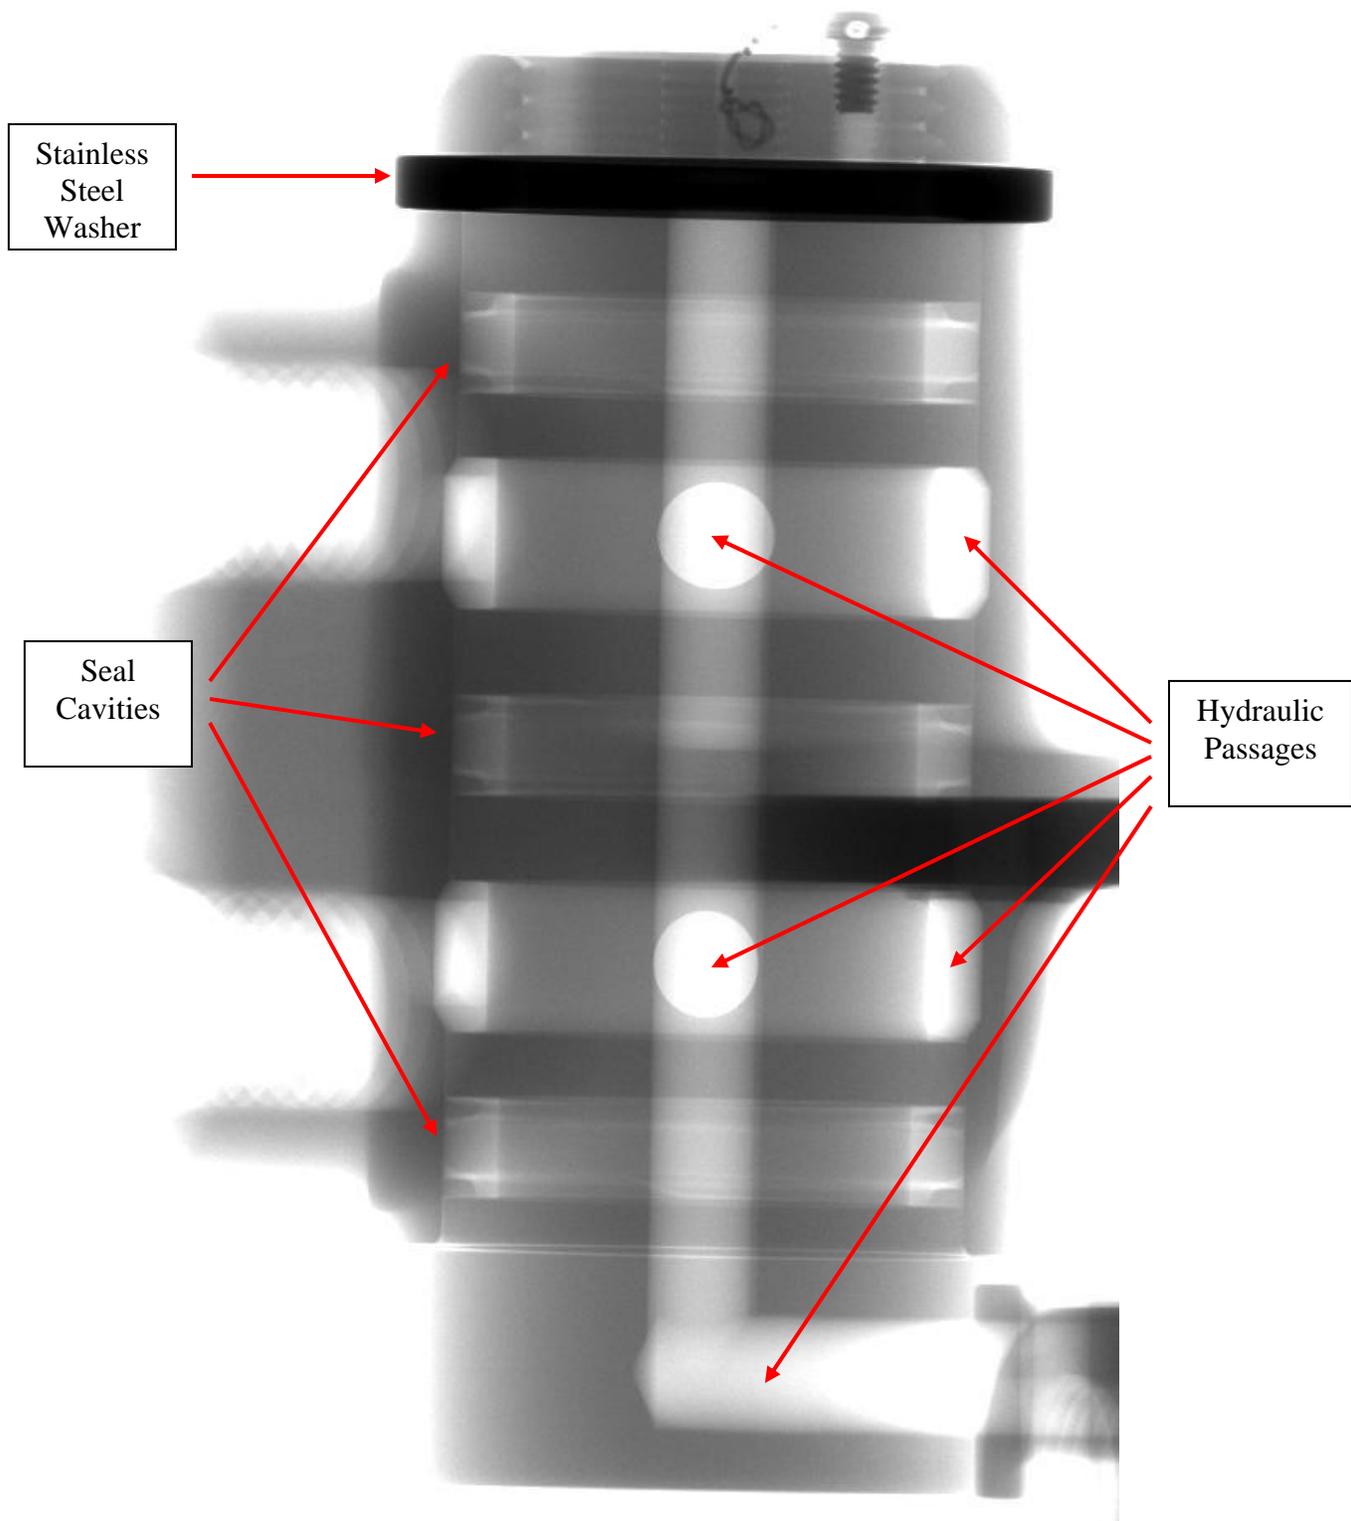
Figure 2  
Digital Radiograph – Swivel 1

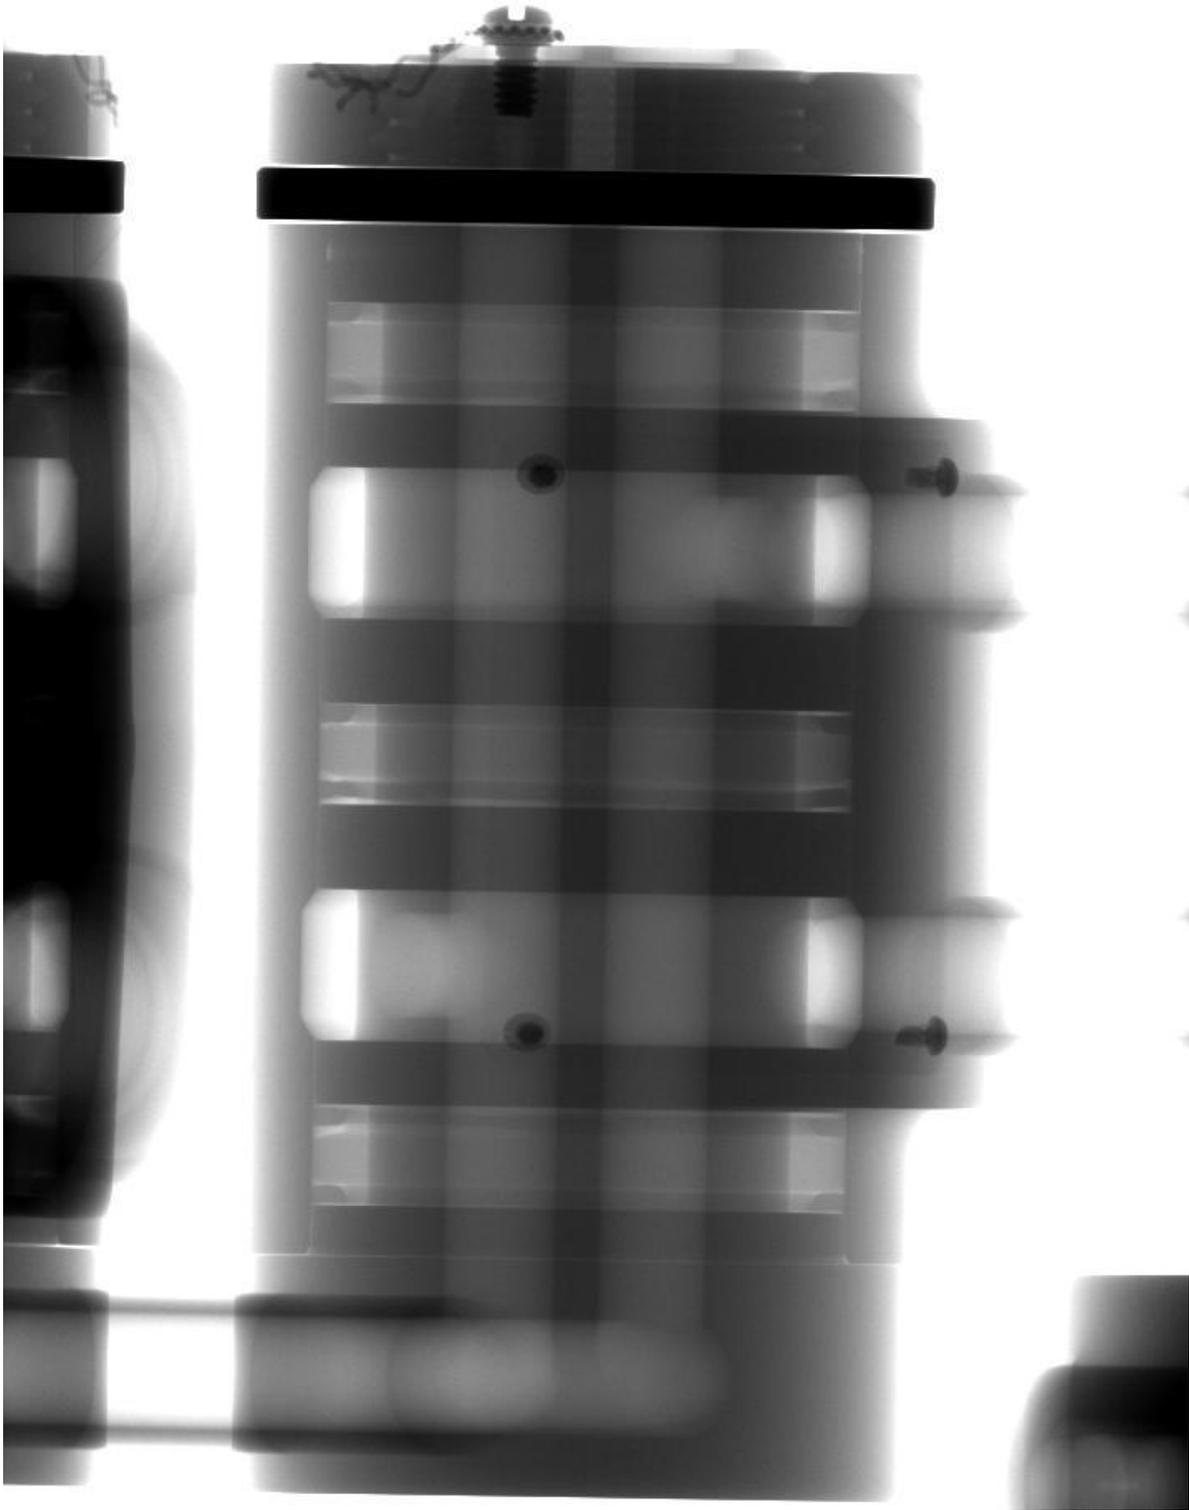
Figure 3  
Digital Radiograph – Swivel 2

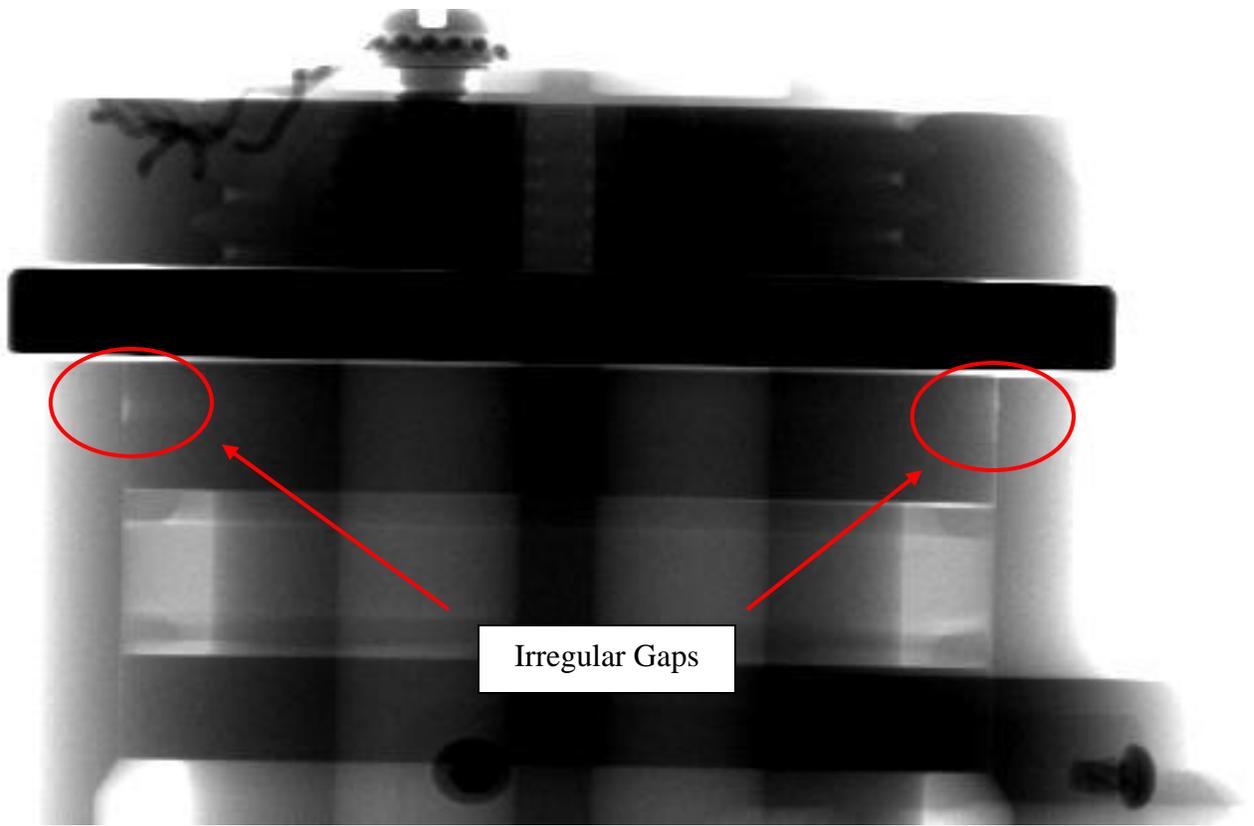
The digital radiographs for the assembly are presented in figures 1 through 6. Note that in figure 1, the swivels are in a different orientation than that shown in Pneu Draulics, Inc. drawing 7438-4, and they are labeled accordingly. A close up of the inner spool of the center swivel showing possible irregularities in the gap between the inner spool and the outer housing is shown in figure 4.

Figure 4  
Digital Radiograph – Swivel 2 – Close up

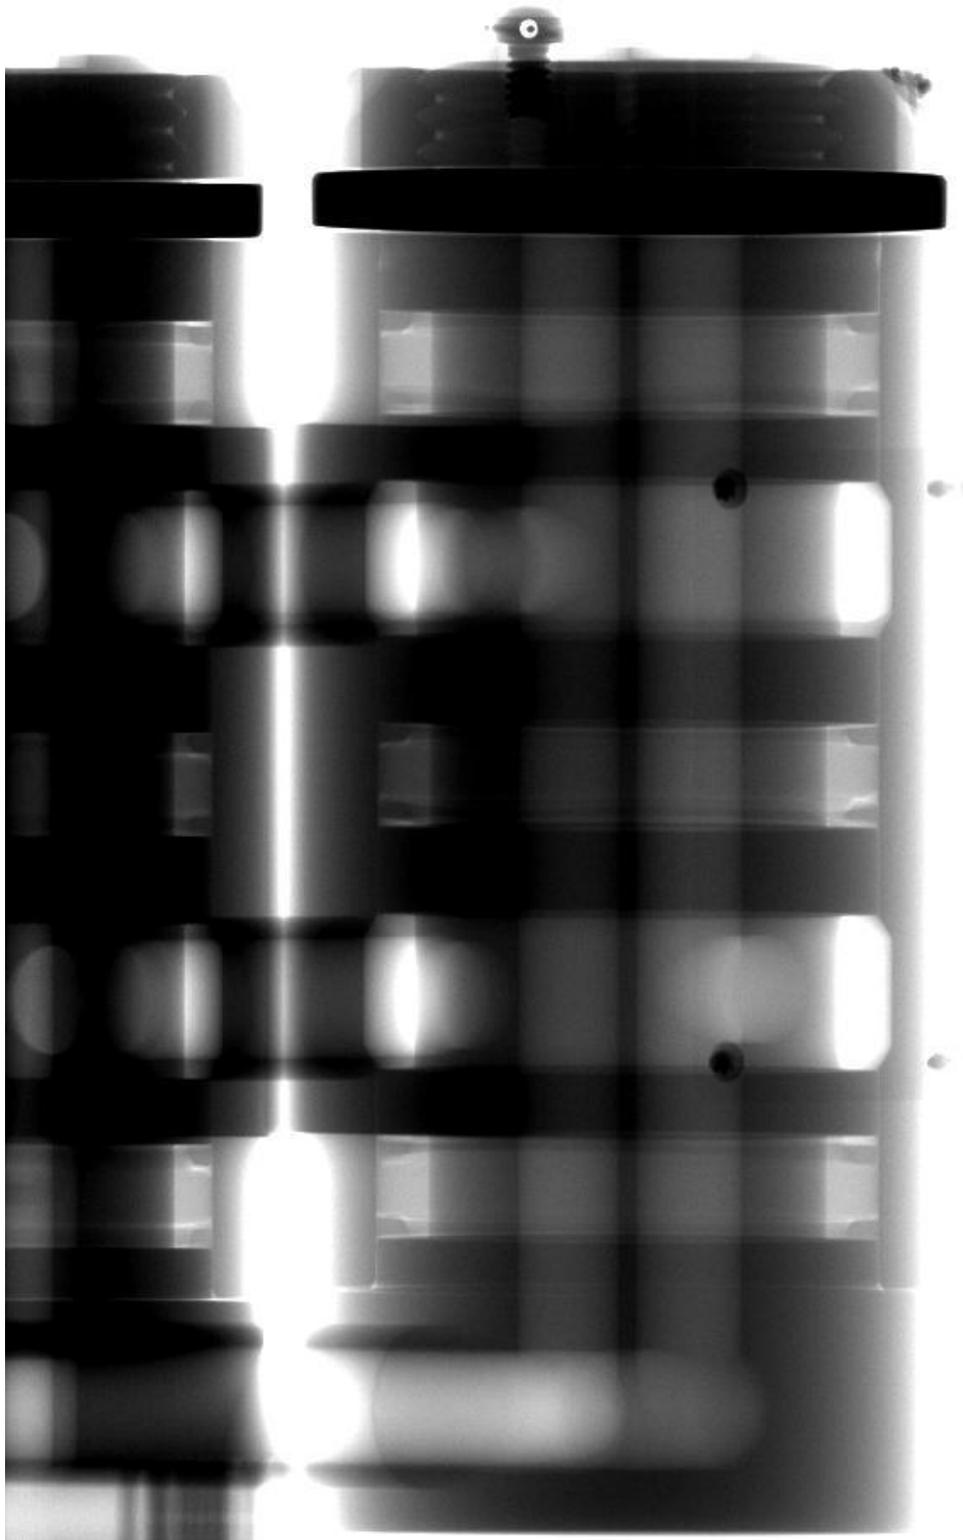
Figure 5  
Digital Radiograph – Swivel 2 (rotated 90 deg)

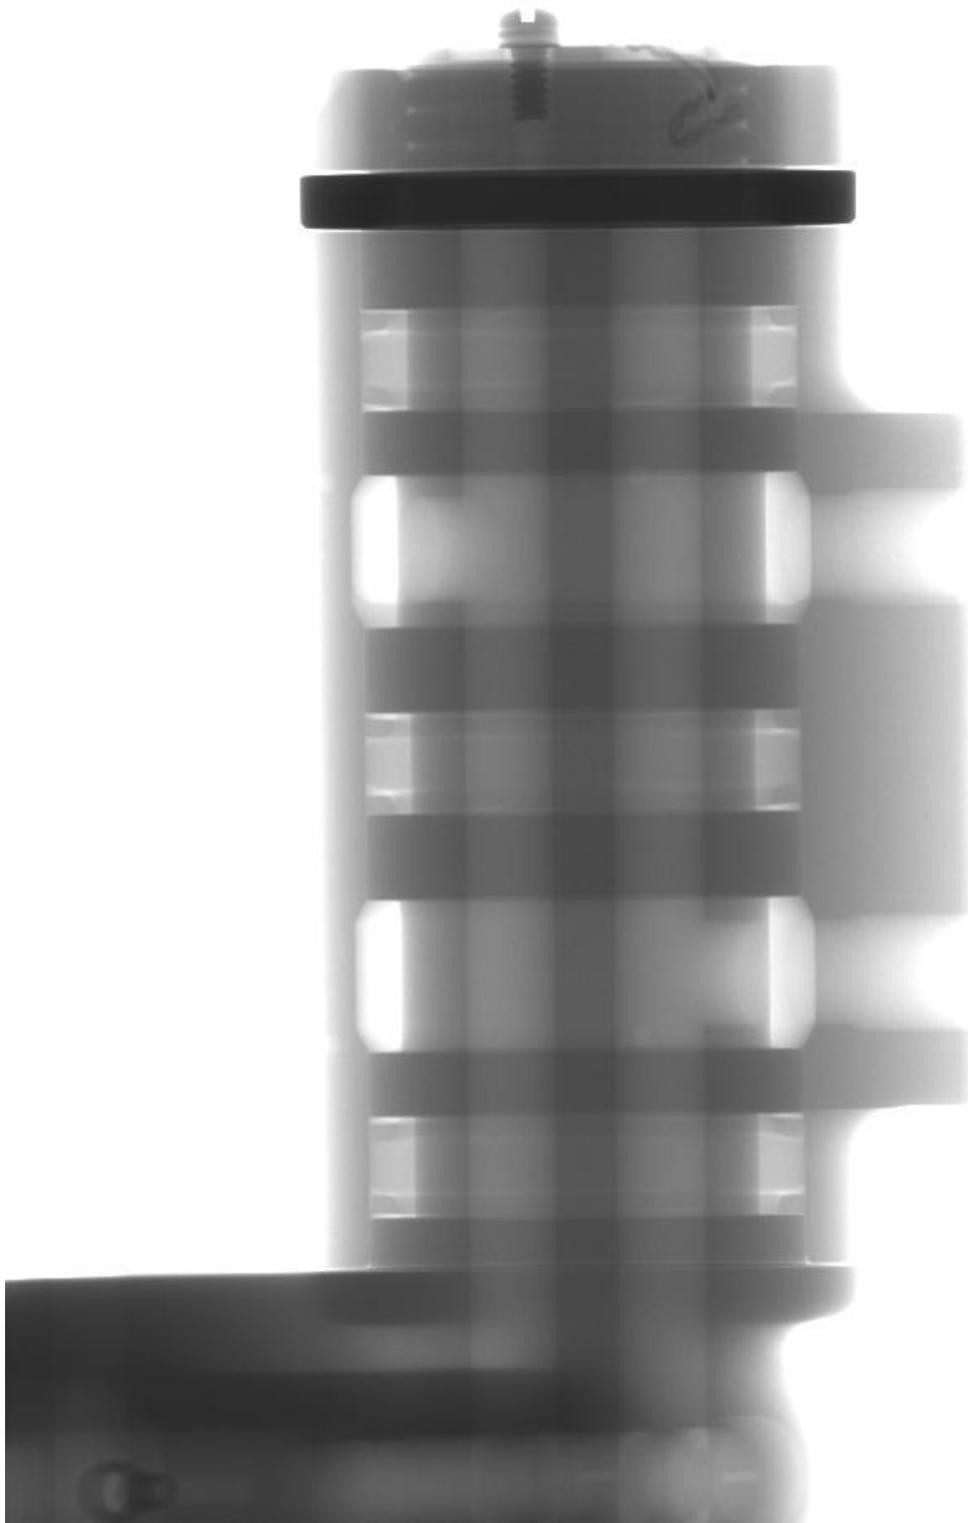
Figure 6  
Digital Radiograph – Swivel 3

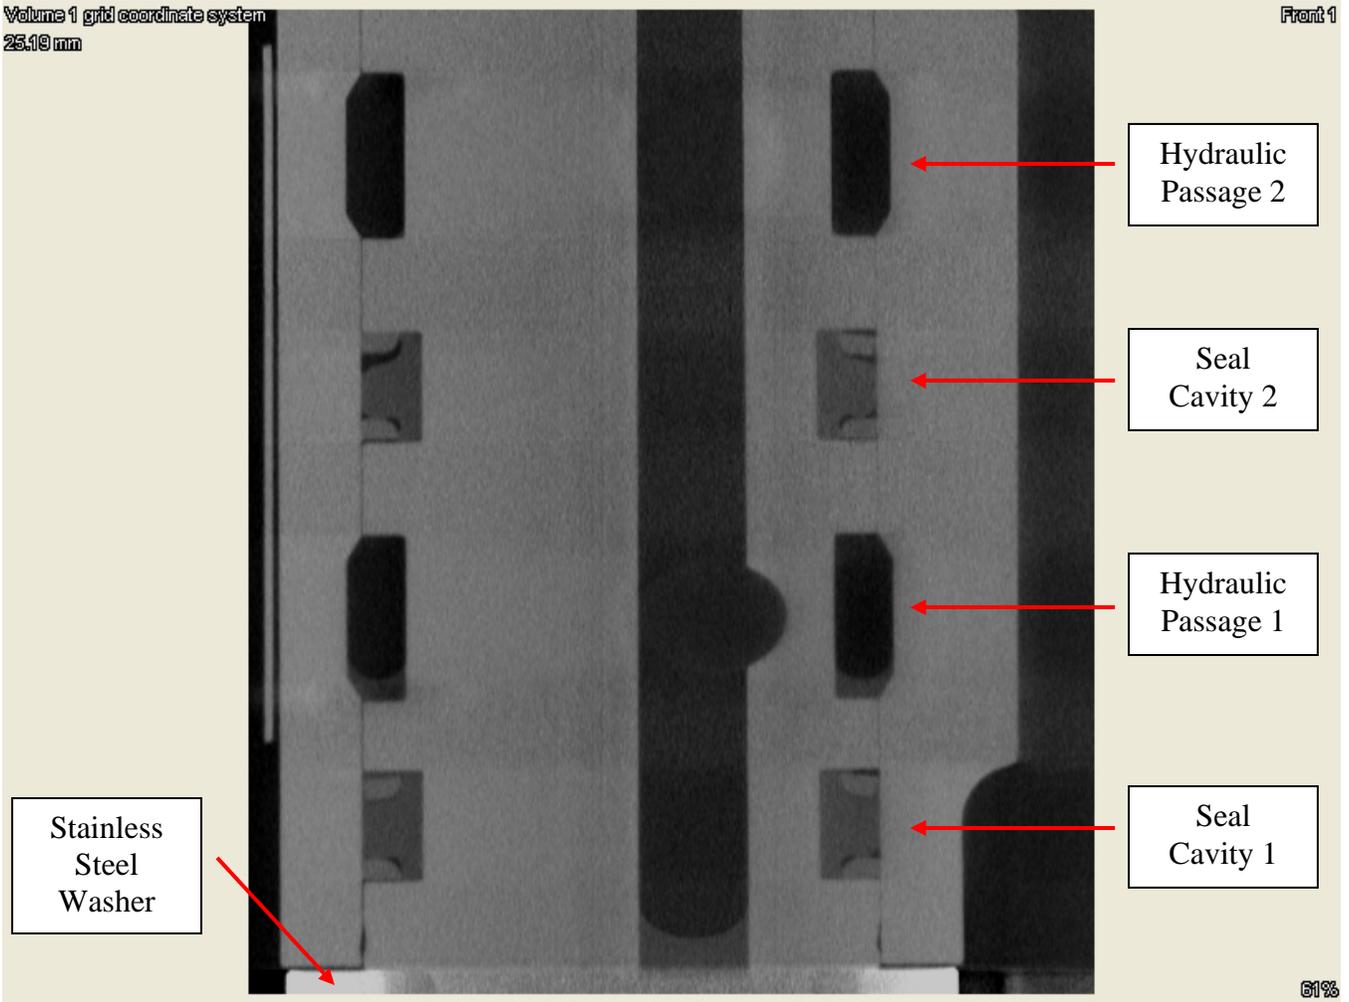
Figure 7  
Frontal Cross Section – Swivel 2 – Overall View Showing Lower (as scanned)  
Portion of the Swivel

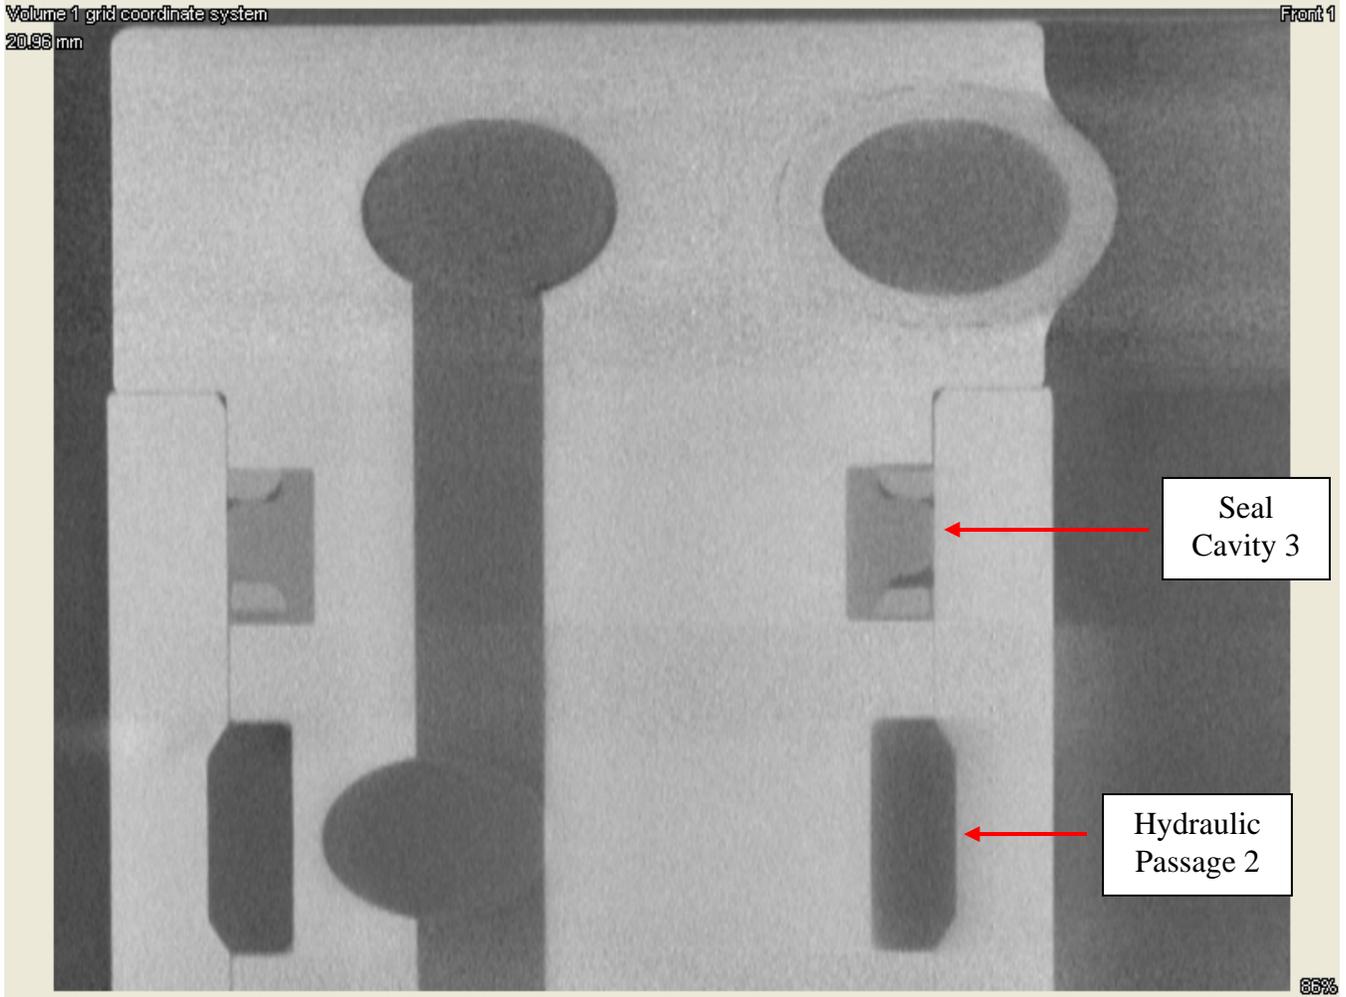
Figure 8  
Frontal Cross Section – Swivel 2 – Overall View Showing Upper (as scanned)  
Portion of the Swivel  
Note: Hydraulic Passage 2 is Shown in this Figure and also in Figure 7

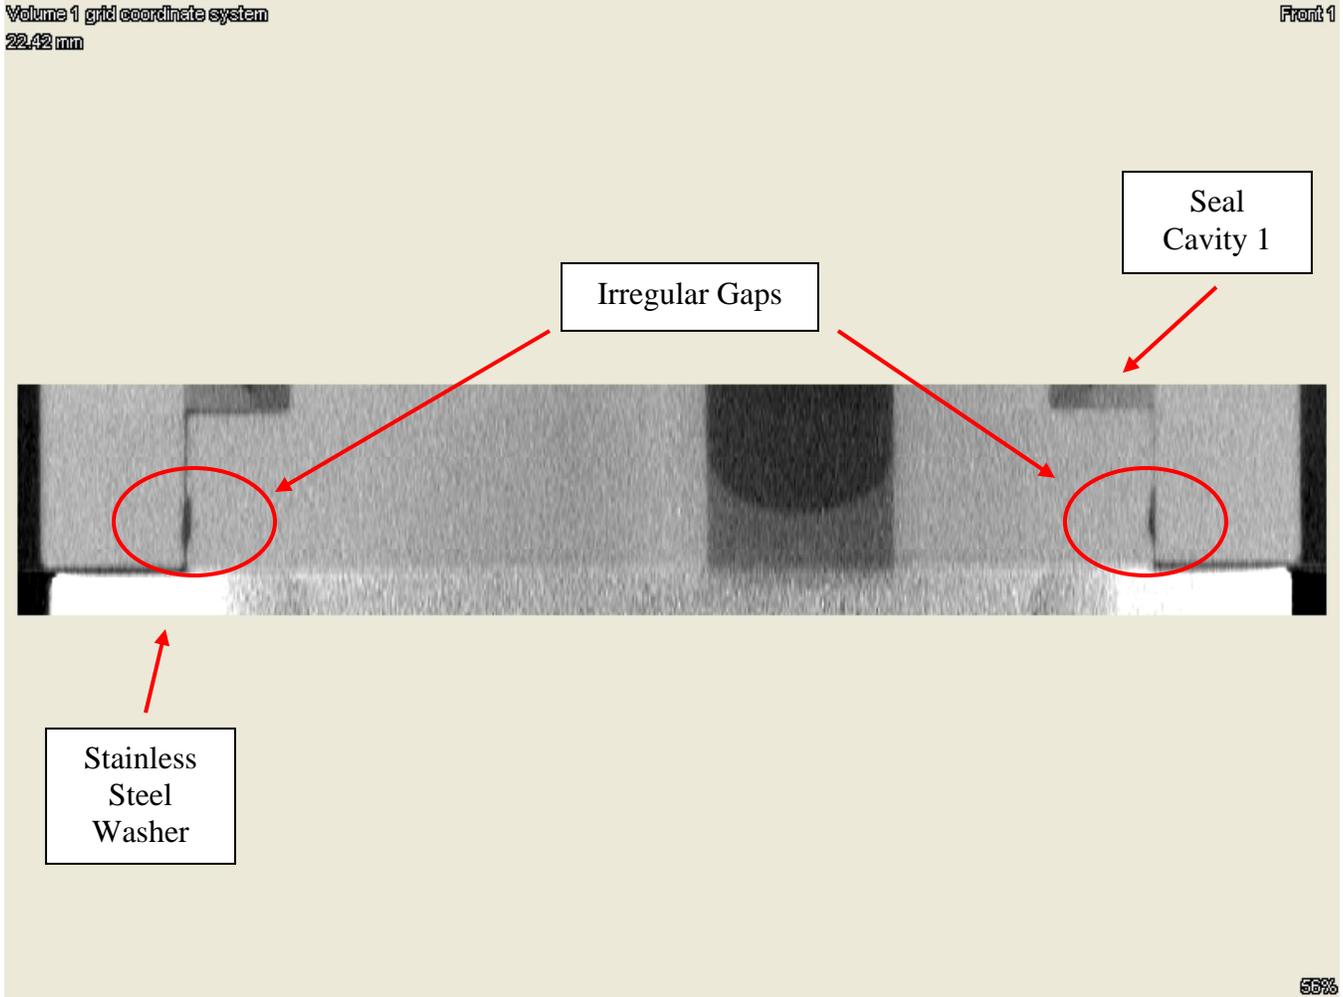
Figure 9  
Frontal Cross Section - Swivel 2 – Irregular Gaps Between Inner Spool and Outer  
Housing Located Between Stainless Steel Washer and First Seal Cavity

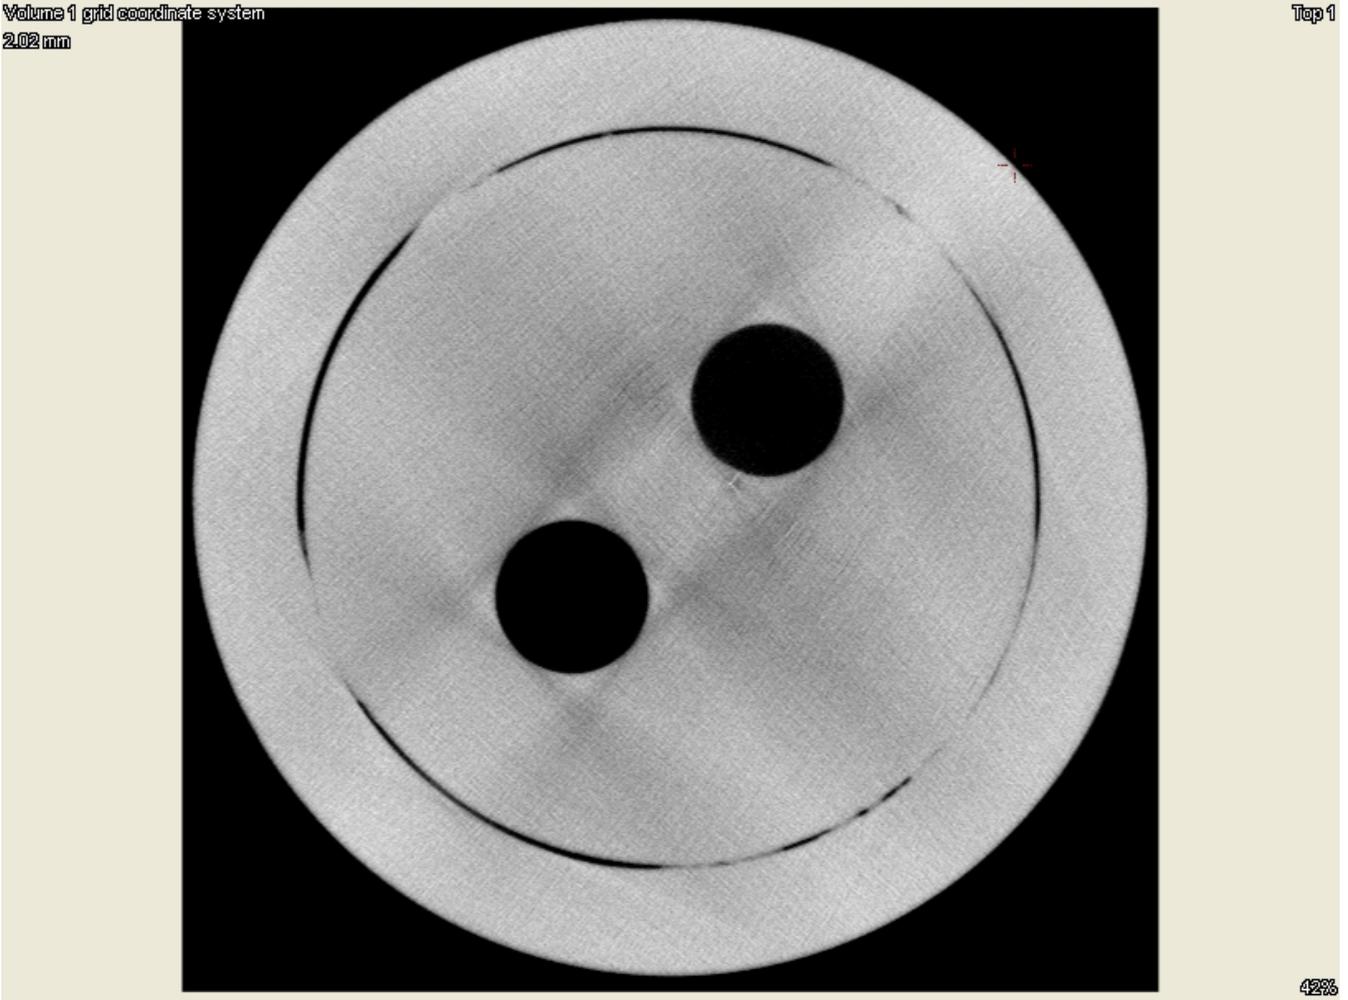
Figure 10  
Axial Cross Section - Swivel 2 – Irregular Gaps Between Inner Spool and Outer Housing  
Located Between Stainless Steel Washer and First Seal Cavity

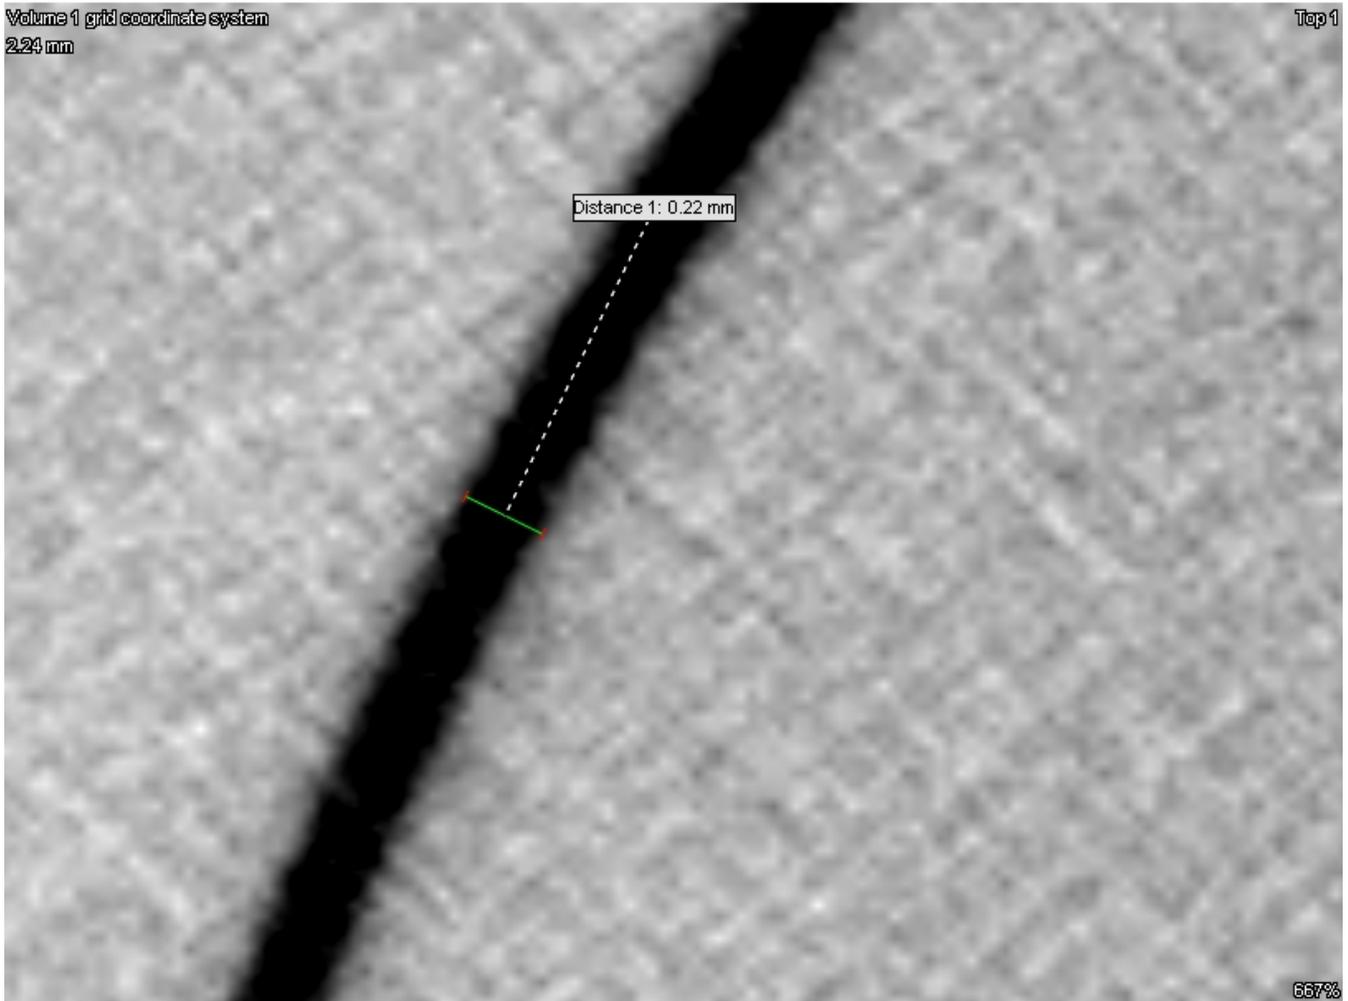
Figure 11  
Axial Cross Section - Swivel 2 – Gap Between Inner Spool and Outer Housing with  
Measurement of 0.22 mm

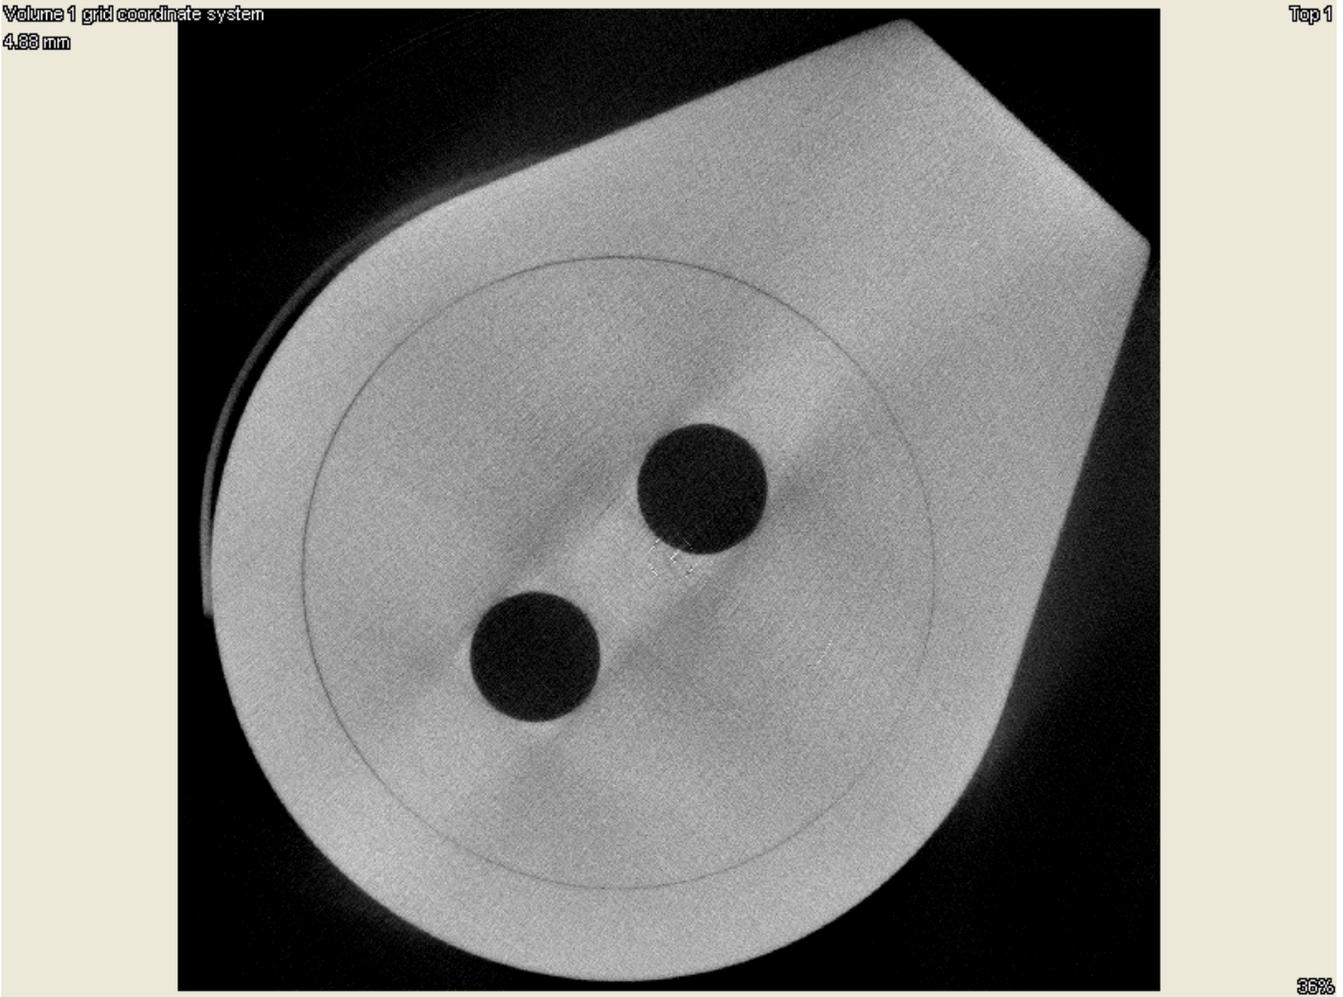
Figure 12  
Axial Cross Section - Swivel 2 – Irregular Gaps Between Inner Spool and Outer Housing  
at a Point Just Above the First Seal Cavity

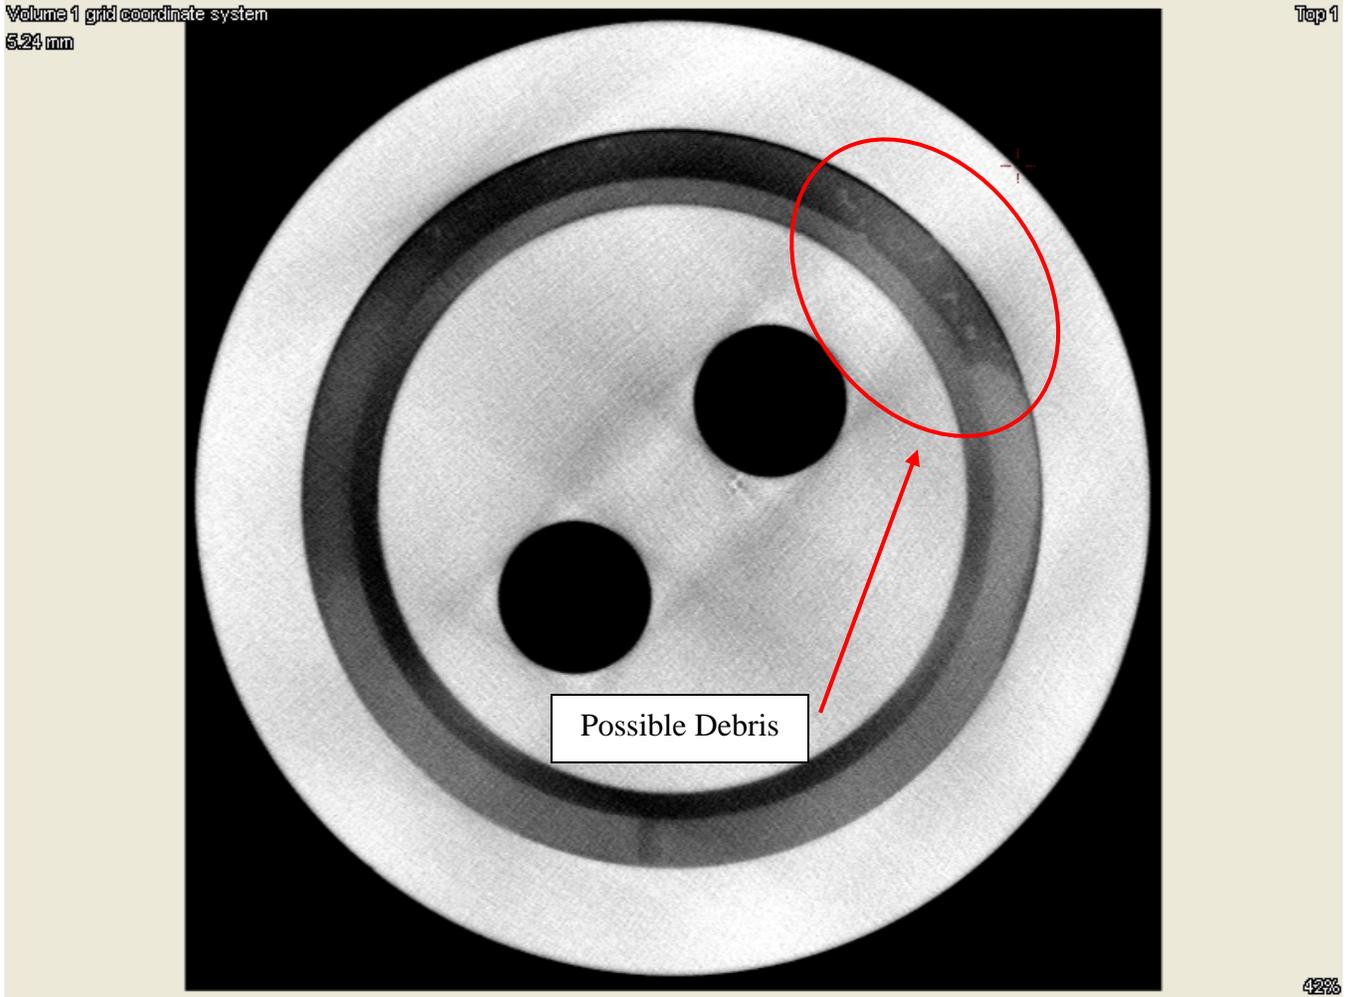
Figure 13  
Axial Cross Section - Swivel 2 – Possible Debris in Seal Cavity 1

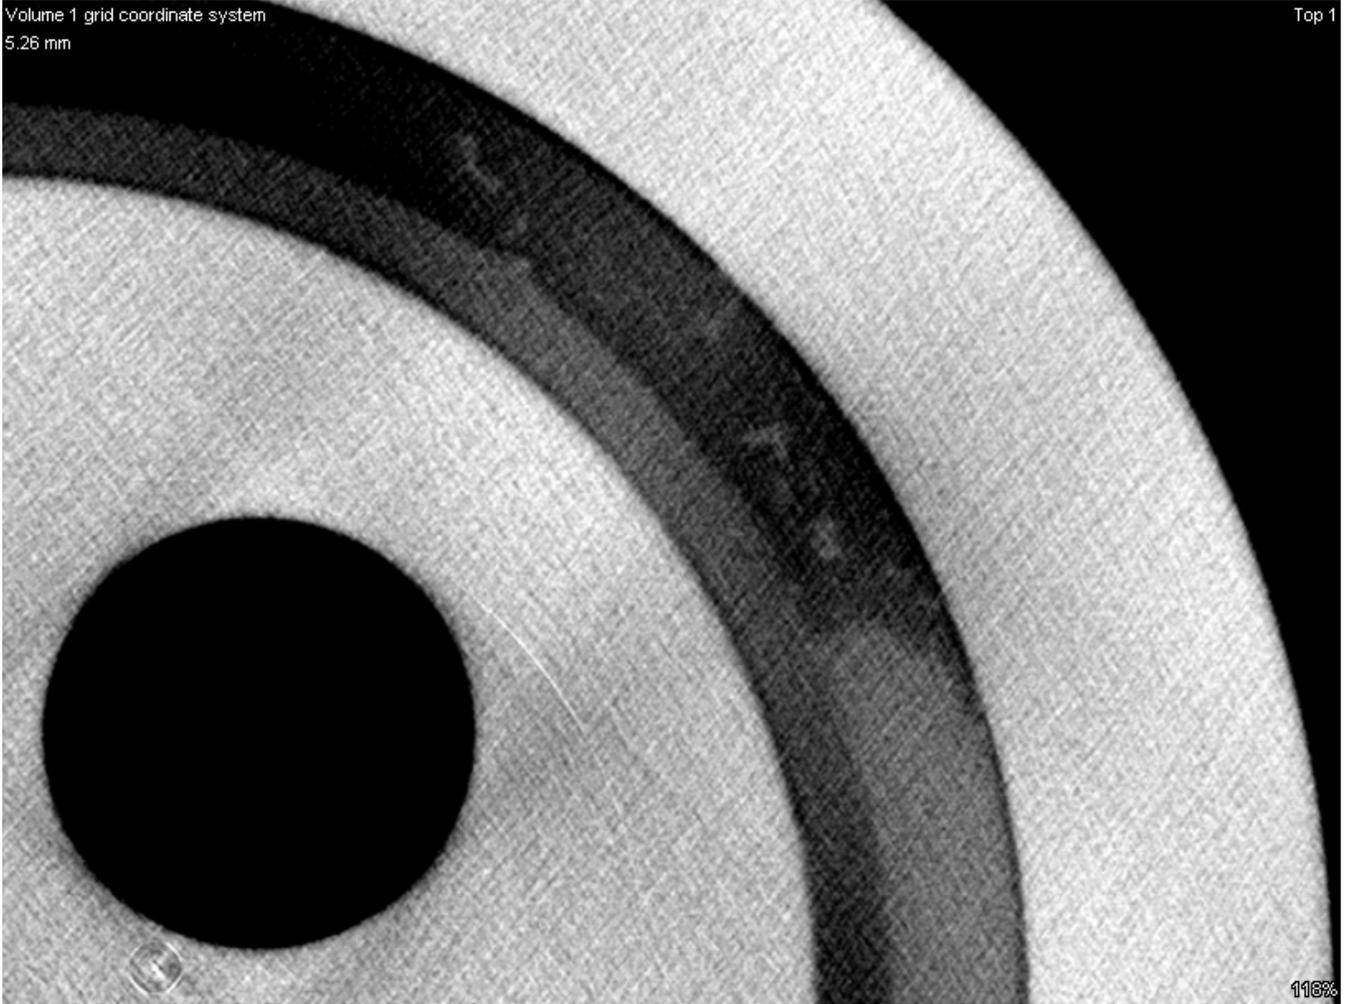
Figure 14  
Axial Cross Section - Swivel 2 – Possible Debris in Seal Cavity 1 (Close Up View)

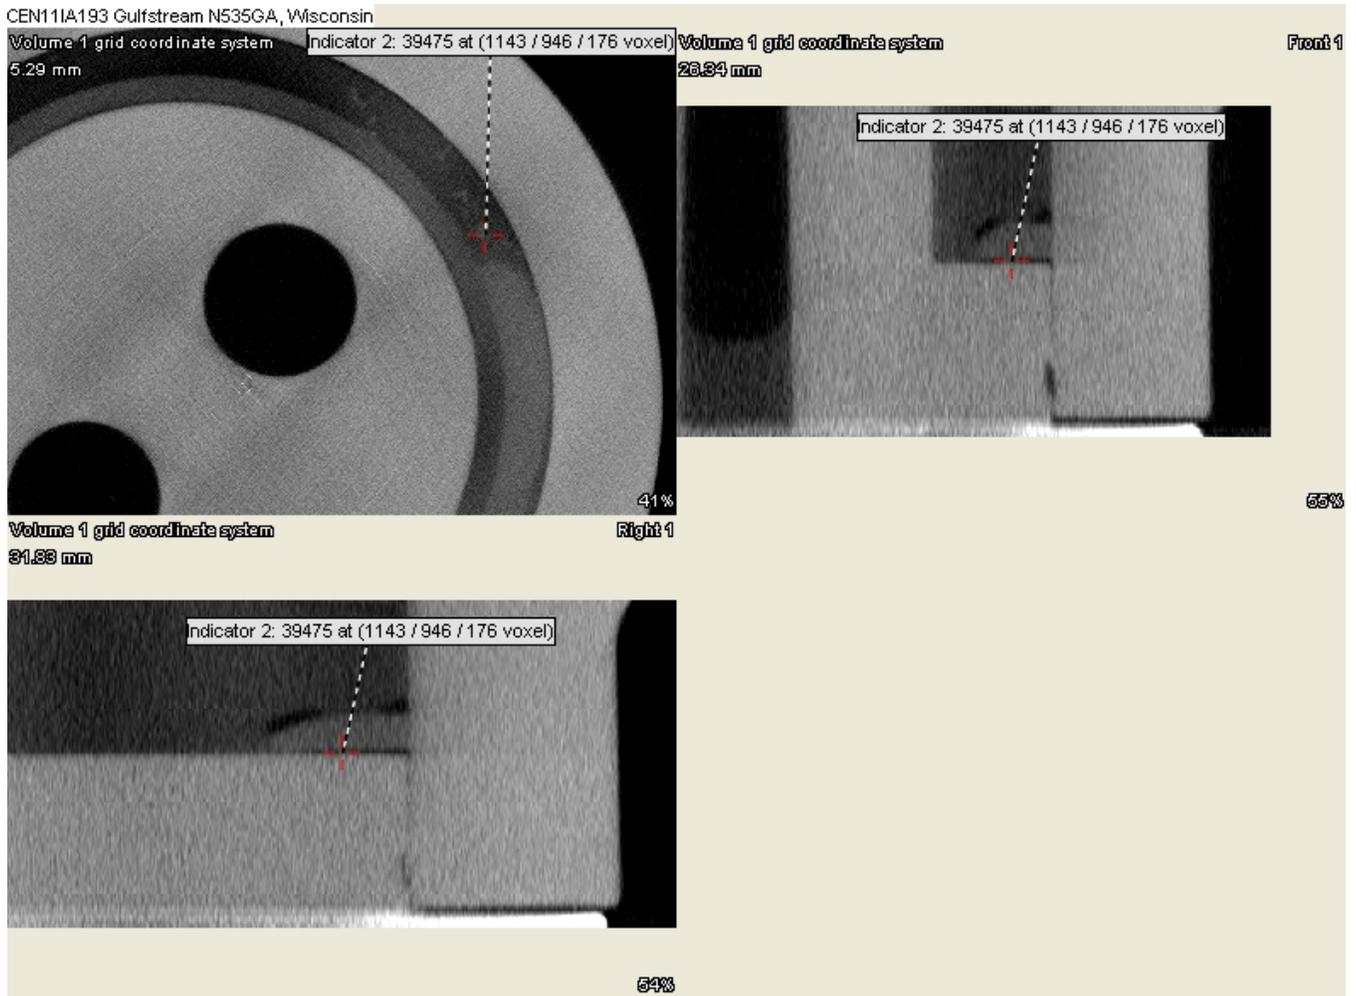
Figure 15  
 Multiple Views (Axial, Frontal and Right Cross Sections) – Swivel 2 – Possible Debris in Seal Cavity 1 - Location of Possible Debris Relative to the Seals

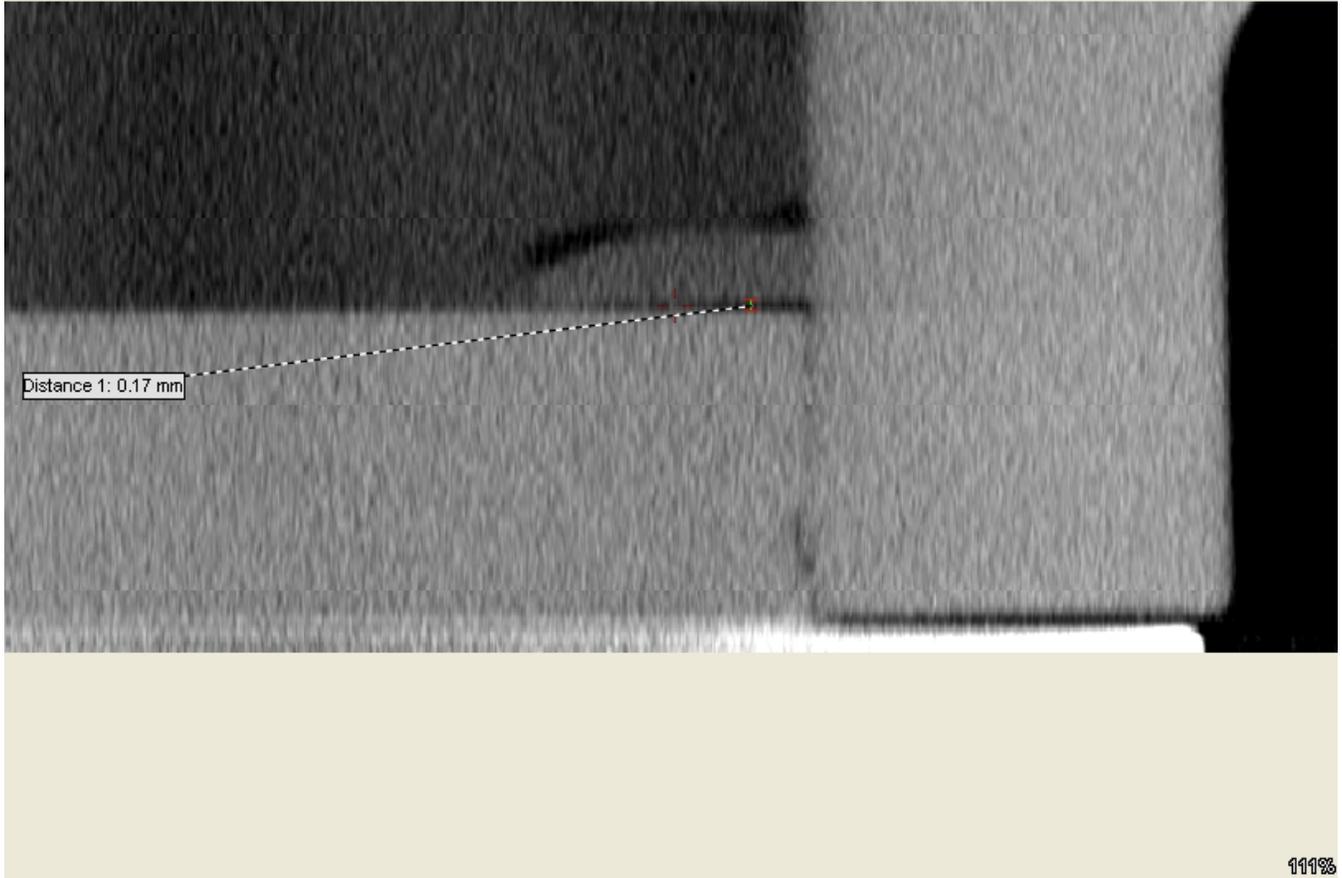
Figure 16  
Frontal Cross Section - Swivel 2 – Possible Debris in Seal Area – Side View Showing  
Gap Dimension of 0.17 mm
