**NATIONAL TRANSPORTATION SAFETY BOARD**  
Office of Aviation Safety  
Washington, D.C. 20594

**Computed Tomography Specialist's Factual Report**

CEN-11-IA-193

Operator: Gulfstream Aerospace  
Location: Outagamie County Regional Airport (ATW), near Appleton,  
Wisconsin  
Date: February 14, 2011  
Time: Approximately 1315 local time  
Airplane: Gulfstream Aerospace GV-SP airplane, N535GA

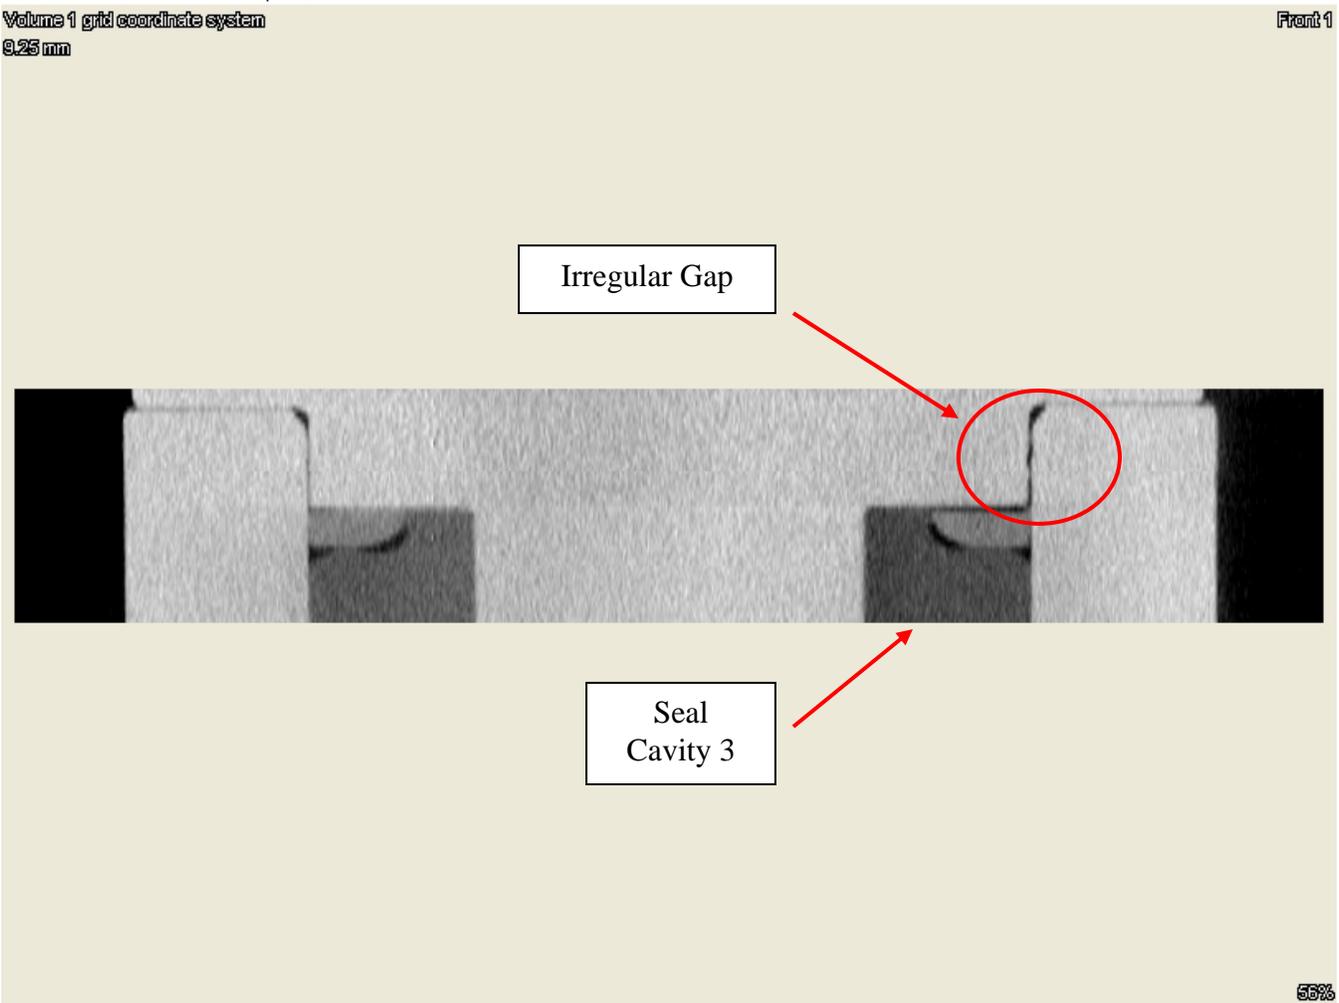
Figure 17  
Frontal Cross Section – Swivel 2 – Irregular Gap Between Inner Spool and Outer  
Housing in Area Above Third Seal Cavity

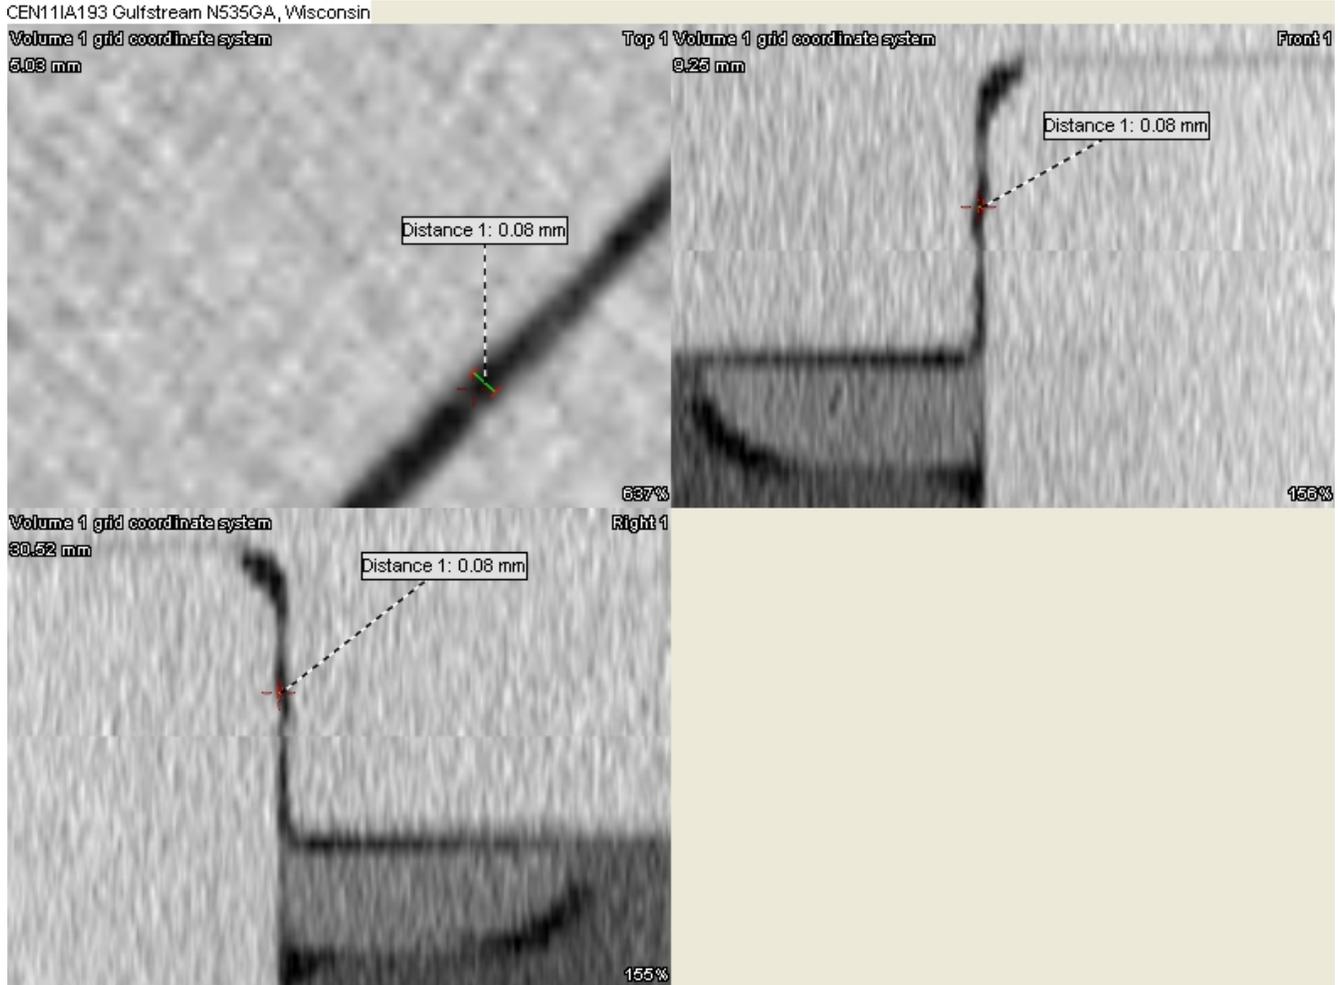
Figure 18  
Multiple Views (Axial, Frontal and Right Cross Sections) – Swivel 2 – Irregular  
Gaps Between Inner Spool and Outer Housing in Area Above Third Seal Cavity  
Showing a Gap Dimension of 0.08 mm

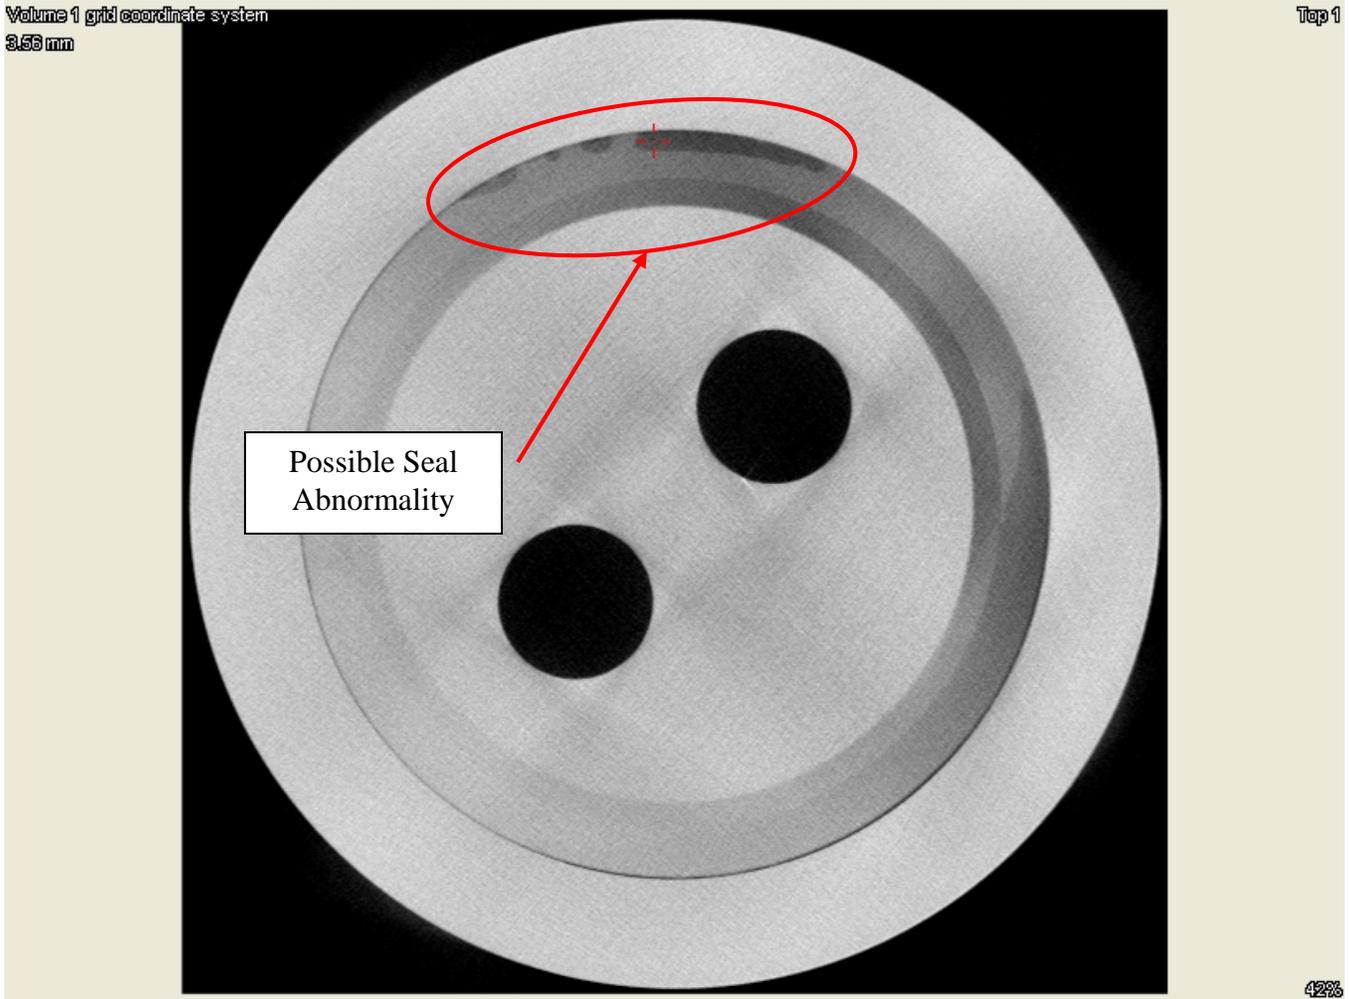
Figure 19  
Axial Cross Section – Swivel 2 – Possible Seal Abnormalities in the Third Seal  
Cavity

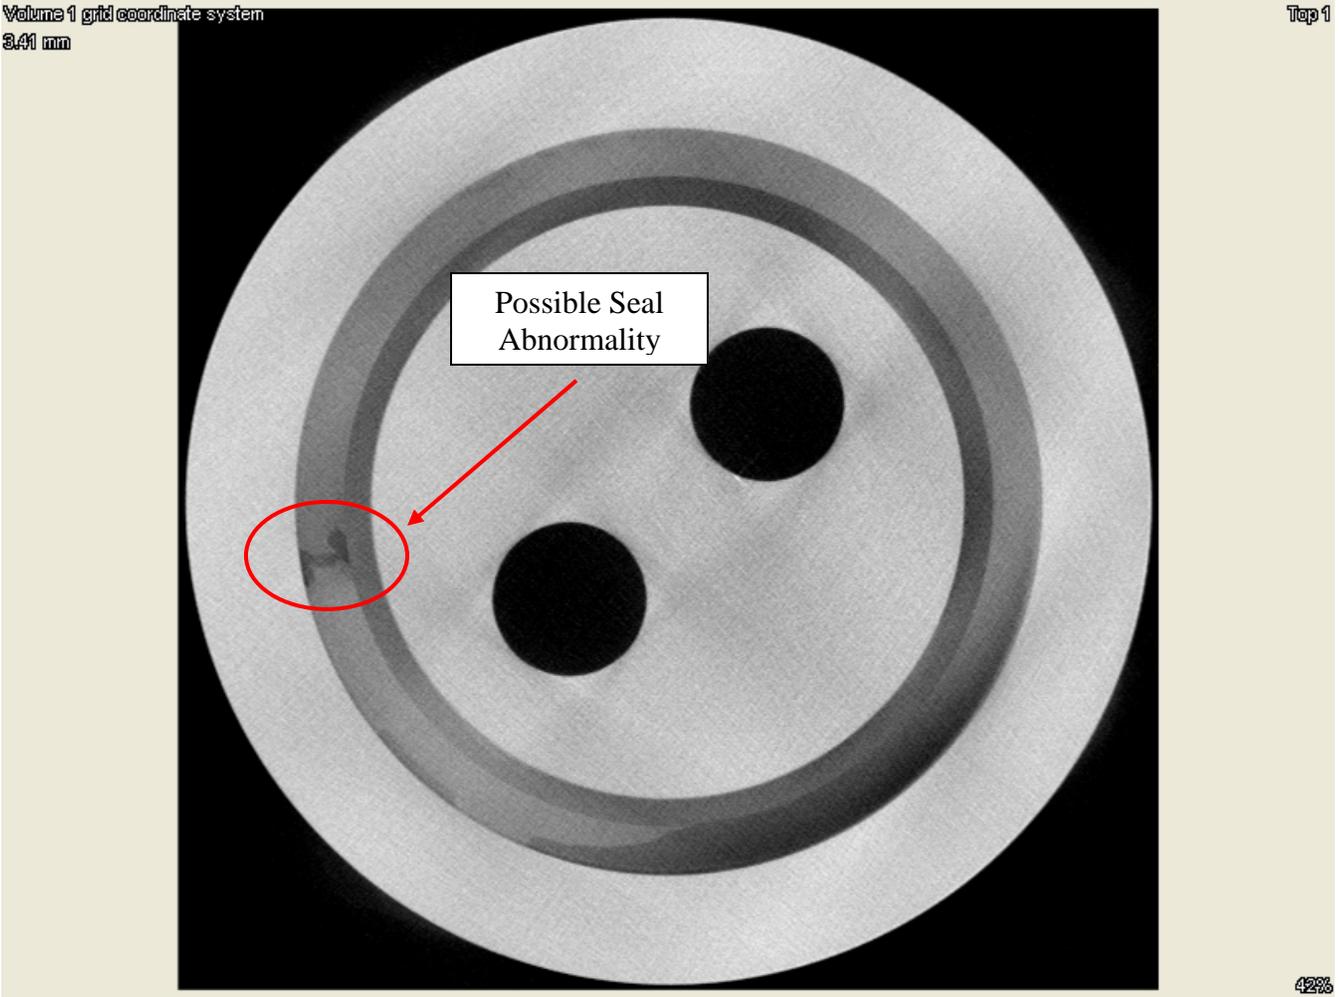
Figure 20  
Axial Cross Section – Swivel 2 – Possible Seal Abnormality in the Third Seal  
Cavity
