NATIONAL TRANSPORTATION SAFETY BOARD
Office of Aviation Safety
Washington, D.C. 20594

Computed Tomography Specialist's Factual Report

ERA-12-FA-056

Operator: Hendrick Motor Sports
Location: Key West International Airport, Key West, FL
Date: October 31, 2011
Time: 1945 EDT
Airplane: Israel Aircraft Industries Gulfstream G150, N480JJ

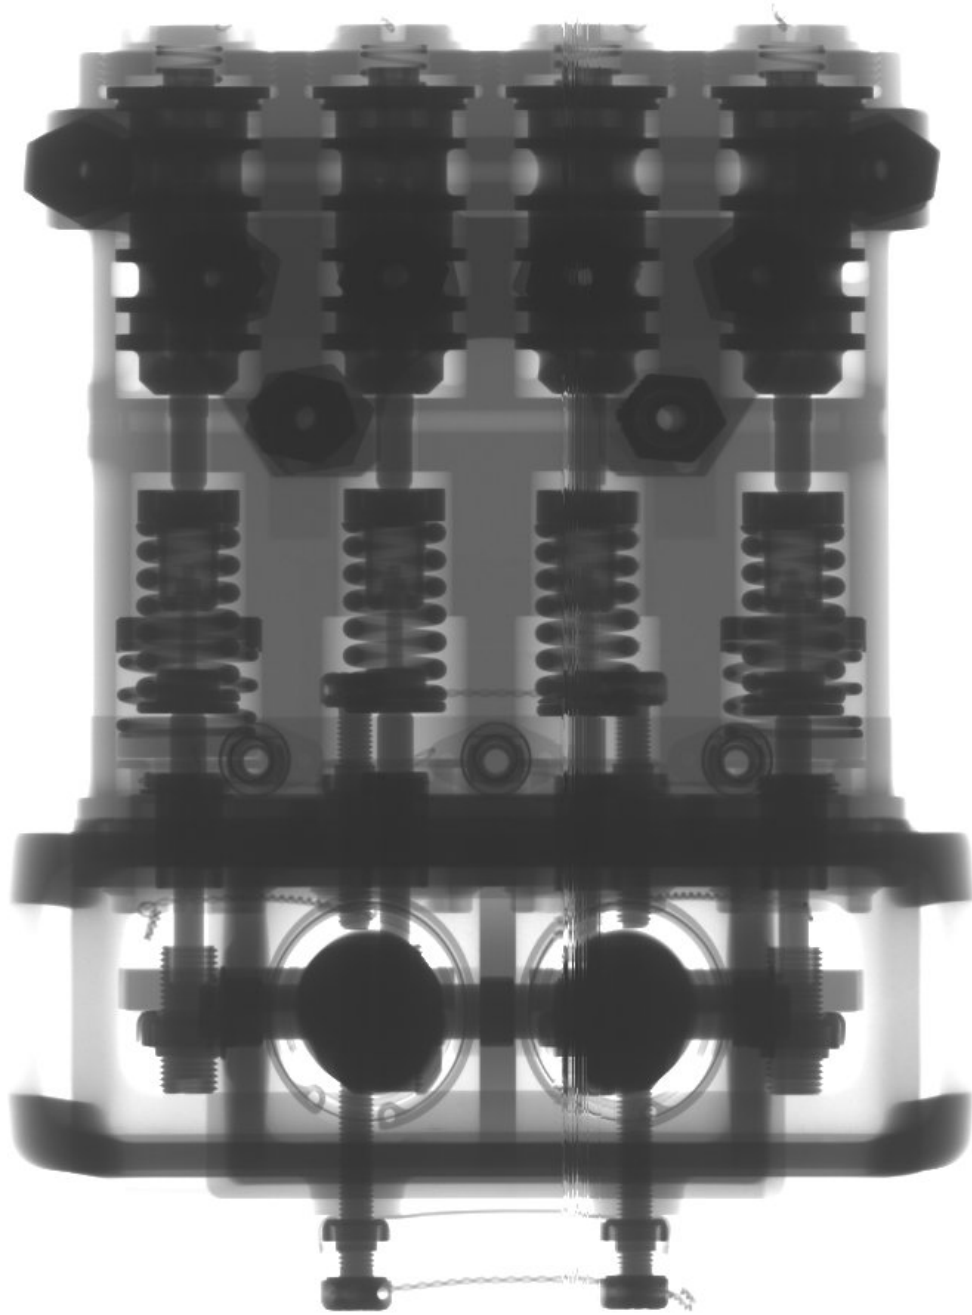
Digital radiograph images of the power brake valve are shown in figures 1 through 4. No particles or other defects were noted in any of the digital radiographs. Some of the digital radiographs have had their window and level values¹ adjusted to make internal portions of the power brake valve more distinct.

Figure 1
Digital Radiograph – Power brake valve, overall view

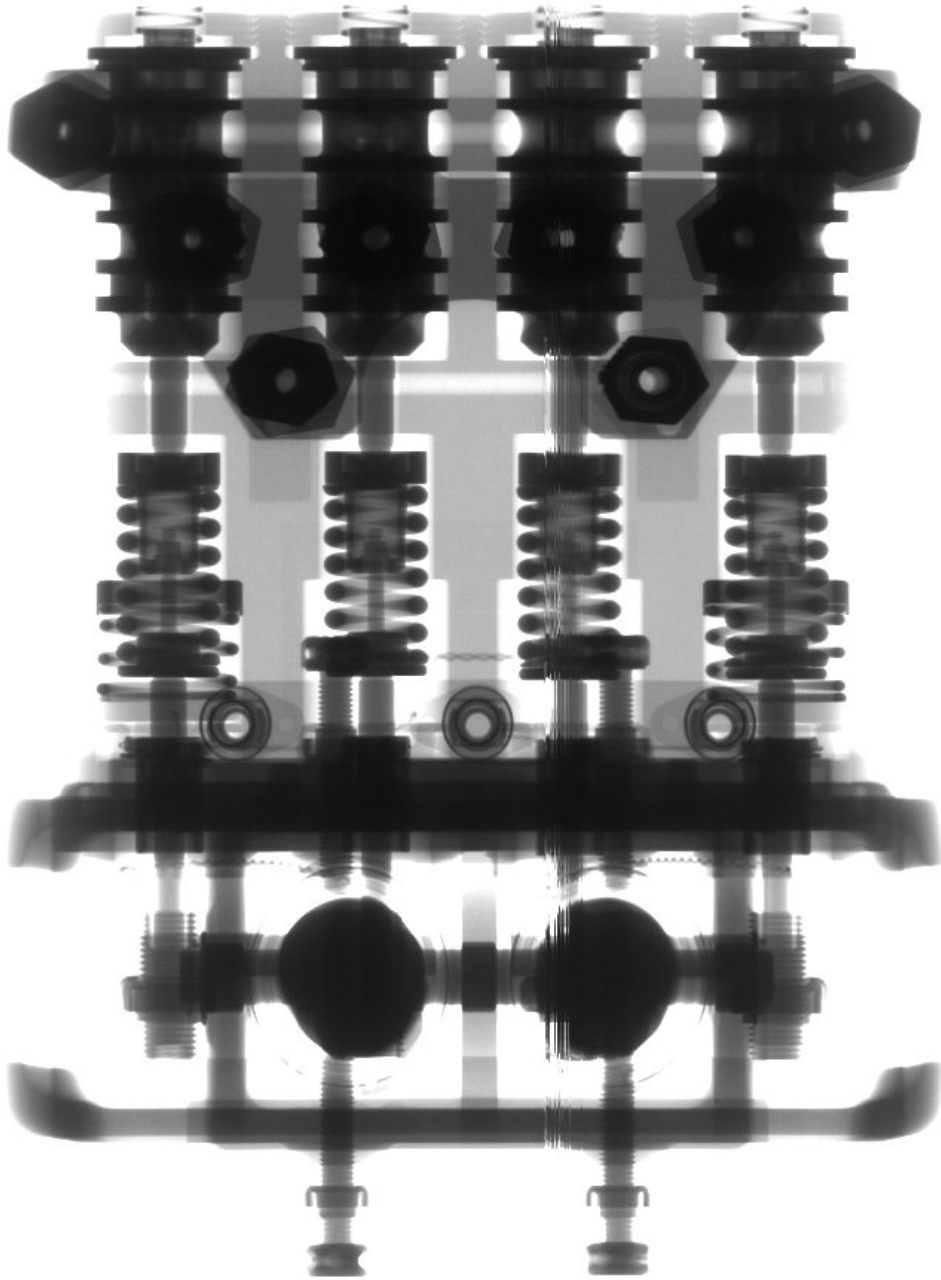
Figure 2
Digital Radiograph – Power brake valve, overall view

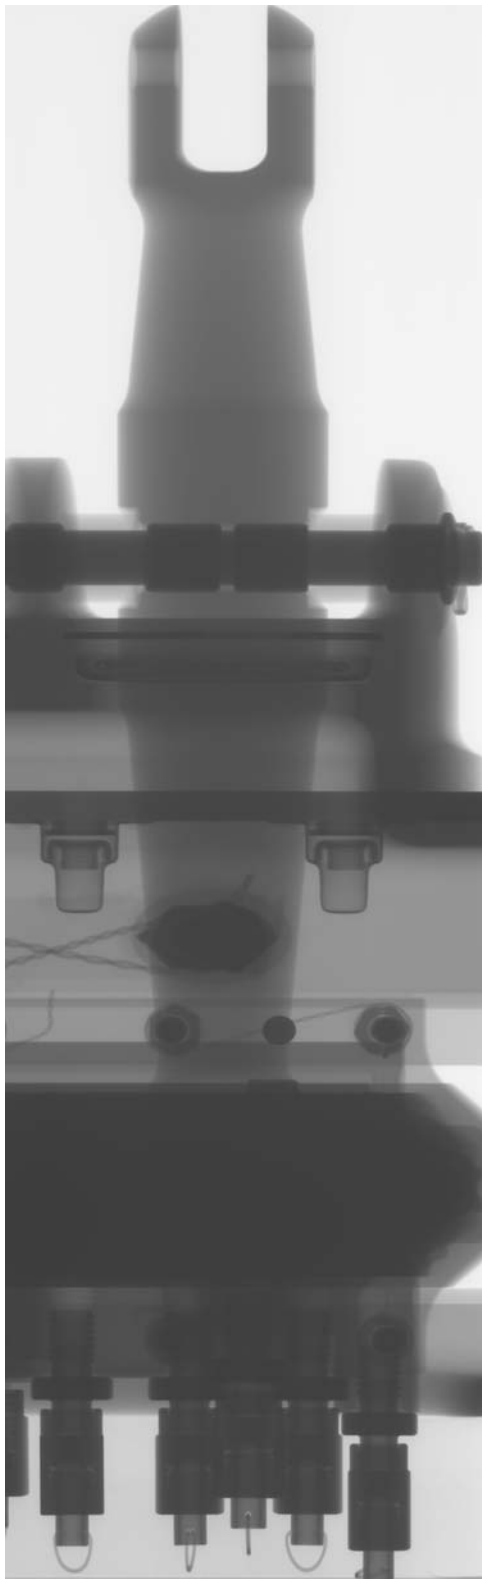
Figure 3
Digital Radiograph – Pivot pin and input rod, left system

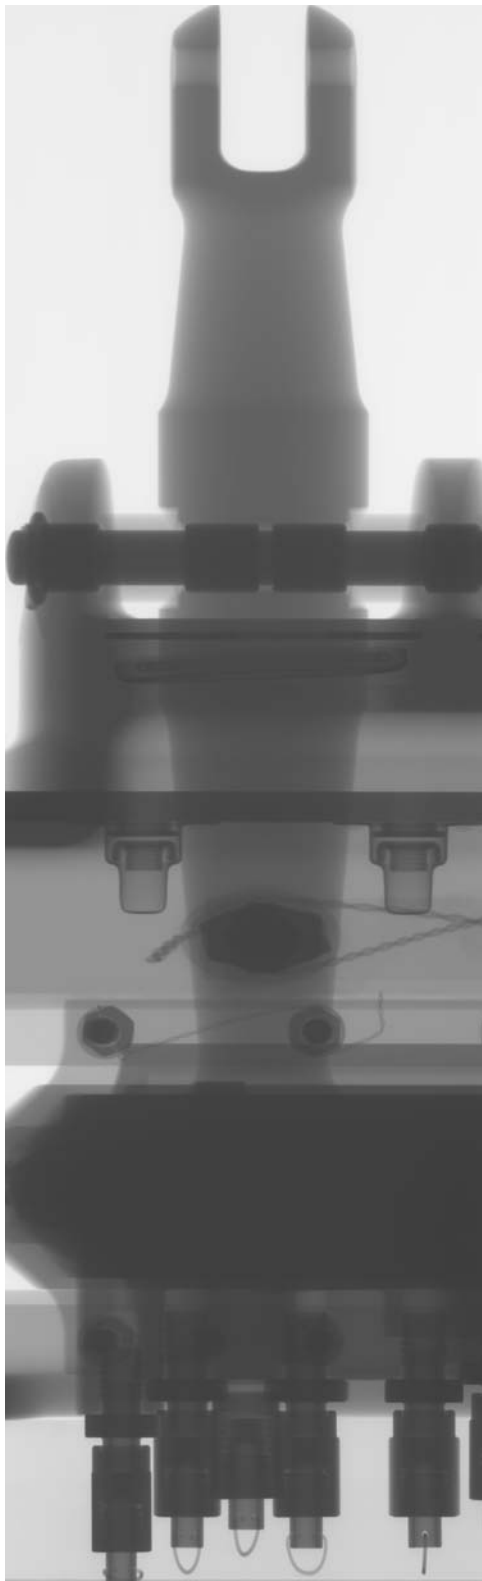
Figure 4
Digital Radiograph – Pivot pin and input rod, right system

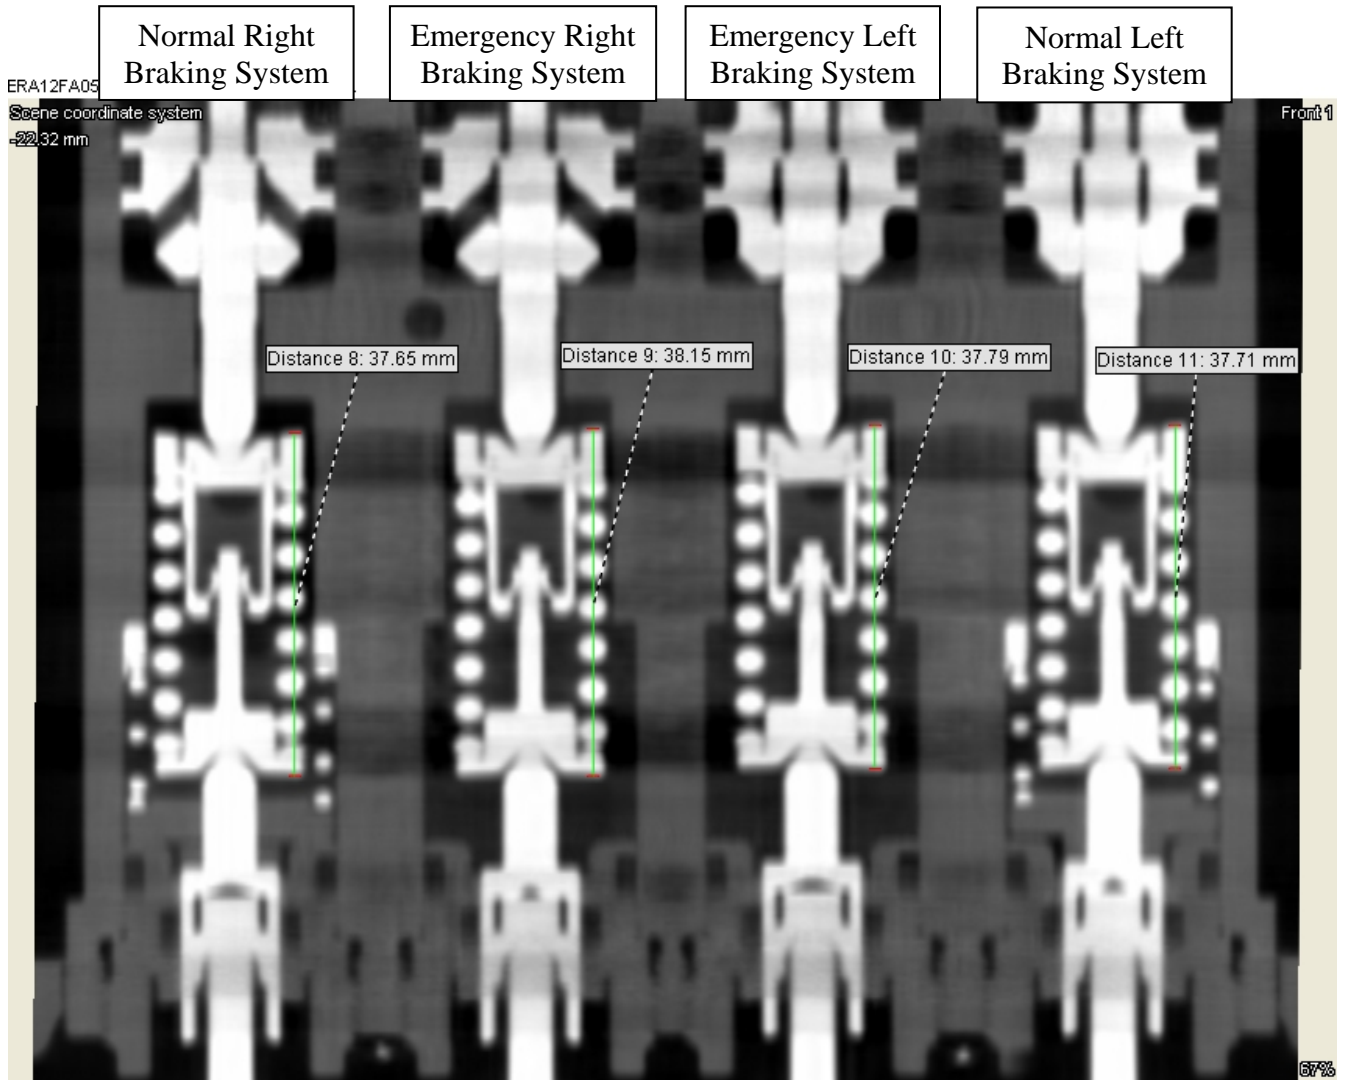
Figure 5
Frontal Cross Section – Power brake valve – Overall cross section showing all valves with measurements for spring lengths shown

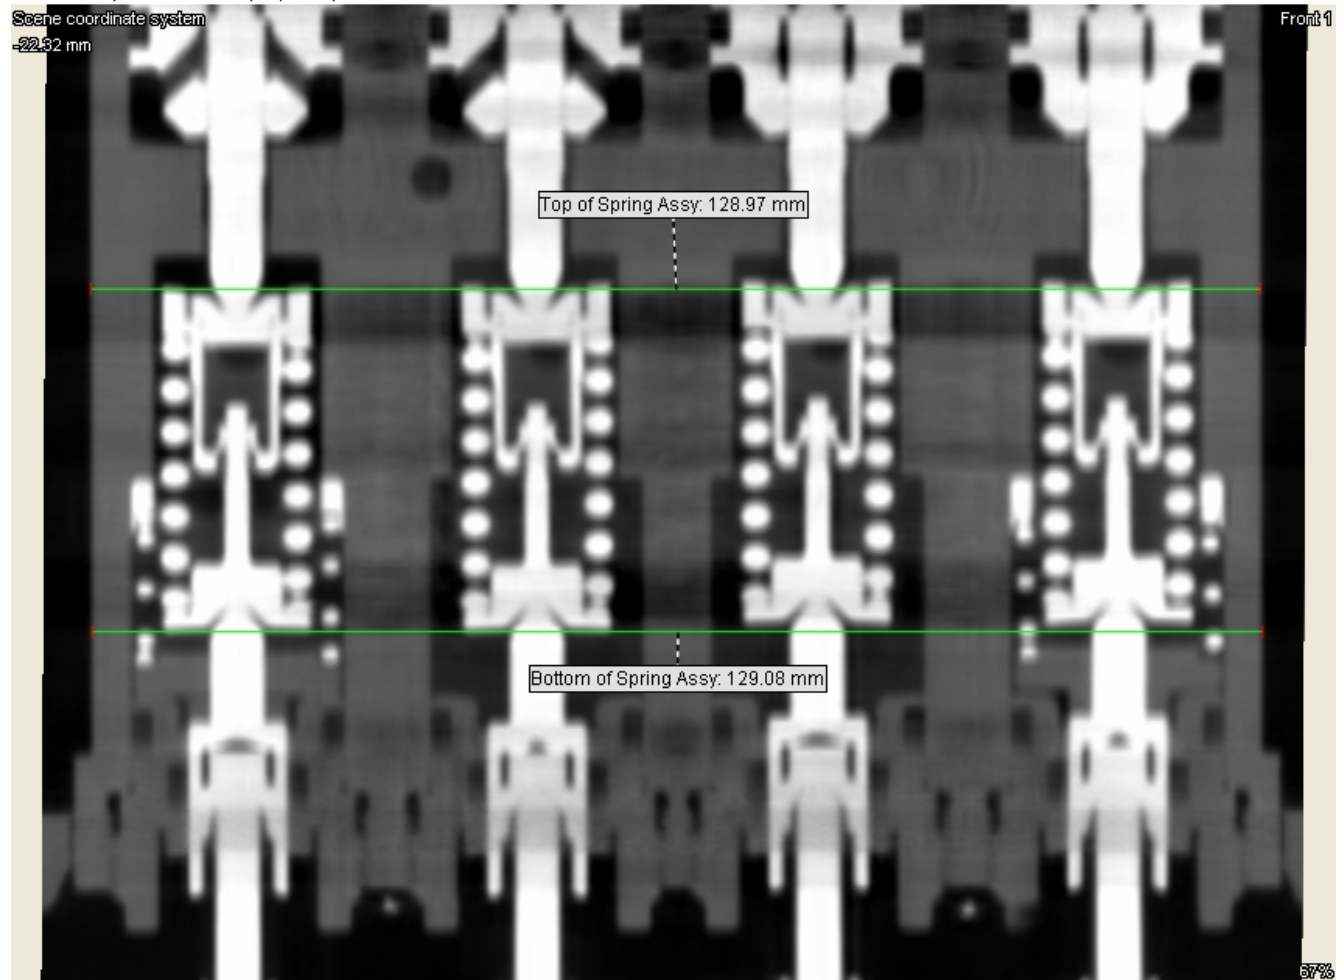
Figure 6
Frontal Cross Section – Power brake valve – Overall cross section showing all valves with comparison lines showing the relative positions of the top and bottom levels for the spring assemblies. (Note: Dimensions contained in the labels for each line are for the length of each green line only)

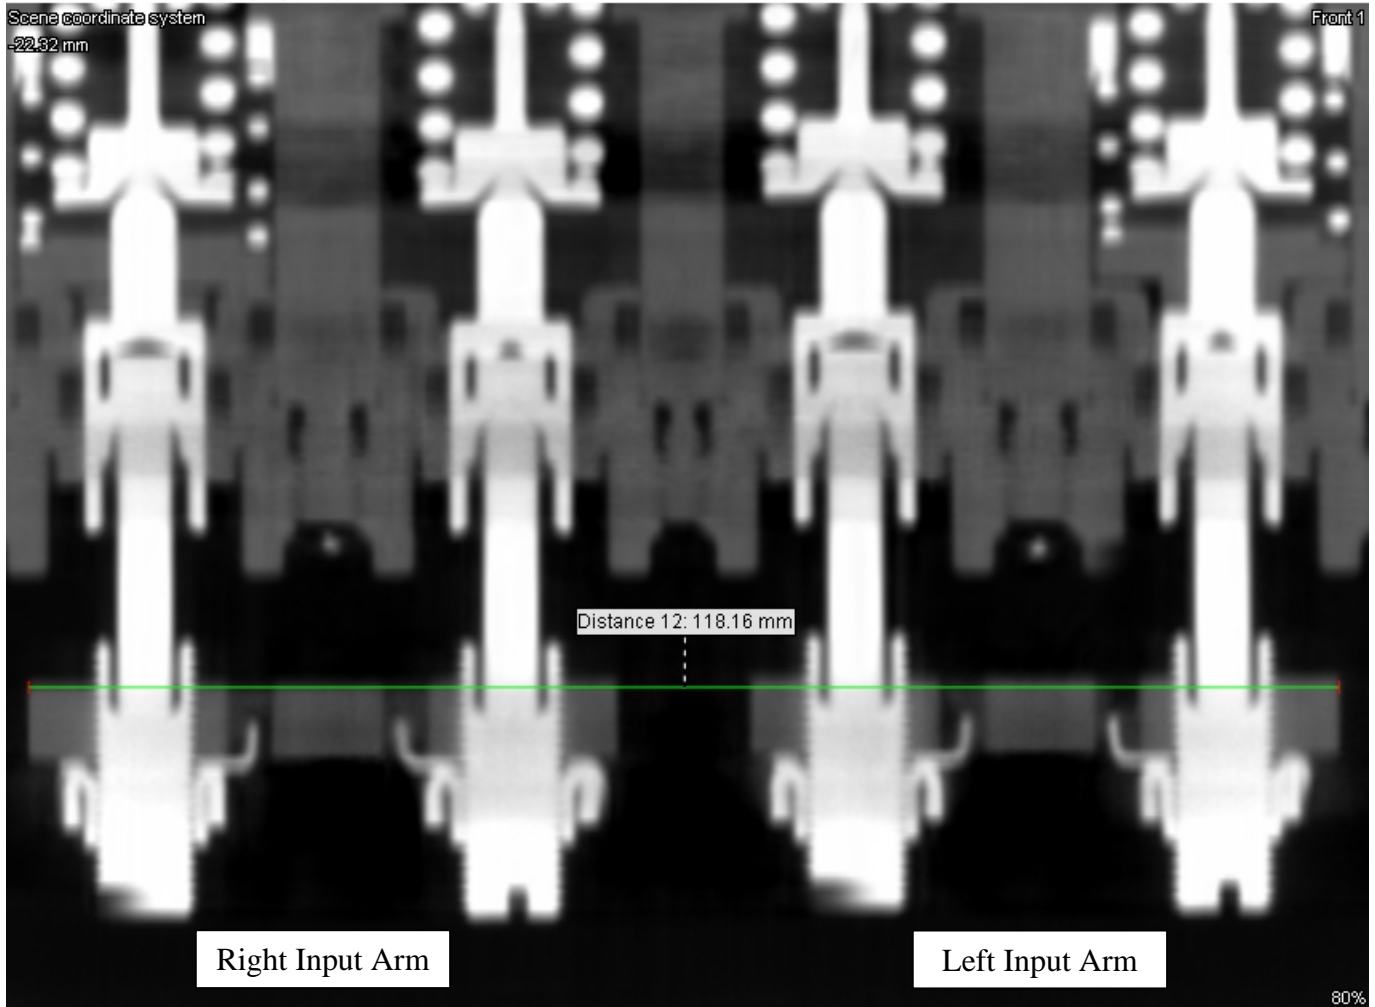
Figure 7

Frontal Cross Section – Power brake valve – Overall cross section showing input arm assemblies with a comparison line showing the relative positions of the left and right input arms. (Note: Dimension contained in the label for the line is for the length of the green line only)

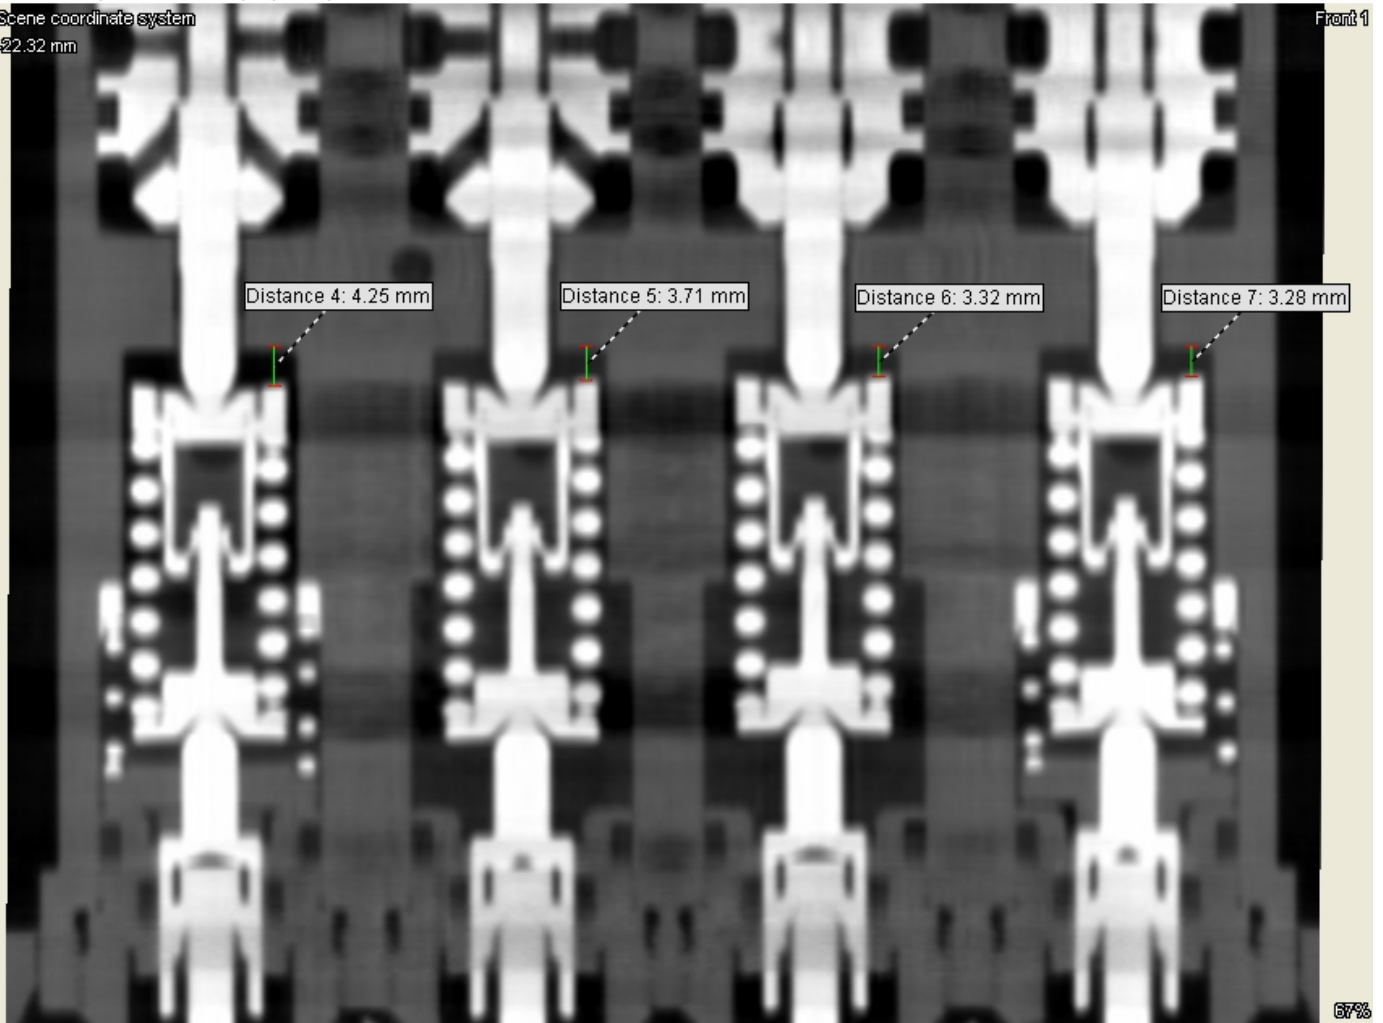
Figure 8

Frontal Cross Section – Power brake valve – Overall cross section showing all valves and the measurements for the clearance between the top of the spring assembly and the spring assembly cavity

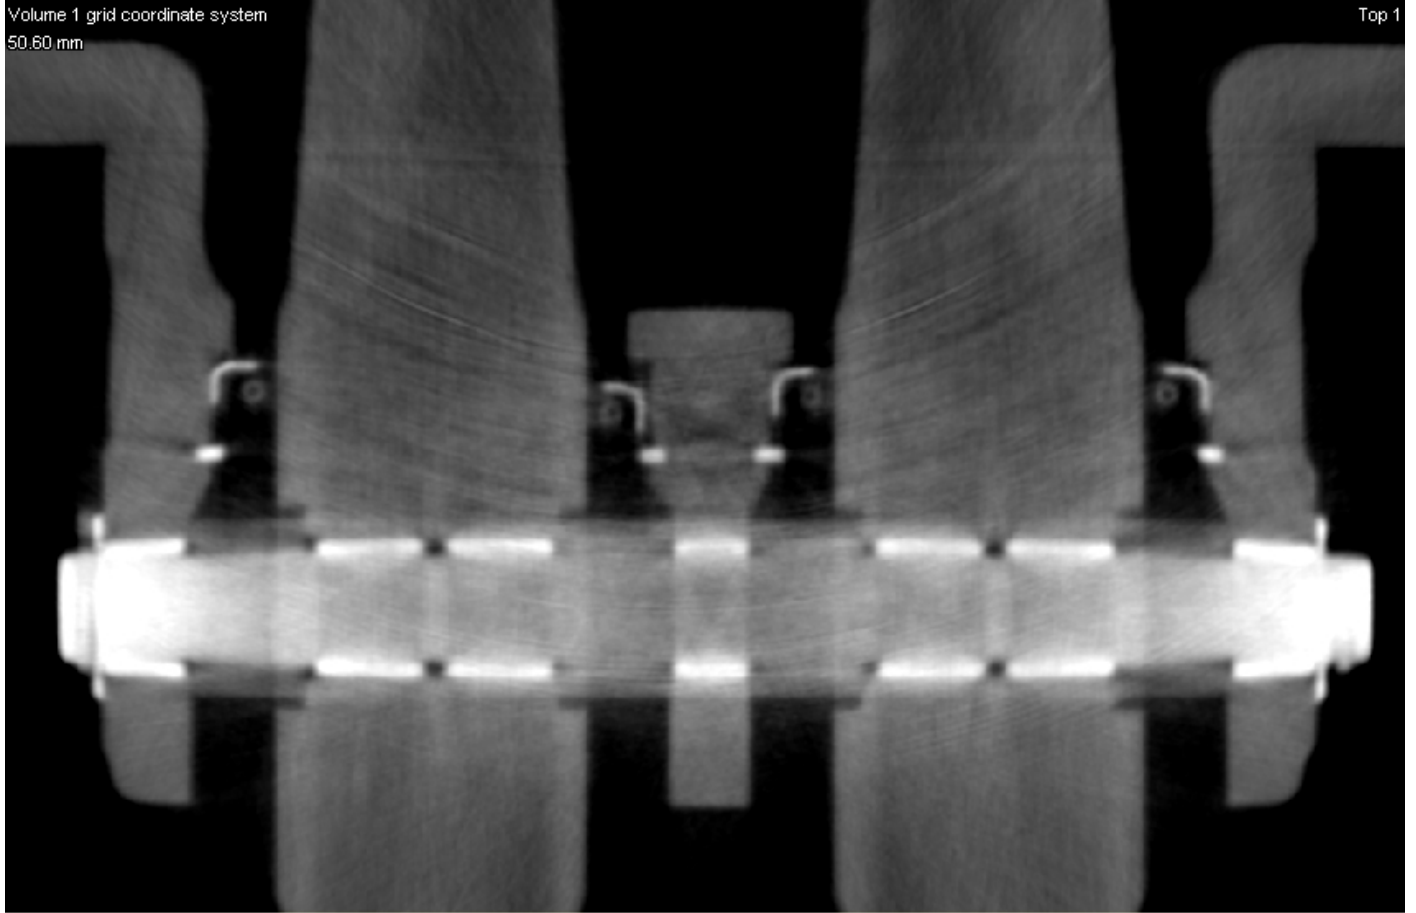
When the pivot pin was examined, an artifact was noted that caused the pin to appear to be tapered on the ends when viewed in an axial slice (but not in the frontal slice images). This artifact, called long path beam starvation, resulted from the fact that when scanning this section of the part, the x-rays traveled down the full length of the pin during each rotation. In general, when there is not quite enough x-ray energy to fully penetrate a long object like the pivot pin, the ends of the object turn out to be very bright and sharp, and the middle of the object turns out to be darker, the edges get much less distinct, and the middle appears to expand. The reason it occurred in only the axial view was due to the fact that this view was how the actual image slices were being captured, so it had the artifact present. The frontal view of the pivot pin (without the distortion) was created by the software by stacking the axial slices on top of each other. Since each of these slices was the same thickness, there was no distortion as they were stacked on one another, and the pin looked square with no distortion.

Figure 9
Axial Cross Section – Power brake valve – Pivot pin cross section showing
apparent tapering of the pin at the ends

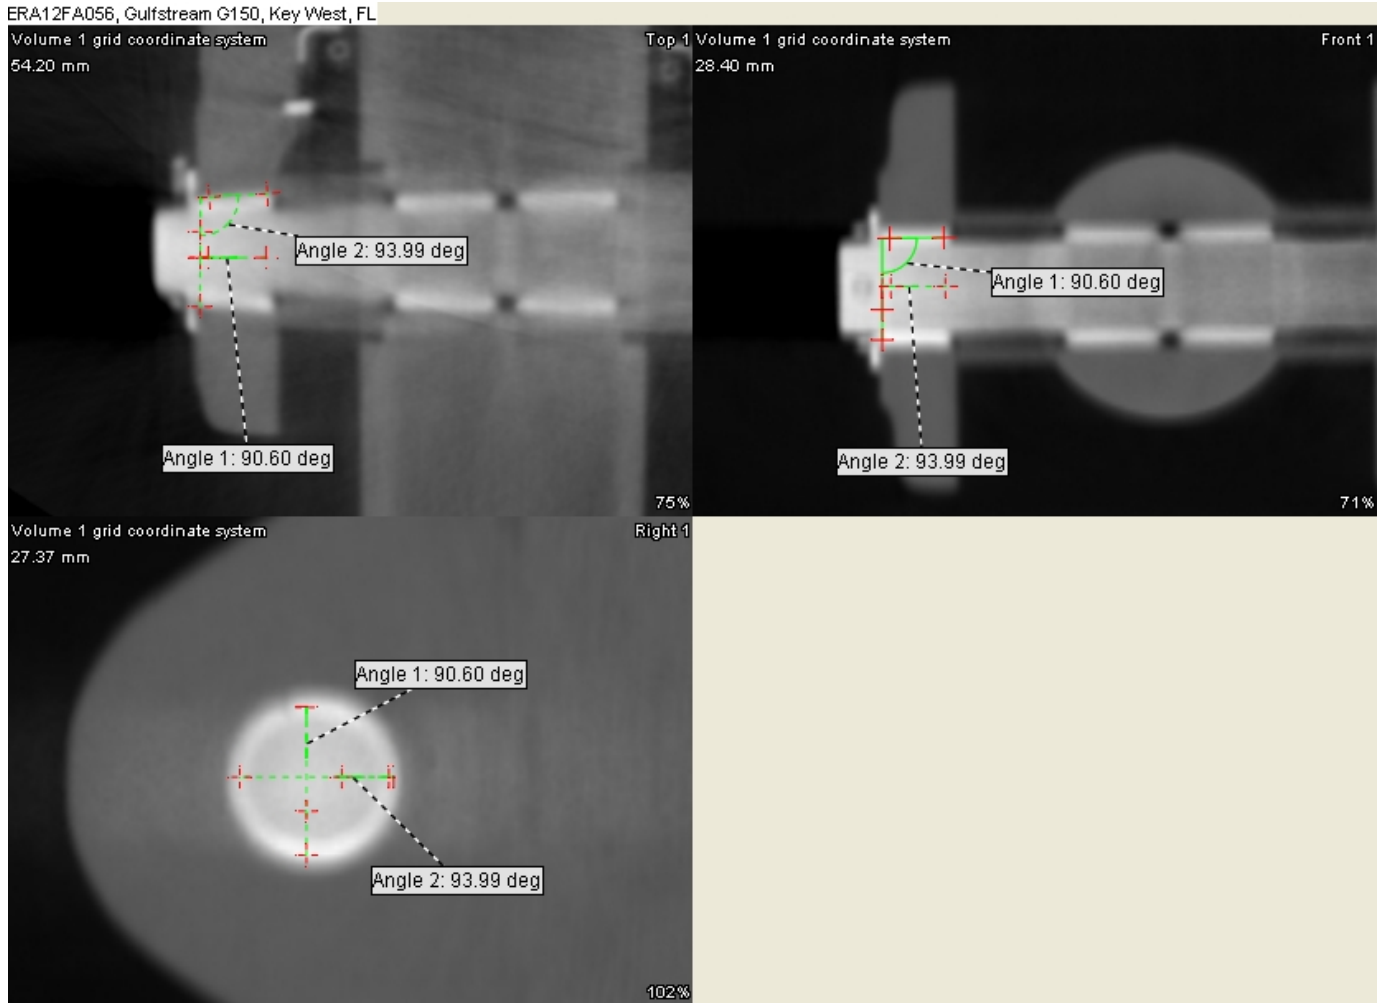
Figure 10
Multiple Cross Sections – Power brake valve – Pivot pin cross sections showing apparent tapering of the pin at the ends (upper left, axial cross section image) and showing no apparent tapering of the pin (upper right, frontal cross section image). The approximate angular dimensions of the pin geometry are shown in each image.
