NATIONAL TRANSPORTATION SAFETY BOARD
Office of Aviation Safety
Washington, D.C. 20594

Computed Tomography Specialist's Factual Report

DCA12MA020

Operator: Sundance Helicopters
Location: Approximately 14 miles east of Las Vegas, NV
Date: December 7, 2011
Time: 1630 Pacific Standard Time
Airplane: Eurocopter AS350-B2, N37SH

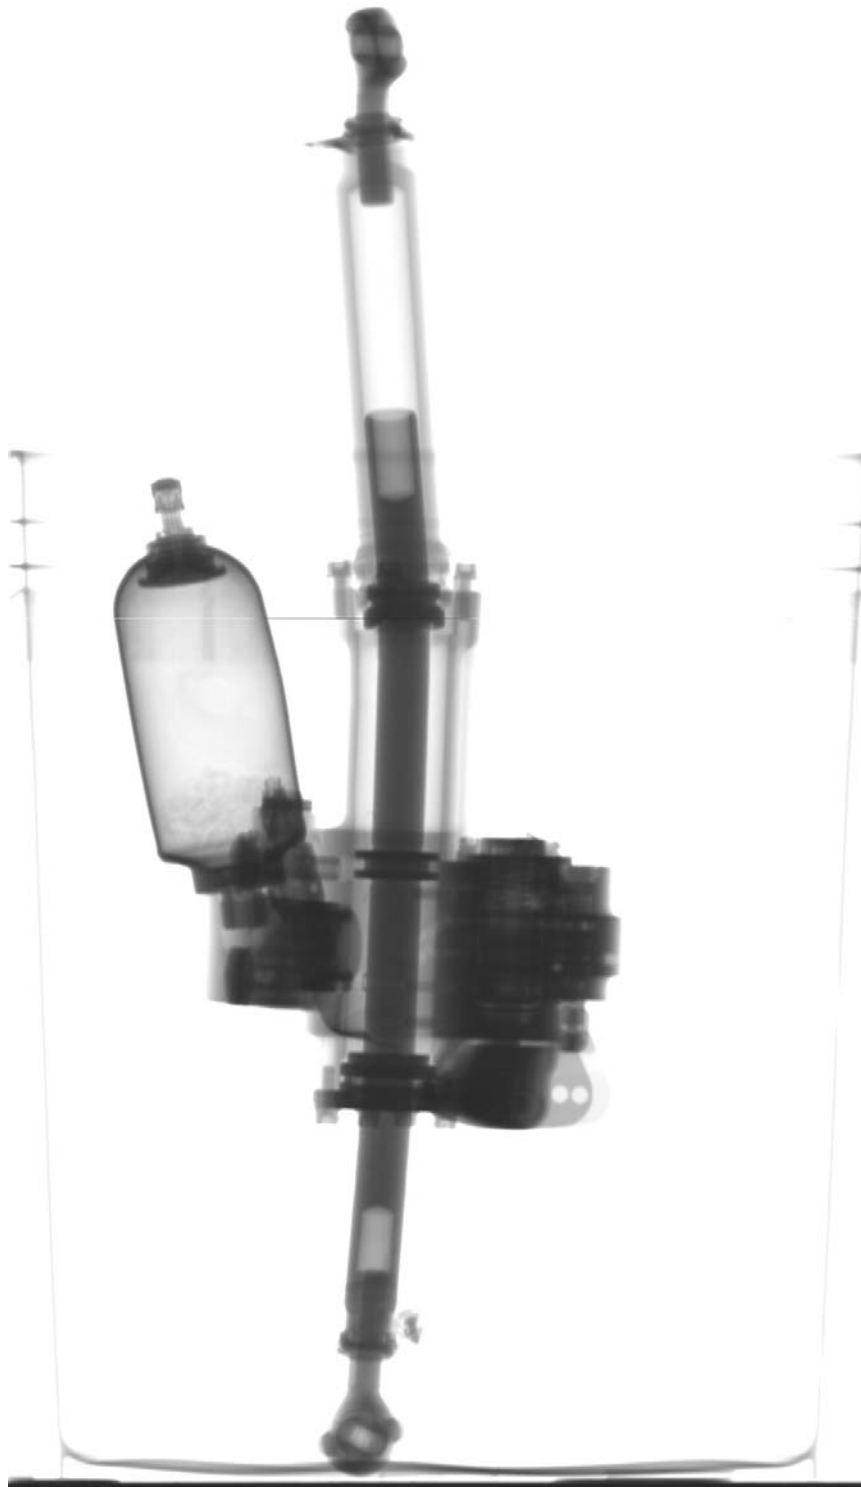
Figure 1
Digital Radiograph – Fore-Aft Actuator

Digital radiograph images from all of the actuators and the fore-aft actuator rod end are shown in figures 1 through 8. No particles or other defects were noted in any of the digital radiographs.

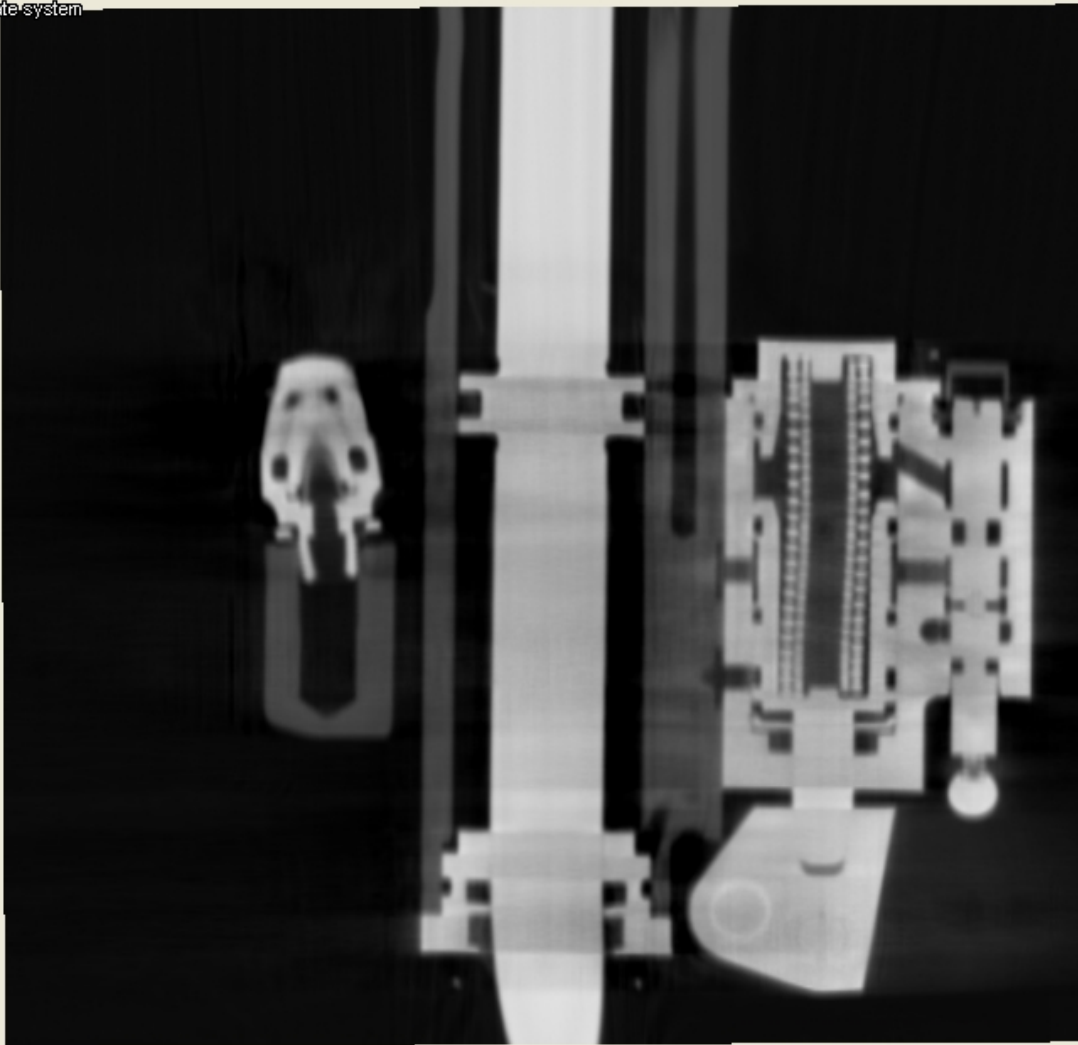
Figure 9

No other anomalies were noted in the actuator. The lock plunger for the actuator appeared to be in the engaged position within the lever assembly.

Right cross section – Fore-Aft Actuator – Overall cross sectional view of the actuator showing the positions of the lock plunger, spool, and piston head

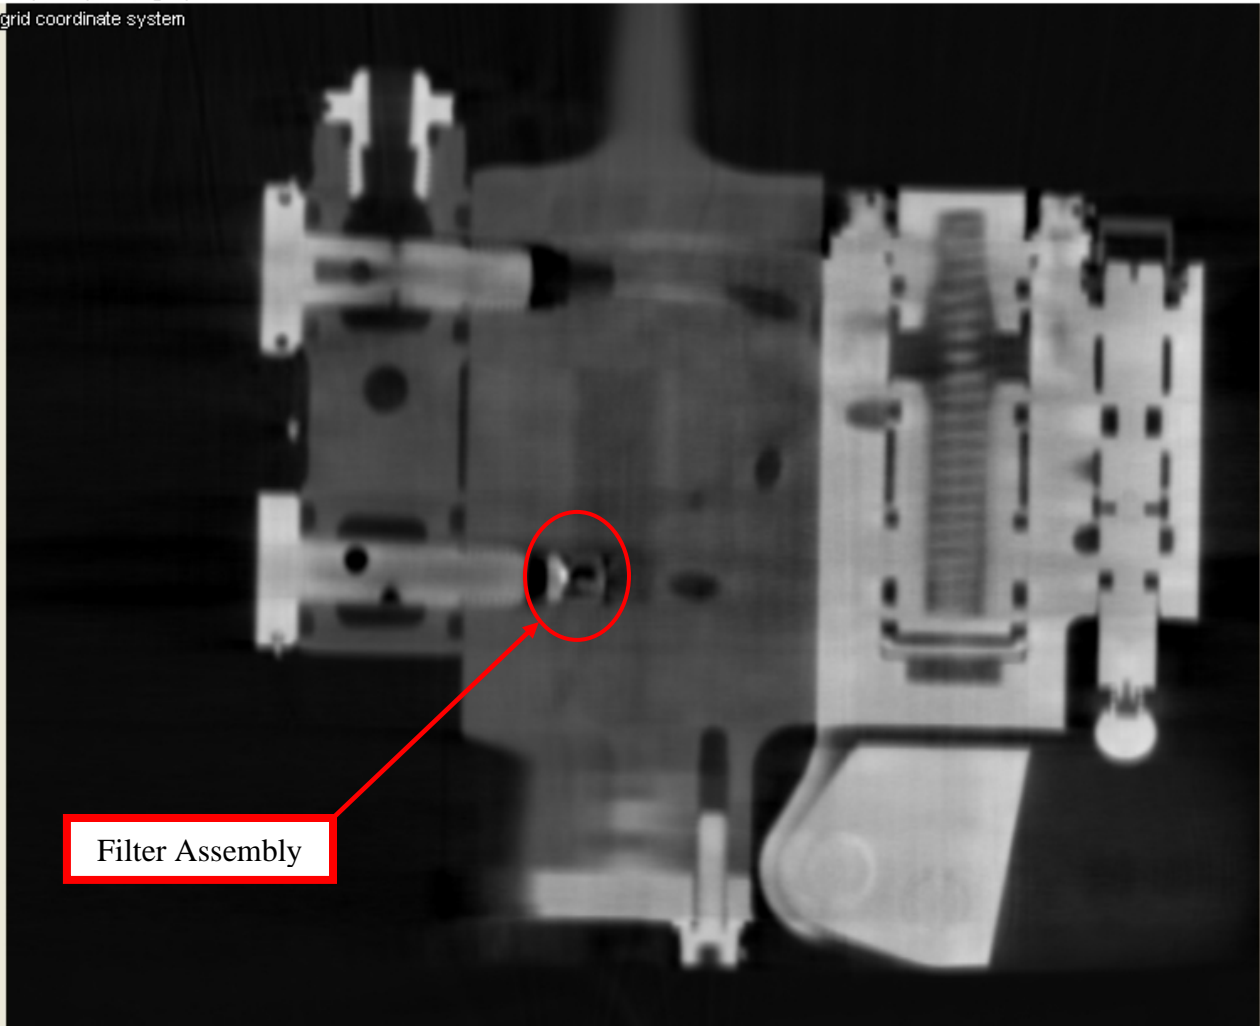
Figure 10
Right cross section – Fore-Aft Actuator – Cross sectional view of the actuator showing the filter assembly

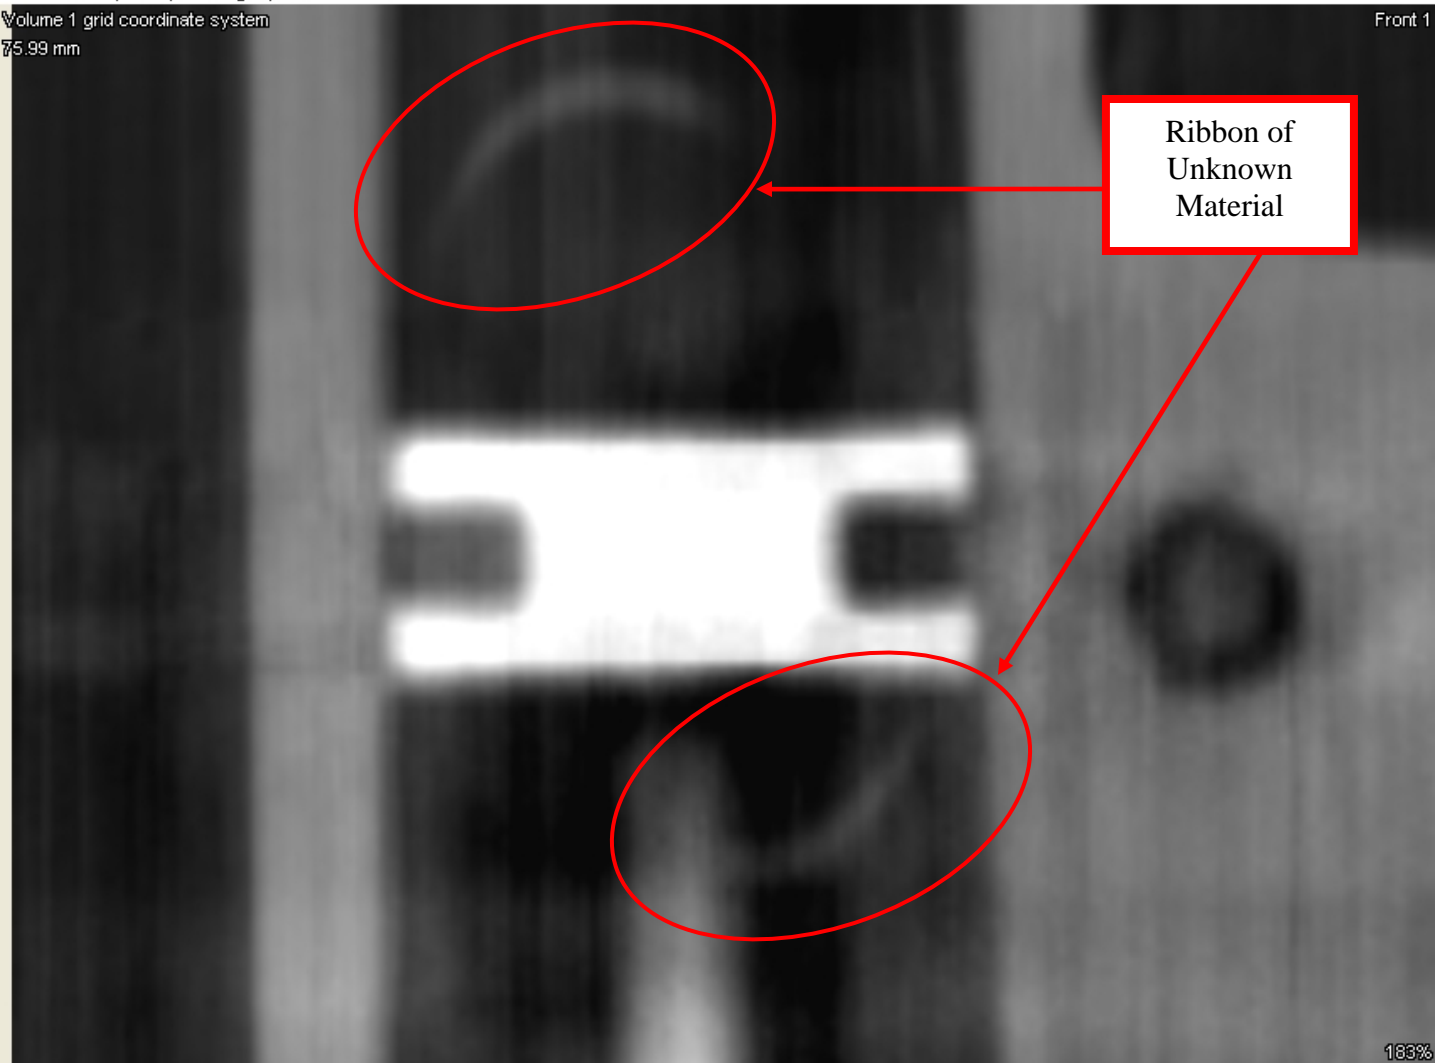
The computed tomography (CT) results for the fore-aft actuator are shown in figures 9 through 13. A ribbon of unknown material was noted above and below the piston head of the actuator. A nominal thickness for the ribbon was measured to be approximately 3.19 mm.

Figure 11
Frontal cross section – Fore-Aft Actuator – Apparent ribbon of unknown material above
and below the piston head of the actuator

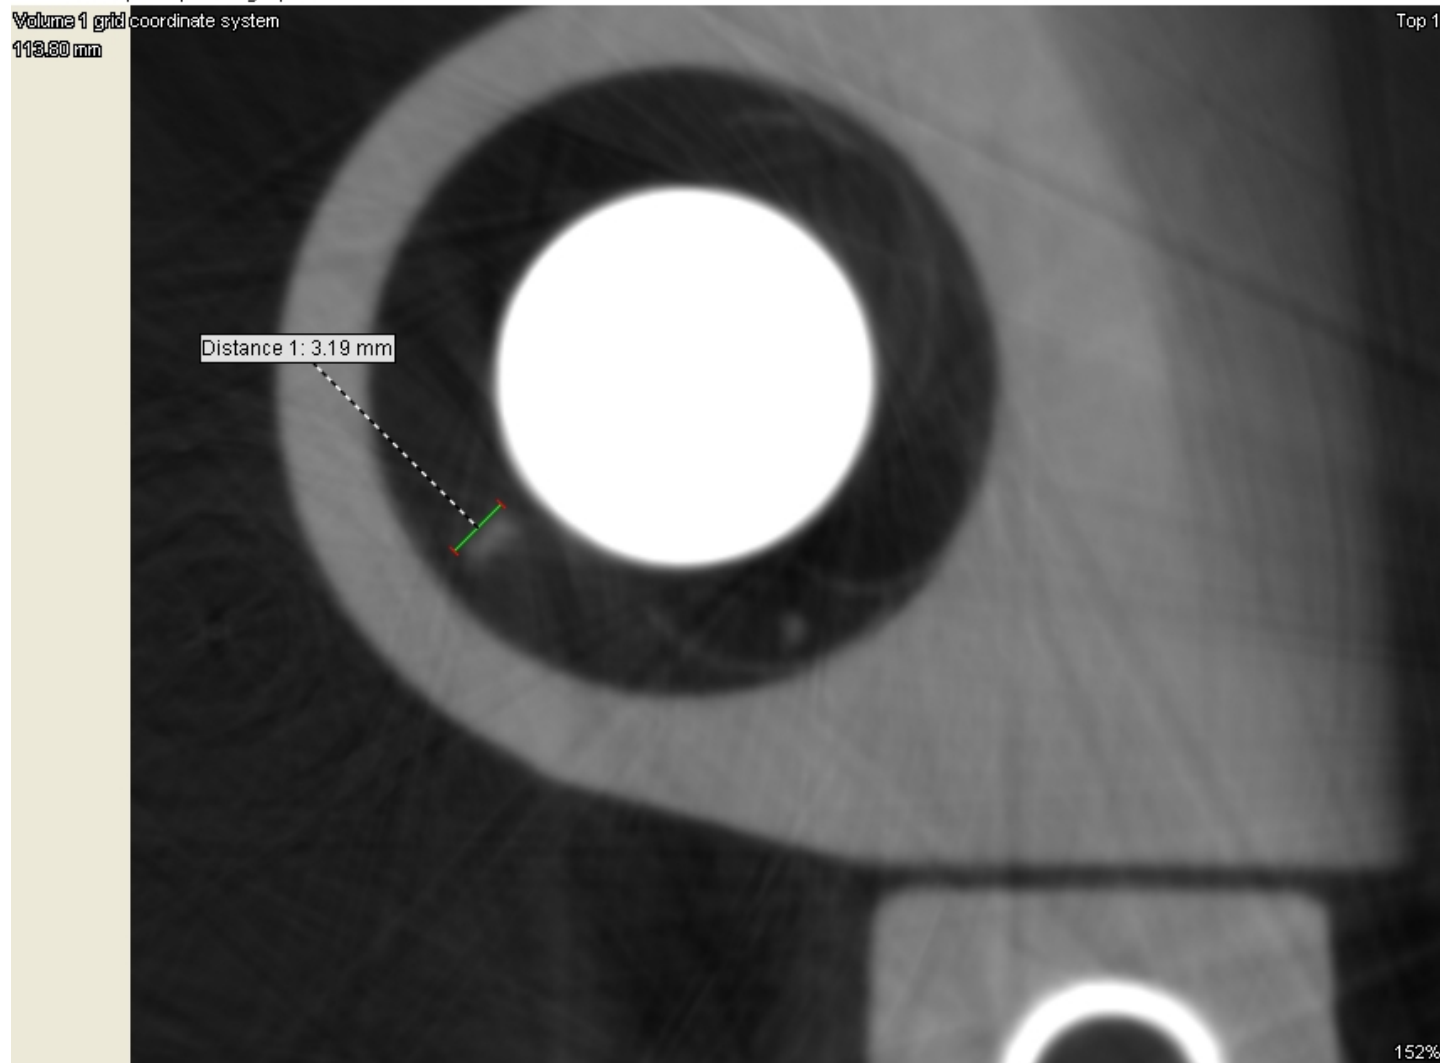
Figure 12
Axial cross section – Fore-Aft Actuator – Thickness of apparent ribbon of unknown material measuring 3.19 mm

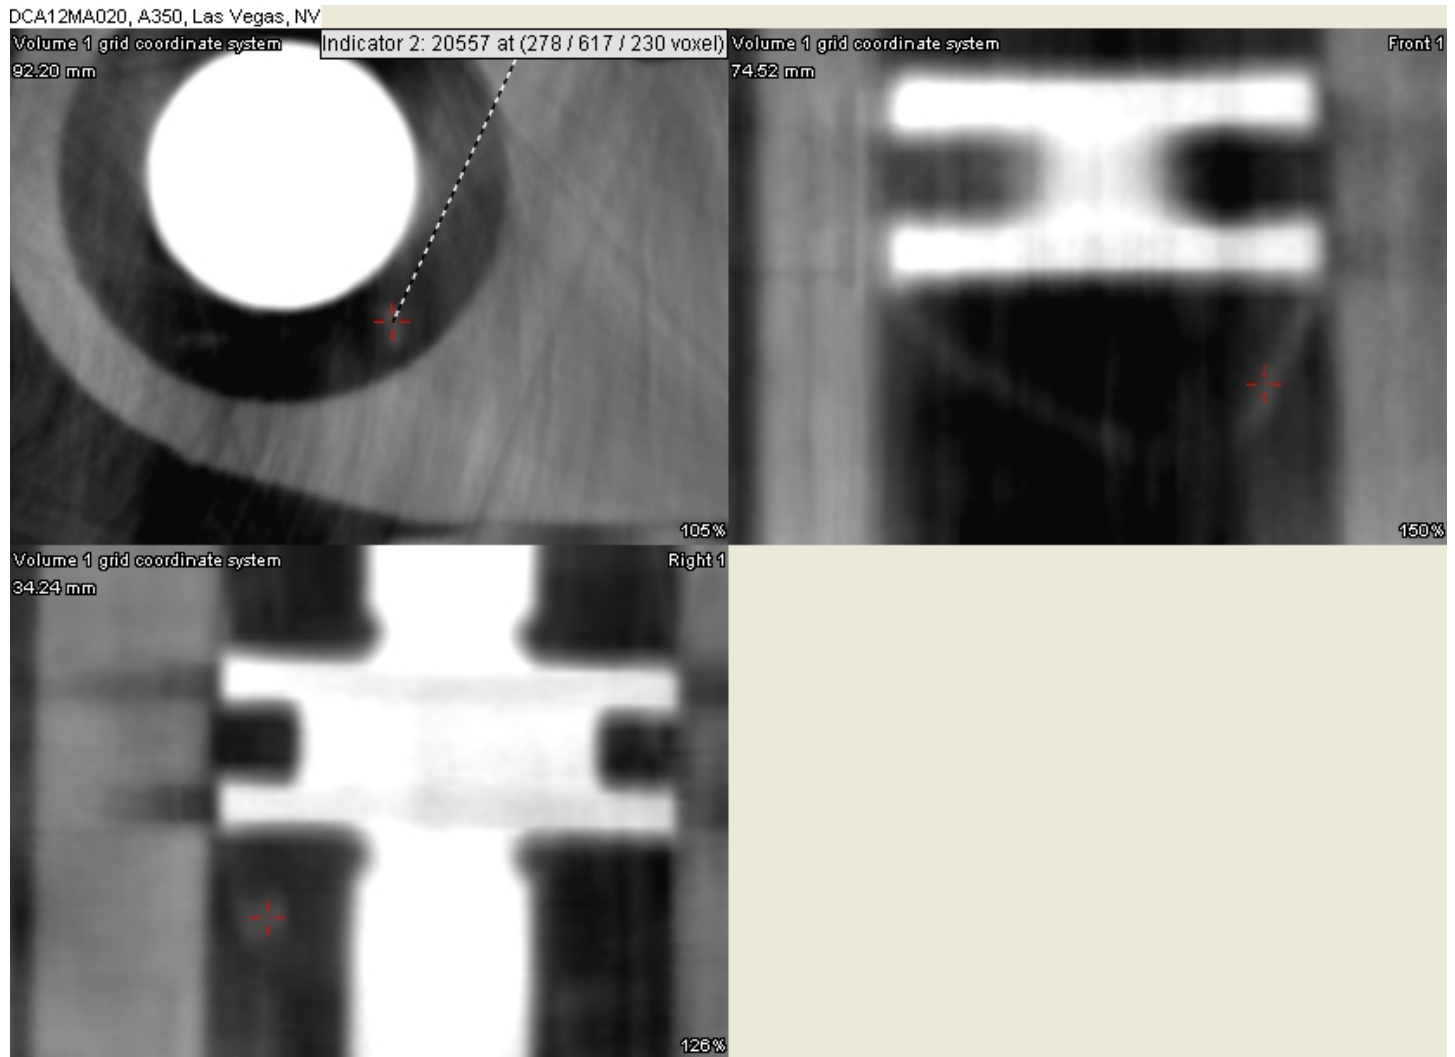
Figure 13
Multiple views – Fore-Aft Actuator – Apparent ribbon of unknown material below the piston head of the actuator

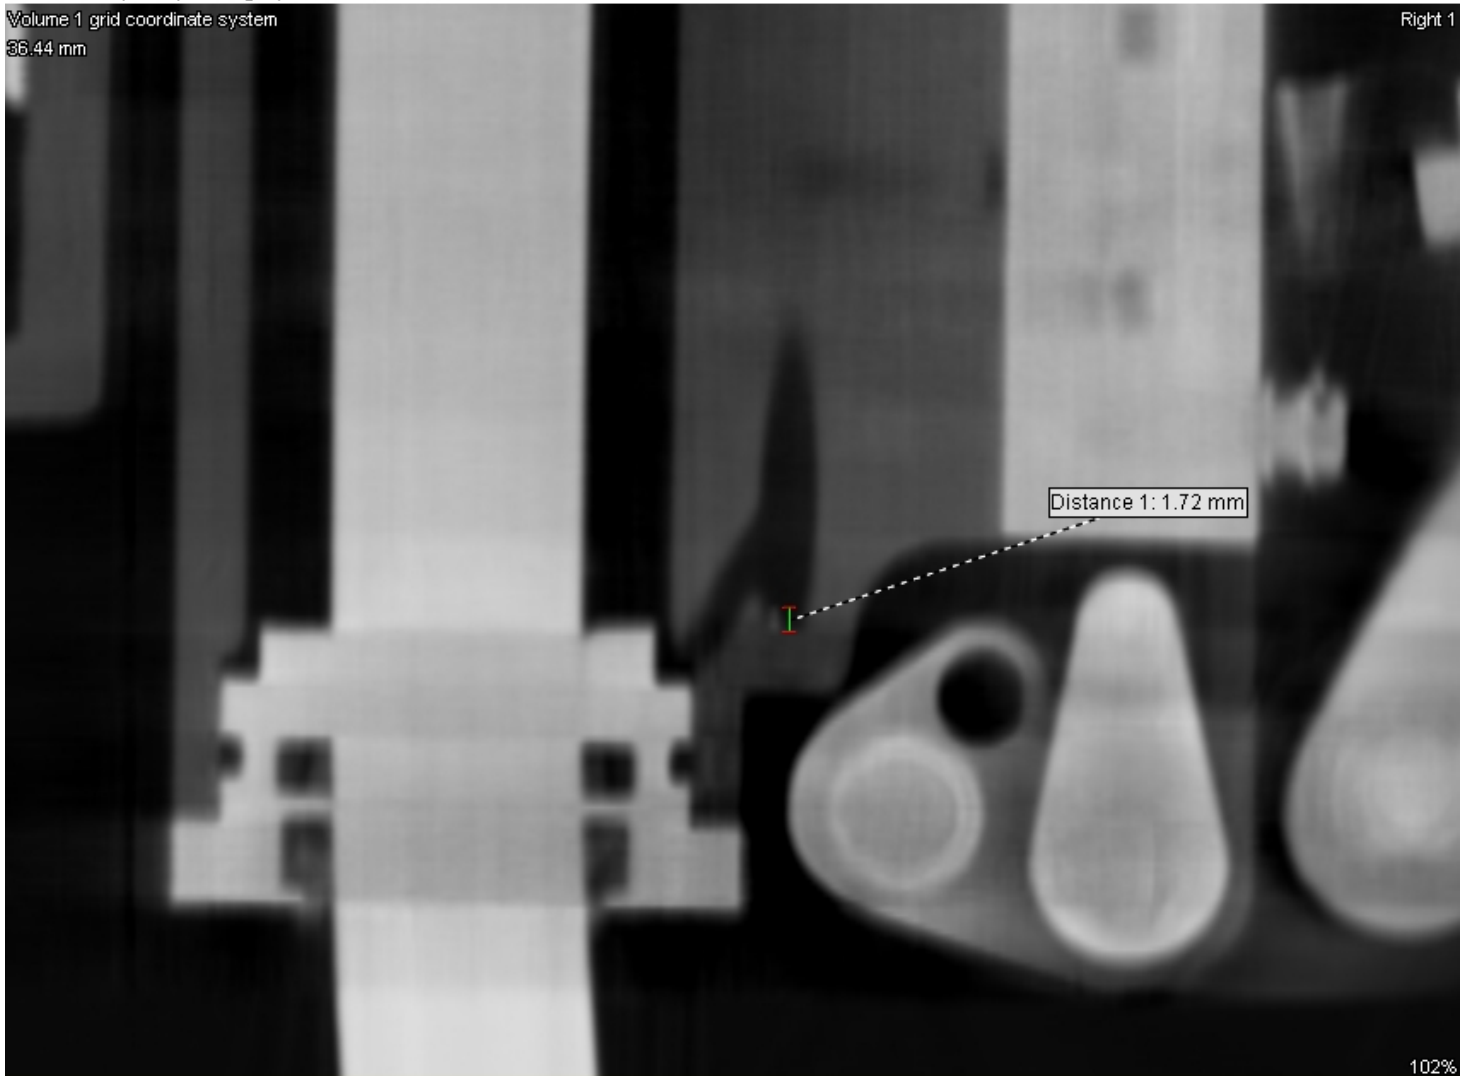
The computed tomography (CT) results for the left lateral actuator are shown in figures 14 through 21. A total of four particles were found in various locations within the actuator.

Figure 17
Right cross section – Left Lateral Actuator – Particle, measuring 1.72 mm long, at the
end of a hydraulic passage

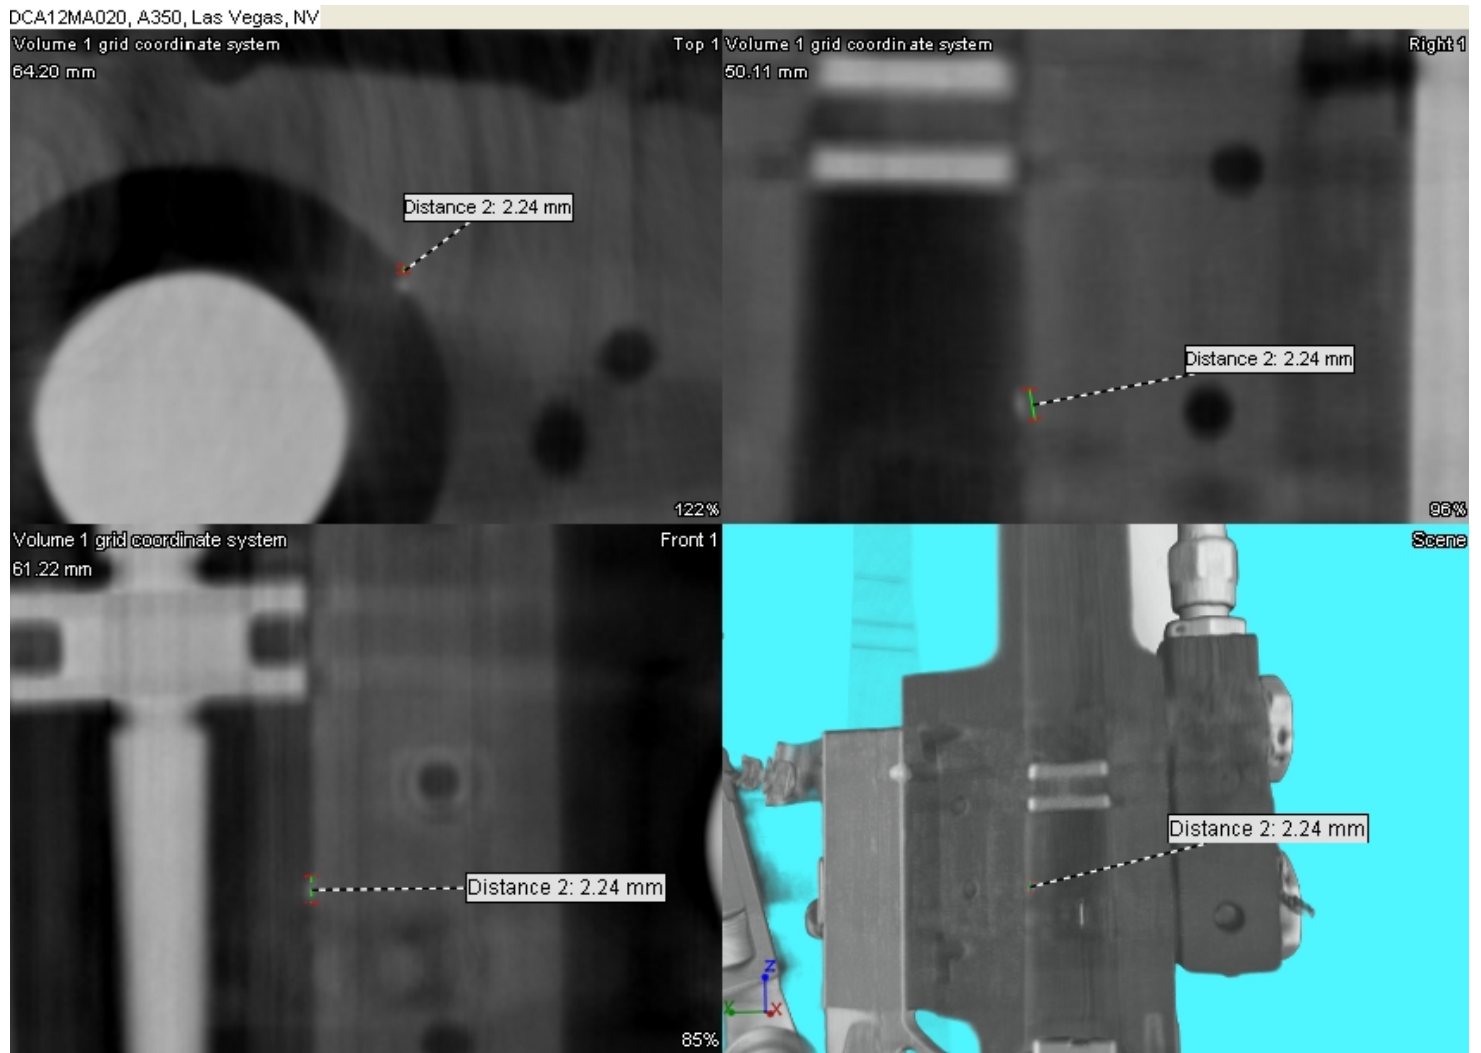
Figure 18
Multiple views – Left Lateral Actuator – Particle 2, measuring 2.24 mm long, on the wall
of the piston cavity

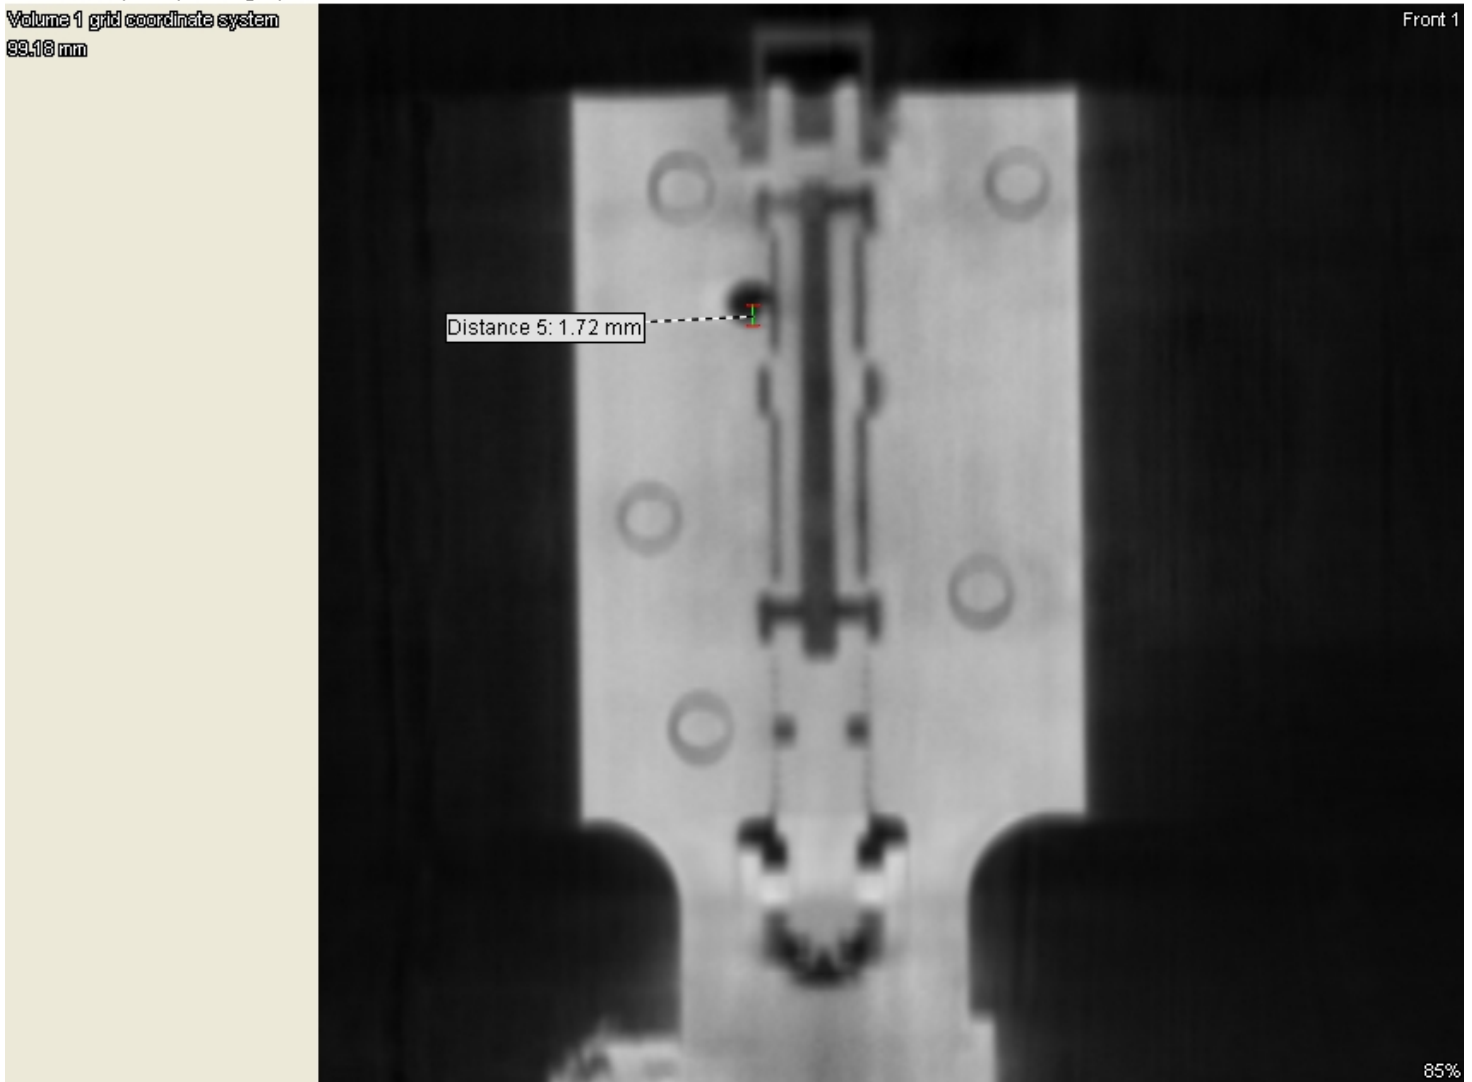
Figure 19
Frontal cross section – Left Lateral Actuator – Particle 3, measuring 1.72 mm long, at the end of a hydraulic passage adjacent to the spool

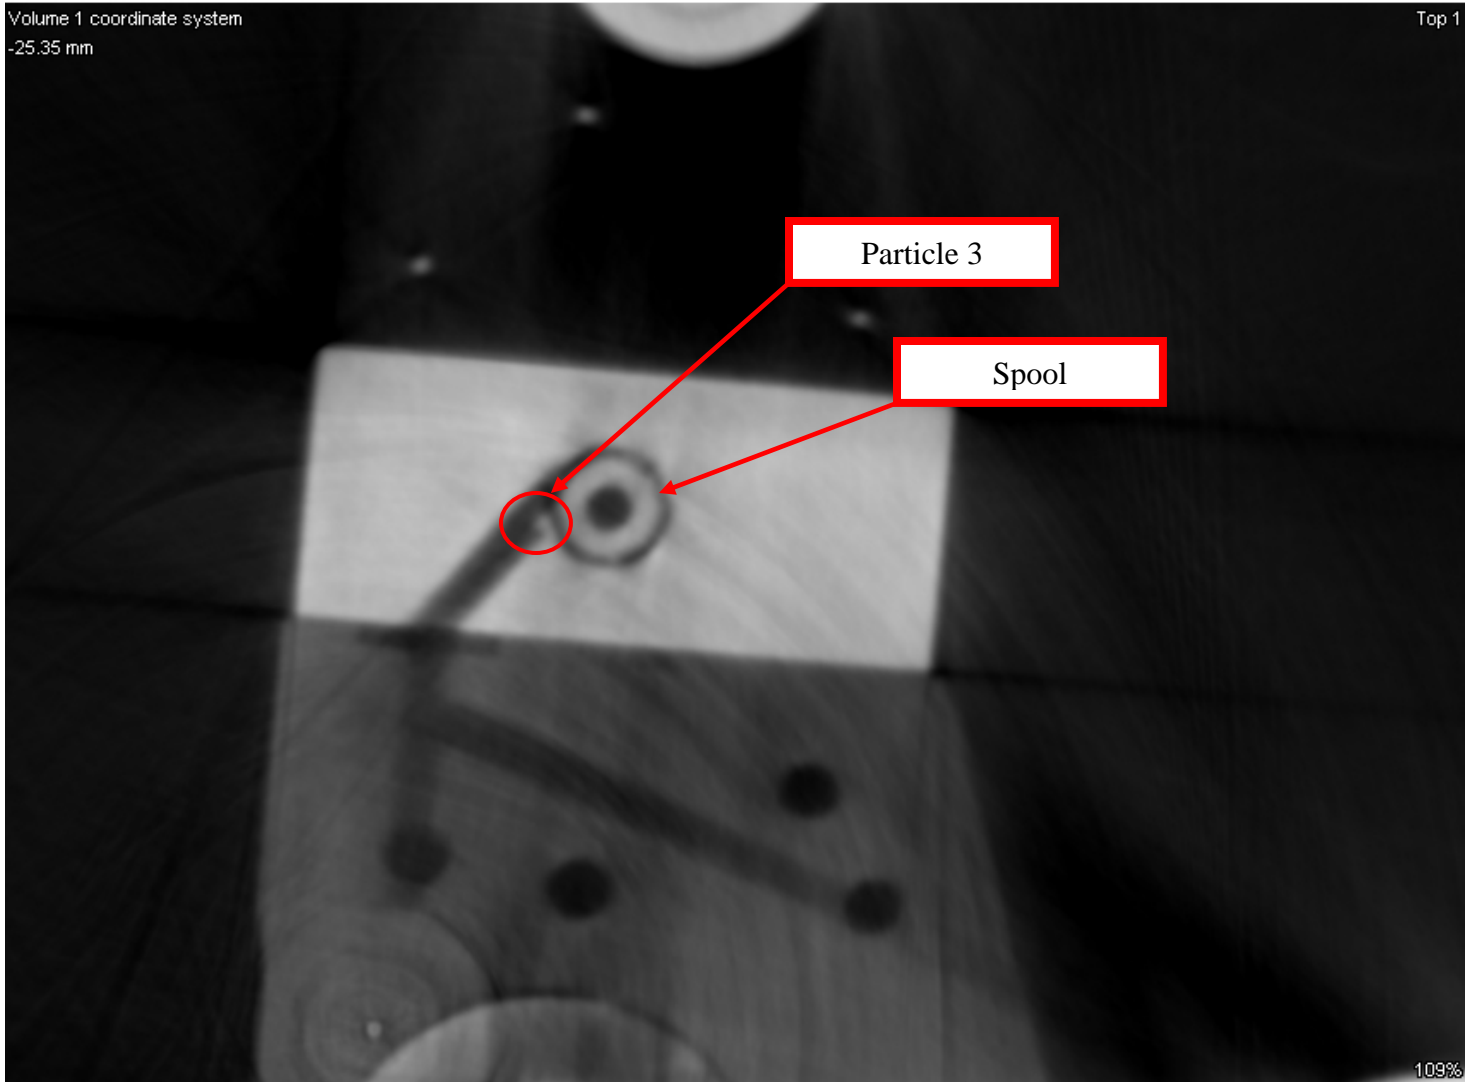
Figure 20
Axial cross section – Left Lateral Actuator – Particle 3, measuring 1.72 mm long, at the end of a hydraulic passage adjacent to the spool

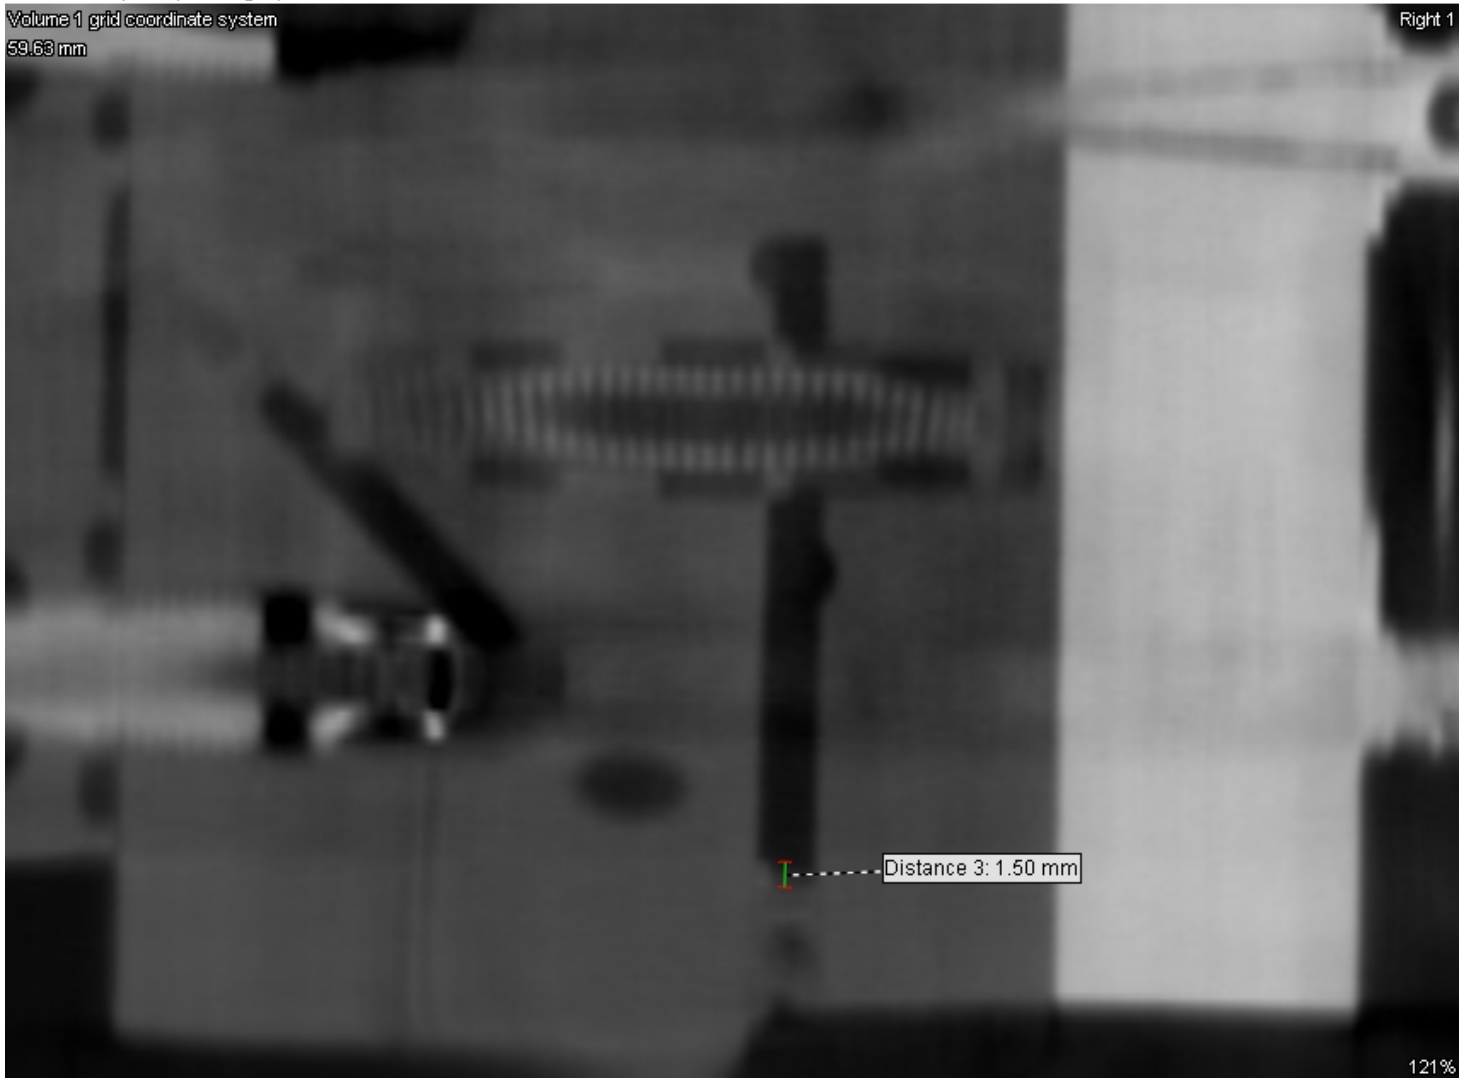
Figure 21
Right cross section – Left Lateral Actuator – Particle 4, measuring 1.50 mm long, at the end of a hydraulic passage

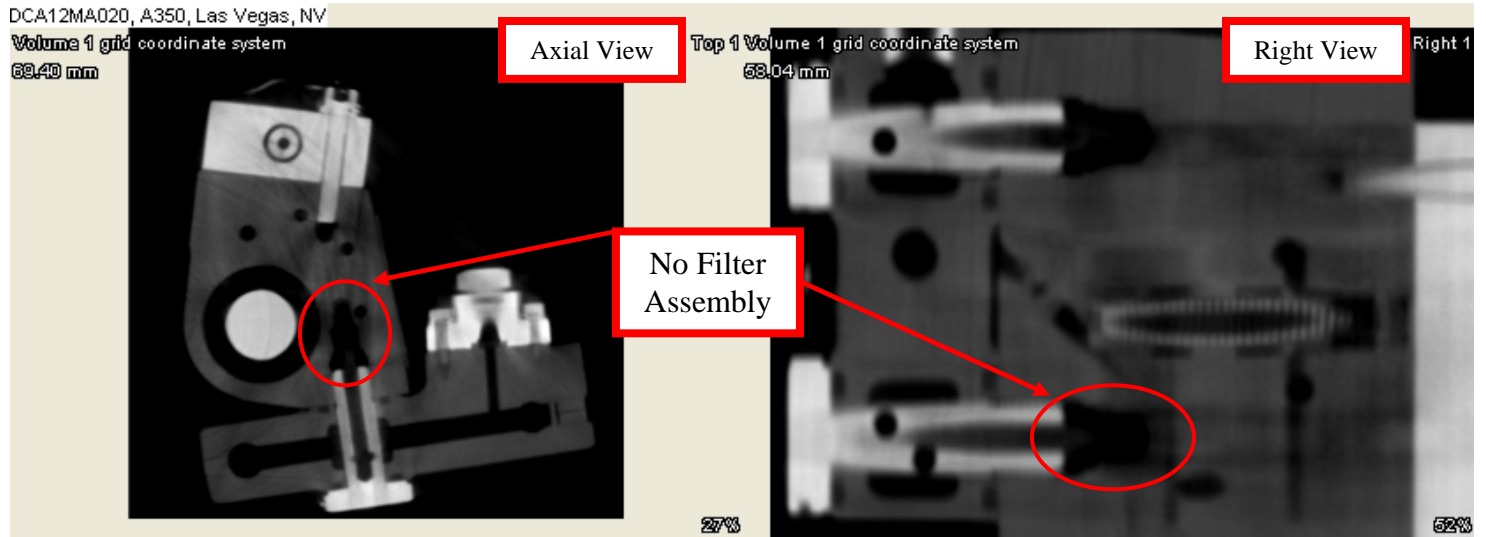
The computed tomography (CT) results for the right lateral actuator are shown in figures 22 through 24. No particles were found in this actuator, however there was no filter visible in the pressure port area.

Figure 24
Multiple views – Right Lateral Actuator – Overall cross section showing the return and pressure ports and no visible filter

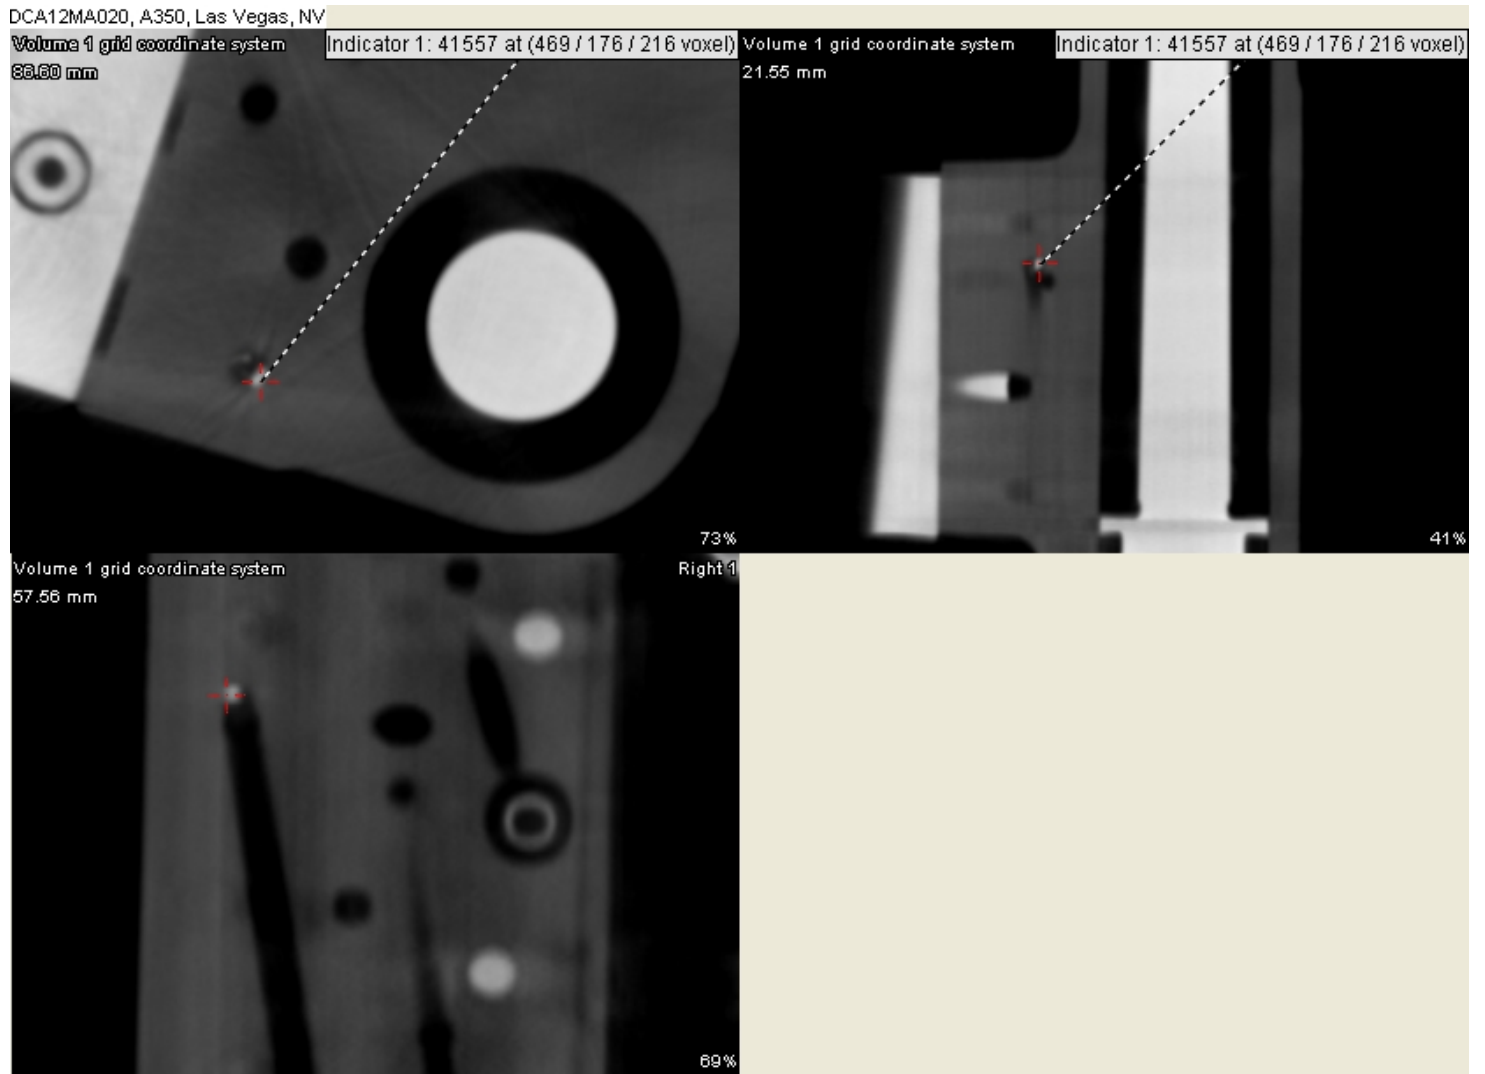
The computed tomography (CT) results for the tail rotor actuator are shown in figures 25 through 30. A total of two particles were found in various locations within the actuator.

Figure 27
Multiple views – Tail Rotor Actuator – Particle 1 located at the end of a hydraulic passage

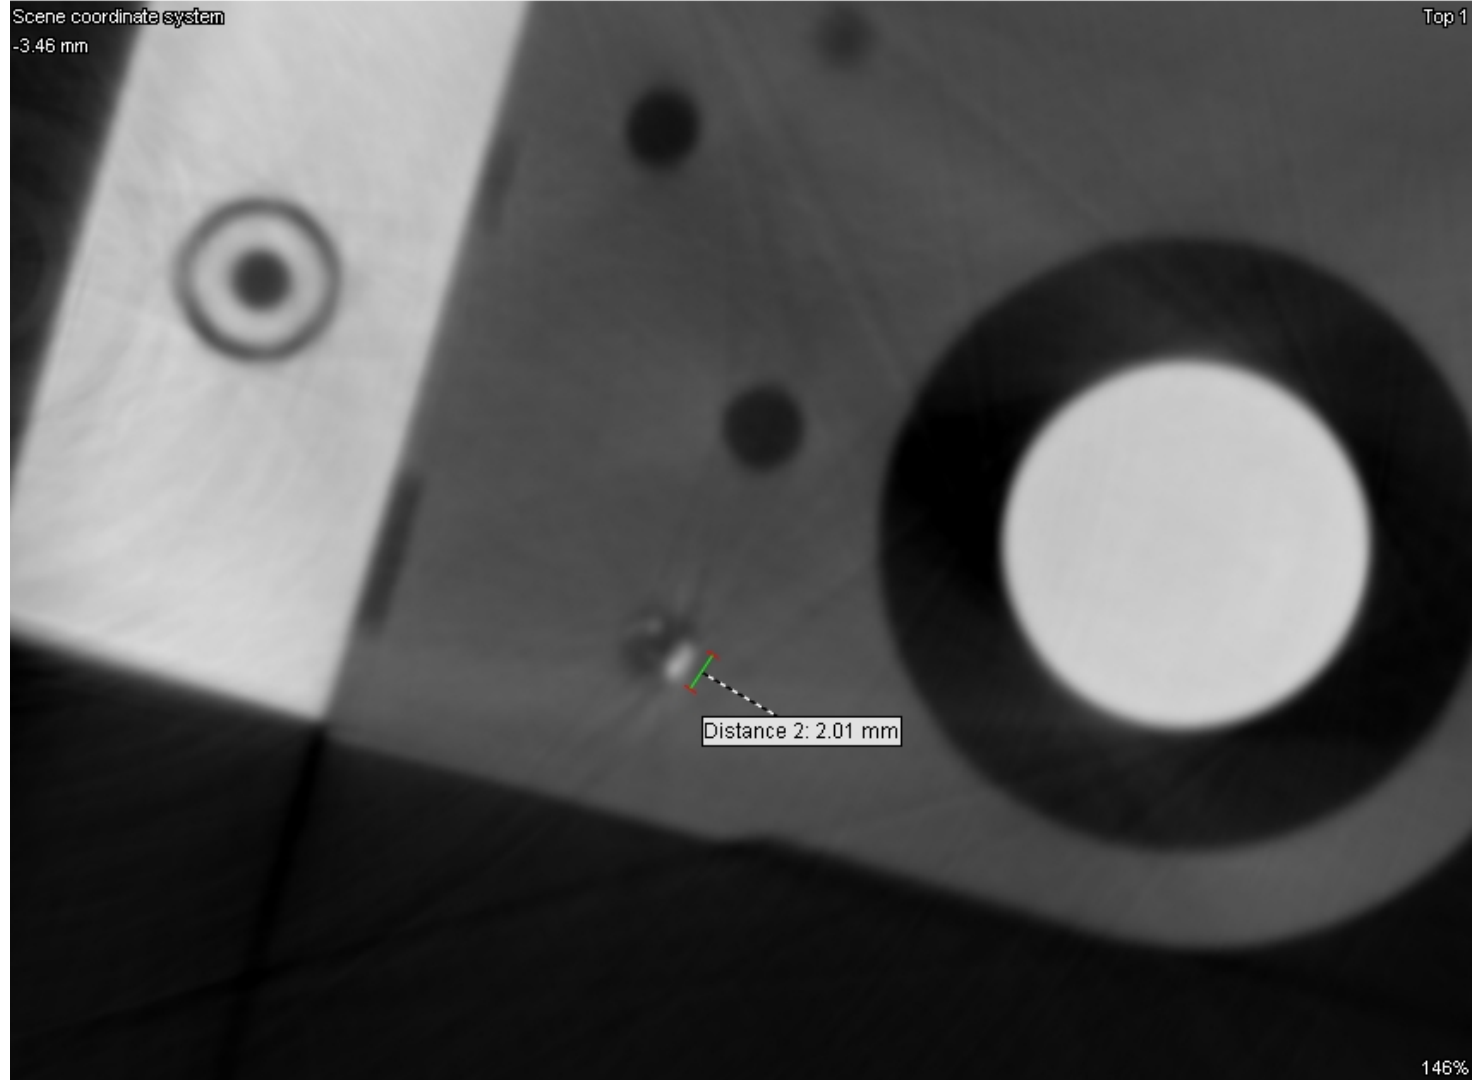
Figure 28
Axial cross section – Tail Rotor Actuator – Particle 1 (measuring 2.01 mm long) located
at the end of a hydraulic passage

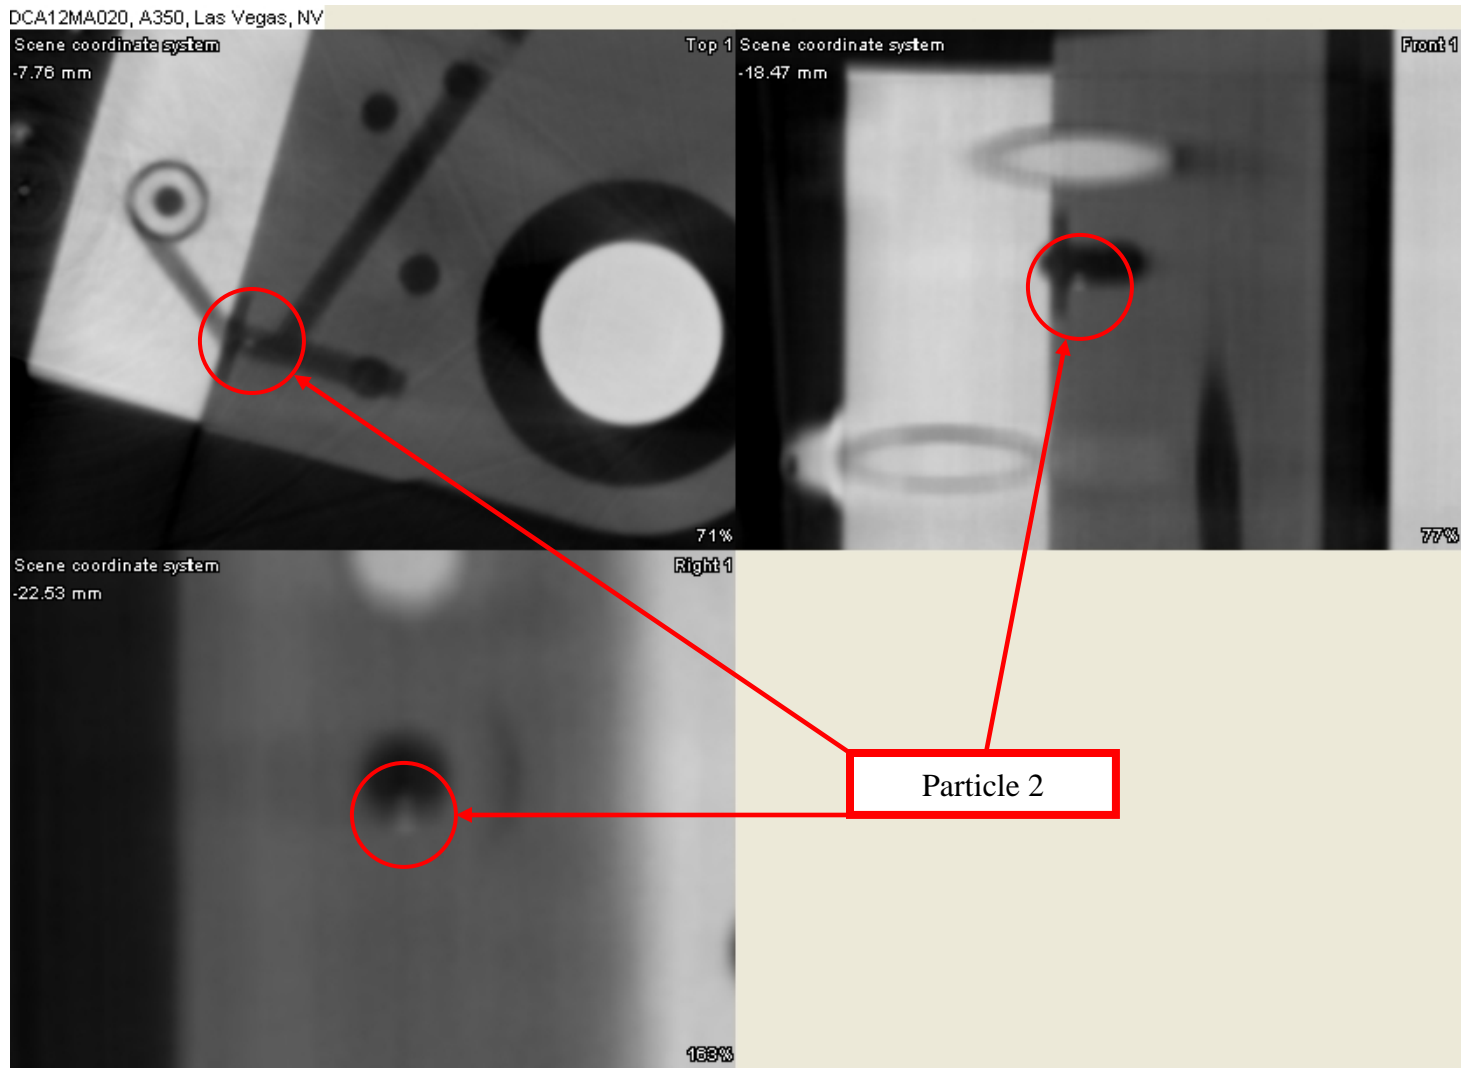
Figure 29
Multiple Views – Tail Rotor Actuator – Particle 2 located in the middle of a hydraulic passage
