NATIONAL TRANSPORTATION SAFETY BOARD
Office of Aviation Safety
Washington, D.C. 20594

Computed Tomography Specialist's Factual Report

DCA12MA020

Operator: Sundance Helicopters
Location: Approximately 14 miles east of Las Vegas, NV
Date: December 7, 2011
Time: 1630 Pacific Standard Time
Airplane: Eurocopter AS350-B2, N37SH

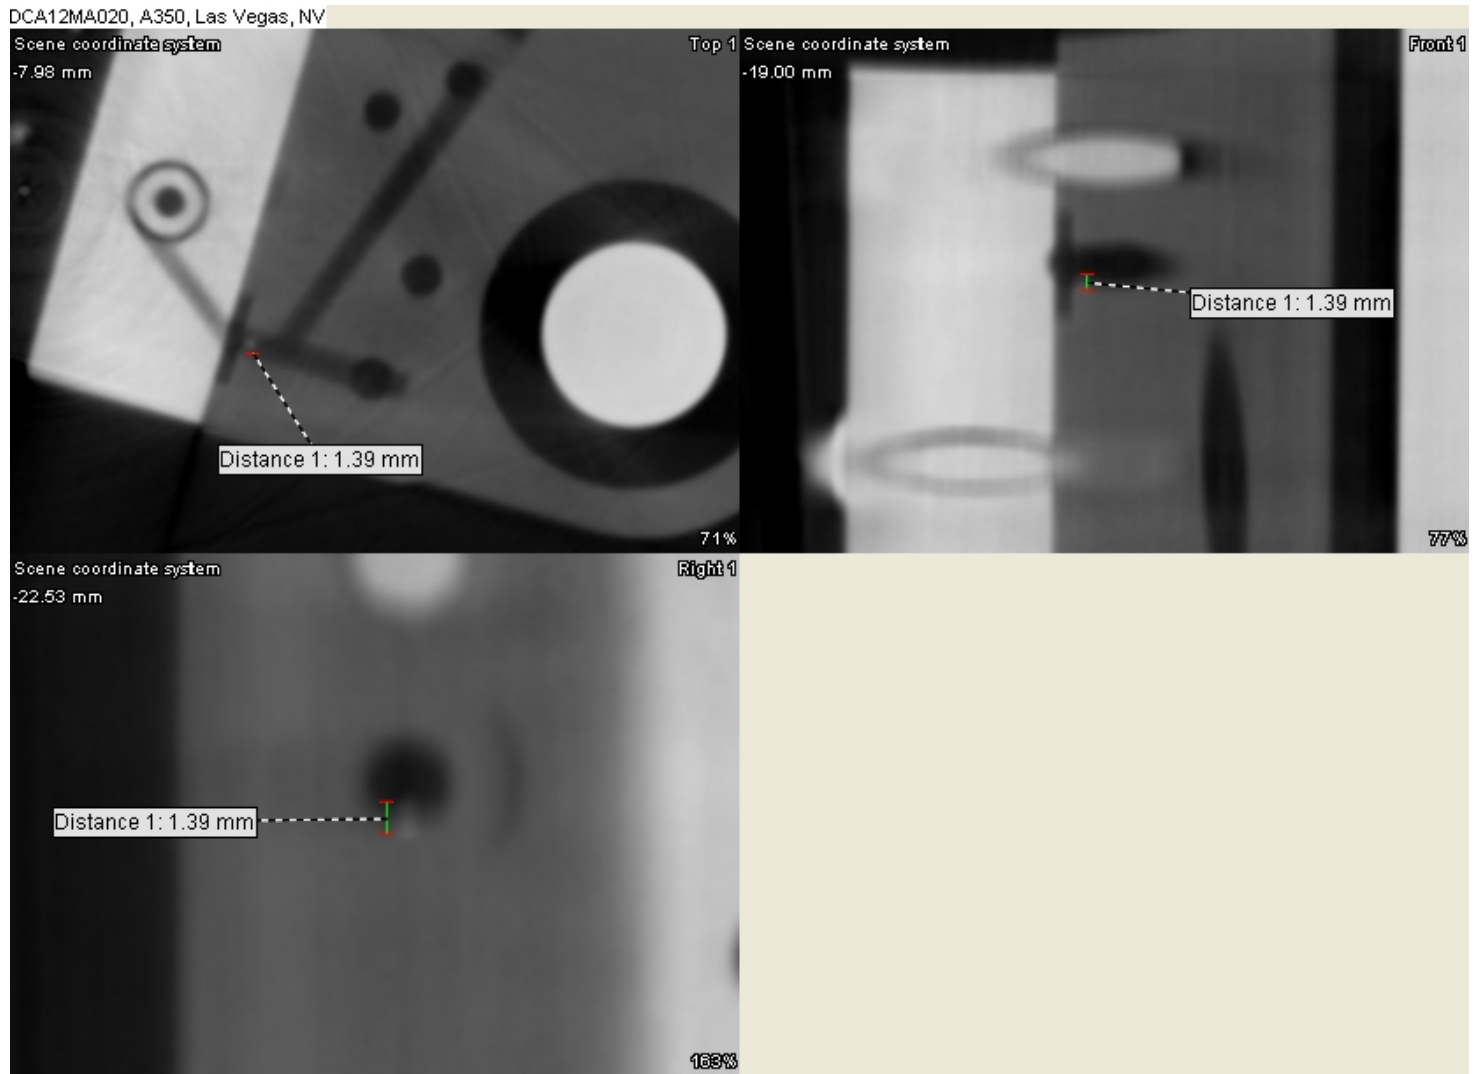
The computed tomography (CT) results for the tail rotor actuator are shown in figures 25 through 30. A total of two particles were found in various locations within the actuator.

Figure 30
Multiple Views – Tail Rotor Actuator – Particle 2 (measuring 1.39 mm high) located in the middle of a hydraulic passage

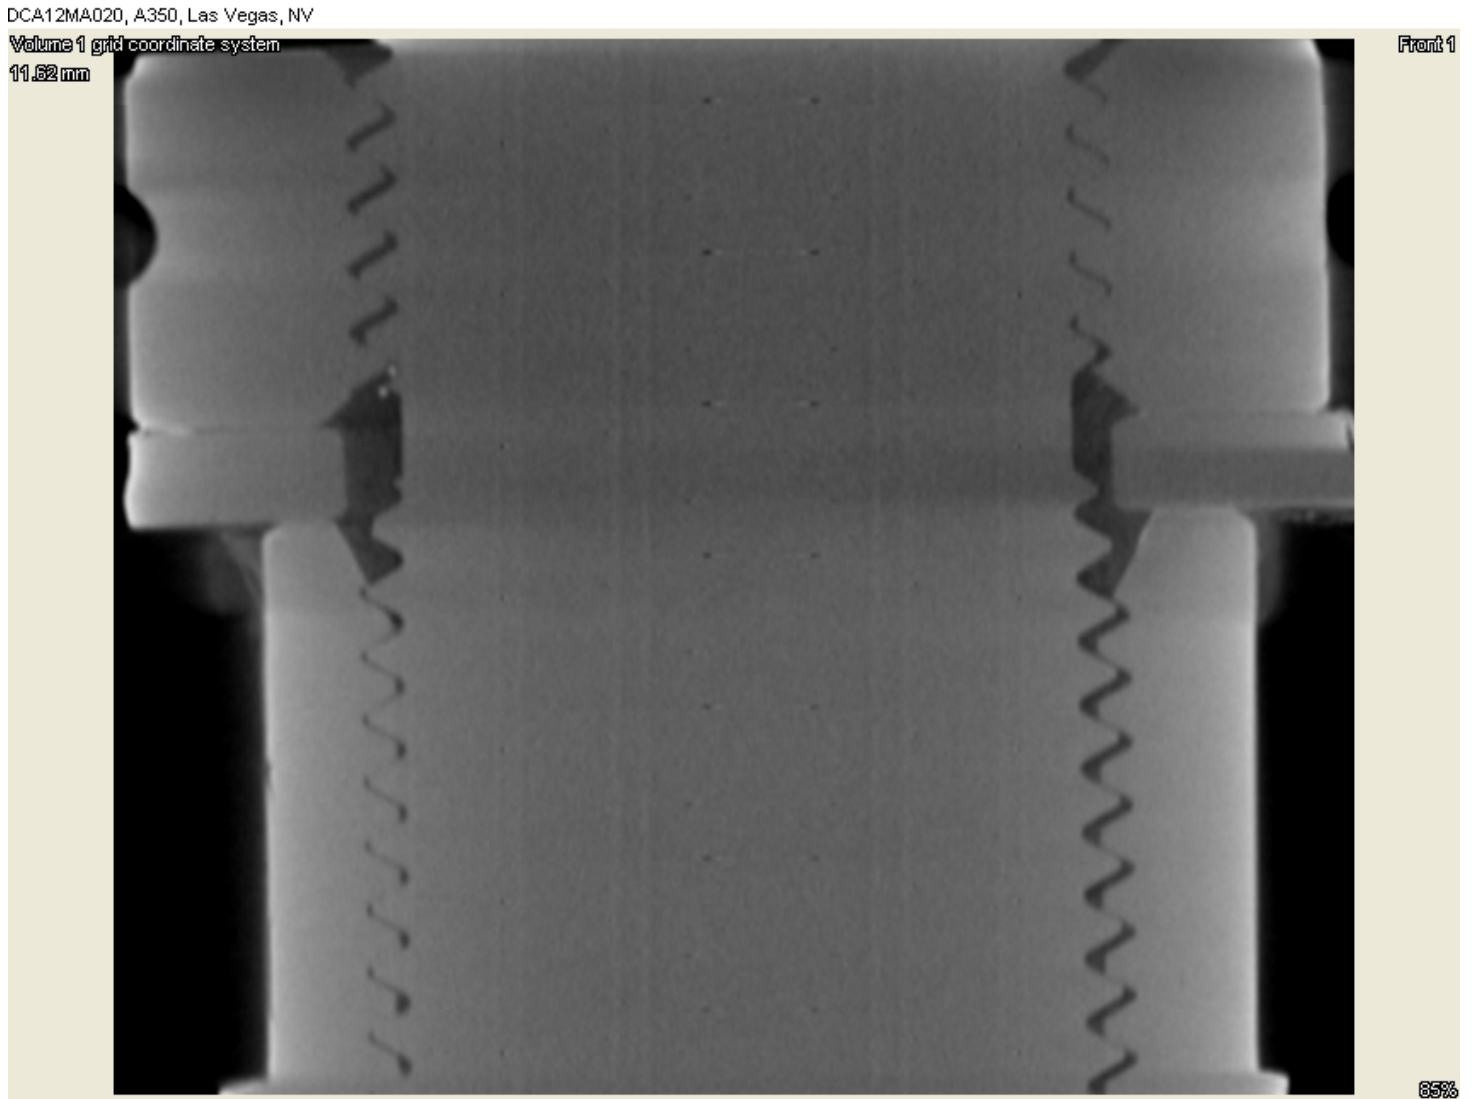
The CT results for the fore-aft actuator rod end are shown in figure 31. There were no abnormalities noted in these CT images.

Figure 31
Frontal cross section – Fore-Aft Rod End – Overall cross section through the nut area and below
