NATIONAL TRANSPORTATION SAFETY BOARD
Office of Aviation Safety
Washington, D.C. 20594

Computed Tomography Specialist's Factual Report

CEN-11-IA-379

Operator: Skywest Airlines
Location: General Mitchell Airport, Milwaukee, Wisconsin
Date: June 6, 2011
Time: 2132 central daylight time
Airplane: Bombardier CRJ-2B19, N866AS

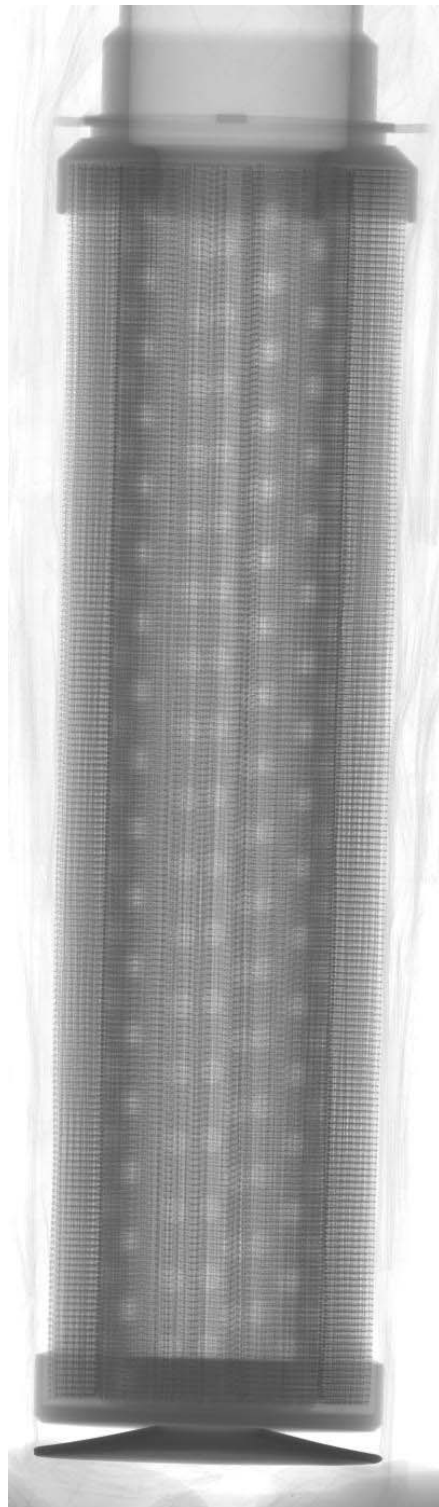
Figure 1
Digital Radiograph – Pressure Filter

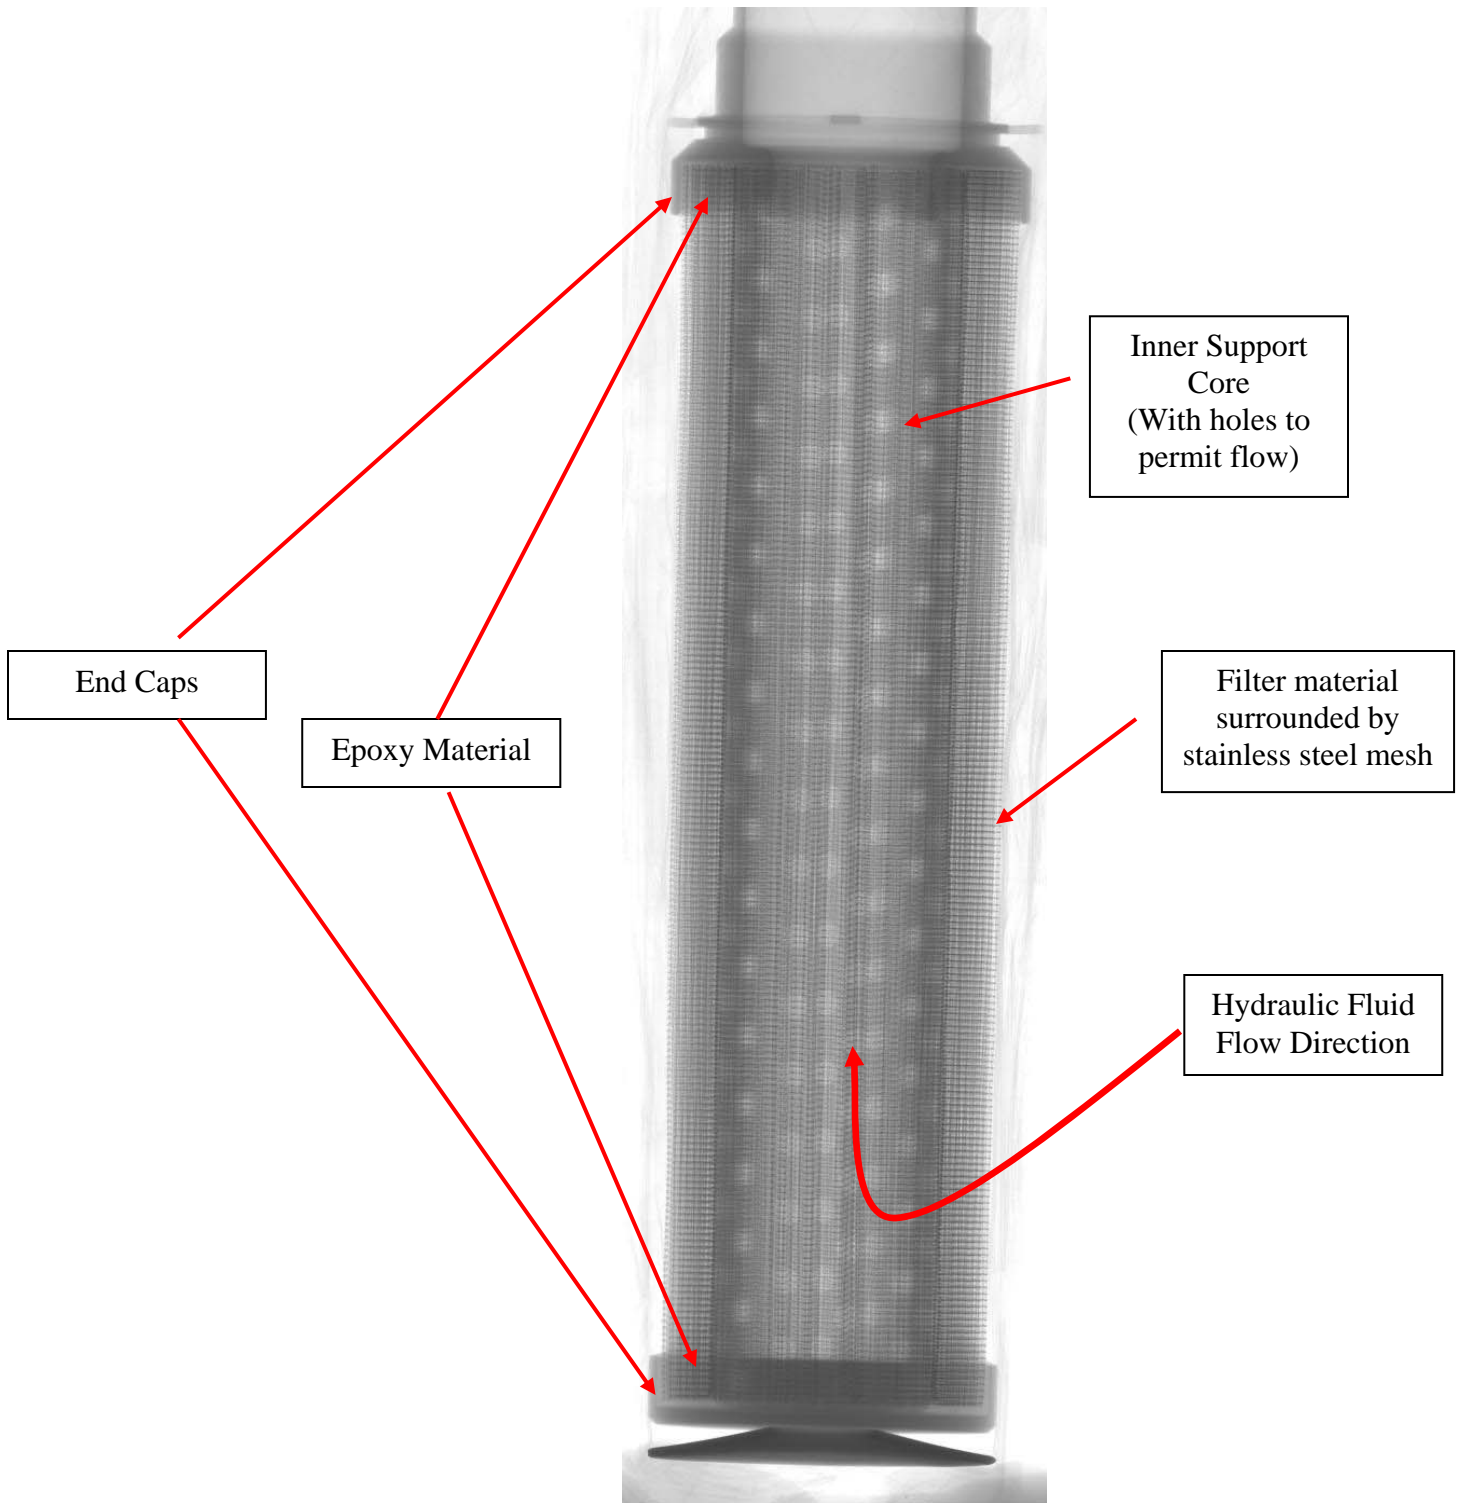
Figure 2
Digital Radiograph – Pressure Filter with components labeled

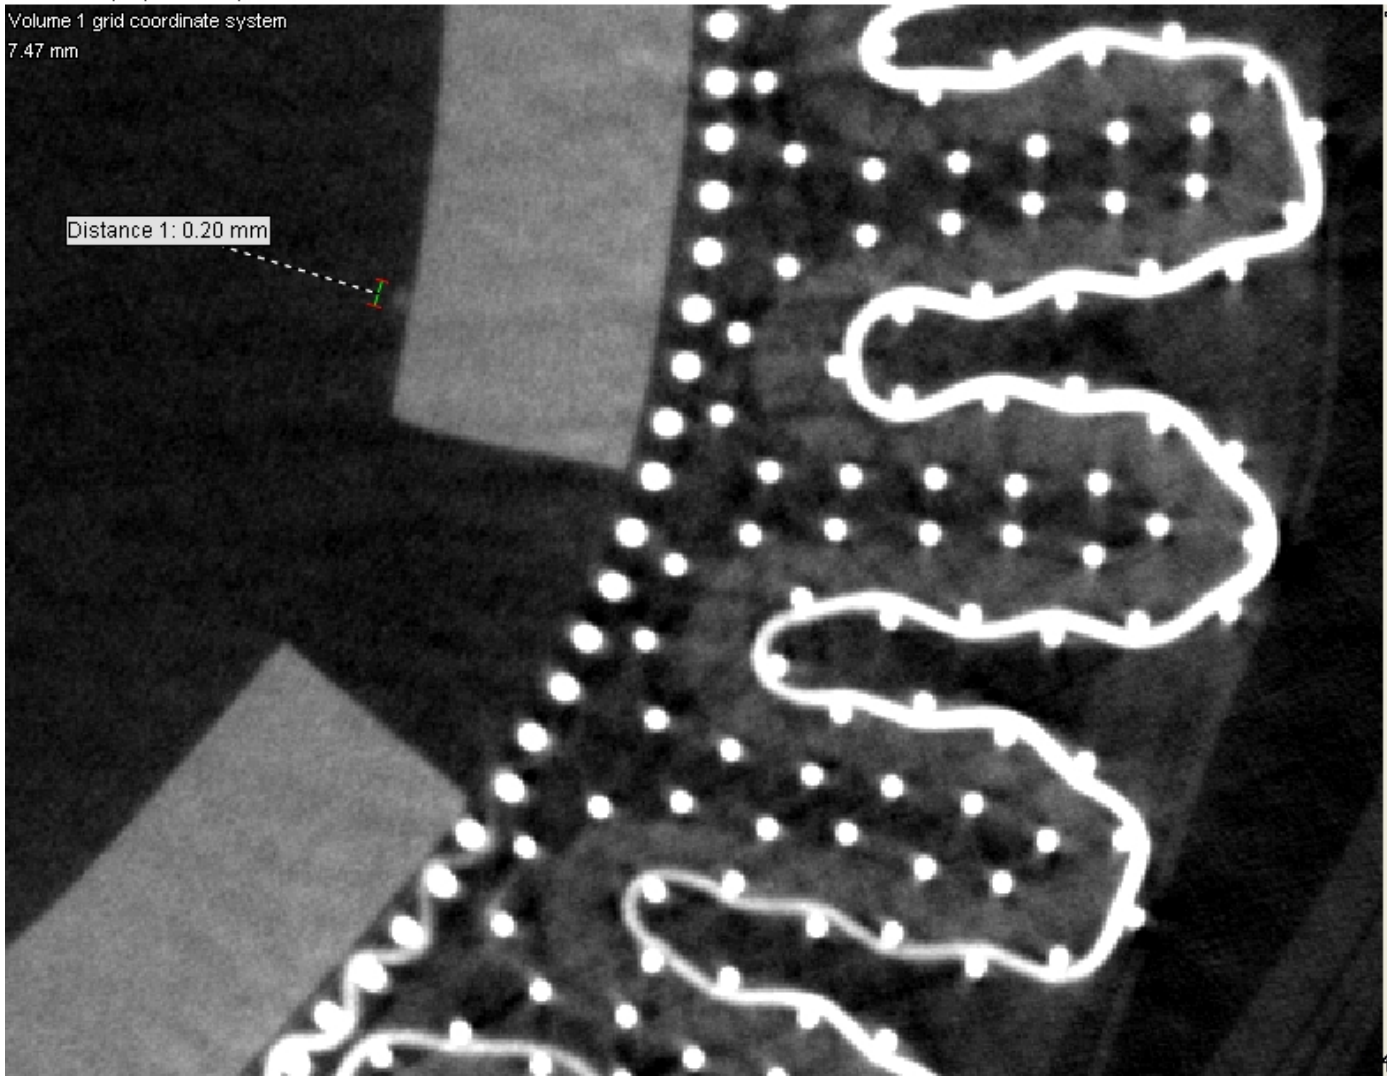
Figure 3
Axial Cross Section – Pressure Filter (section 494-504) – Low density
particle, measuring 0.20 mm x 0.32 mm, on the inside surface of the inner
support core.

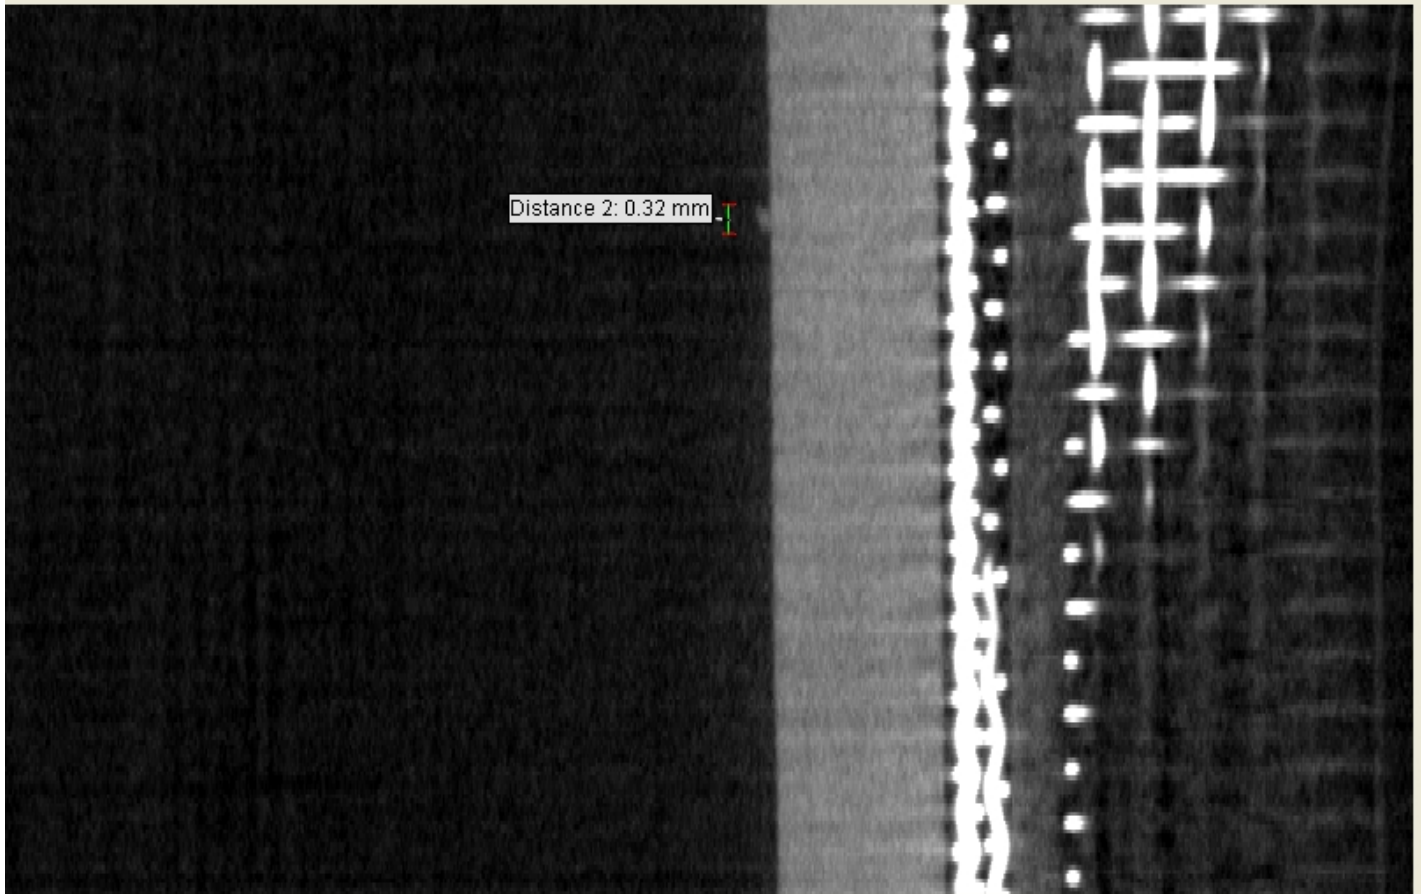
Figure 4
Frontal Cross Section – Pressure Filter (section 494-504) – Low density
particle shown in figure 3, measuring 0.20 mm x 0.32 mm on the inside
surface of the inner support core

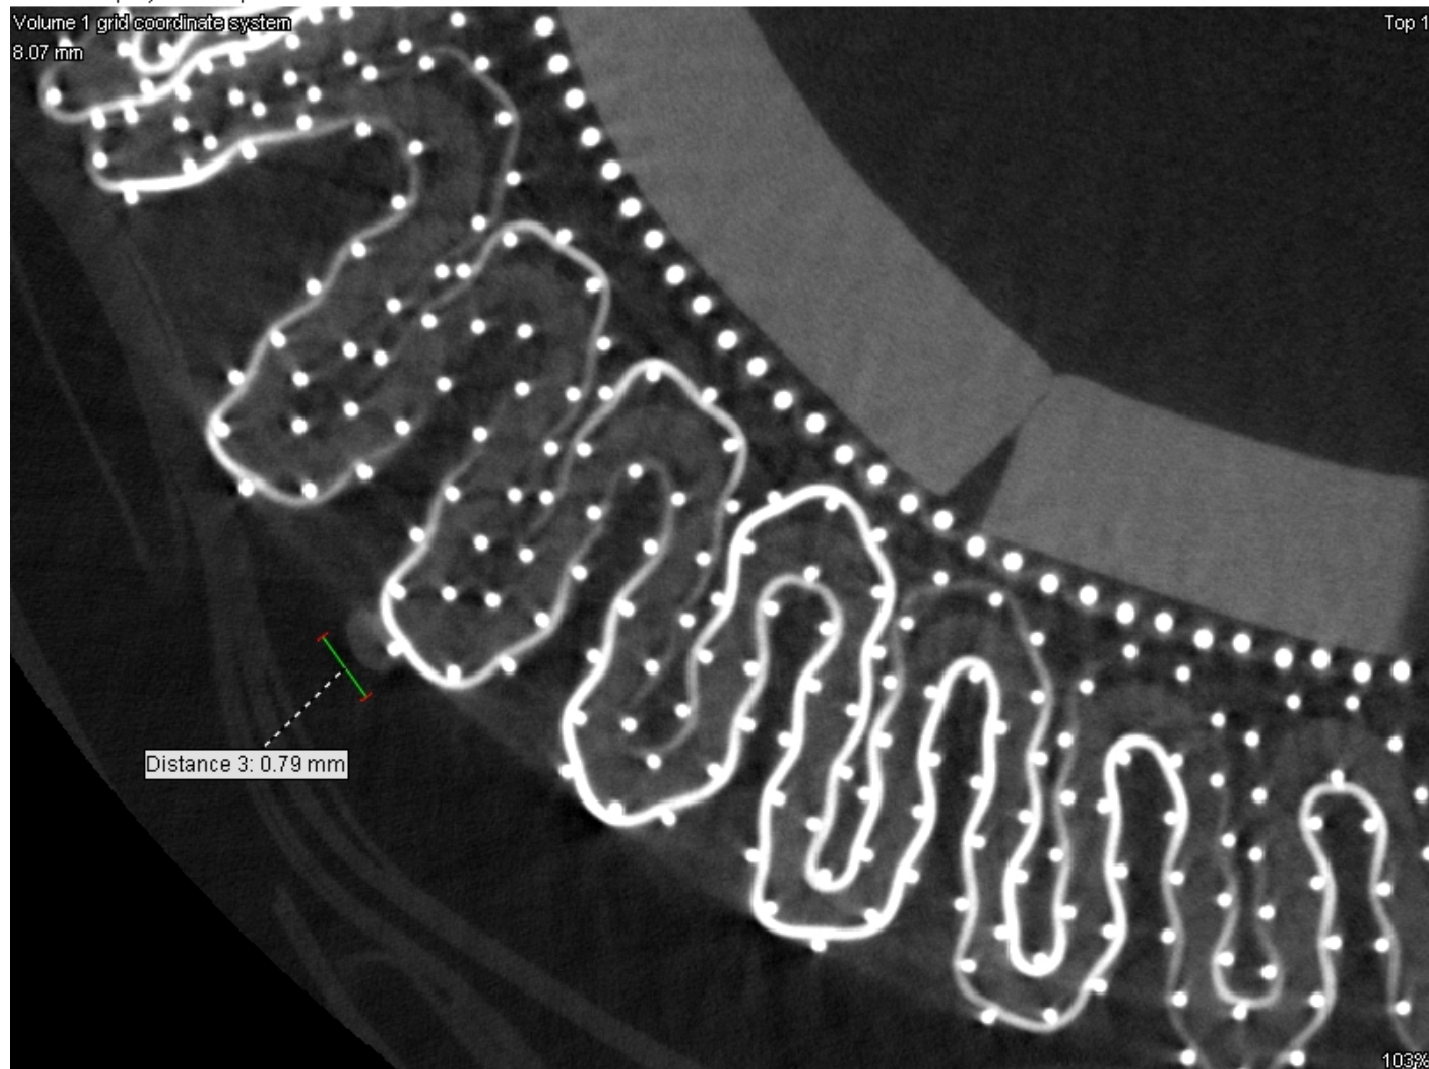
Figure 5

Axial Cross Section – Pressure Filter (section 494-504) – Low density particle measuring
0.79 mm x 1.38 mm, on the outer stainless steel mesh

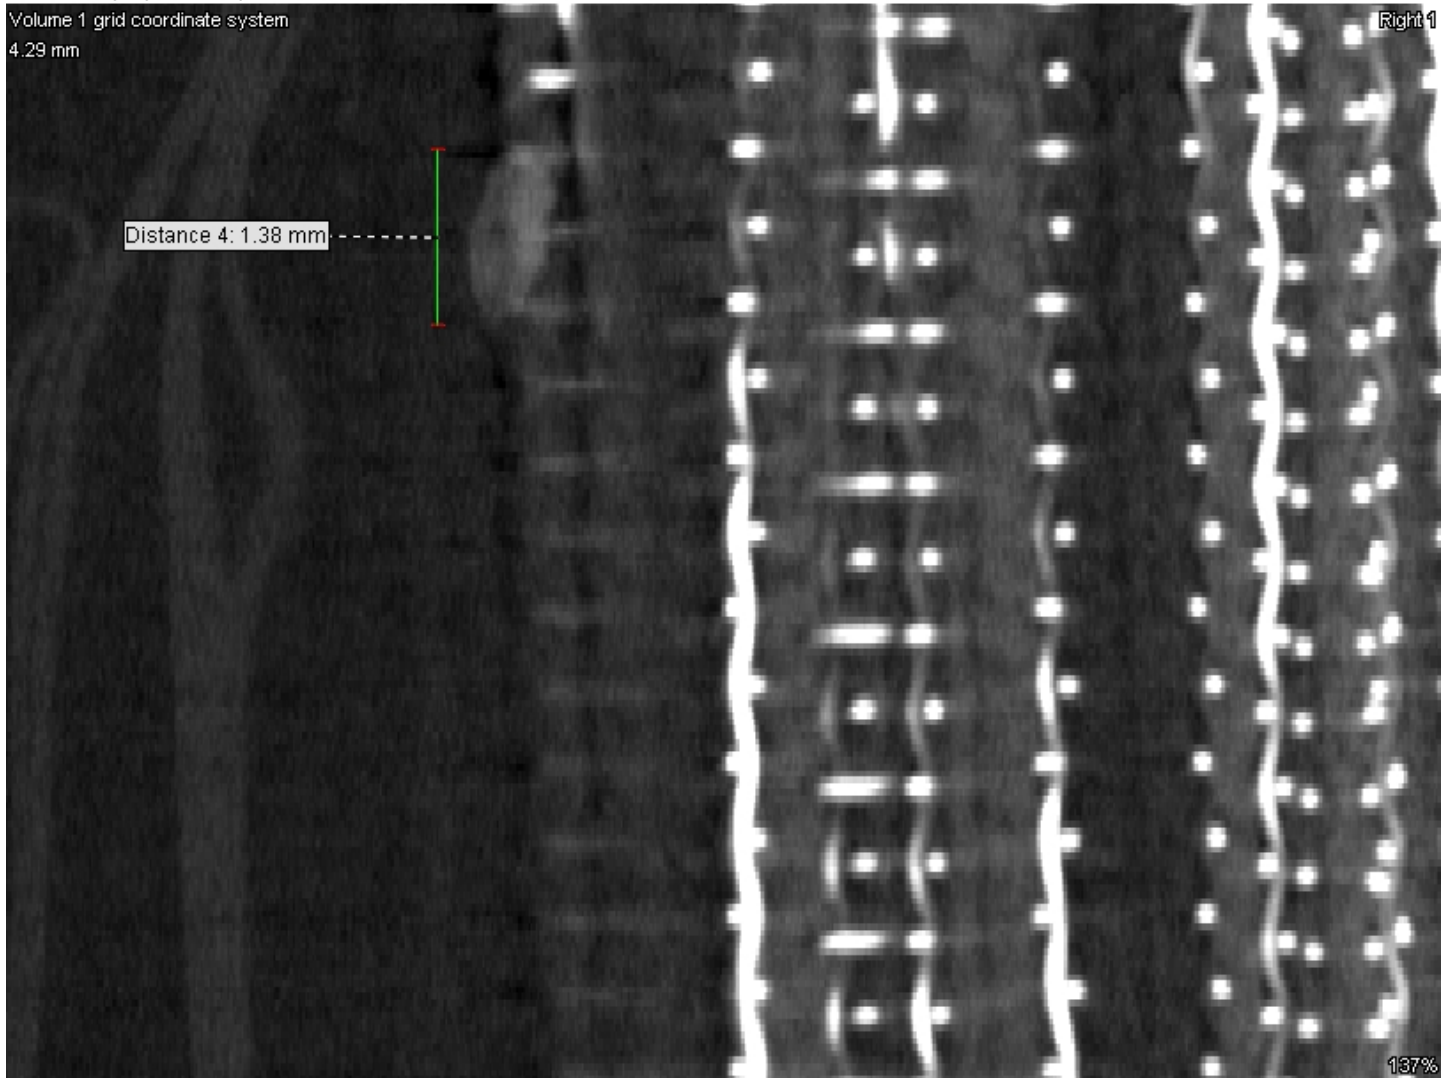
Figure 6
Right Cross Section – Pressure Filter (section 494-504) – Low density particle (shown in figure 5) measuring 0.79 mm x 1.38 mm, on the outer stainless steel mesh

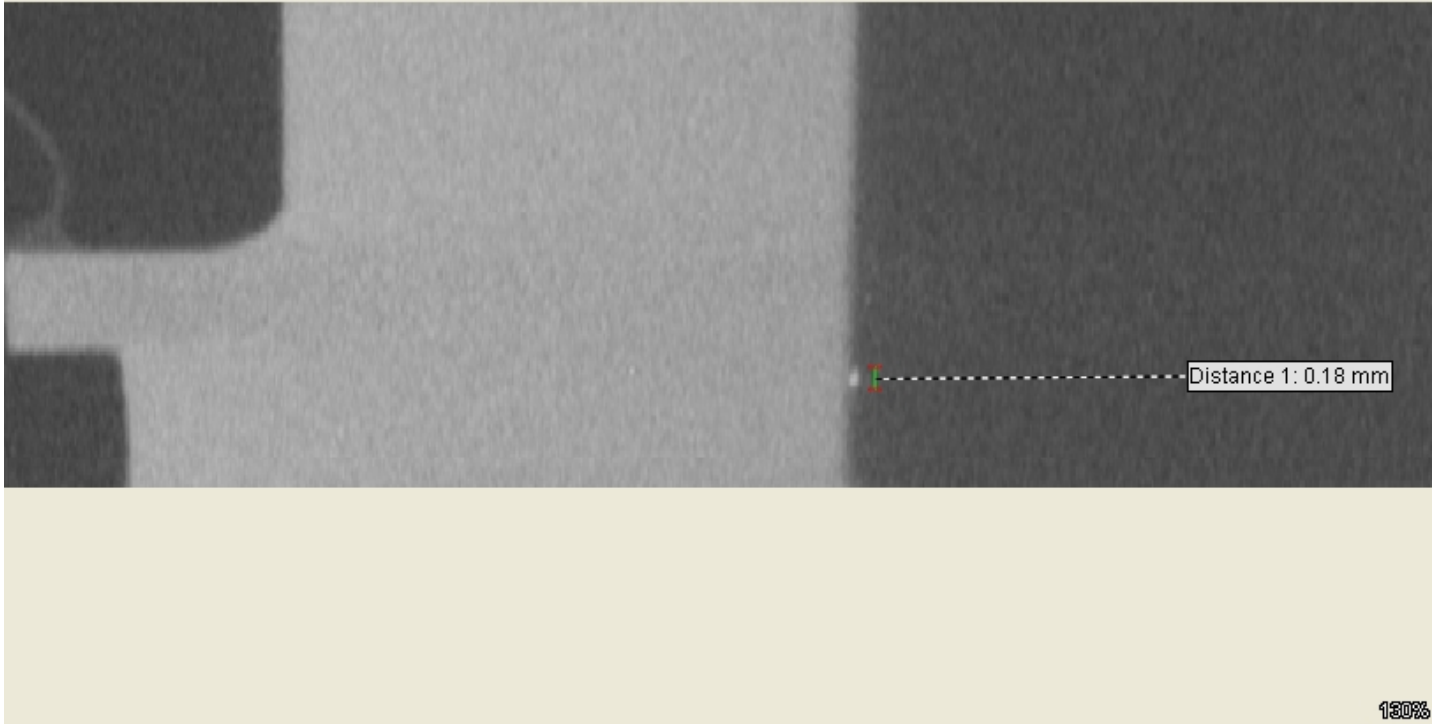
Figure 7
Right Cross Section – Pressure Filter (section 514-518) – Particle, measuring 0.18 mm,
on the inside surface of the inner support core

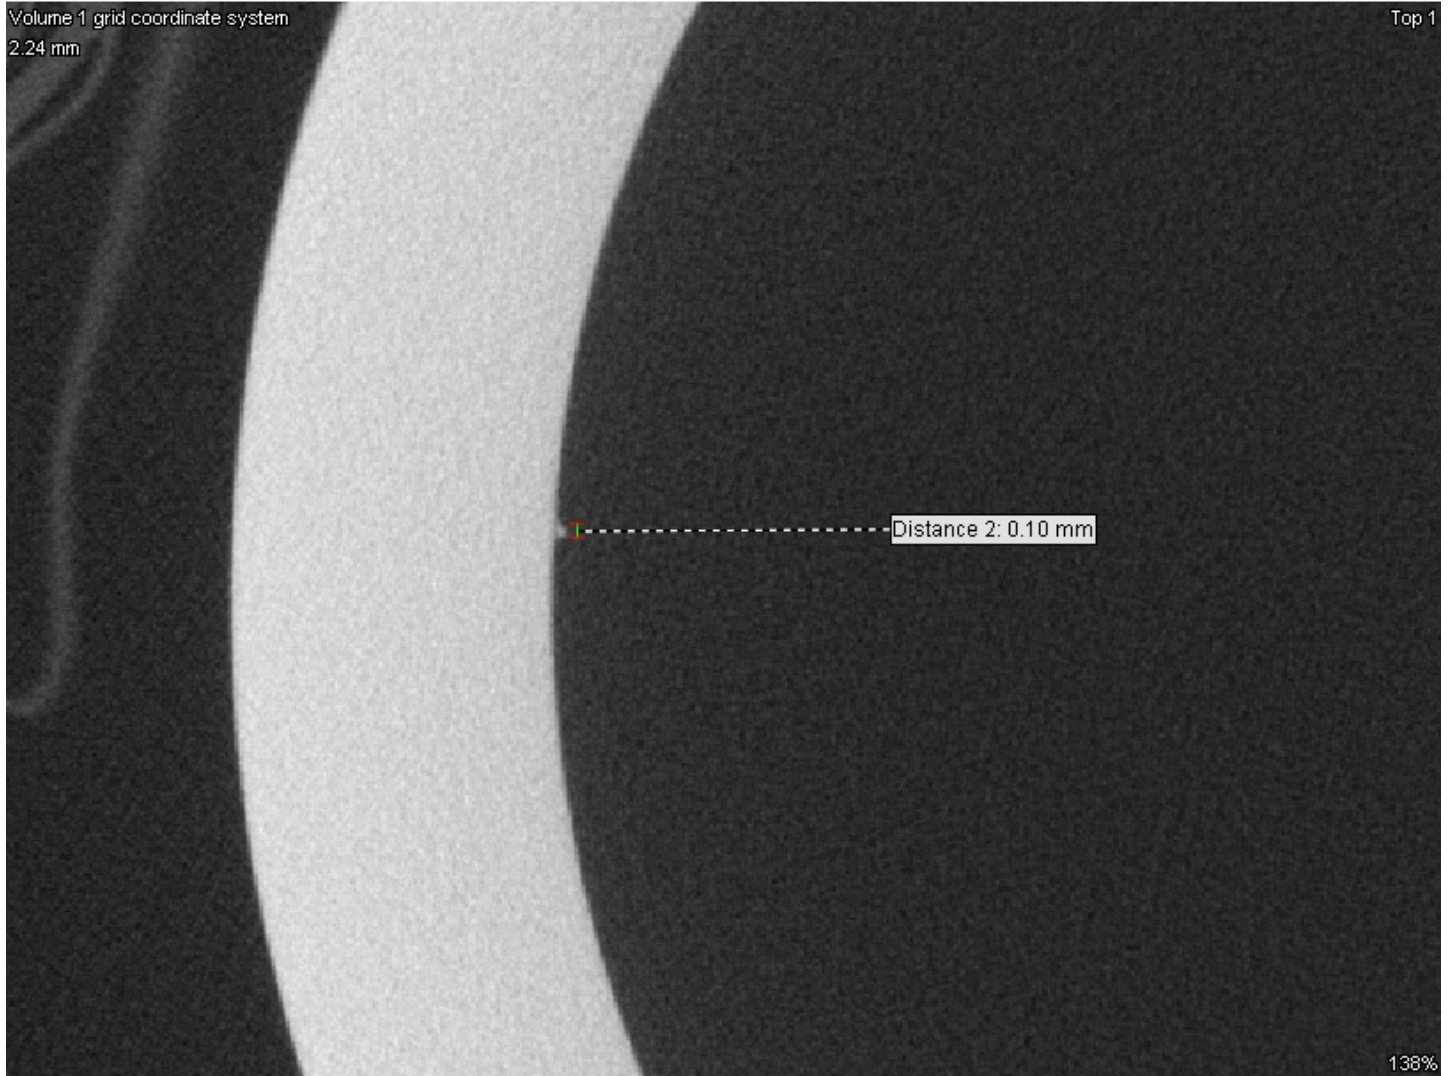
Figure 8
Axial Cross Section – Pressure Filter (section 514-518) – Particle measuring 0.10 mm x
0.13 mm on inside surface of inner support core

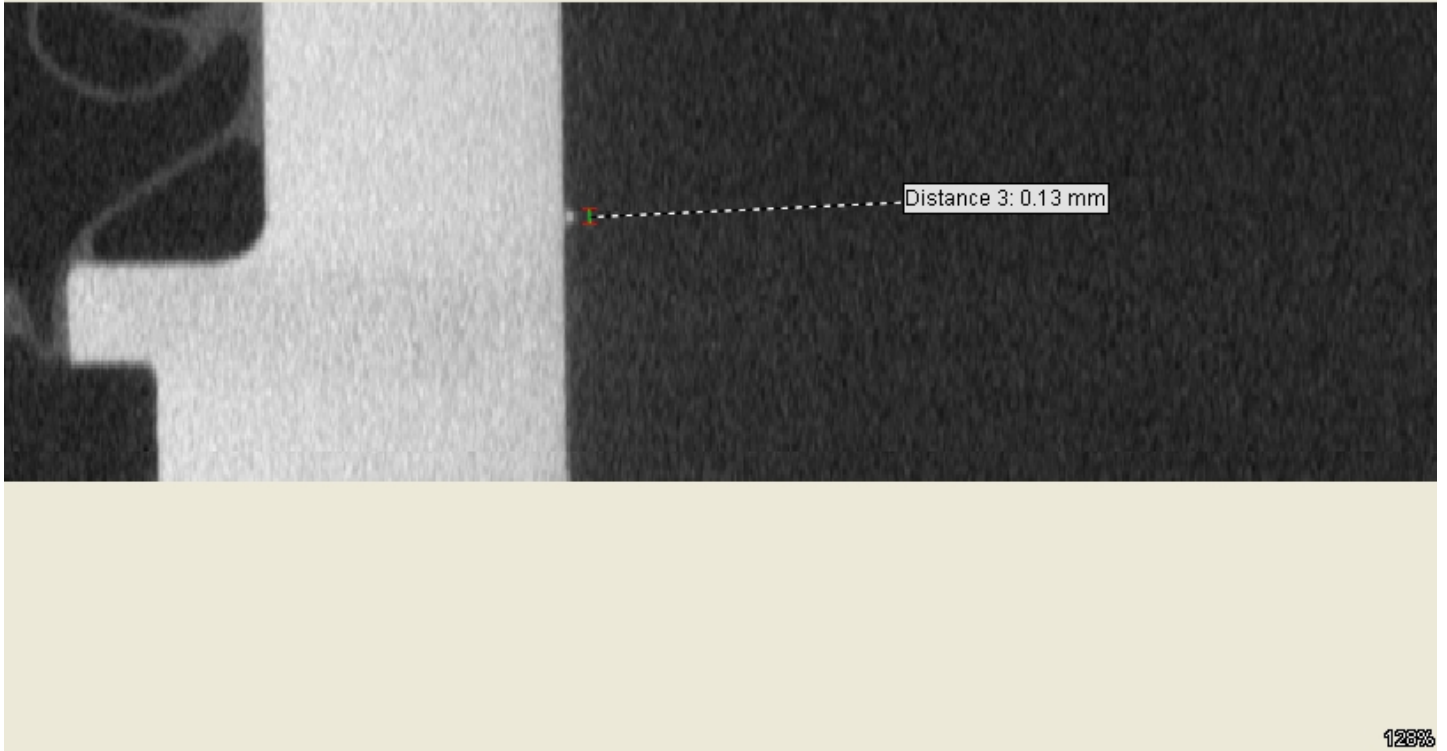
Figure 9
Frontal Cross Section – Pressure Filter (section 514-518) – Particle (shown in figure 8),
measuring 0.10 mm x 0.13 mm, resting on the inner surface of the inner support core

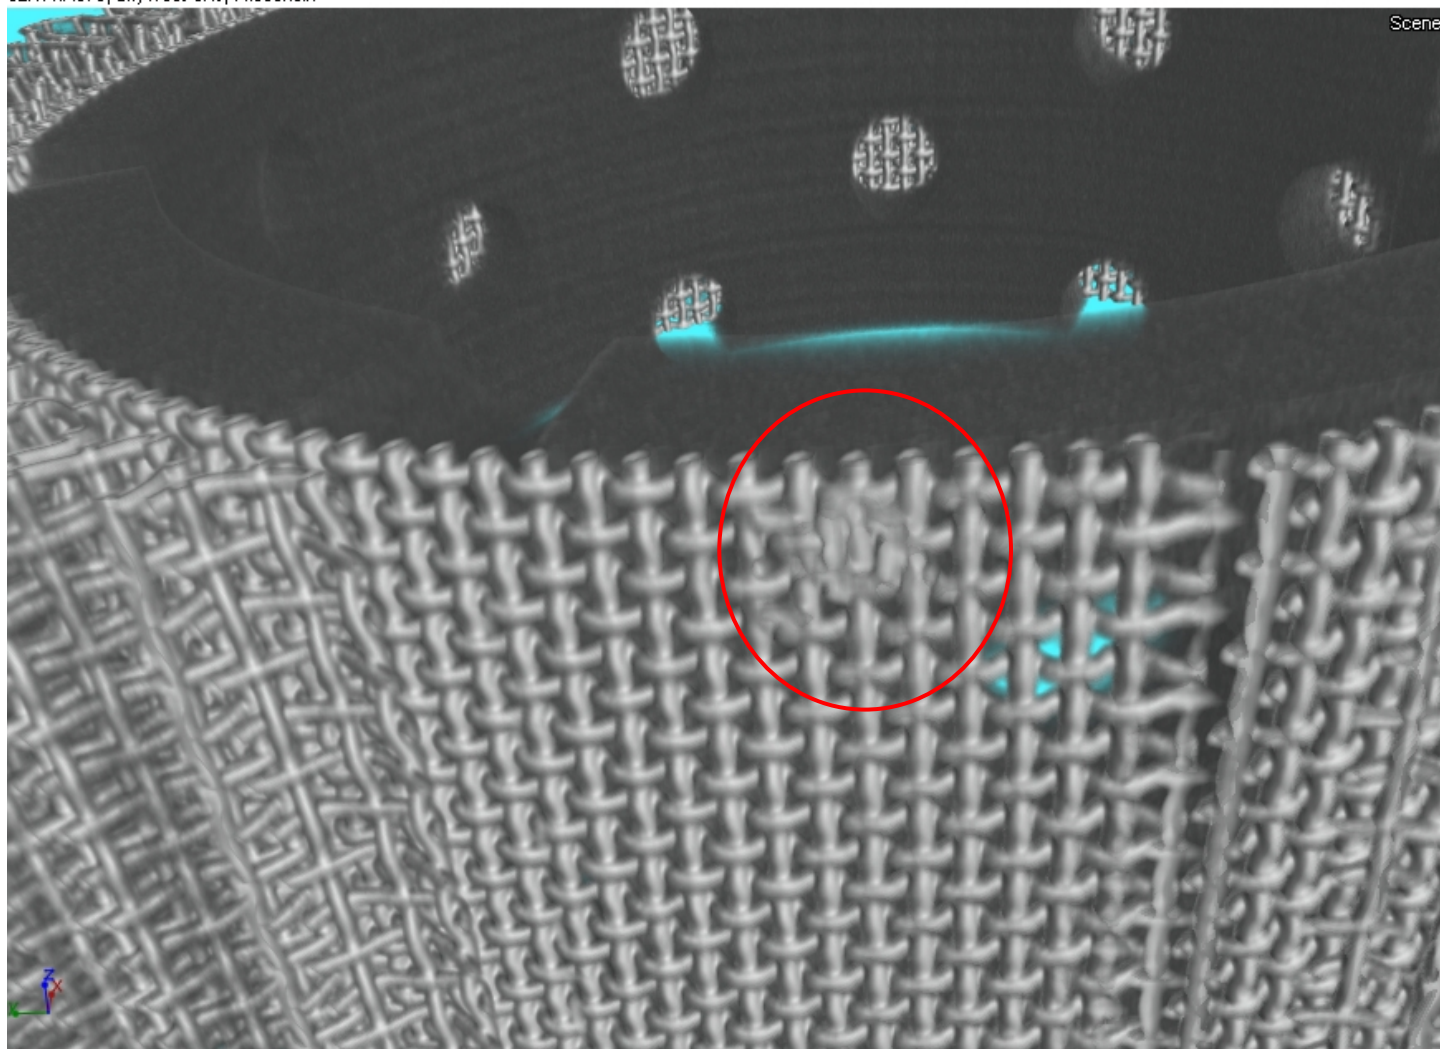
Figure 10
Three dimensional view – Return Filter (section 358-368) – Distortion in the
inner stainless steel mesh material

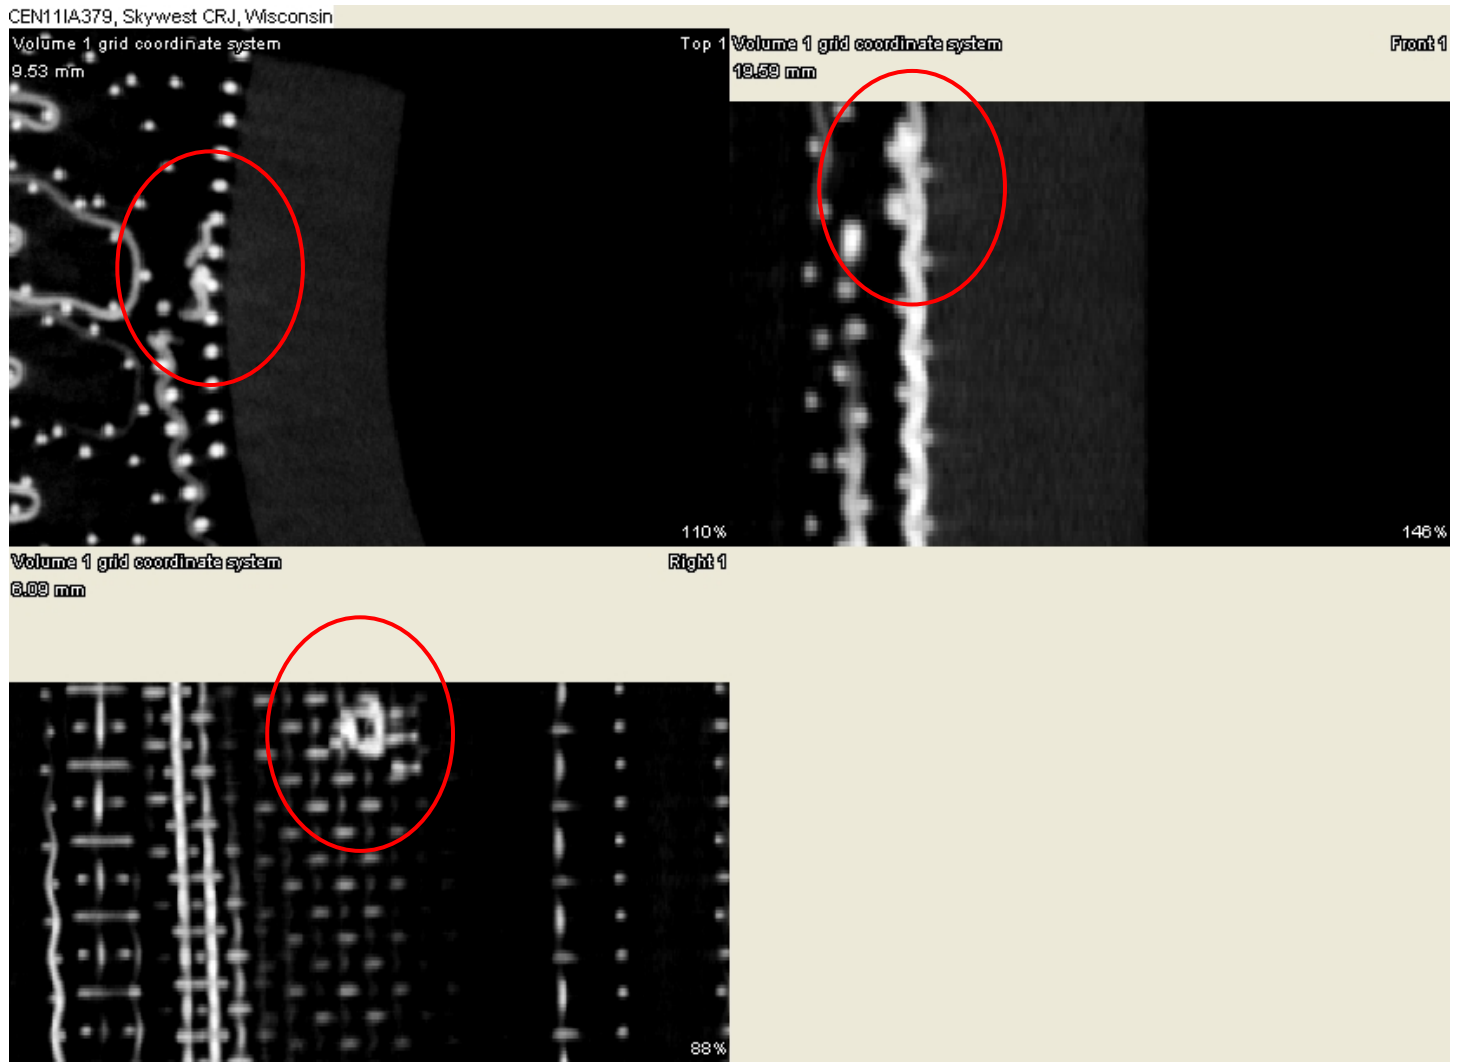
Figure 11
Multiple views – Return Filter (section 358-368) – Distortion in the inner stainless steel mesh material seen in figure 10

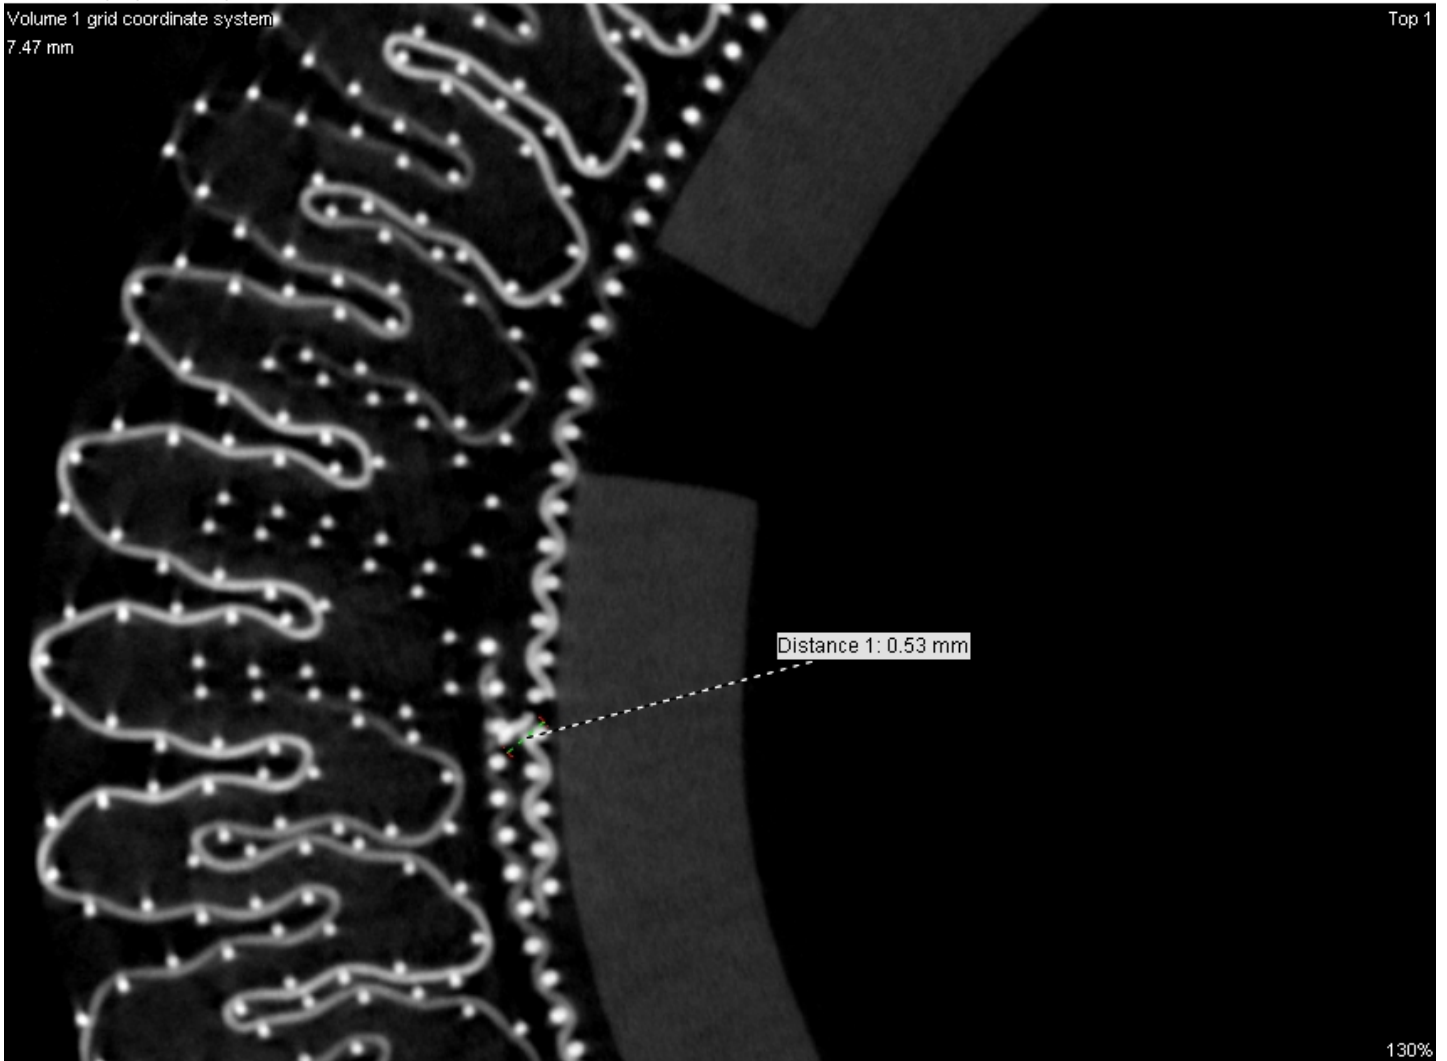
Figure 12
Axial Cross Section – Return Filter (section 408-418) – Particle, measuring
0.53 mm, located within the overlap area of the inner stainless steel mesh

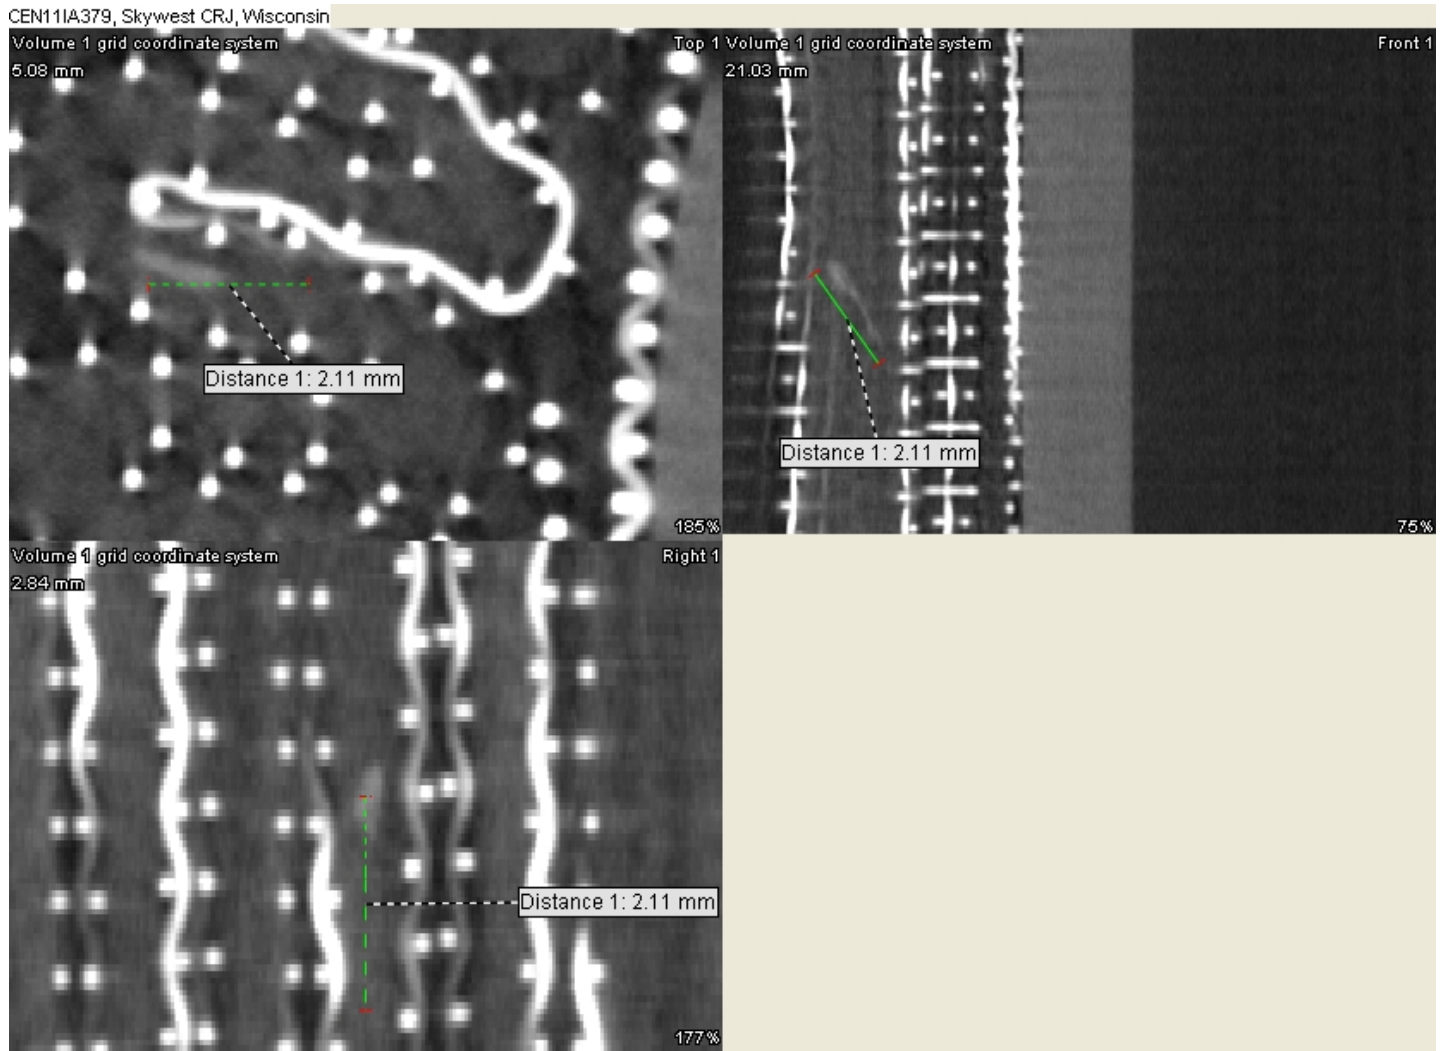
Figure 13
Multiple views – Return Filter (section 428-438) – High density area of filter material, measuring 2.11 mm long

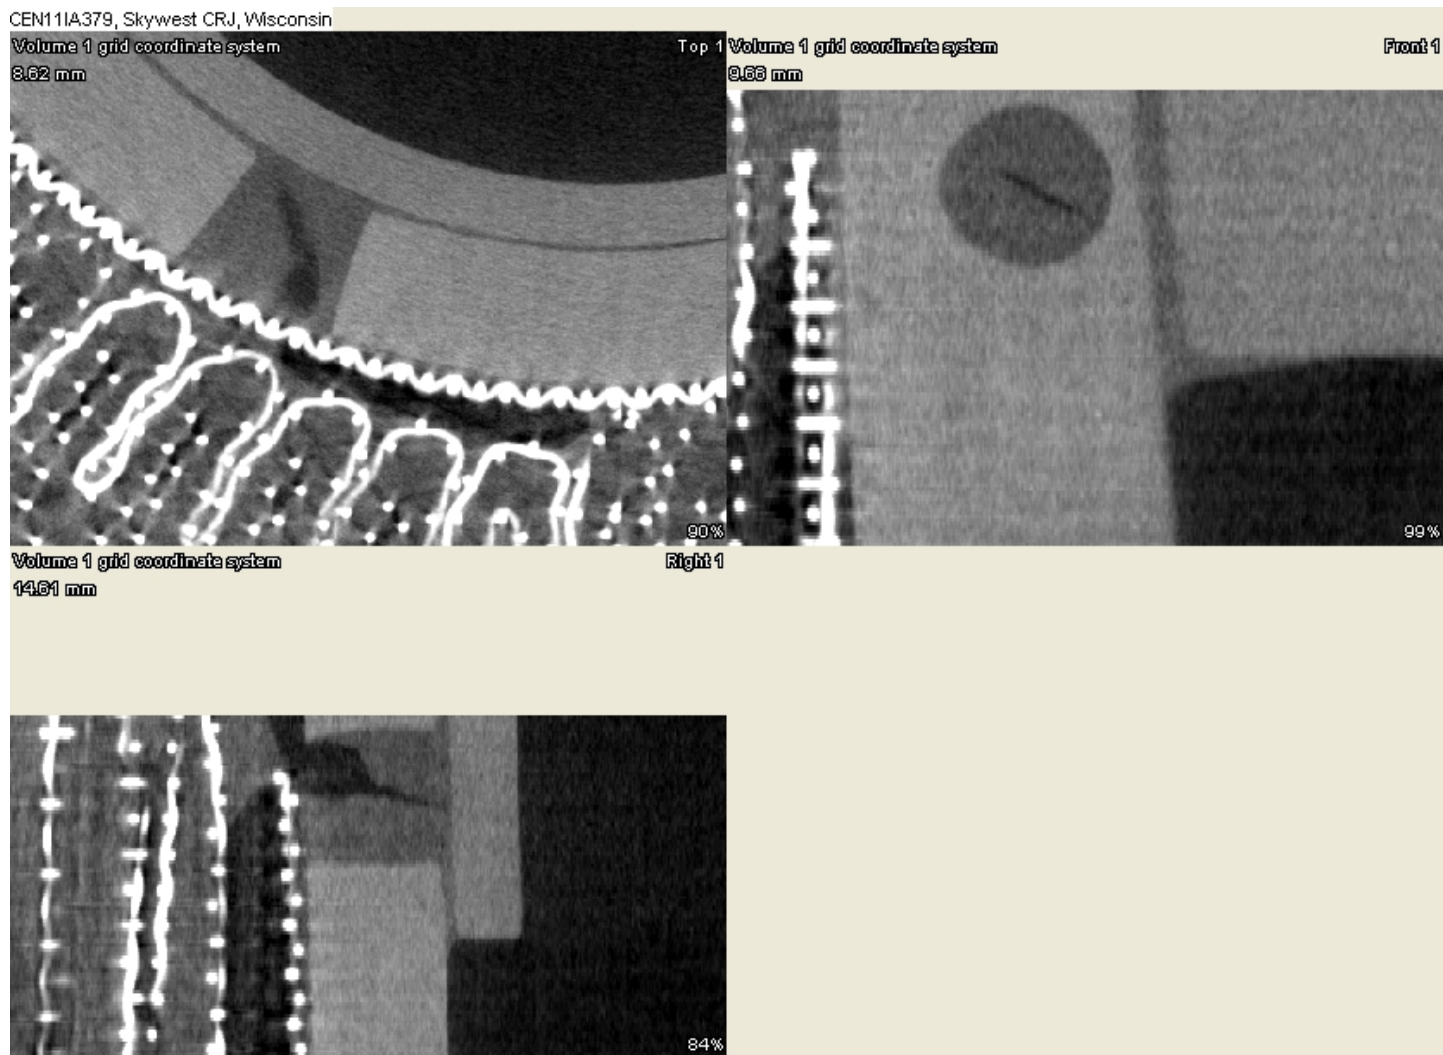
Figure 14
Multiple views – Return Filter (section 458-468) – Cracks in epoxy material
used in the filter end cap

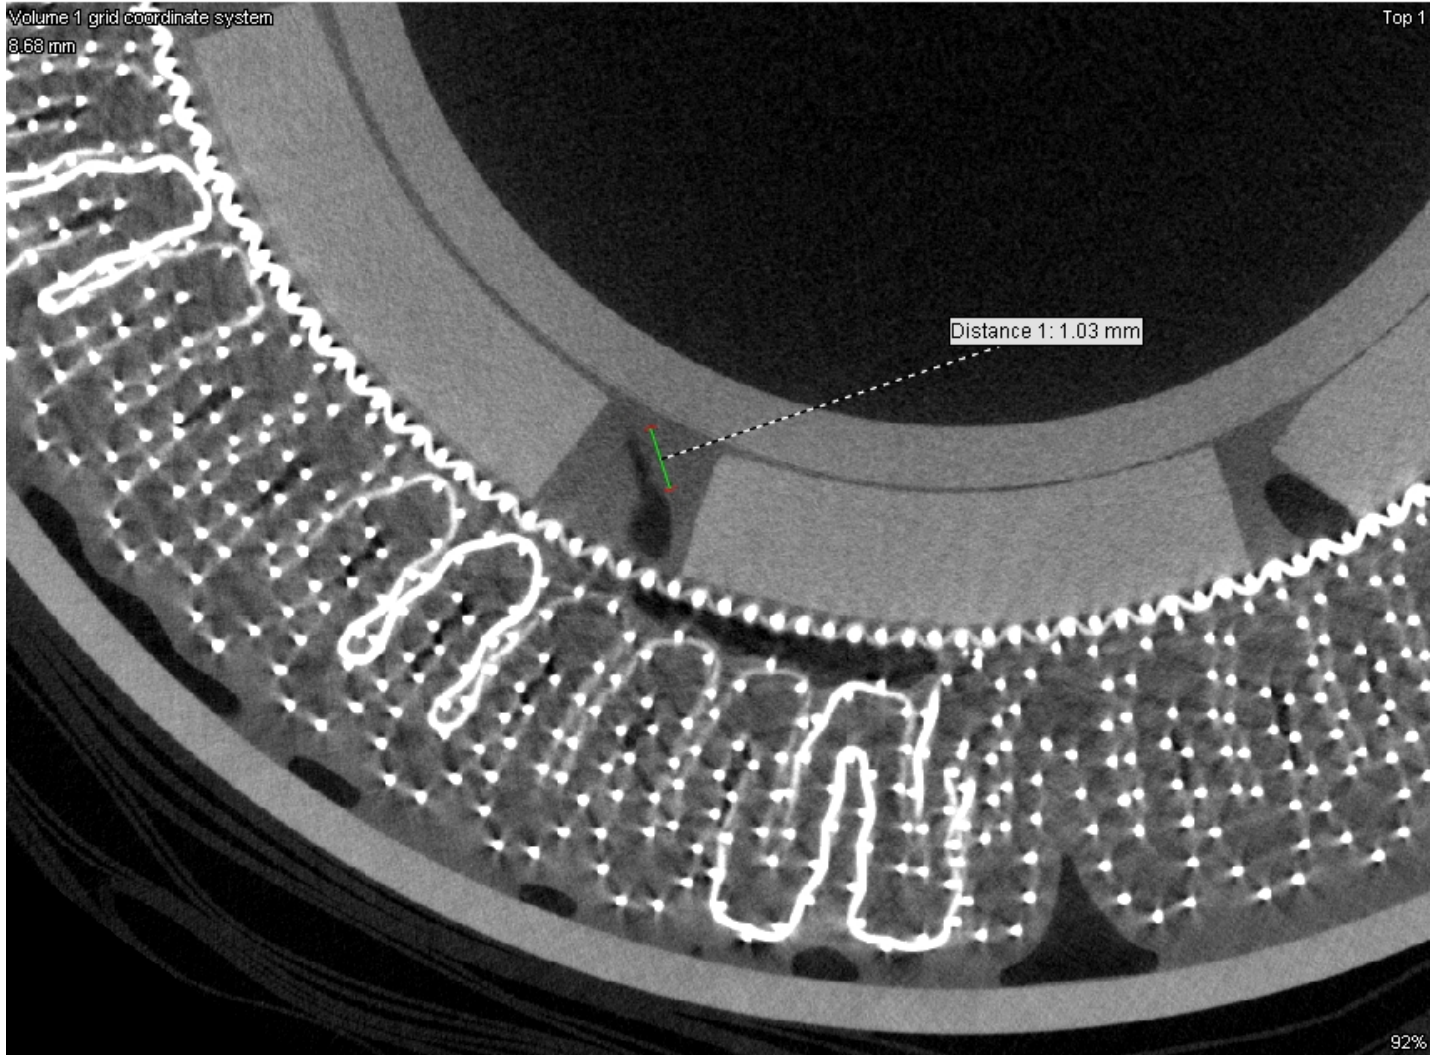
Figure 15
Axial view – Return Filter (section 458-468) – Close up view of crack in epoxy material (shown in figure 14), measuring 1.03 mm

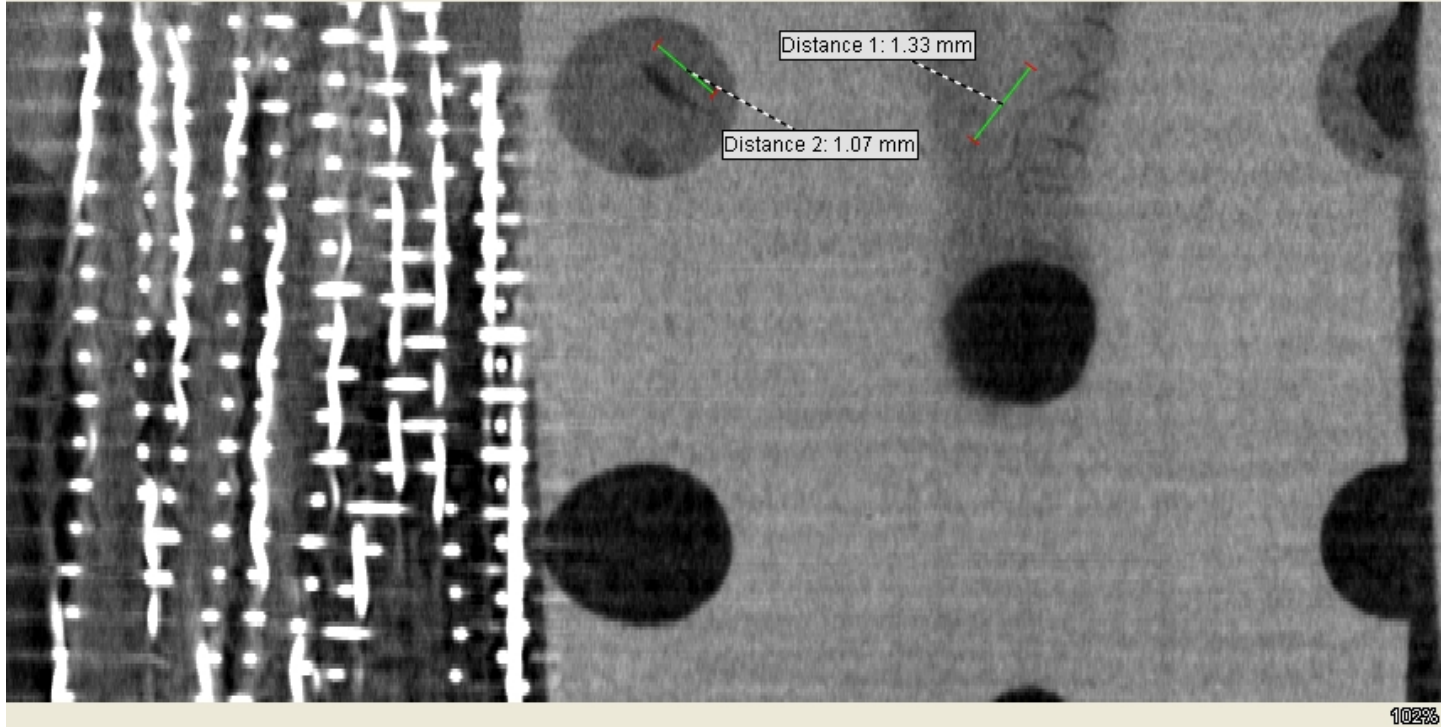
Figure 16
Frontal view – Return Filter (section 458-468) – Cracks in epoxy material
measuring 1.07 mm and 1.33 mm
