NATIONAL TRANSPORTATION SAFETY BOARD
Office of Aviation Safety
Washington, D.C. 20594

Computed Tomography Specialist's Factual Report

CEN-11-IA-379

Operator: Skywest Airlines
Location: General Mitchell Airport, Milwaukee, Wisconsin
Date: June 6, 2011
Time: 2132 central daylight time
Airplane: Bombardier CRJ-2B19, N866AS

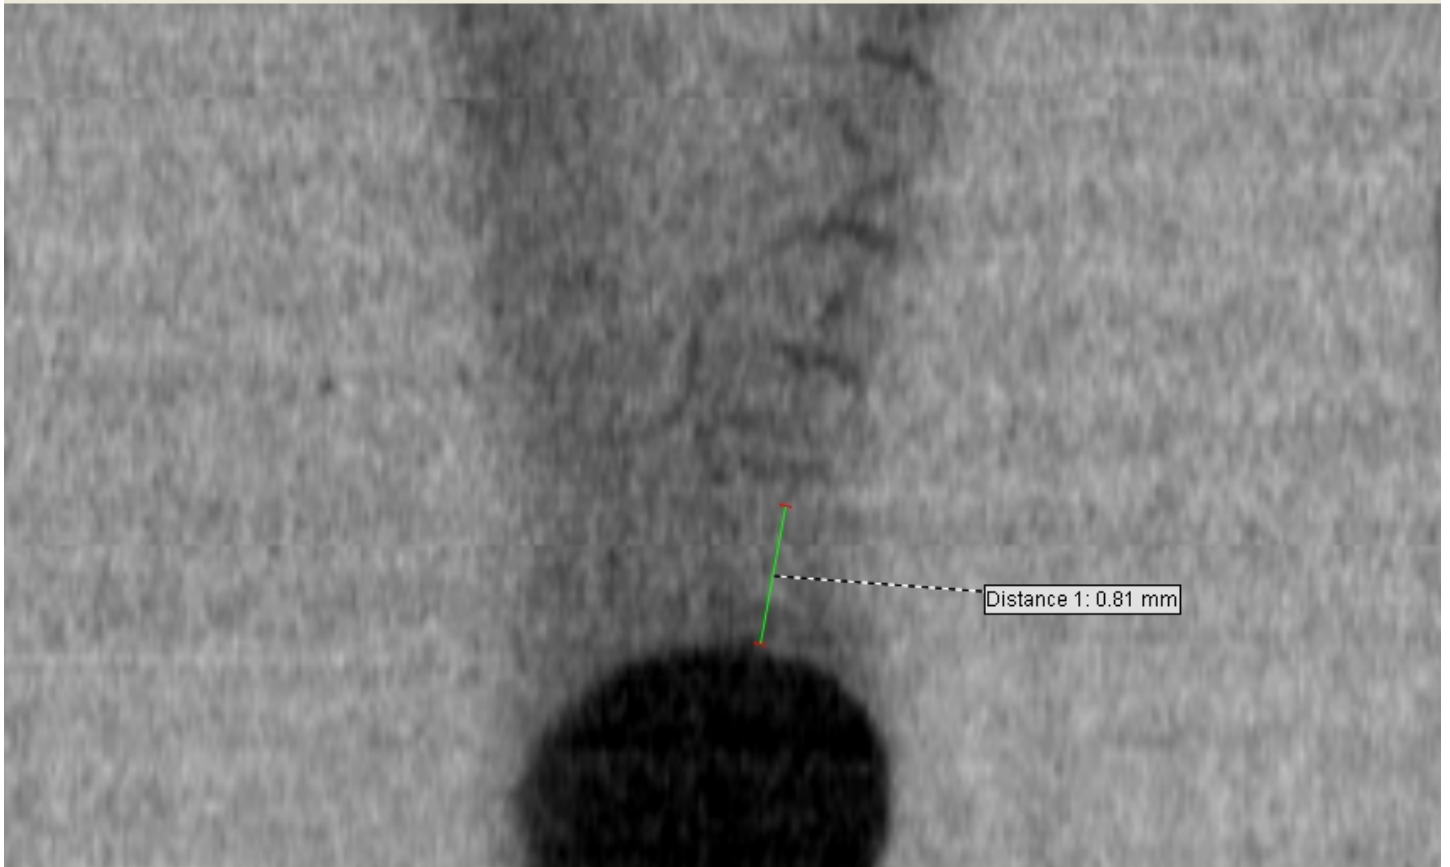
Figure 17
Frontal view – Return Filter (section 458-468) – Close up view of crack (shown in figure 17, labeled 1.33 mm) in epoxy material showing the network of cracks in the material and the distance from the cracks to the hole in the inner support core (0.81 mm)

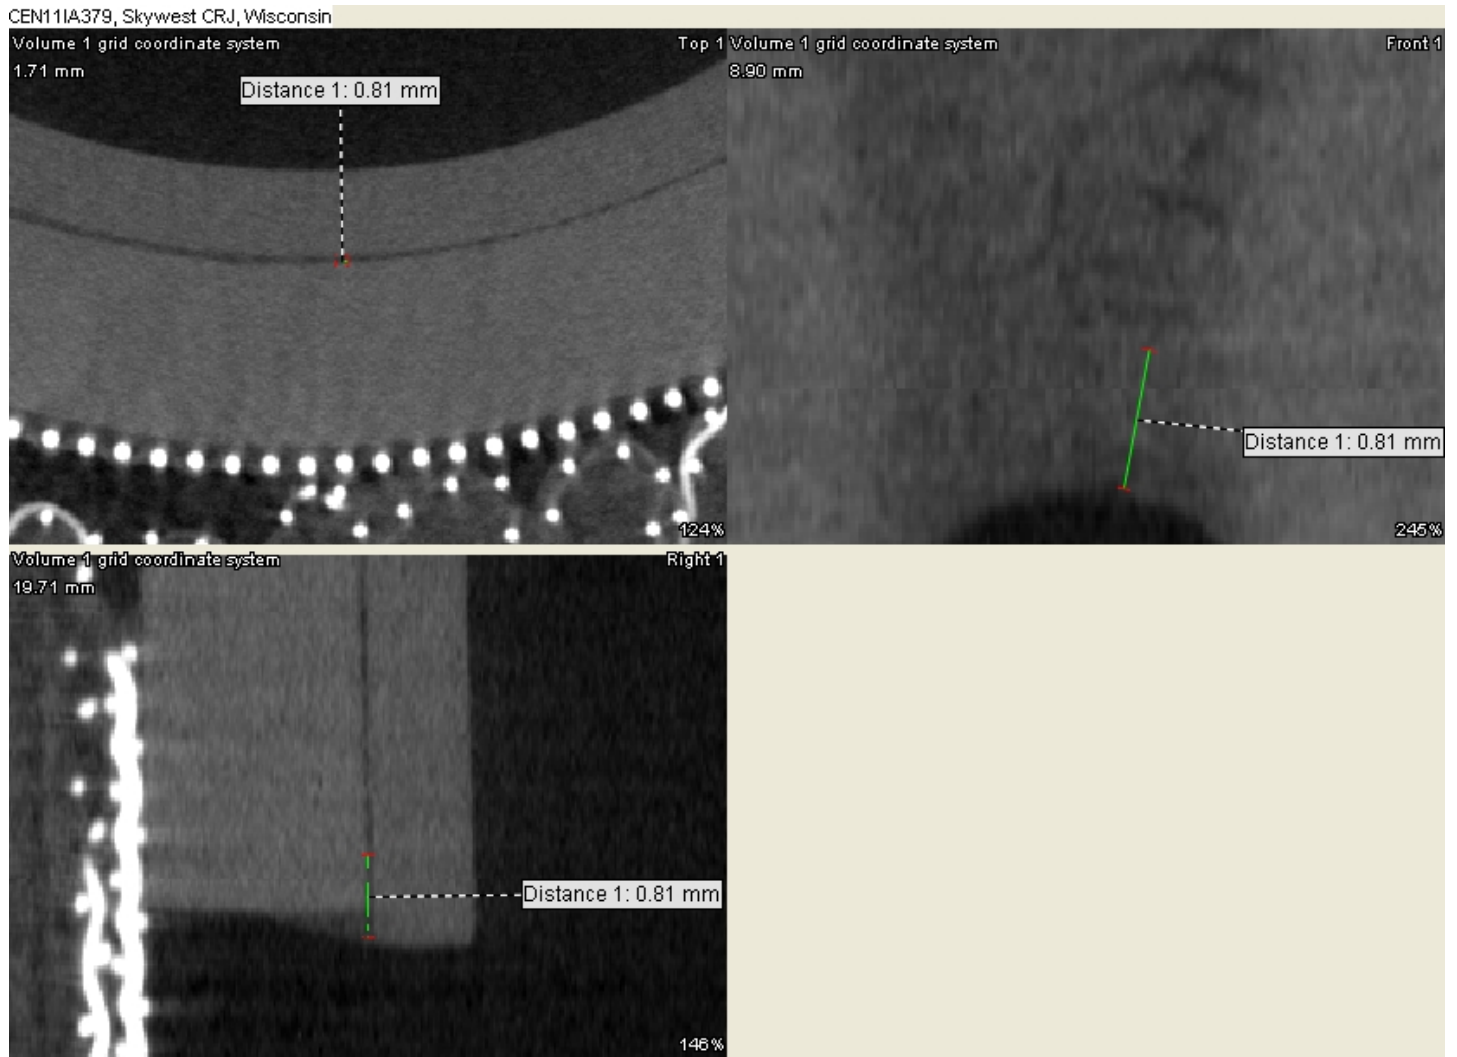
Figure 18
Multiple views – Return Filter (section 458-468) – Views showing the location of the network of cracks in the epoxy material (shown in figure 17)

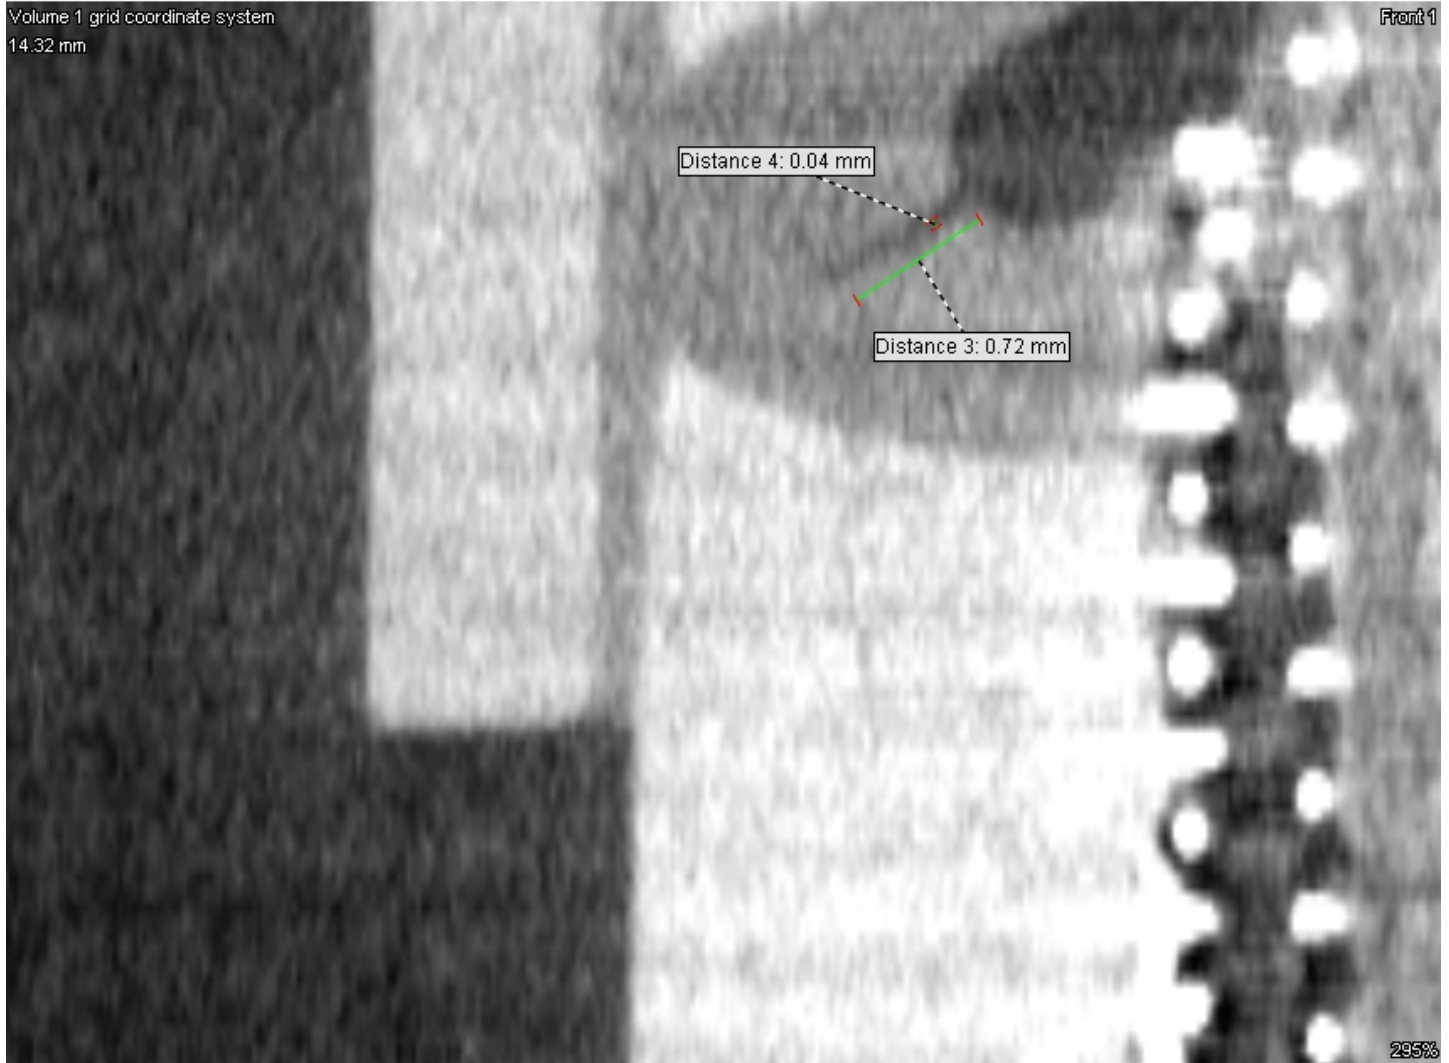
Figure 19
Frontal view – Return Filter (section 458-468) – Close up view of crack in epoxy material (not shown in previous figures), measuring 0.72 mm long and 0.04 mm wide
